**CALIFORNIA REGIONAL WATER QUALITY CONTROL BOARD
SAN DIEGO REGION**

In the matter of:)	
)	
San Diego County)	Order No. R9-2019-0020
Sanitation District)	
)	
February 2017 Sanitary Sewer)	
Overflow, Los Coches Creek,)	Settlement Agreement and
San Diego River)	Stipulation for Entry of
)	Administrative Civil Liability
)	Order
Place ID: 631623)

**CONCEPTUAL MITIGATION PLAN
SIERRA ALTA WAY WASTEWATER EMERGENCY PIPE REPLACEMENT PROJECT
LAKESIDE, SAN DIEGO COUNTY, CALIFORNIA**

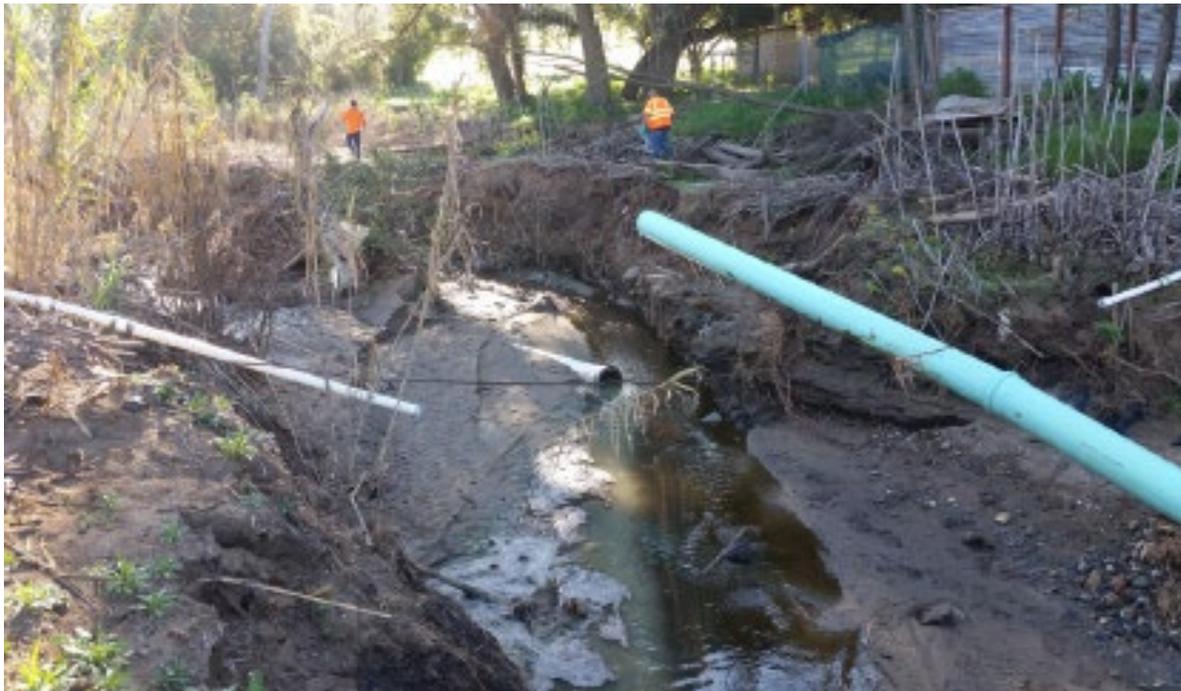
From February 28, 2017 to March 17, 2017 (18 days of discharge) a San Diego County Sanitation District (District) owned and operated sewer main discharged **762,739 gallons** of untreated raw sewage into Los Coches Creek, a water of the United States, in the vicinity of Sierra Alta Way in El Cajon, CA. The sewer main was damaged as result of stream bank erosion that occurred during a 25-year, 24-hour storm event near then end of February 2017 (see Photo 1). The damaged sewer main was discovered by District Staff during a routine maintenance inspection on March 17, 2017. The starting date of the SSO was determined by information obtained from a nearby property owner who noticed the pipe break on February 28, 2017. The eyewitness failed to contact any agency to report the pipe break.

PHOTO 1: Damaged 12-inch PVC sewer line in Los Coches Creek. (photo by SD Sanitation District)

Upon discovery of the damaged pipe, the District set up a bypass of the line, ceasing the discharge within 2 hours of their arrival on the scene. On March 18, 2017, the District hired an outside contractor to repair the line. The County of San Diego acting on behalf of the District applied for and received an emergency Clean Water Act Section 404 permit under Regional General Permit 63 (RGP 63) to conduct repair work in the creek. The repair activities resulted in permanent impacts to 0.05 acre (234 linear feet) within the channel of Los Coches Creek through the discharge of riprap to protect the repaired line, which remains in the creek, and temporary impacts to 0.1 acre (60 linear feet) (see Photo 2).

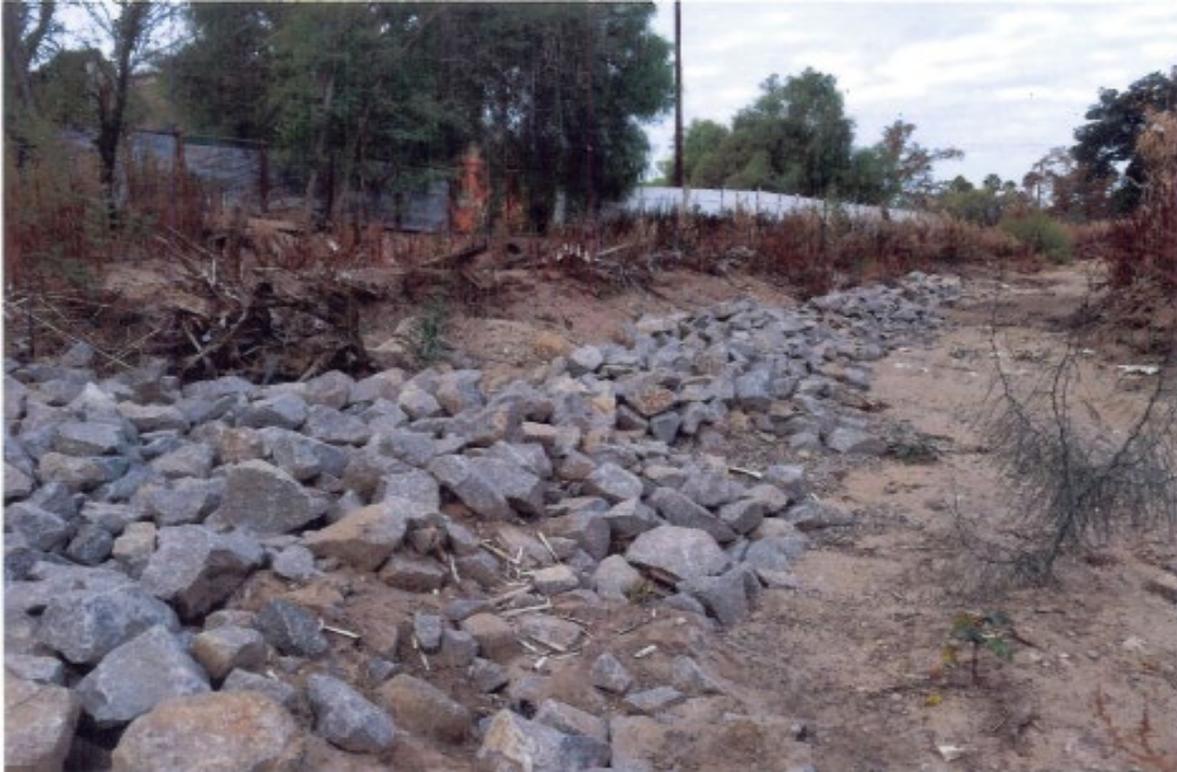
PHOTO 2: Rip rap protection installed in Los Coches Creek channel.

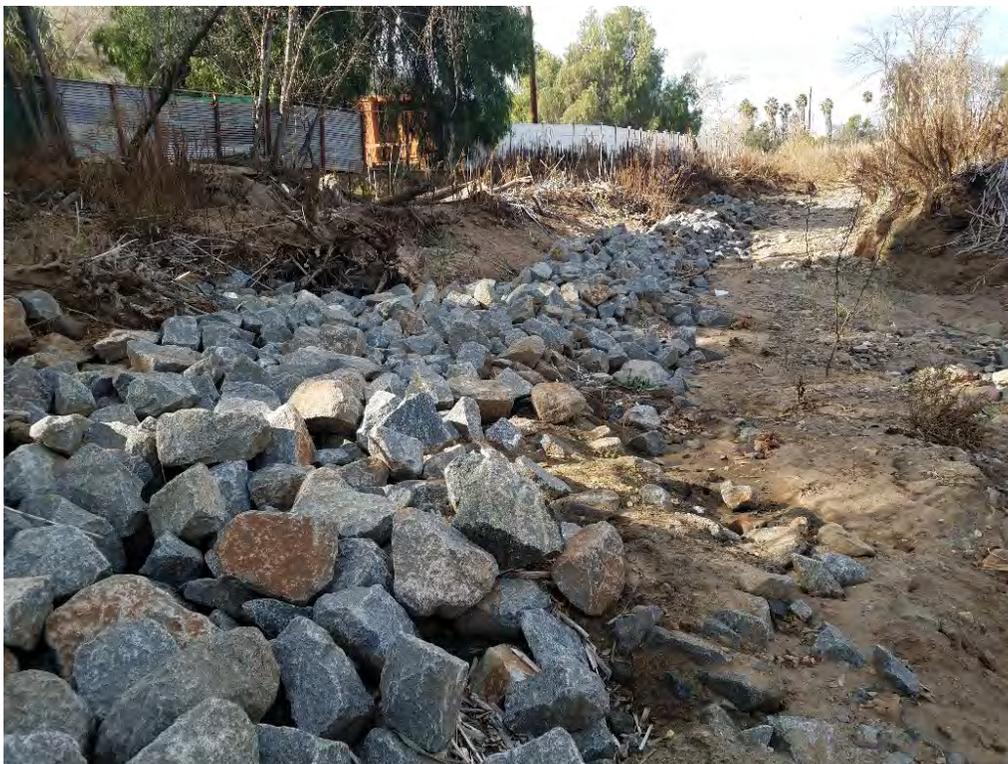
The broken section of sewer line was replaced and a total of 174 cubic yards of crushed rock (riprap) was installed on top of the replacement pipe to prevent future erosion and pipe failure. Overall, emergency maintenance activities were completed in compliance with avoidance and minimization measures, guidelines, and conditions of Regional General Permit No. 63, and the verification letter for the Sierra Alta Way Wastewater Emergency Pipe Replacement Project (File No. SPL-2017-00194-WSZ) issued April 3, 2017.

Photograph 1: Riprap Installed within Los Coches Creek. Facing West.

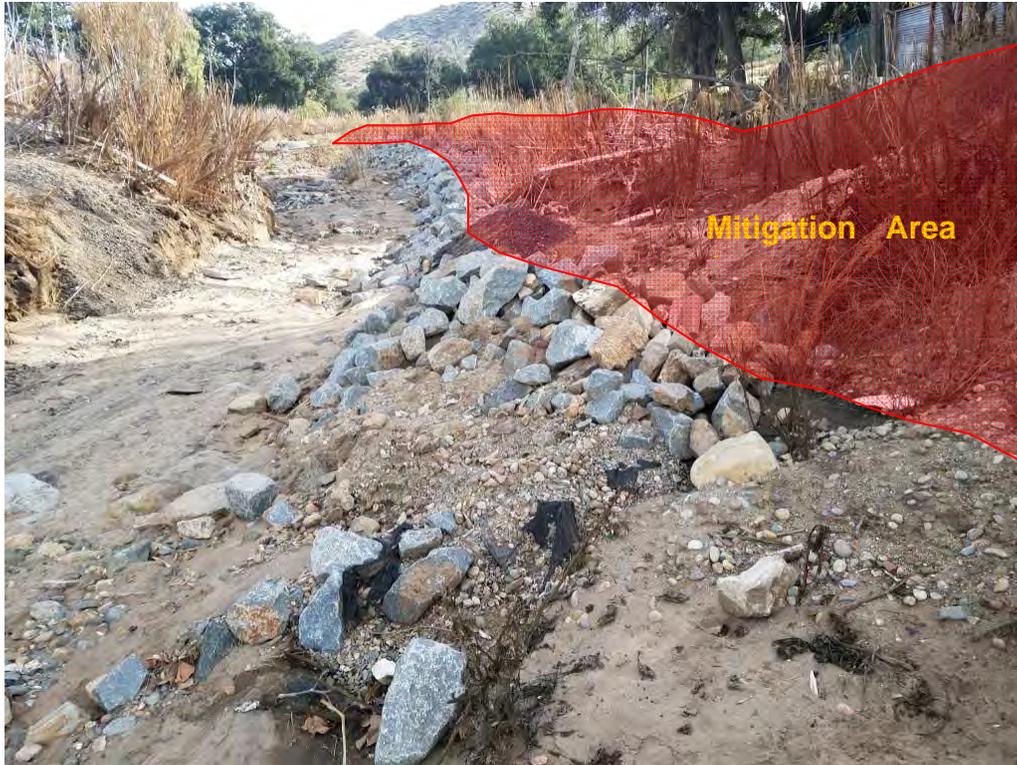
Photograph 2: Mitigation Area 1 along Southern Bank with Installed Riprap. Facing East.

At approximately 275 linear feet (0.06 acre) and 427 linear feet (0.09 acre) respectively, on-site re-establishment within Area 1 and Area 2 would mitigate permanent project impacts of 234 linear feet (0.05 acre) at a 3:1 ratio. Prior to the commencement of restoration activities, the boundaries of mitigation area will be field-verified to ensure that at least 702 linear feet of wetland and riparian habitat will be re-established along Los Coches Creek on-site.

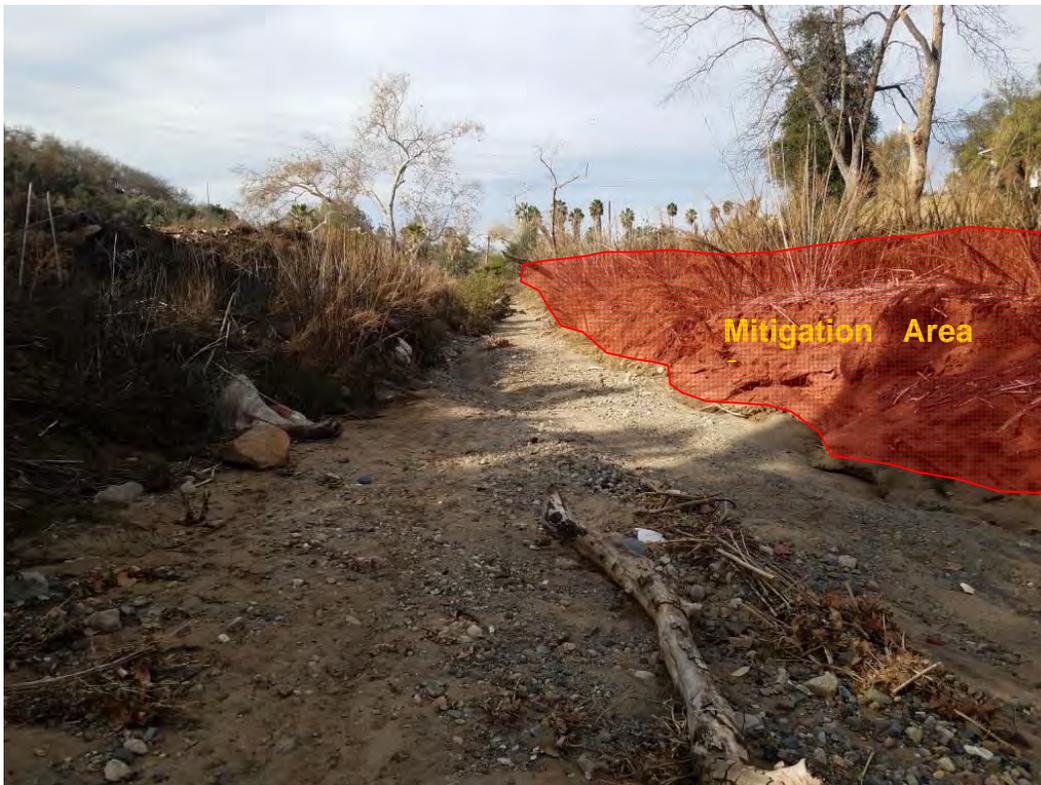
Photograph 3: Mitigation Area 2 along Northern Bank. Facing West.

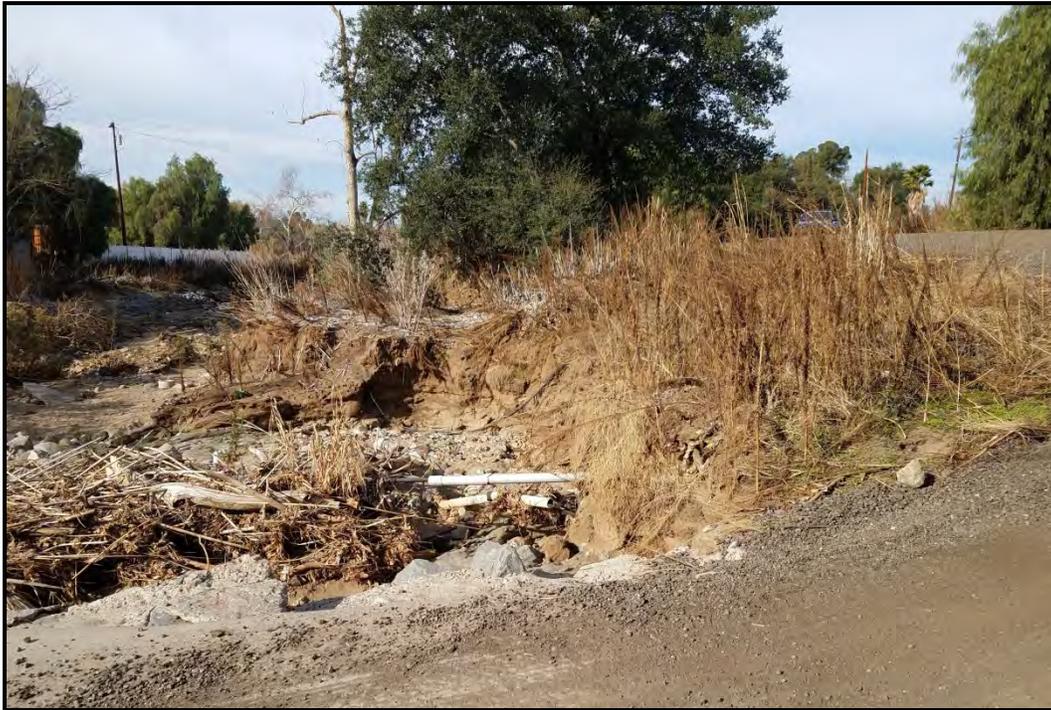
PHOTOGRAPH 1
View of Los Coches Creek and Disturbed Habitat within Survey Area
Facing West, January 30, 2018

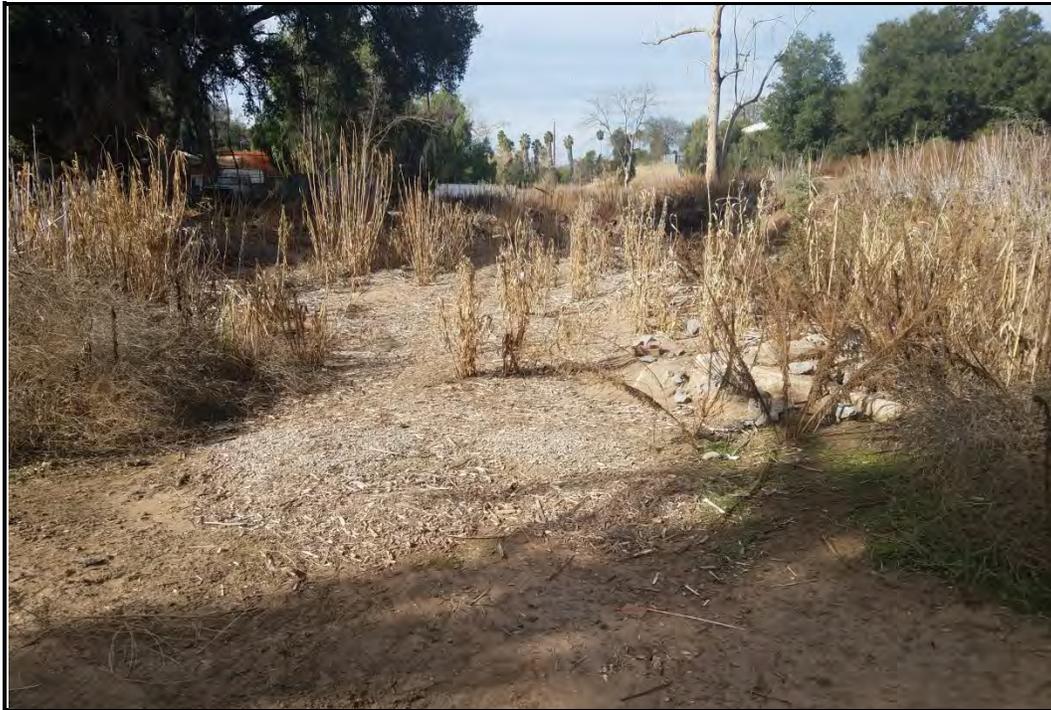
PHOTOGRAPH 2
View of Dead Giant Reed and Mulch in Disturbed Habitat South of
Los Coches Creek within Survey Area, Facing West, January 30, 2018

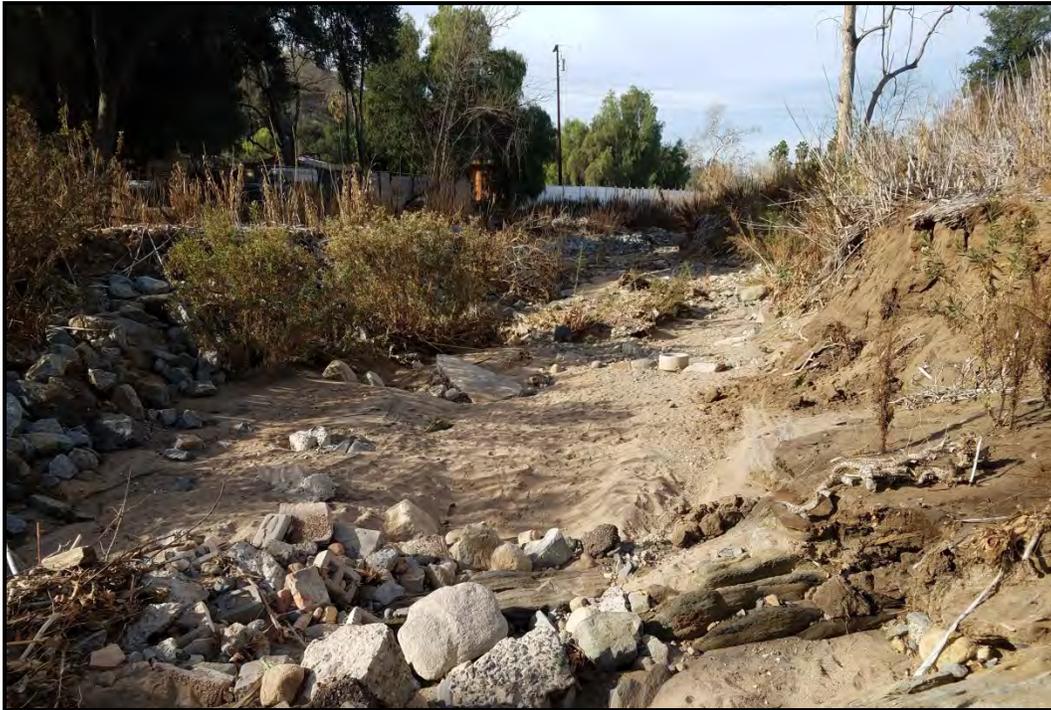
PHOTOGRAPH 3
View of Los Coches Creek within Project Area, Facing West
January 30, 2018

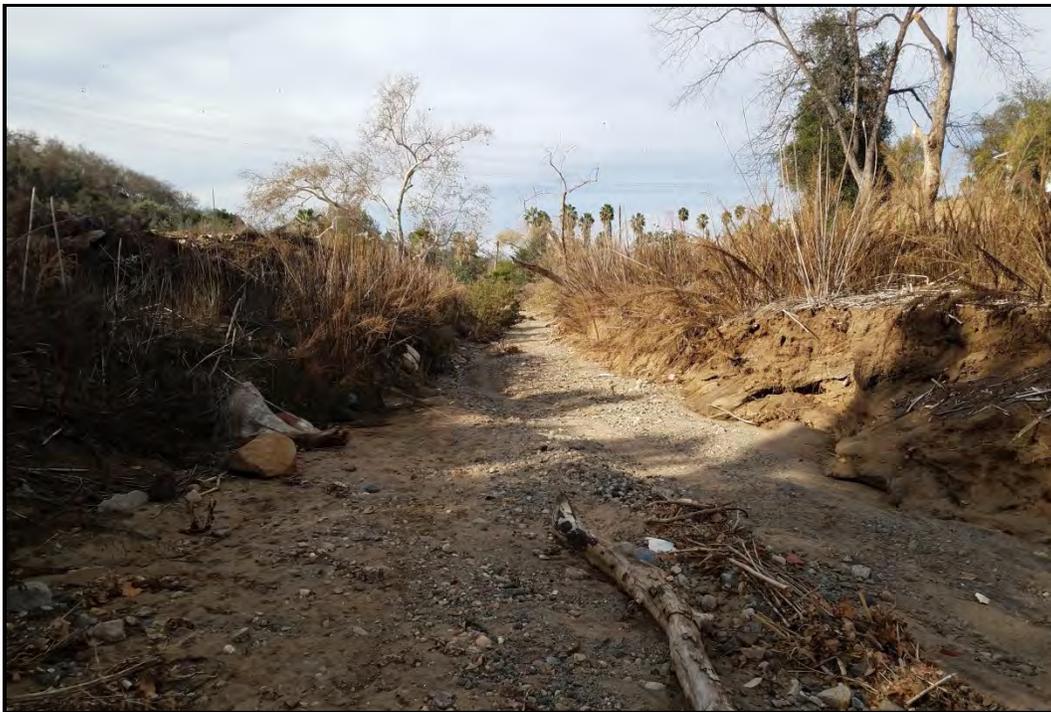
PHOTOGRAPH 4
View of Los Coches Creek Downstream of Project Area
within Survey Area, Facing West, January 30, 2018
