Re: Required Technical Report in Response Notice of Violation NO. R9-2007-0063, reference number CWU:10-3022900.02:neilb

Required Technical Report (RTR) Response to NOV No. R9-2007-0063

Response to Violations within the City of Oceanside

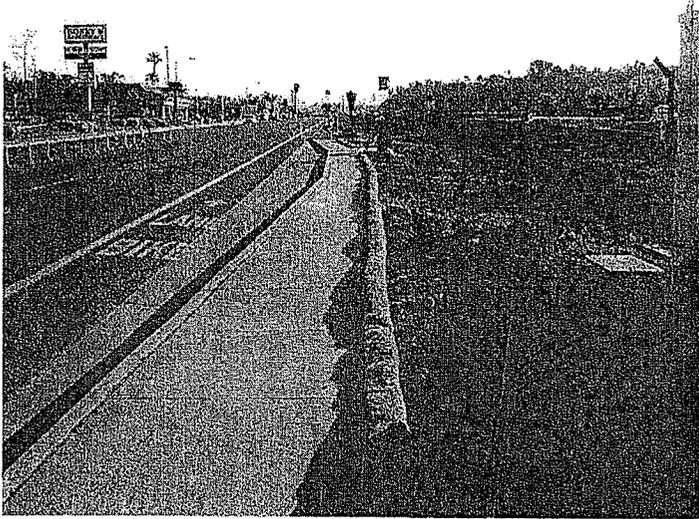
Observation: Your site entirely lacked effective sediment controls along the site perimeter. Fiber rolls have been driven over repeatedly destroying the fiber rolls. Other areas along Oceanside Blvd and Loma Alta Creek completely lacked sediment controls such as silt fencing or fiber rolls. Storm drain inlet protection had an inadequate amount of gravel bag protection and a temporary construction road built across the corner of one inlet.

Photo 1
Repair to Photo 1 in the NOV. New fiber rolls are in place.

Immediate actions: Immediately following the inspection, NCTD contractors replaced the fiber rolls along Oceanside Blvd (see photos 1 & 2). NCTD contractors likewise placed gravel bags two rows high around the drainage inlet to provide the necessary level of protection for the inlet (see photo 3).

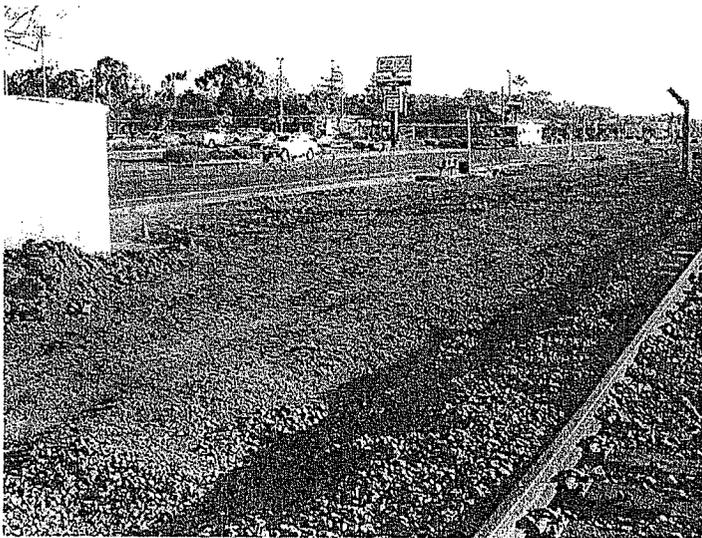
Photo 2
Repair to photo 2 in the NOV. Fiber rolls in place to provide sediment control.

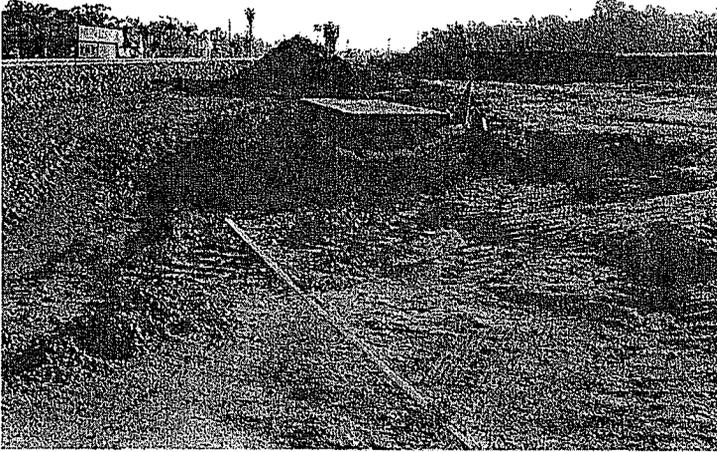
Repair to Photo 3 in the NOV. New gravel bags in place to provide adequate inlet protection.

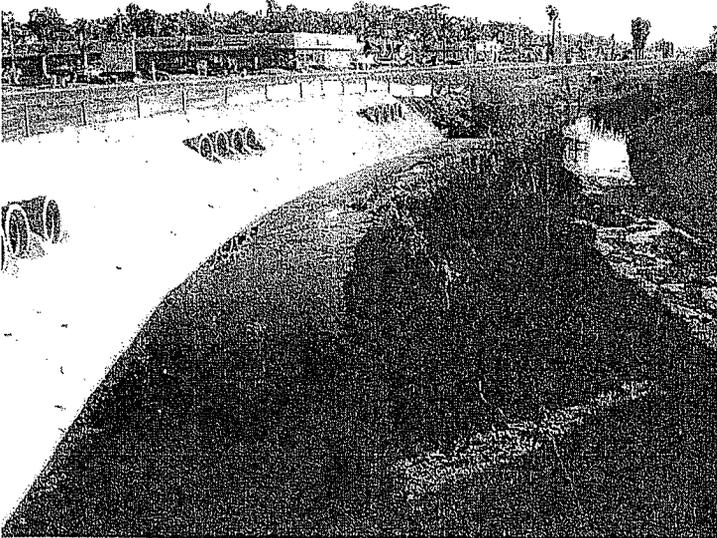
Photo 4

Repair to photo 4 in the NOV. Silt fence has been placed at the toe of slope next to the creek. The large amount of sediment in the middle was a preexisting condition.

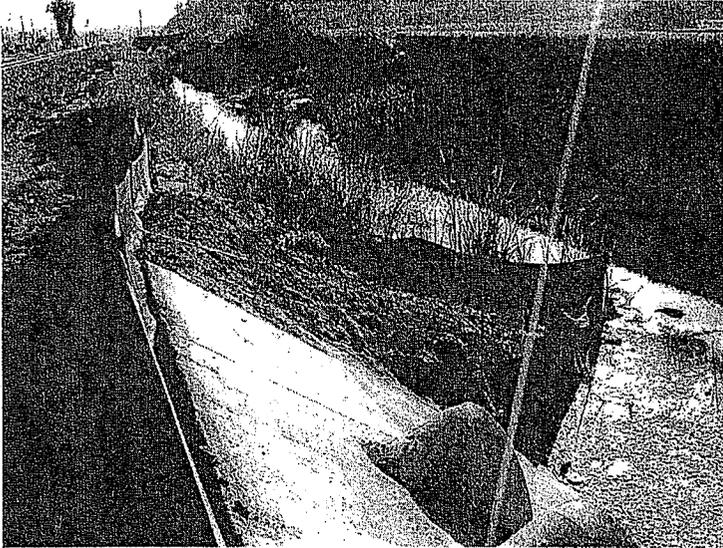
Observation: Your site was documented as having two unauthorized discharges of sediment to Loma Alta Creek. The two unauthorized discharges were within the City of Oceanside near the El Camino Real Road crossing and along Oceanside Blvd South near Union Plaza Court.

Photo 5
Repair to Photo 5 in the NOV. Silt fence has been placed at the toe of slope next to the creek.

Immediate Actions: NCTD Contractors installed silt fences and other sediment control BMPs to provide the proper level of protection for Loma Alta Creek (see photos 5, 6, 8, & 9).

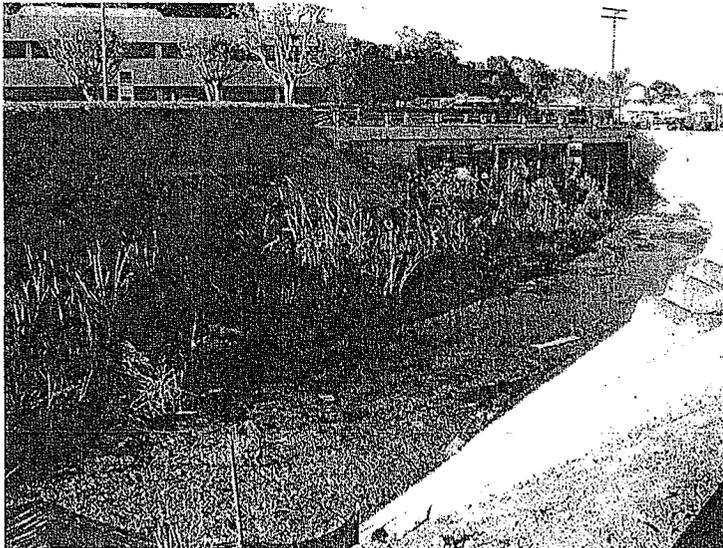
Photo 6
Repair to photo 6 in the NOV.

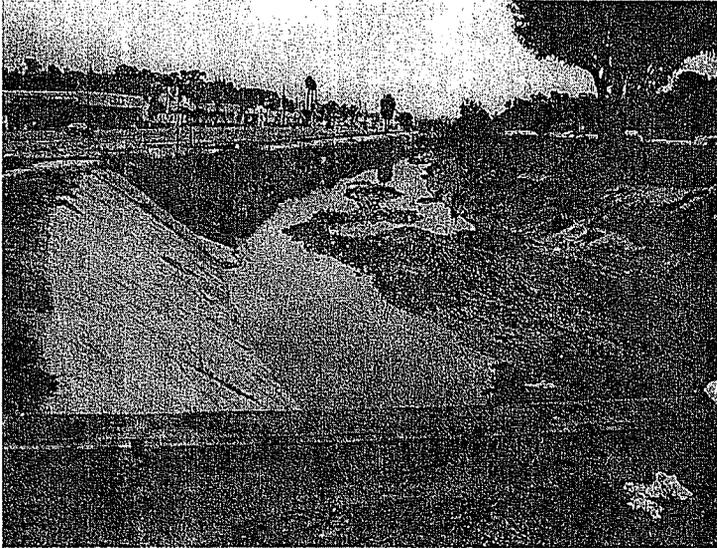
Site Status: Loma Alta creek now has the proper BMPs in place to protect against any sediment discharges. The large amount of sediment in the creek near El Camino Real Road (photo 6 in the NOV) was a preexisting condition (see photo 7 taken on 10/24/04). Recognizing that sediment is an ongoing a problem for the creek, NCTD contractors will pay extra attention to ensure that the recently upgraded BMPs are diligently maintained.

Photo 7
Preexisting condition for the area in NOV photo 6. Photo was taken on 10/26/2004.

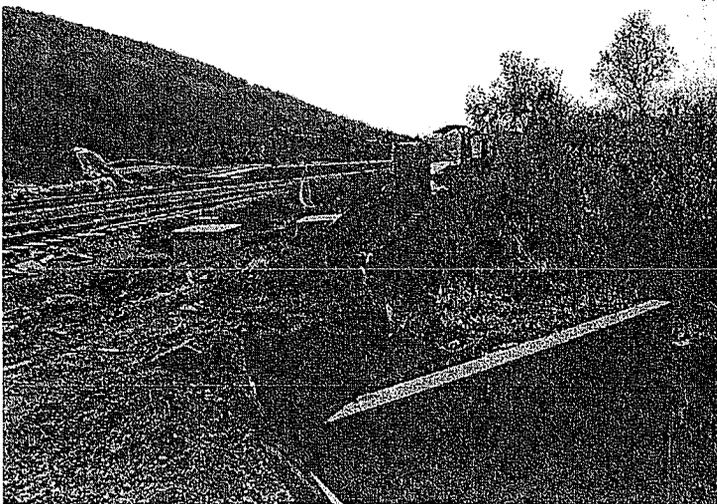
Photo 8
Repair to Photo 7 in the NOV.

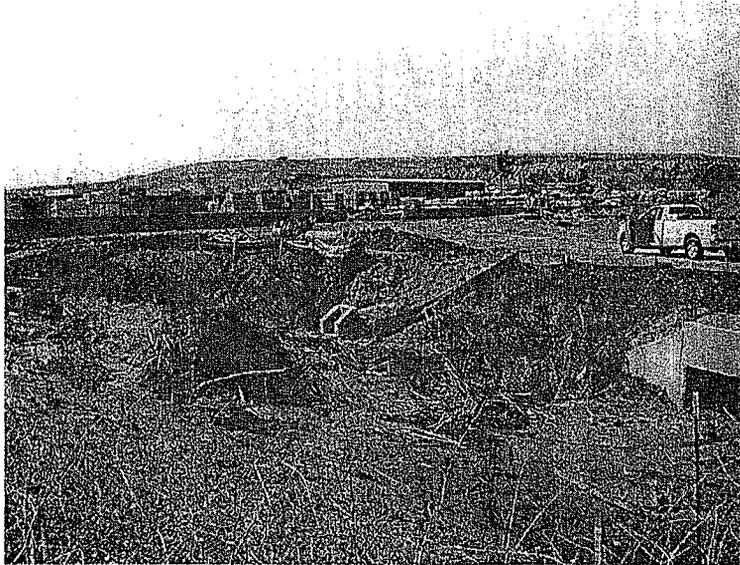
Repair to Photo 9 in the NOV. Silt fence has been placed around new drainage structure.

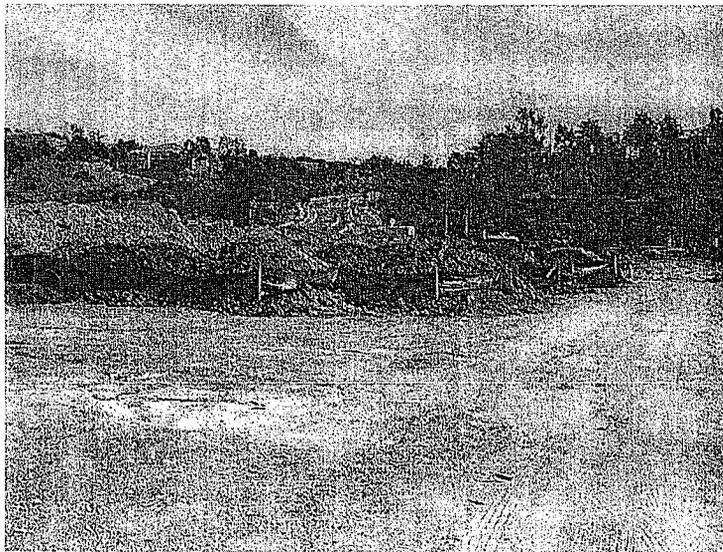
Photo 10

Observation: Your site had inadequate BMPs to minimize or eliminate the exposure to storm water to construction waste and trash. Near El Camino Real rail crossing, a soil stockpile and construction waste pile were uncovered and not contained to minimize exposure to storm water runoff.

Repair to photo 10 in the NOV. Soil stockpile has sediment perimeter control in place. Stockpile is active, but is still protected.

Immediate Actions: NCTD contractors placed silt fencing around the soil stockpile in the El Camino real yard. That stockpile has since been removed and used as backfill on the jobsite. NCTD contractors also placed silt fencing around the soil stockpile in the Rancho del Oro yard (photo 10). These BMPs remain in place. Lastly, NCTD contractors have cleaned up and properly disposed of any construction trash or debris at both yards.

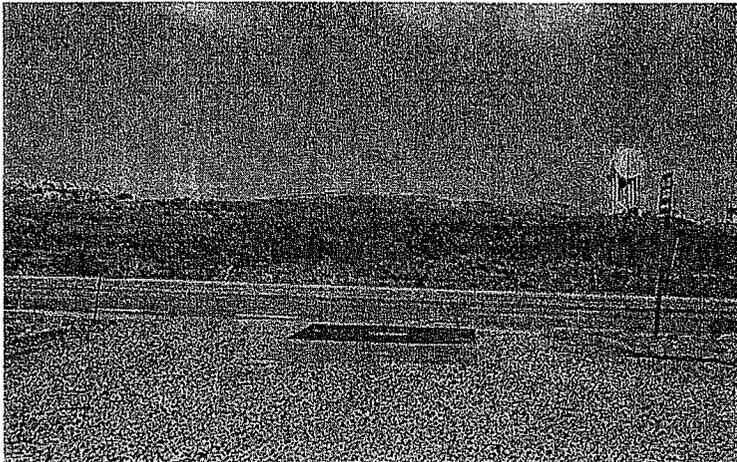
Photo 11

Observation: Construction site exits had insufficient BMPs to reduce the tracking of sediment onto paved roads. Significant sediment tracking was observed onto Oceanside Blvd near Rancho Del Oro. The rock gravel apron implemented to prevent tracking was inadequate in width and length. Site personnel purposefully drove around the rock apron to exit the site.

Repair to photo 11 in the NOV. More rock and 2 shaker plates have been placed. Rock extends the full width of the exit.

Immediate Actions: NCTD contractors have reconstructed the existing tracking control BMP. Contractors placed more aggregate around the BMP to make sure that it was the proper length (fifty feet). The BMP was additionally extended so that it covers the entire width of the entrance/exit point (photo 11). Third, NCTD instructed workers to make sure they drove over the BMP, rather than around it, to avoid sediment tracking. Lastly, NCTD contractors are using sweepers on a regular basis to clean up any sediment tracking throughout the project.
