**WRITTEN MATERIAL SUBMISSION FOR  
DECEMBER 12, 2007 AGENDA ITEM NO. 16  
COMPLAINT NO. R9-2007-0099  
(TENTATIVE ORDER NO. R9-2007-0215)  
FOR ADMINISTRATIVE CIVIL LIABILITY AGAINST THE CITIES OF  
VISTA AND CARLSBAD FOR VIOLATION OF NO. R9-2006-0003-DWQ,  
STATEWIDE GENERAL WASTE DISCHARGE REQUIREMENTS FOR  
SANITARY SEWER SYSTEMS  
(Reference: NCRU:01-0743.02 & 01-0764.02:ebecker)**

## **INVESTIGATIVE ORDER NO. R9-2007-0060, DISCHARGE OF UNTREATED SEWAGE INTO BUENA VISTA LAGOON, WITHIN THE CITY OF CARLSBAD, SAN DIEGO COUNTY**

**INVESTIGATIVE ORDER NO. R9-2007-0060  
FOR  
CITY OF VISTA  
CARLSBAD MUNICIPAL WATER DISTRICT  
VIOLATION OF WASTE DISCHARGE REQUIREMENTS NO. R9-2007-0005  
FOR THE  
DISCHARGE OF UNTREATED SEWAGE INTO THE BUENA VISTA LAGOON  
WITHIN THE CITY OF CARLSBAD  
SAN DIEGO COUNTY**

**CITY OF CARLSBAD  
24-INCH FORCE MAIN FAILURE  
BUENA VISTA LAGOON  
Carlsbad, California  
NCRU: 01-0743.02 & 01-764.02:ebecker**

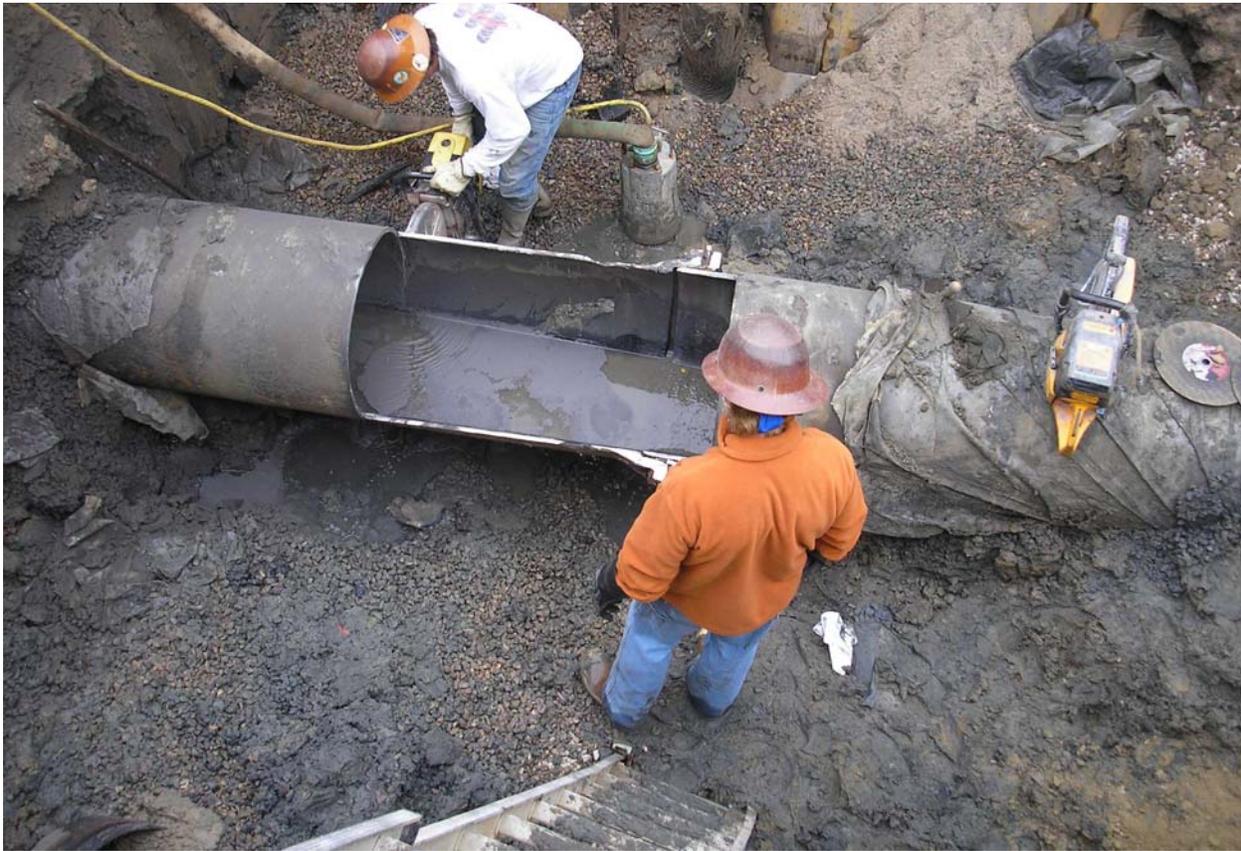
It does preliminarily appear that the cause of the failure was external corrosion. The early testing of soils from the site by Schiff Associates, Inc. indicates a highly corrosive

In order to perform properly and obtain maximum protection, the polyethylene encasement must be installed correctly. This requires correct wrapping and sealing of encasement sections. It also requires care be given to prevent rips or tears during installation. By examination of available design documentation for the pipeline construction and testing that has been performed on the *in situ* pipe and polyethylene liner materials, there is nothing to suggest that corrosion damage is more widespread than that found on the specific segment of the pipe where the failure occurred. In fact, the pipeline extending in both directions from the 3'9" segment that was removed and replaced is in excellent condition and shows no corrosion (see photo).

Corroded segment of pipe being removed.

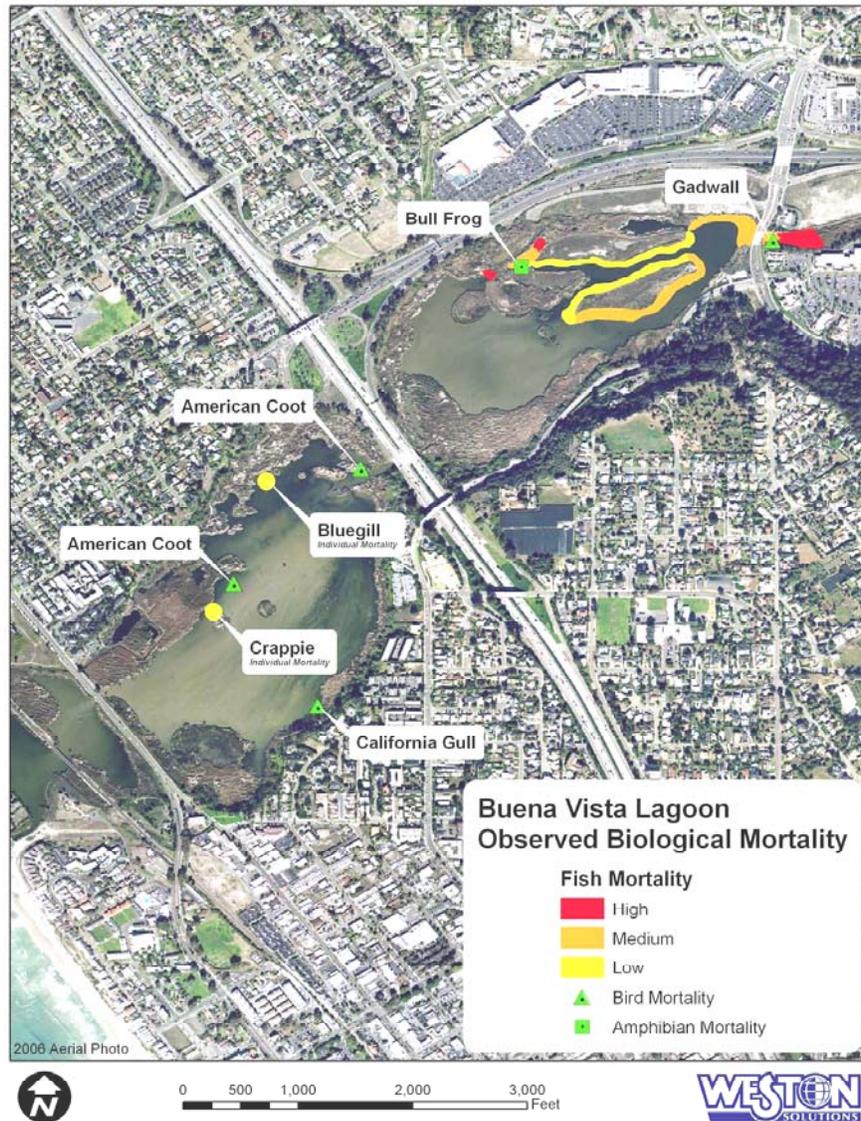
One bullfrog was found dead in the east basin (Figure 4).

**Figure 4.** Distribution of fish and bird collections during April 2007 spill.

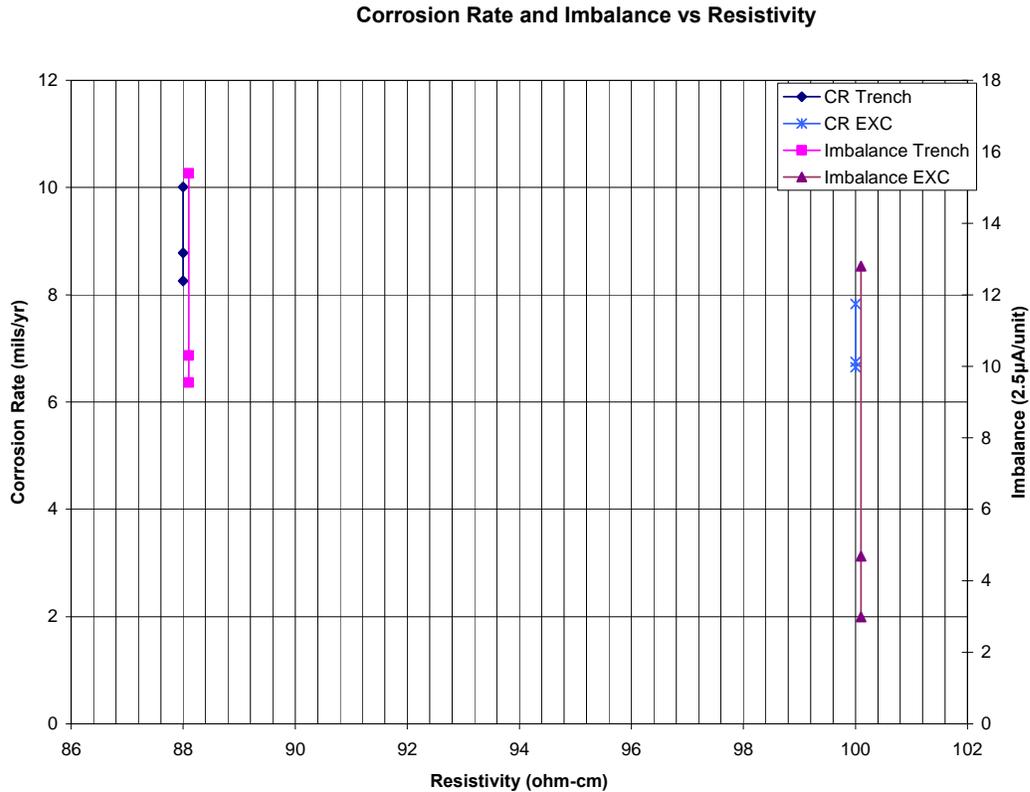
The measurements taken from both of the soil samples, shown in Figure 1, indicate that both general corrosion and localized corrosion are taking place.

**Figure 1: Linear Polarization Tests and Electrochemical Imbalance for Soil Samples from Excavation**

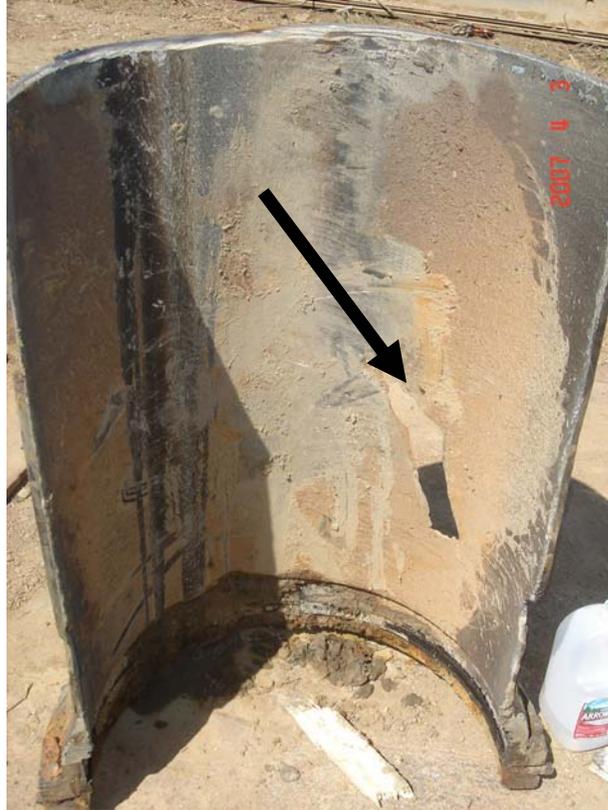
Inspection of the pipe at the rupture site showed the internal surfaces were in excellent condition, with no observable internal corrosion. The section removed was inspected in greater detail and also showed no internal corrosion of the mortar lining. In fact, the pipe appeared to be in excellent condition internally as would be expected for this sewage force main. Based on these reviews, it is not believed that internal corrosion played any role in the failure of this line.

**Figure 4: Overall View of Failed Half of Pipe from Interior. Arrow indicates hole. Note, there was no sign of internal corrosion damage.**

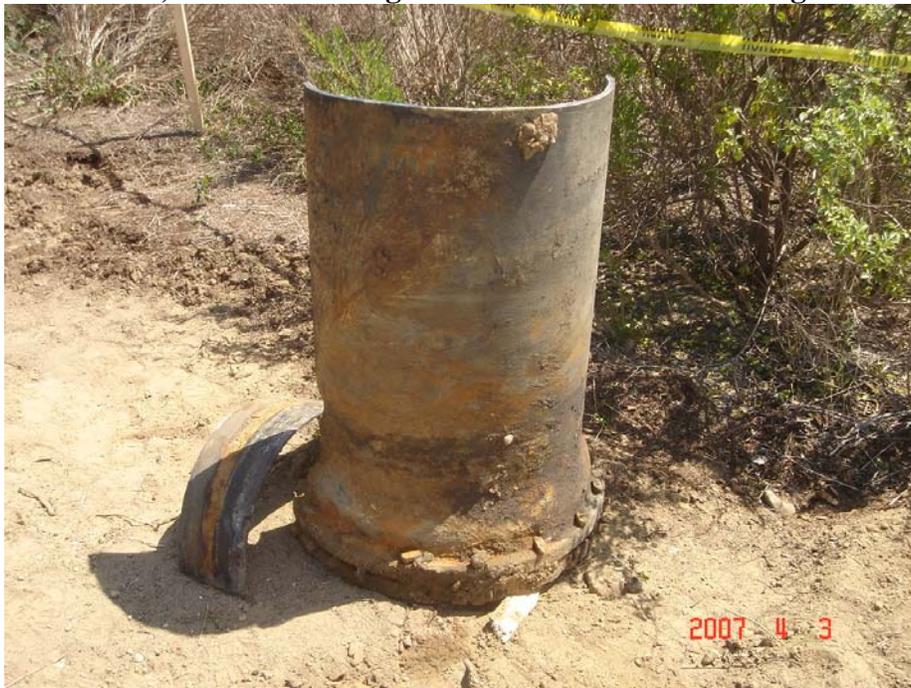
**Figure 5: External Surface of Unfailed Half Section of DIP Removed from Discharge Excavation**

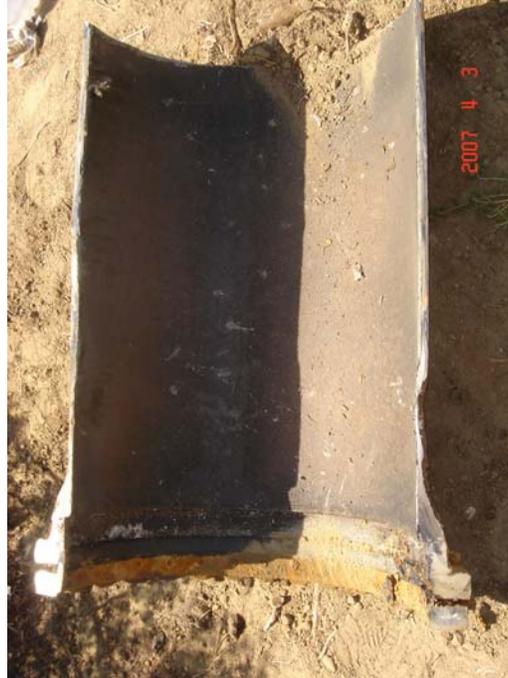
**Figure 6: Internal Surface of Unfailed Half Section of DIP Removed from Discharge Excavation. No sign of internal corrosion damage.**
