Buena Vista Force Main Wastewater Discharge to Buena Vista Lagoon March 31-April 2, 2007

REVISED FINAL REPORT

***24-in Ductile Iron Force Main Failure
Buena Vista Lagoon
Carlsbad, California***

**CITY OF CARLSBAD
24-INCH DUCTILE IRON FORCE MAIN FAILURE
BUENA VISTA LAGOON
Carlsbad, California
NCRU: 01-0743.02 & 01-764.02:ebecker**

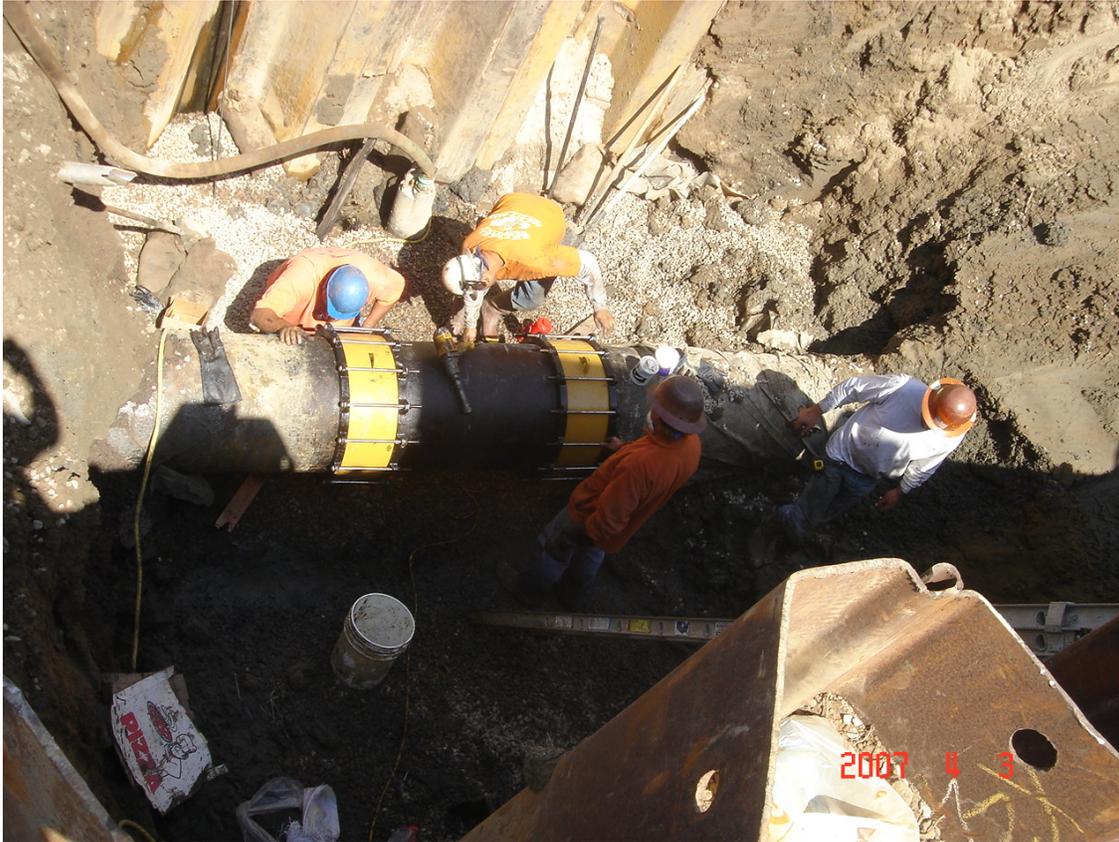
Figure 1 - Excavation Site

The rectangular corrosion hole was preserved in one half of the sectioned pipe. Two in-line pipe couplings and a short section of pipe were installed in order to place the force main back in service (see Figure 1). The two sections of pipe including the intact restrained joint were preserved and transported to Encina Wastewater Treatment Plant, 6200 Avenida Encinas, Carlsbad, CA. From there they were moved to Schiff Associates, 431 W. Baseline Rd,

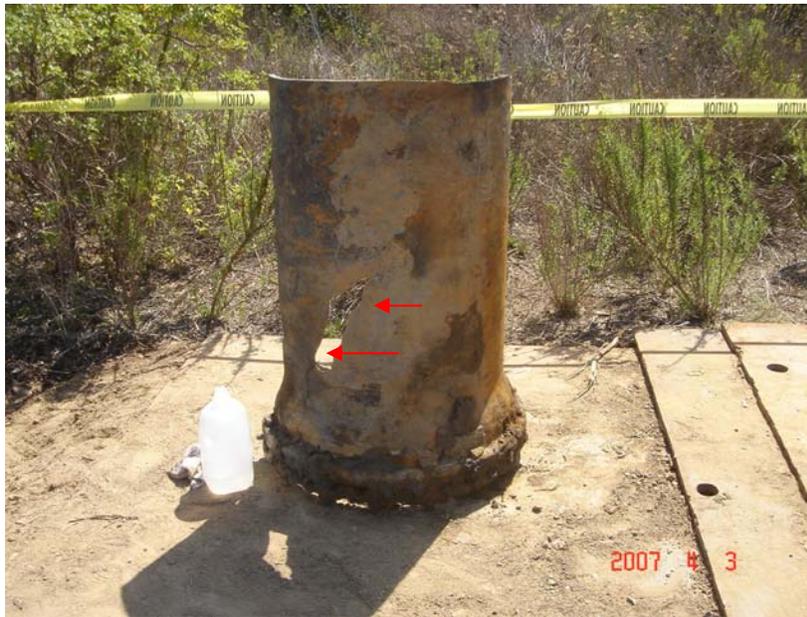
Figure 2 – Sectioned pipe with failure (below springline)

This is the condition of the pipe section, from below the springline, at the failure site. The leakage hole is in this section, red arrows.

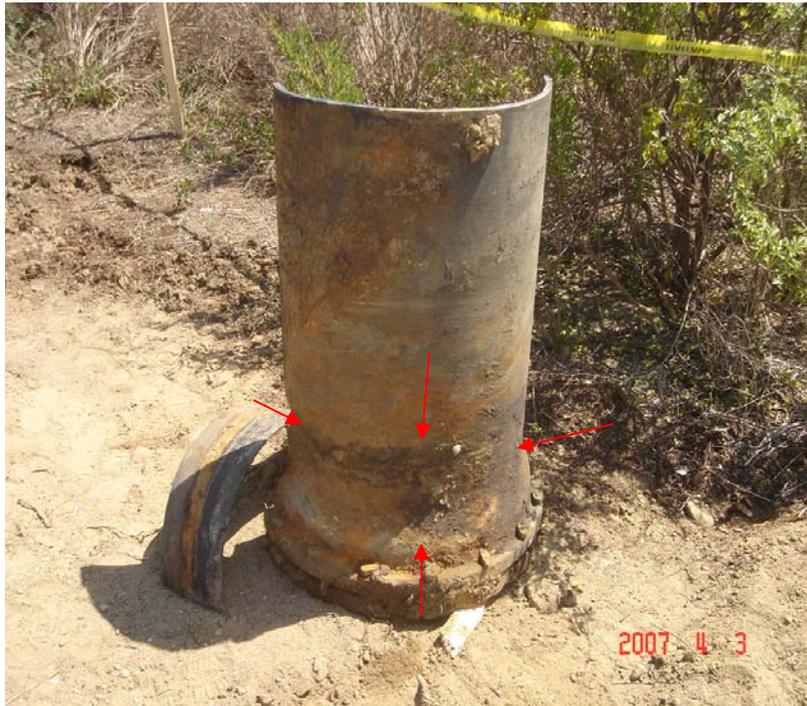
Figure 3 – Sectioned pipe opposite side of failure (above springline)

This is the section from above the spring line. This has not been cleaned, yet the band on the pipe adjacent to the bell can be seen. It is this band that delineates the taping of the PE encasement. There is no appreciable corrosion outside the encasement or above the springline. The four red arrows locate the area of the corroded band.

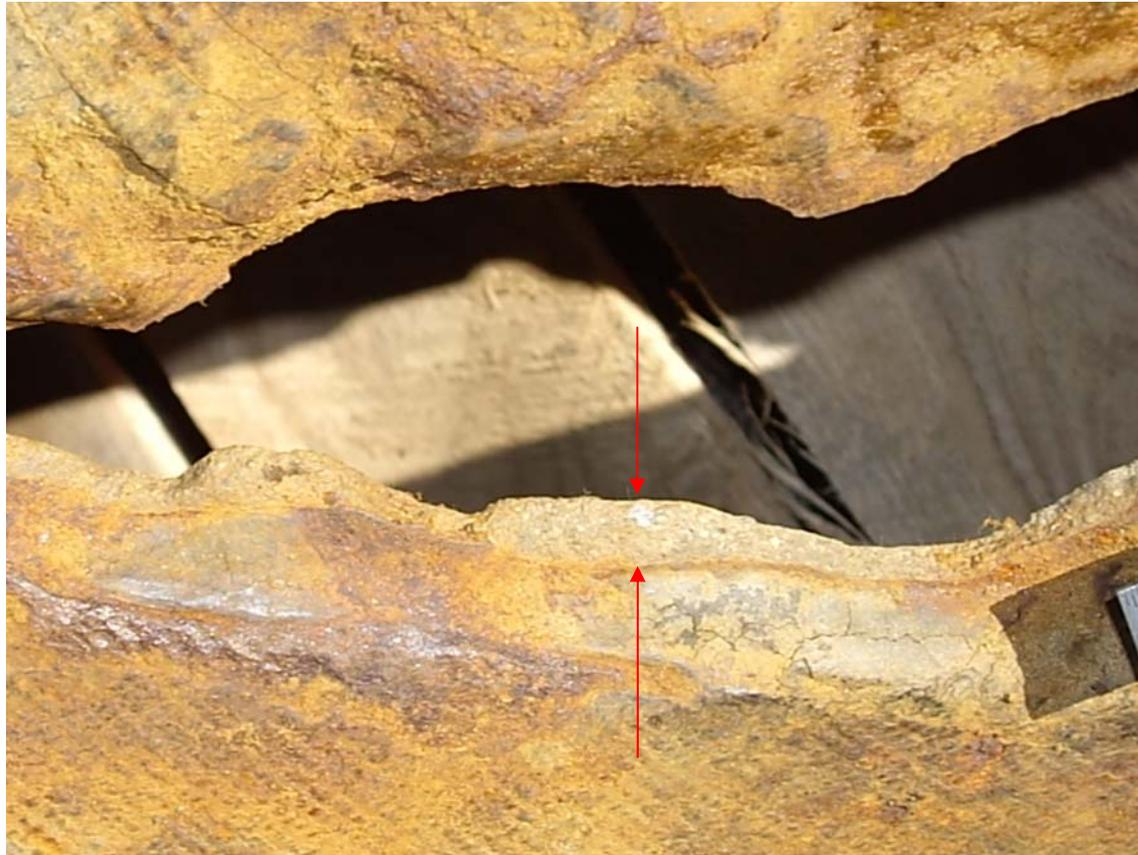
Figure 4 - Corrosion hole close-up

The stipple pattern from the foundry mold is still present. One characteristic of graphitic corrosion is that small details like this may still be seen but the iron has been removed due to corrosion. In this photo the stipple pattern has been retained on the corrosion product. The red arrows show the thickness of the cement liner. There is no metal left, corrosion has removed the supporting iron. The liner failed in a fast manner and not from a slow dissolution. There is no indication that the line had been thinned from a long period of time of leakage. This supports the conclusion that the leak was not slow with the hole gradually growing in size.

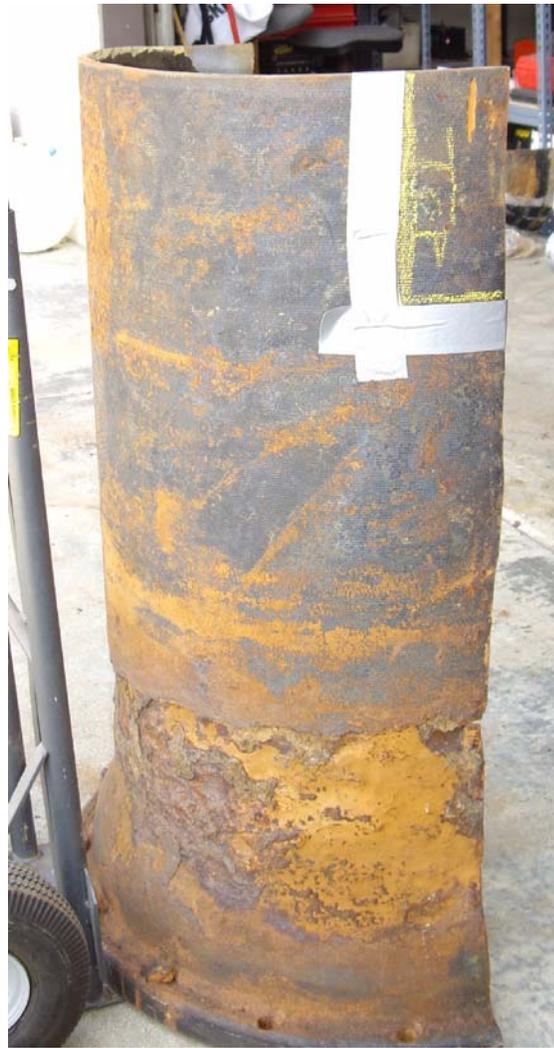
Figure 5 - Cleaned upper section of pipe

This is the pressure cleaned upper section. The heavily corroded area is the lower portion of the Figure. This is showing the area adjacent to the taped PE encasement. After the pipe was shot blasted, it was discovered that the liner was the only material left in some of these areas, the iron was gone due to corrosion. The marked area in the upper right locates where material was taken for the mechanical tests (Charpy impact bars, metallography and chemical analysis). A similar sample was taken 180° from this on the lower section. Figures 9 through 12 are from these locations.

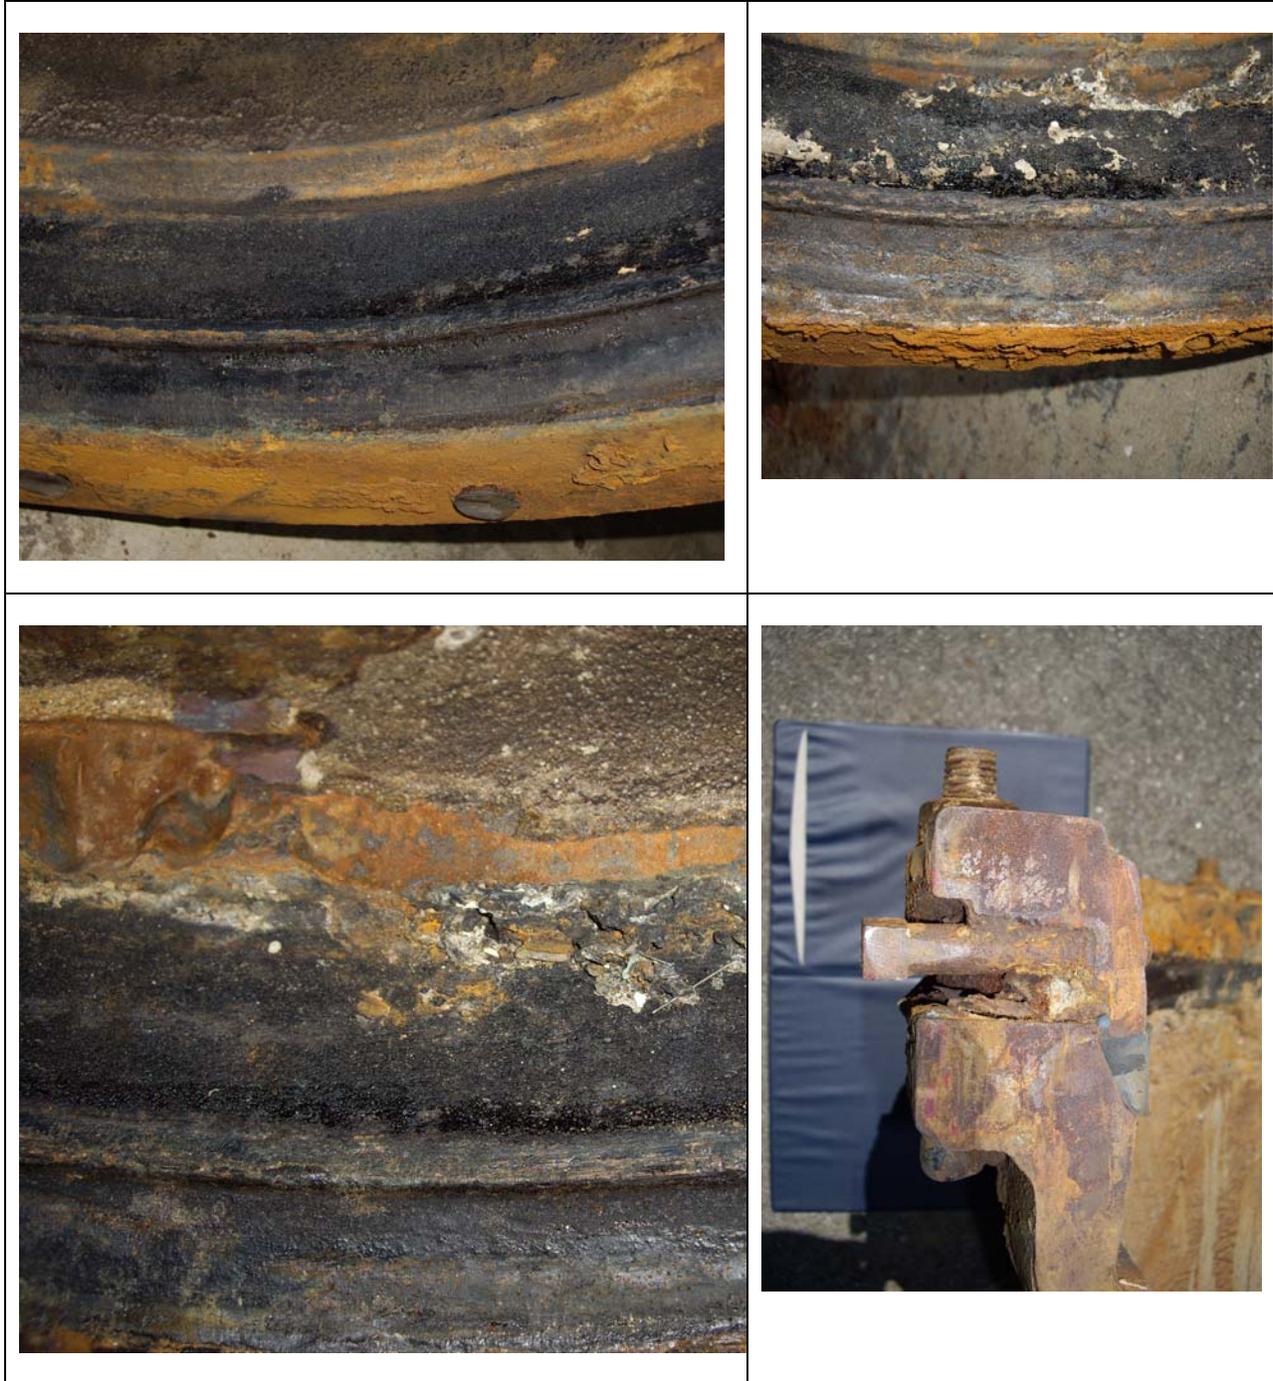
Figure 6 – Four photos showing asphaltic coating and joint condition

Three photos from Figure 6 above show the excellent condition of the asphaltic lining applied at the foundry and sealed by the gasket. The pristine condition of these pipe surfaces is certain evidence that there was no leaking at the compressed joint. The lower right photograph in Figure 6 is a section through the gasket material showing a good pipe joint. The inspection of the gasket's surface after removal of the flange showed the gasket material to be undamaged, consistent with a leak free joint.

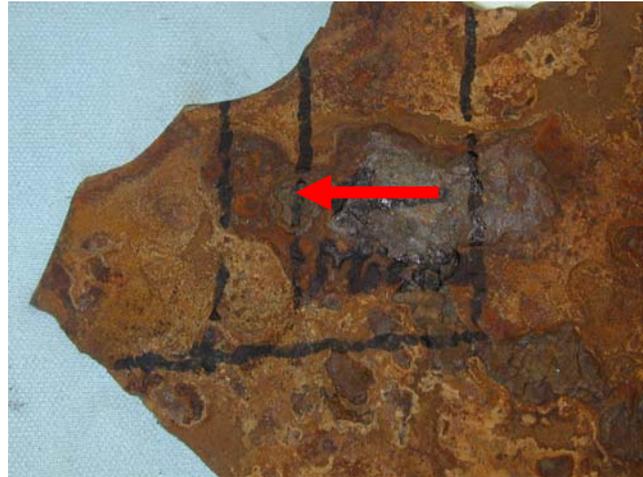
Figure 7 – Pipe specimen identified for metallographic analysis

Besides the metallographic examination taken from the area in Figure 5 another sample was taken from the bottom of a graphitic corrosion pit as seen in Figures 7 and 8. The red arrows locate the plane of sectioning through the remaining metal and the corrosion product.

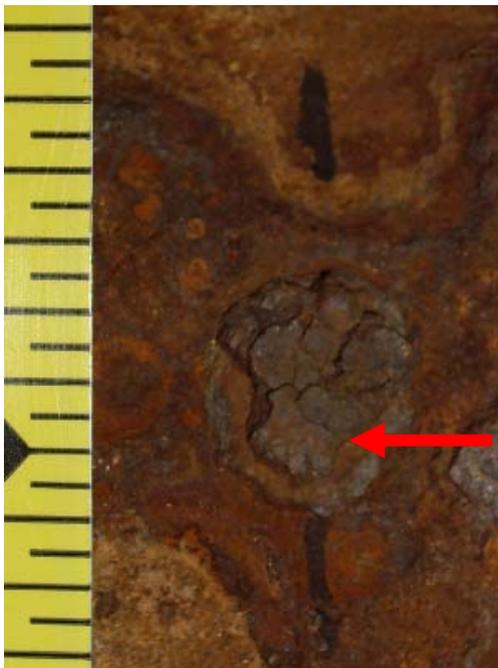
Figure 8 – Close up of corrosion product

Figure 8 is a close-up of the plane (red arrow) of sectioning through the corrosion product and the DIP base metal. The results of the metallography are shown in micrograph, Figure 13. The micrograph also shows the structure of the DIP to be vermicular as the inside diameter is approached. The same structure as seen in Figure 11.

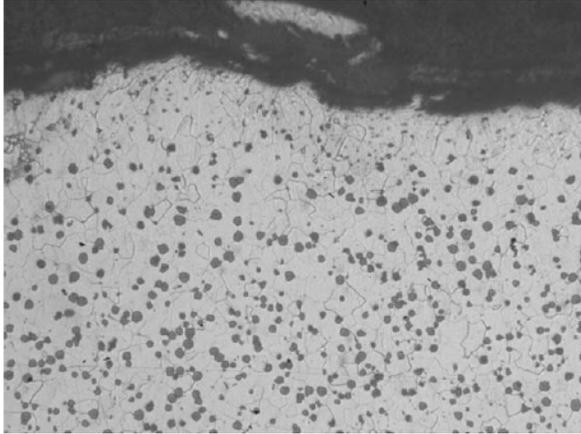
Figure 9 - Light micrograph of pipe surface

Micrograph of outside diameter surface
Upper specimen
Etched 2% Nital
Magnification 200X
Cast Ductile Iron

The microstructure is typical of that for ductile iron. The graphite nodules are dispersed. This is an acceptable microstructure. It meets the ASTM A247 Type I and Type II chart. It is of interest that this shows no corrosion or loss of metal on the outside surface of the pipe in this specific area.

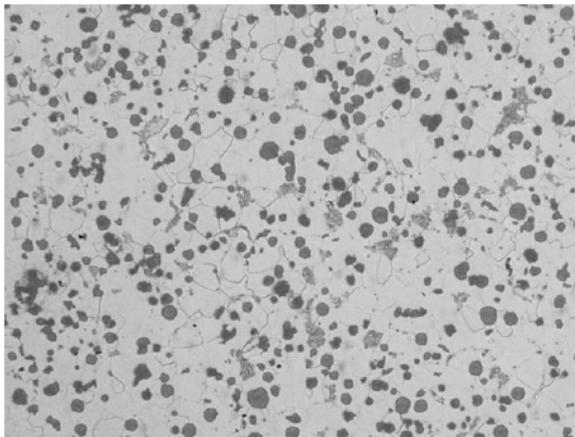
Figure 10 - Light micrograph of pipe core

Micrograph of core
Upper specimen
Etched 2% Nital
Magnification 200X
Cast Ductile Iron

This shows the microstructure of the mid section of the wall of the ductile iron. Some of the graphite nodules are well shaped and some are showing an irregular, non preferred shape. The microstructure is starting to decay and exhibit the structure of that found in grey iron. It meets the ASTM A247 Type II chart.

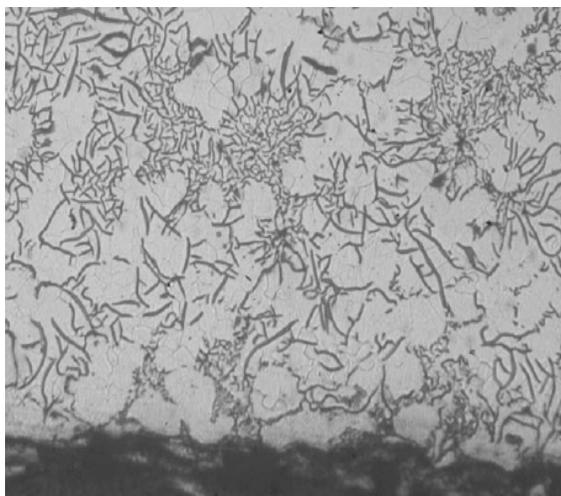
Figure 11 - Light micrograph of pipe interior

Micrograph of inside diameter surface
Upper specimen
Etched 2% Nital
Magnification 200X
Cast Ductile Iron

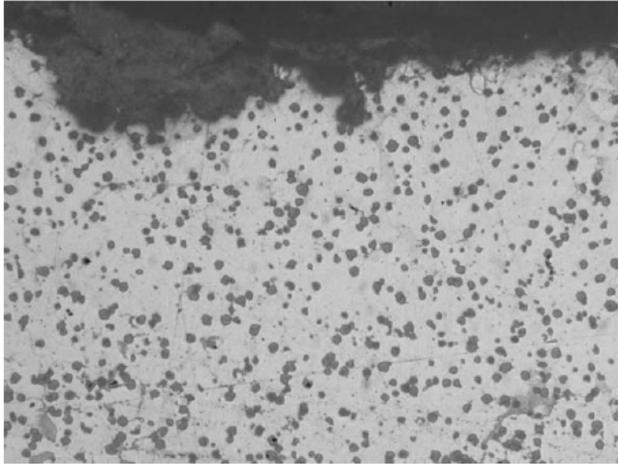
Figure 12 - Light micrograph of pipe surface (below springline)

The micrographs of the specimen taken at 180°, Lower Specimen (Figure 12), are similar to the previous micrographs, Figures 9, 10, 11). The outside diameter surface does show more

corrosion than this one. This is consistent with the cause of corrosion failure presented in this report. The specimen from the lower section is below the springline and would see some more metal loss than the upper section.

Micrograph of outside diameter surface
Lower specimen.
Etched 2% Nital
Magnification 200X
Cast Ductile Iron

The microstructure is typical of that for ductile iron. The graphite nodules are well shaped and evenly dispersed. This is an acceptable microstructure. It meets the ASTM A247 Type I. chart. Because this was taken from the lowest outer section of the DIP it does evidence slightly more corrosion.

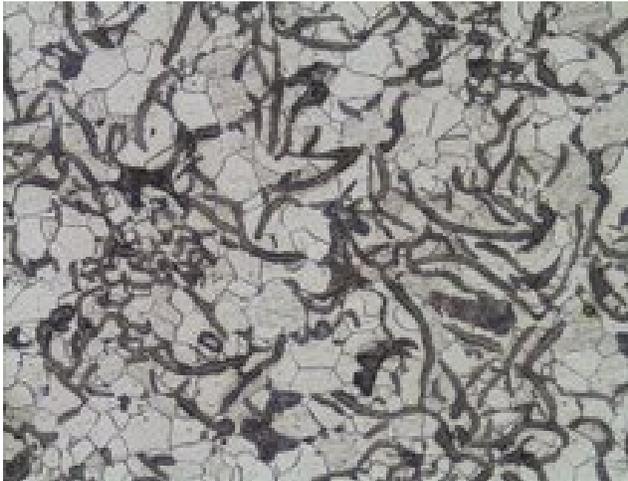
Figure 13 is the microstructure of the iron located below the corrosion pit, (Figure 8). The pit is due to graphitic corrosion.

Micrograph of DIP below corrosion pit.
Corrosion specimen.
Etched 2% Nital
Magnification 200X
Cast Ductile Iron

This is not ductile iron. It is the same vermicular structure as seen in Figure 12. There are no graphite nodules in the microstructure. This is not an acceptable microstructure for impact resistance. The microstructure has no susceptibility or resistance to corrosion over that of a nodular structure. The cement liner was protecting this structure from corrosion from the inside of the pipe. The corrosion came from the outside diameter thought the nodular structure. The corrosion rate would be similar between the nodular graphite and this vermicular structure.

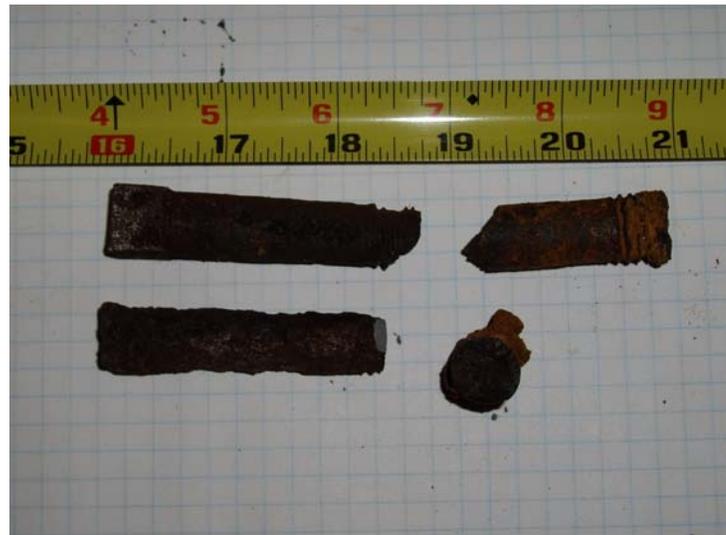
Figure 14 – Corrosion of fasteners

Figure 14 above shows two sets of fasteners. The left is surface corroded grey iron. It is heavy and the fracture surface is clean and metallic in appearance. The pieces on the right are the same fasteners but they have undergone graphitic corrosion. They have very little weight because of the loss of the iron in the matrix

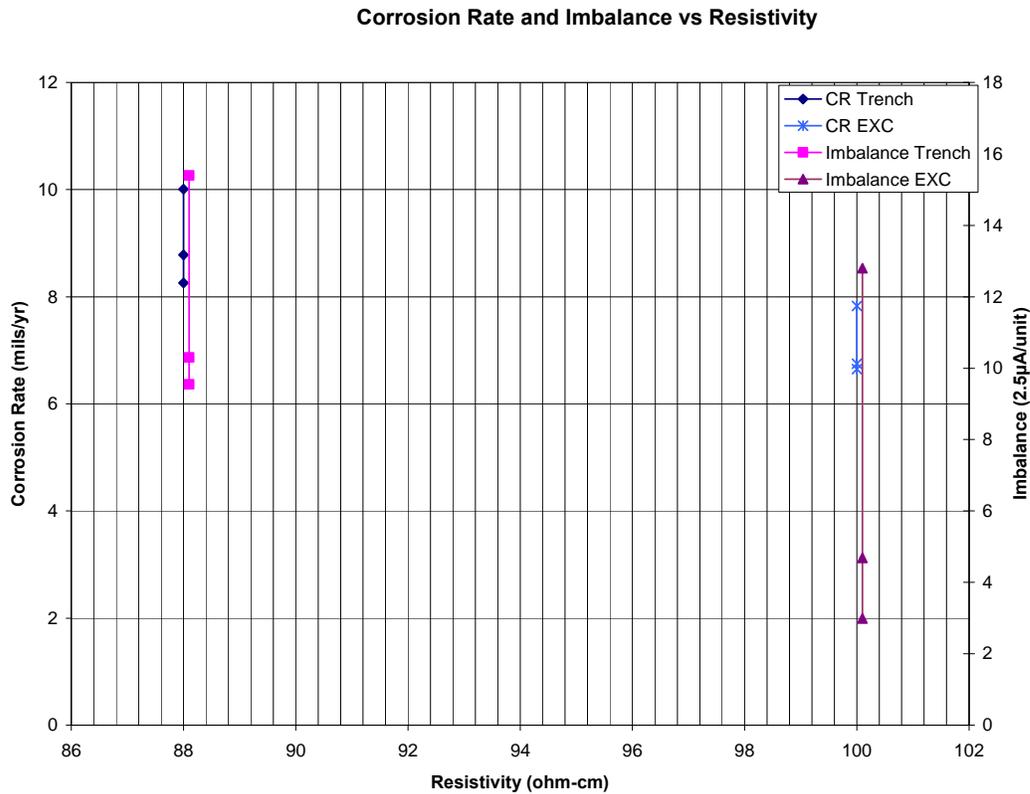
Figure 15 - LPR Tests and ECI for Soil Samples from Excavation

The measurements taken from both of the soil samples, shown in Figure 15 indicate that both general corrosion and localized corrosion are taking place.
