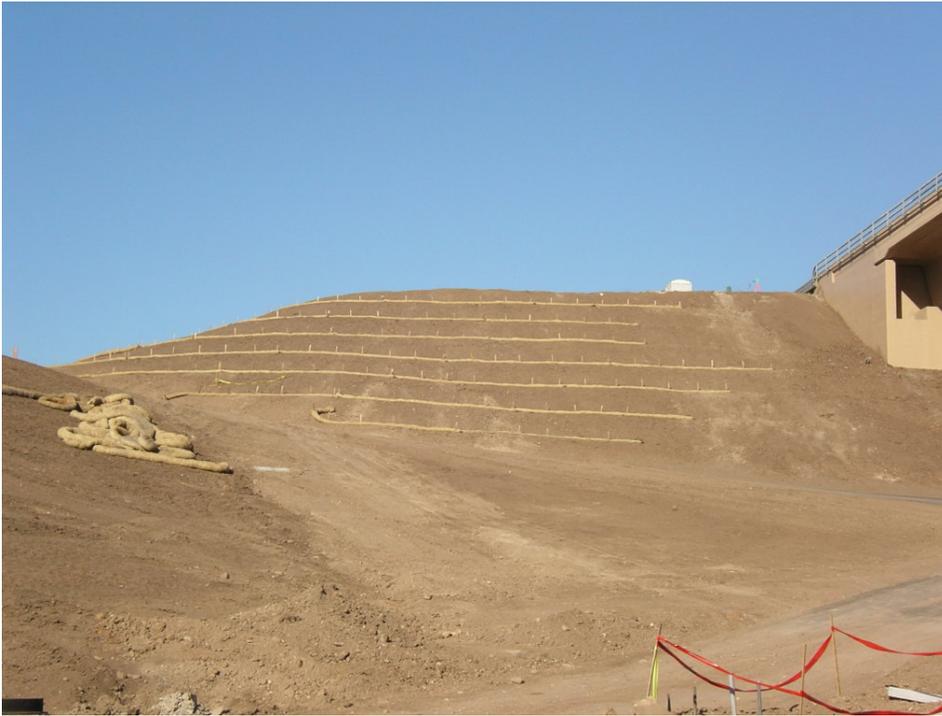
Figure 1. Slope stabilization adjacent to extended detention basin under Otay River Bridge

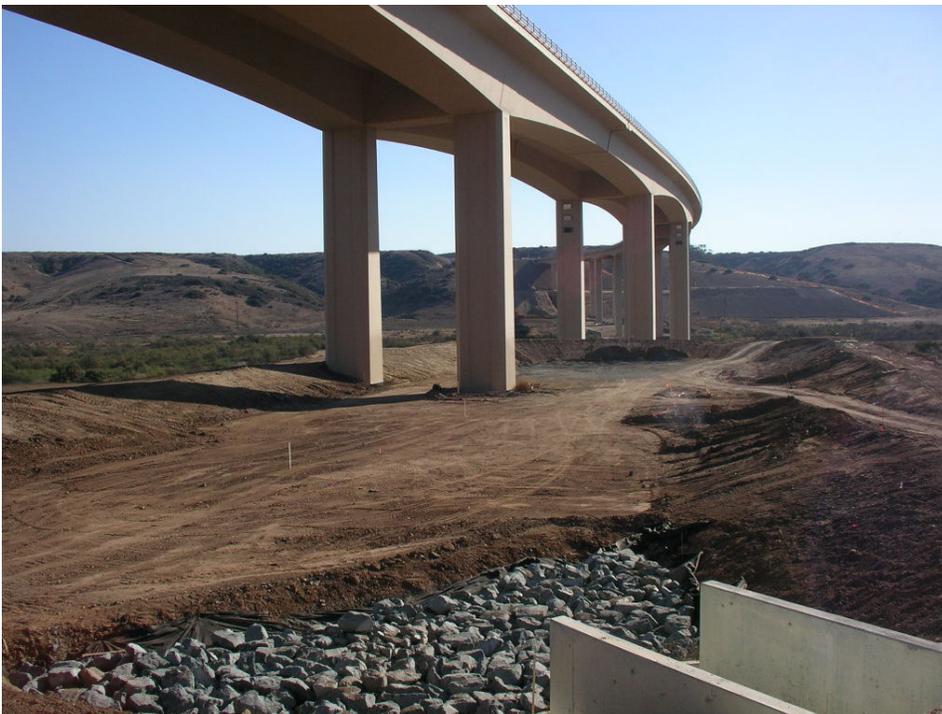
Figure 2. Extended detention basin under Otay River Bridge

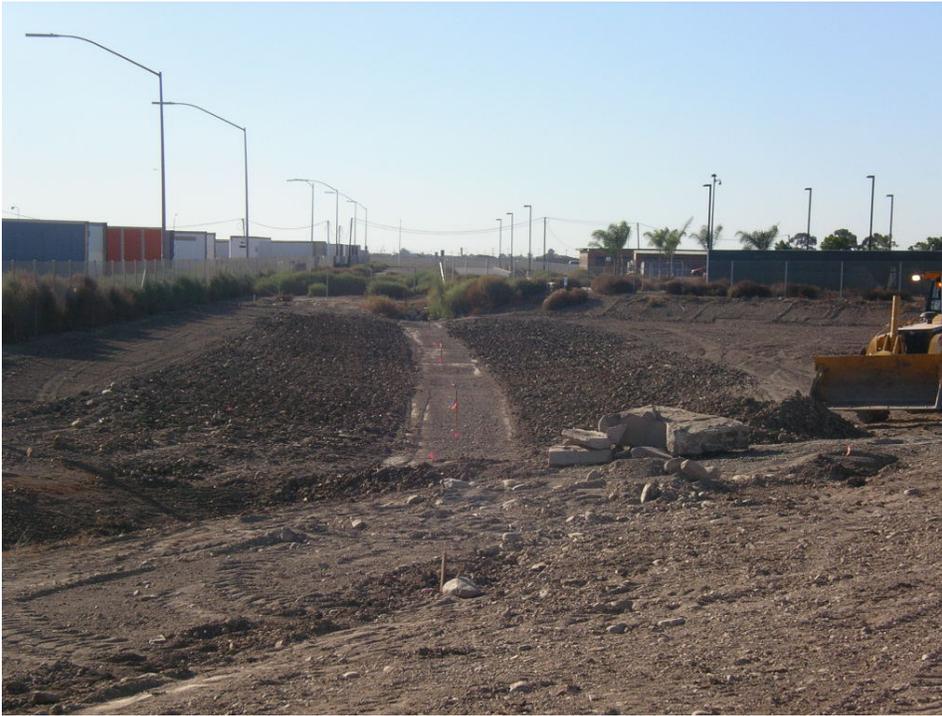
Figure 3. Recently graded bio-swale south of Operations Center building.

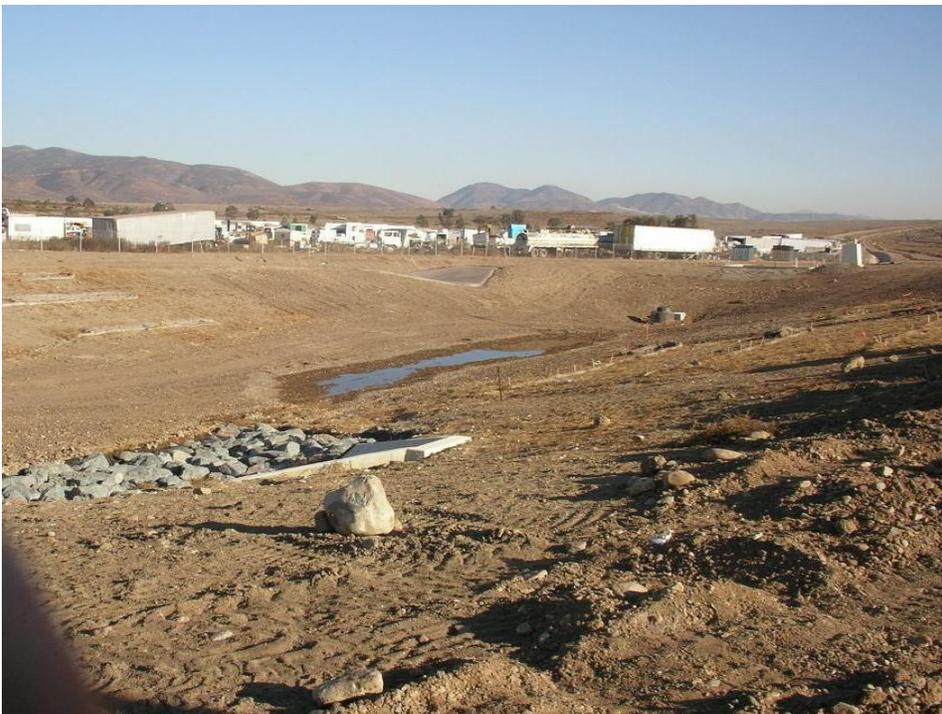
Figure 4. Extended detention basin between Otay River and Otay Mesa Rd.

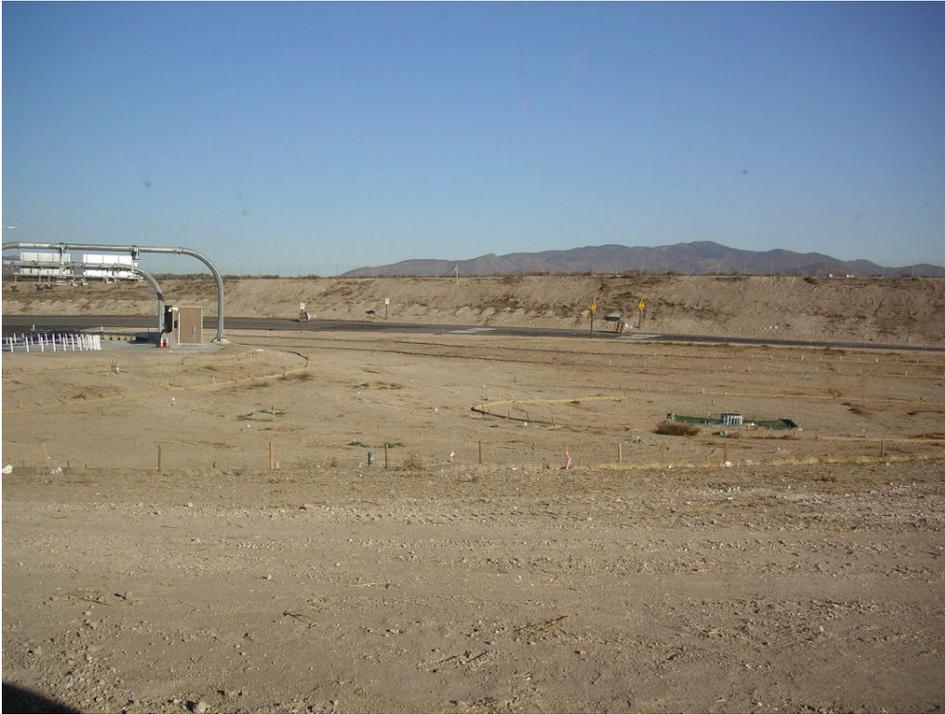
Figure 5. Extended detention basin South of Birch Rd.

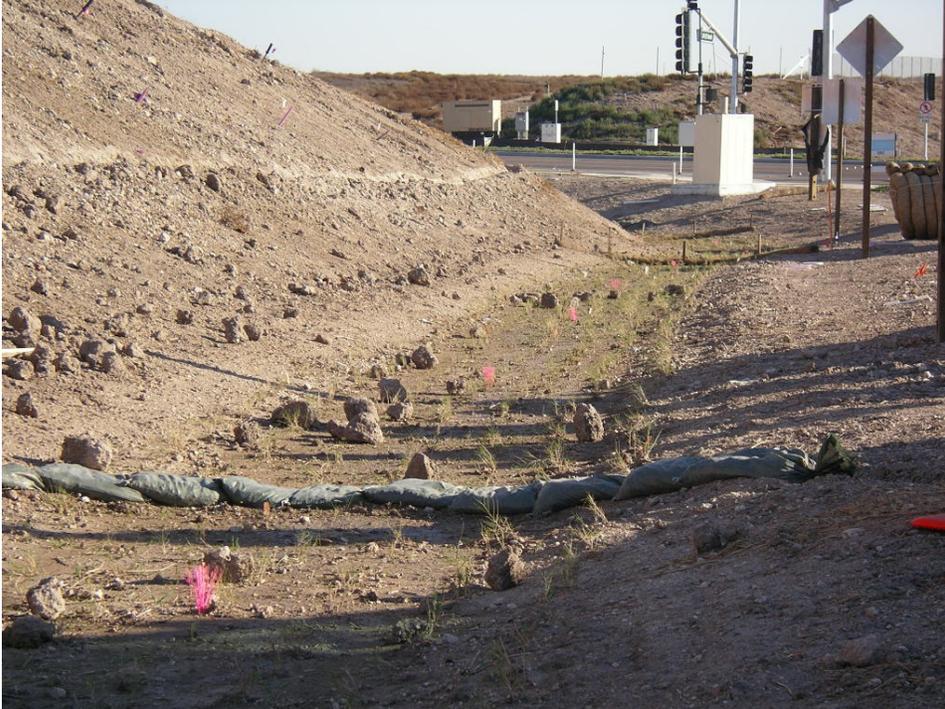
Figure 6. Bio-swale at Birch Rd. (East side)

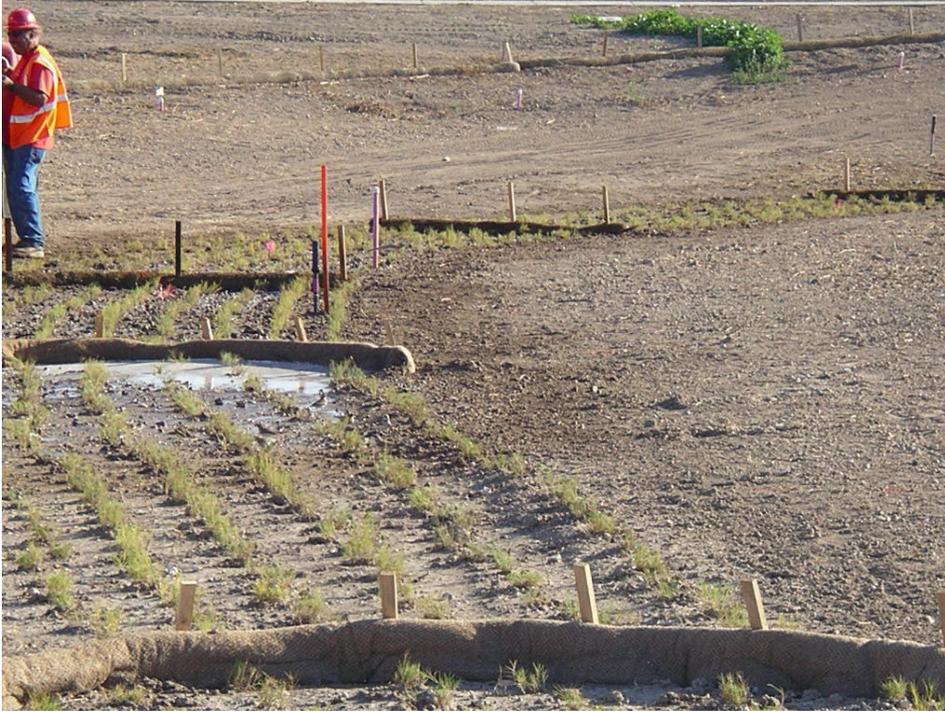
Figure 7. Bio-swale at Birch Rd. (West side)

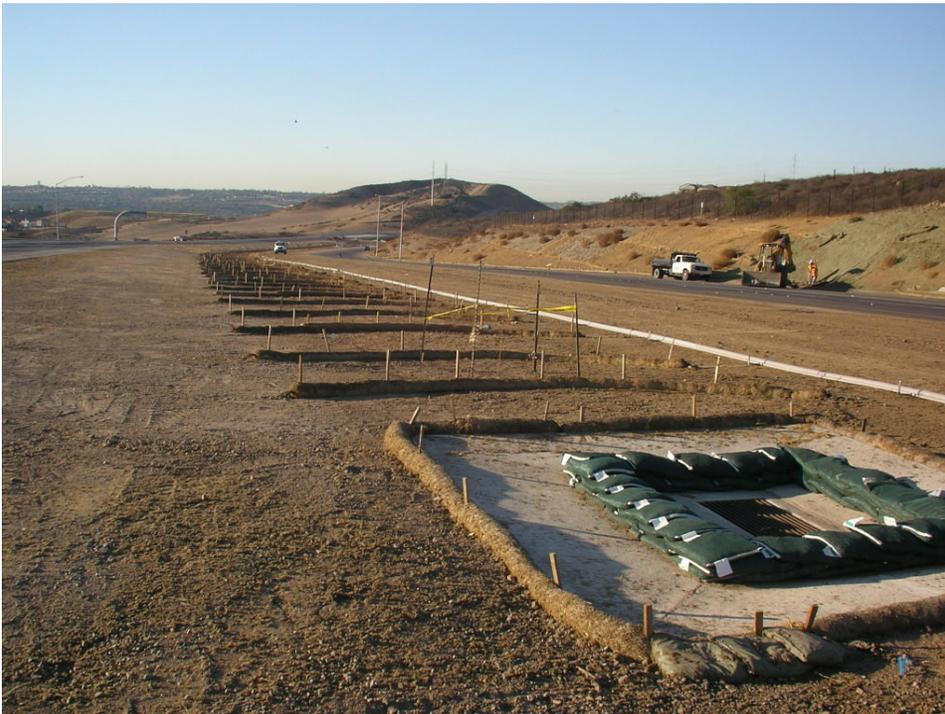
Figure 8. Median bio-swale North of E. H St.
