**EVALUATION OF TREATMENT PLANT OPERATION AND  
POTENTIAL CAUSES OF TREATMENT PLANT EFFLUENT  
LIMITATION VIOLATIONS (April to June 2004) FOR THE CITY  
OF ESCONDIDO HALE AVENUE RESOURCE RECOVERY  
FACILITY**

**Boris Trgovcich**  
Water Resources Control Engineer  
Compliance Assurance and Enforcement Unit  
State Water Resources Control Board

**April 7, 2005**

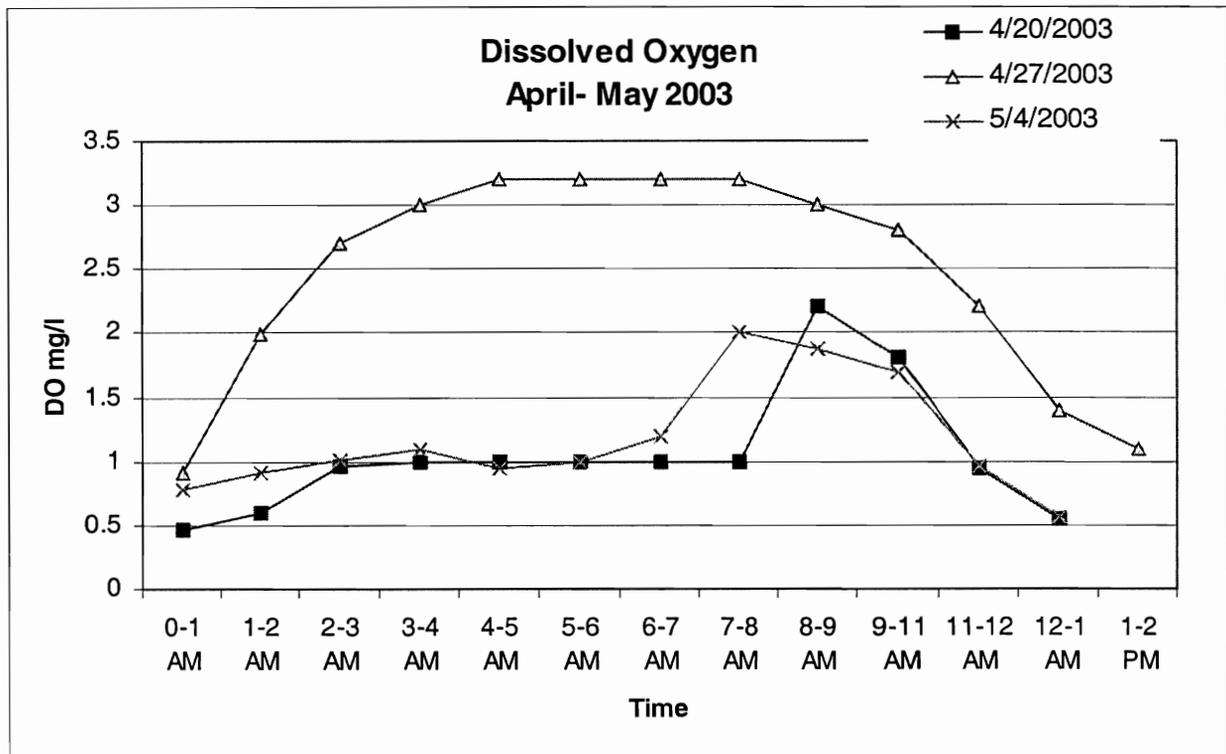
noticeable effect on the plant performance. For example, **Figure 1** shows DO “spikes” at this facility for selected days during three consecutive weeks, one year prior to the alleged April –June upset. During that three week period the plant experienced was no appreciable decrease in performance and no documented effluent limit violations.

**Figure 1** – Example of DO “spikes” at HARRF during three days, one week apart in April-May 2003. The average DO concentration for the remainder of each day was approximately 1 mg/l.
