**Required Technical Report**

**CITY OF ESCONDIDO**

**Hale Avenue Resource Recovery Facility**

**Order Number R9-2005-0077**

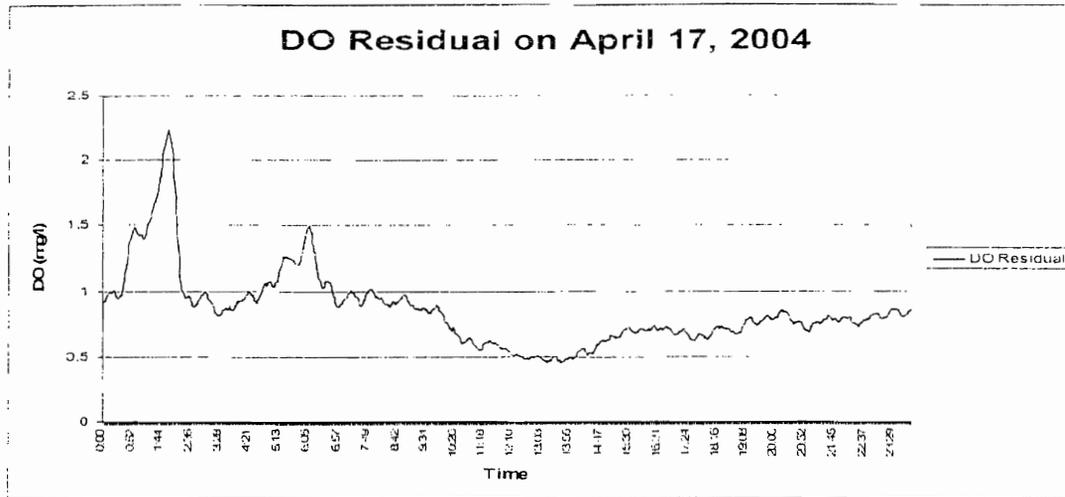
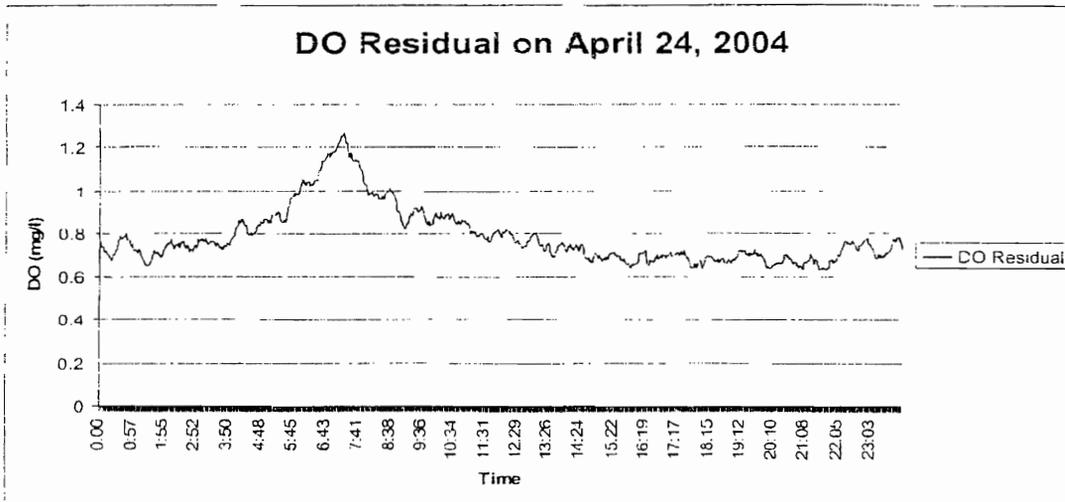
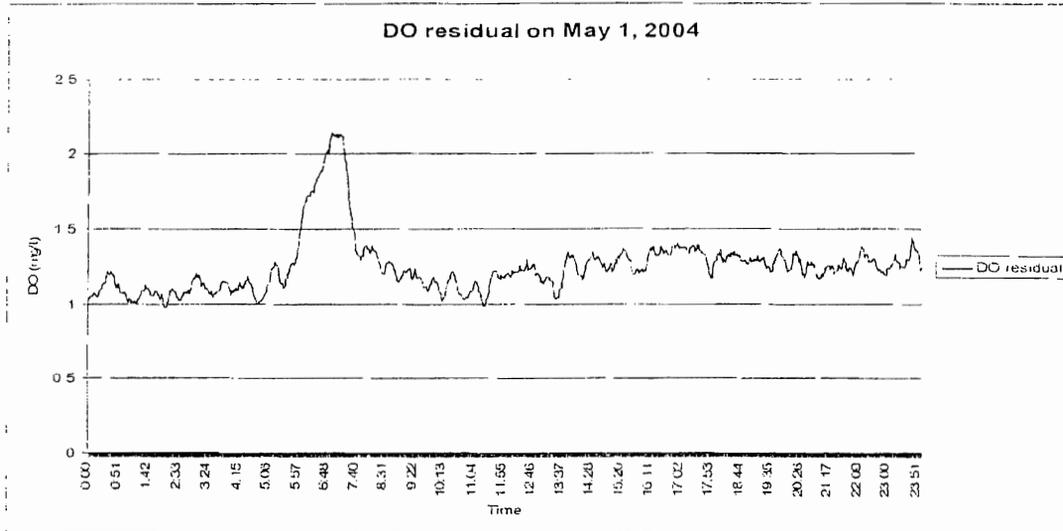
**Figures 1-3. Daily Dissolved Oxygen Levels (Average of All Five Aeration Basins)**

The treatment performance declined notably and in a similar fashion during the next three consecutive Saturdays. Specifically, sudden decreases in dissolved oxygen demand were noted in all five aeration basins beginning April 17, 2004 and continuing on each Saturday through May 1, 2004. Although the microorganism population began to recover after each weekend, the cumulative effect of these weekly disturbances was significant, and eventually the treatment process transitioned from aerobic to facultative and anaerobic. As a result of the change in microorganism population, secondary settling, turbidity and odors worsened.

This cyclic change in influent quality is not normal and indicates that something was being introduced into the collection system upstream from HARRF on a weekly basis, for example, as a result of a cleaning schedule for an industrial or commercial facility. The introduction of a toxin to the wastewater system can be seen by numerous indicators, including elevated levels of CBOD, TSS, odors, increased turbidity, acute toxicity in the secondary effluent and less activity noted in the microscopic examination of the activated sludge. These indicators were noted in the activated treatment process during the April 2004 disturbances. Toxic impacts on the biological treatment process can also be seen by increased levels of residual dissolved oxygen in the activated sludge (as described above) and poor CBOD removal in the secondary effluent. Indeed, as shown in Figures 1-3, there were unusually high spikes in the dissolved oxygen residual levels on April 17, 24, and May 1, consistent with short-term and intense hits by toxic materials from upstream of the facility. In addition, as shown in Figure 4, the cumulative effects of these impacts can be seen by the increasing average daily dissolved oxygen residual levels at the end of April 2004. This pattern is in marked contrast to the normal average daily dissolved oxygen level in any given month, as can be seen from the February 2004 average set

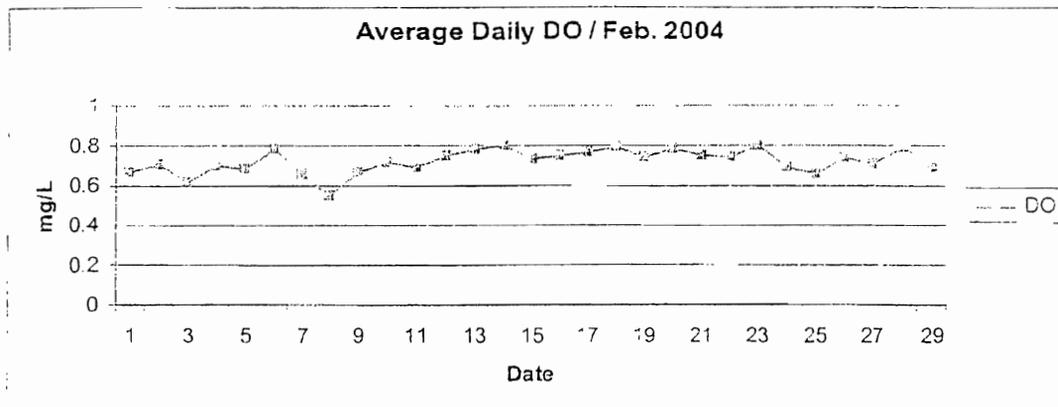
Figure 5. Dissolved Oxygen Levels (Average Daily, All Five Basins)

forth in Figure 5. There were no changes in HAARF's operational procedures, staffing, maintenance or equipment that would otherwise explain these treatment performance abnormalities.

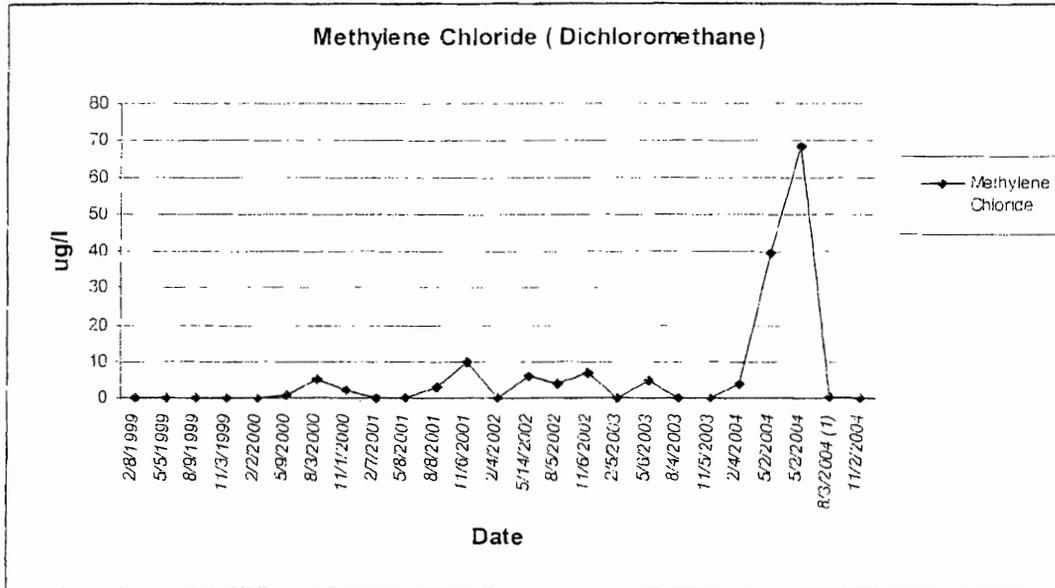
**Figure 6. Methylene Chloride Levels in HARRF Influent 1999 to 2004**

On May 2, 2004, an unusual and suspicious spike of methylene chloride (dichloromethane) was identified in the Escondido main sewer line. Monitoring results for this constituent from 1999 to 2004 are shown in Figure 6. The May 2004 sample is considerably higher than other recorded levels of methylene chloride (dichloromethane). Although the amount of methylene chloride (dichloromethane) that was found may not

have been responsible for the entire upset, it likely played a role in the disturbance of the previously weakened activated sludge process described above and prolonged the upset.

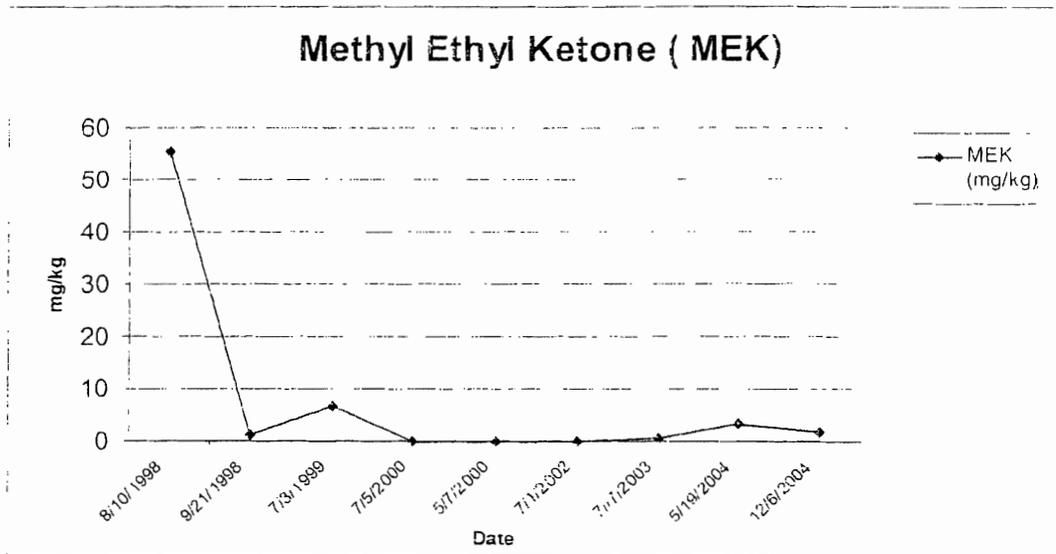
**Figure 7. Methyl Ethyl Ketone Levels in HARRF Centrifuge Sludge Cake 1998 to 2004**

On June 21-23, 2004, the sampling was expanded again to include another three lines (4937, 5105, and 4936). Results from these trunk lines showed high levels of toxic metals, TRPH and VOCs, including acetone. Results for the centrifuge sludge cake showed high levels of acetone and MEK. The levels of these constituents were higher than had been noted anytime within the past six years. MEK in the centrifugal sludge cake was 3200 micrograms per kilogram. In fact, the last time the MEK levels were found to be this high was during two previous plant upsets in 1998 and 1999. As noted in Figure 7, the spike in MEK in the influent was also higher than normal (although not as

high as in the sludge cake). Over the past six years, the spikes of MEK noted in the centrifuge sludge cake show a correlation with the treatment plant upsets in 1998, 1999 and 2004. MEK was identified as the cause of the 1998 incident, as well as the 1999 incident when similar levels of MEK were at issue.

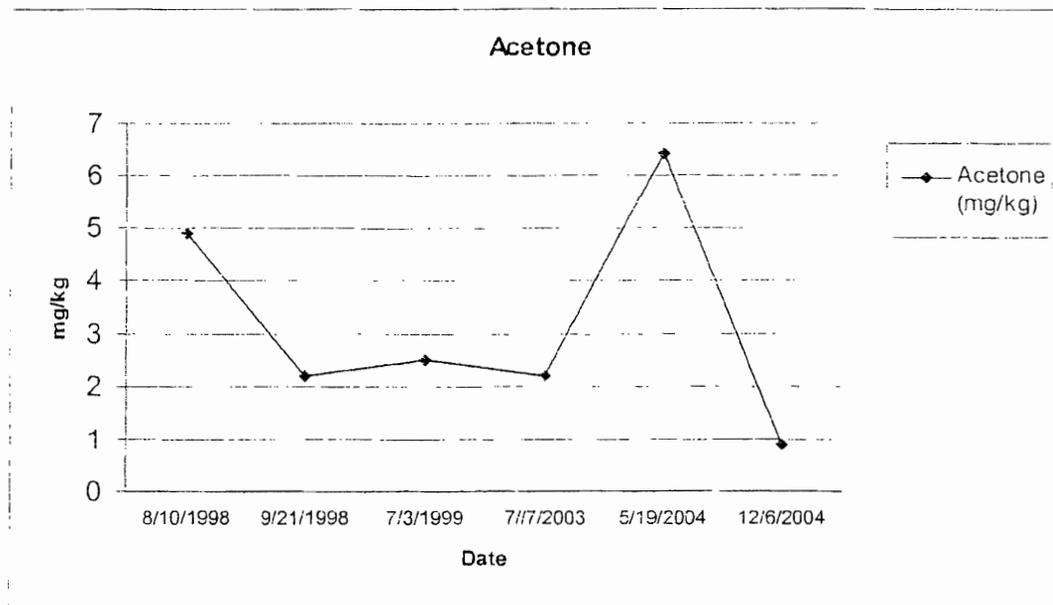
Figure 8. Acetone Levels in HARRF Centrifuge Sludge Cake 1998 to 2004

Acetone may also have had a role in negatively impacting the plant process because it was found at extremely high levels in the centrifuge sludge sample. These high levels are anomalous compared to sludge analyses in previous years as shown in Figure 8. The high acetone level in the sludge is also suspicious since the holding time for the sludge is approximately 25 days and much of the original levels in the influent would have been expected to degrade while traveling through the system.

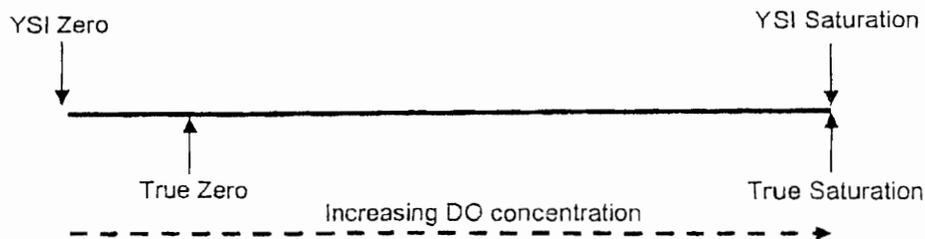
**Figure 9**

In July 2004, the City determined that the YSI Model 55 handheld unit was inaccurate at lower readings (zero saturation). Specifically, the handheld meter was registering levels of dissolved oxygen adequate for the treatment processes even though very little, if any, oxygen may have been present (see Figure 9). Thus, the City's weekly calibration of the handheld probe was inadequate because lower level readings can not be accurately determined in the YSI Model 55. If calibration inaccuracies had been occurring during the plant upset at the lower levels, the operators would have assumed that the dissolved oxygen levels in the basins at the lower levels were higher than the basin probes were indicating and adjusted the basin probes accordingly. Based on such inaccurate readings, the blower output would have been lowered. Such actions may inadvertently have resulted in further depriving the aerobic microbes of oxygen and prolonged the upset.

Figure 1 Relationship of YSI Model 55 DO probe readings to true DO readings

The YSI Model 55 handheld unit was replaced with HACH Model HQ10 LDO in July 2004, promptly after the YSI calibration problems were discovered. The replacement meter has demonstrated accuracy at a wider range of dissolved oxygen levels than the original, including at the lower levels up to and including zero oxygen levels. All the basin probes were replaced between April 29, 2004 and July 27, 2004. The replacement of the basin probes had been planned before the plant upset because the manufacturer no longer supports the equipment and it was difficult to obtain replacement parts.

Additionally, quality control procedures have been revised and implemented to include the laboratory checking the bench and handheld meters weekly using a titration method for dissolved oxygen. The laboratory will also run titrations on aeration basin samples weekly to verify the accuracy of the handheld unit and basin probes.

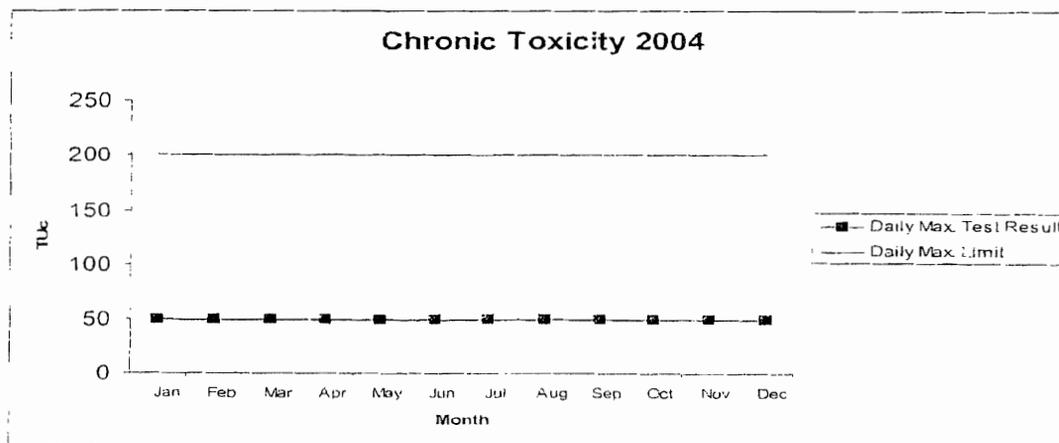
**Figure 10. Chronic Toxicity in HARRF Effluent During 2004**

In the monthly testing of secondary effluent, chronic toxicity was performed to evaluate the long term effects on the germination and growth of the most sensitive species of *Macrocystis pyrifera* (commonly known as Kelp). The May through August test results showed no effects on this species from HARRF discharges. Quarterly testing is also required to analyze toxic material for the protection of marine aquatic life. None of the toxic constituents were in violation of the daily maximum during May or August testing. Chronic toxicity testing results are shown in Figure 10. Tables showing the effluent limitations for toxic materials are located at the end of this Technical Report.
