Subject: Valencia Project Site – Meeting with CRWQCB, Follow up Requirements

INSPECTOR'S REPORT

Memo

Subject: May 15, 2015 Sampling at Valencia Construction Site

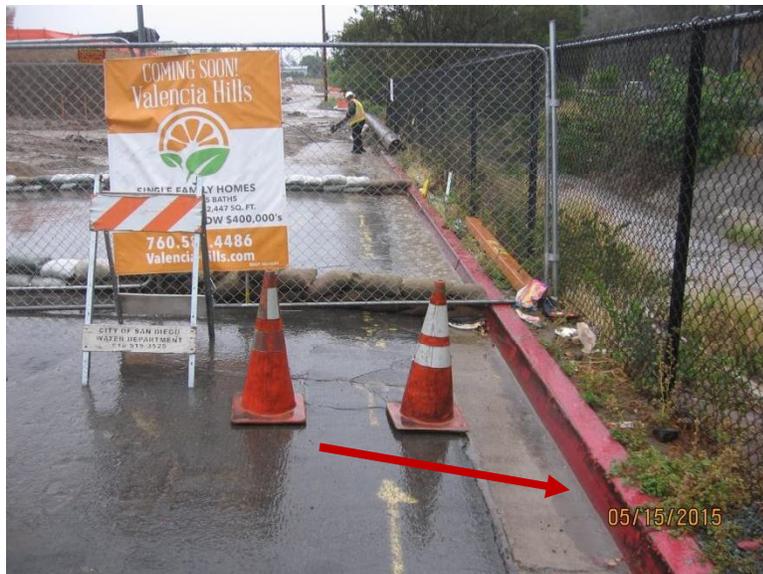
Each sample was collected and analyzed for turbidity and pH using a calibrated field meter. The Valencia_Akins site had a turbidity value that exceeded the numeric action level of 250 NTU. Unprotected loose sediment observed along the site perimeter near the Akins entrance likely contributed to the high turbidity levels. Photo 3a shows the project area near the Akins inlet during the rain event on 5/15/2015. Photo 3b is a close-up photo of the same area two days earlier. It appears that the loose sediment observed on 5/13/2015 was not sufficiently cleaned up or protected prior to the rain event.

Photo 1. Site Valencia_Akins

Following sampling, the construction site foreman was informed of the high turbidity measurement, and he stated he was working toward remediating the issue.

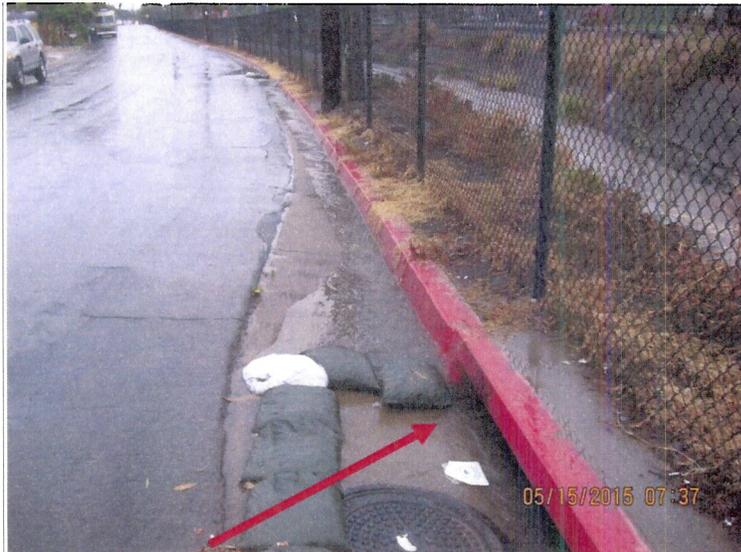
The sample collected at the Akins_Inlet site downstream of the Akins entrance had a turbidity value below the numeric action level. This decrease in turbidity between the Valencia_Akins and Akins_Inlet locations may be due to a combination of sediment settling out at the gravel bag check dams and the runoff from Akins Avenue comingling with the site runoff. Results are summarized in the table below, and photos of the samples in clear containers are presented as photos 4 and 5.

Photo 2. Site Akins_Inlet

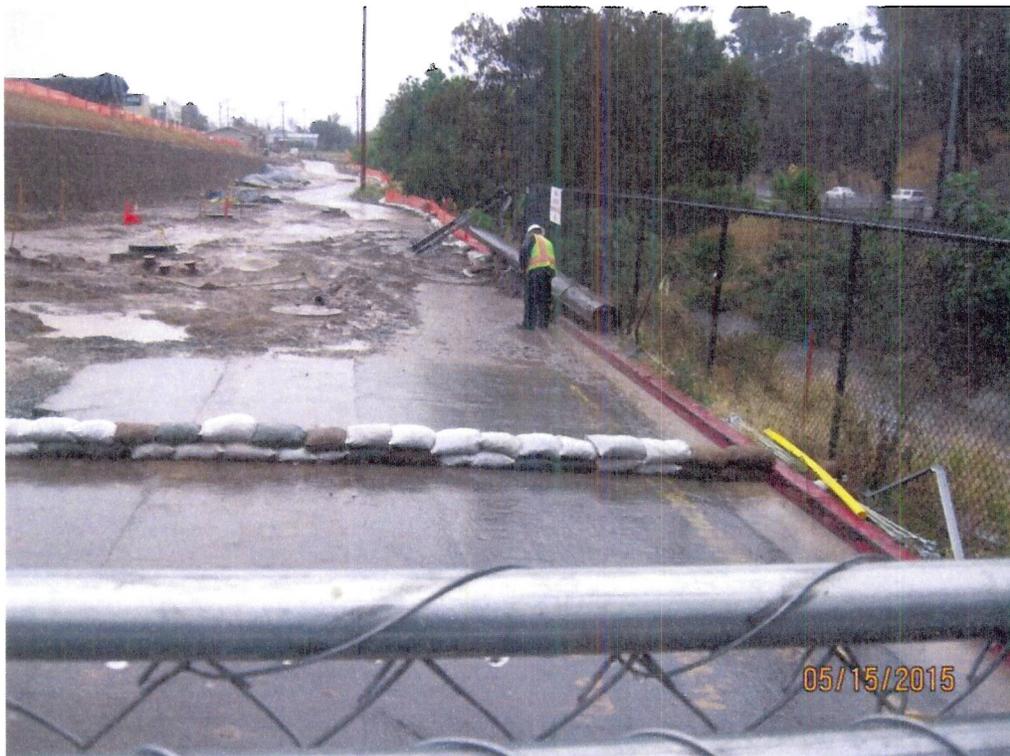
Photo 3a. Project area at the Akins Ave entrance/exit during rain event

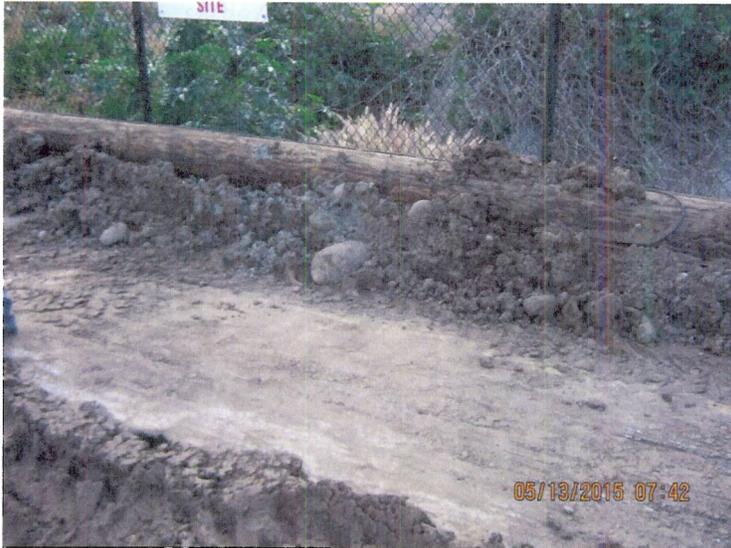
Photo 3b. Project area at the Akins Ave entrance/exit on 5/13/2015. (Same telephone pole as seen in photo 3a)

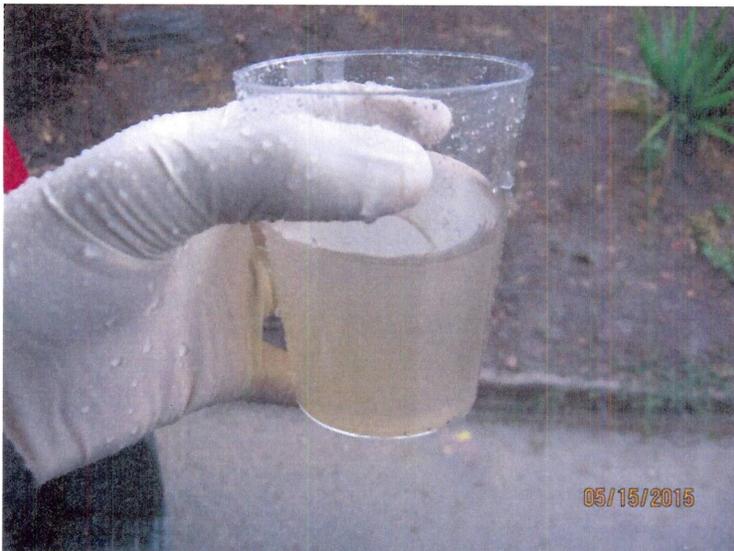
Site	Sample Date	Sample Time	Turbidity (NTU)	pH
Valencia_Akins	5/15/2015	07:20	308	8.35
Akins_Inlet	5/15/2015	07:40	95	8.23

Photo 4. Sample from Site Valencia_Akins

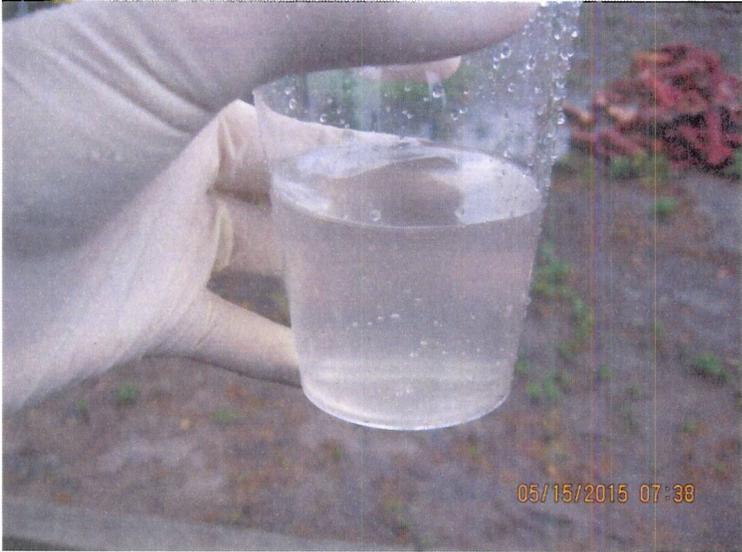
Photo 5. Sample from Site Akins_Inlet
