CALIFORNIA REGIONAL WATER QUALITY CONTROL BOARD  
SAN DIEGO REGION

TECHNICAL REPORT

Proposed in  
Complaint No. R9-2008-0021  
North County Transit District  
Sprinter Rail Project  
San Diego County

Noncompliance with  
Order No. 99-08-DWQ  
National Pollutant Discharge Elimination System (NPDES)  
General Permit for  
Storm Water Discharges Associated With  
Construction Activity

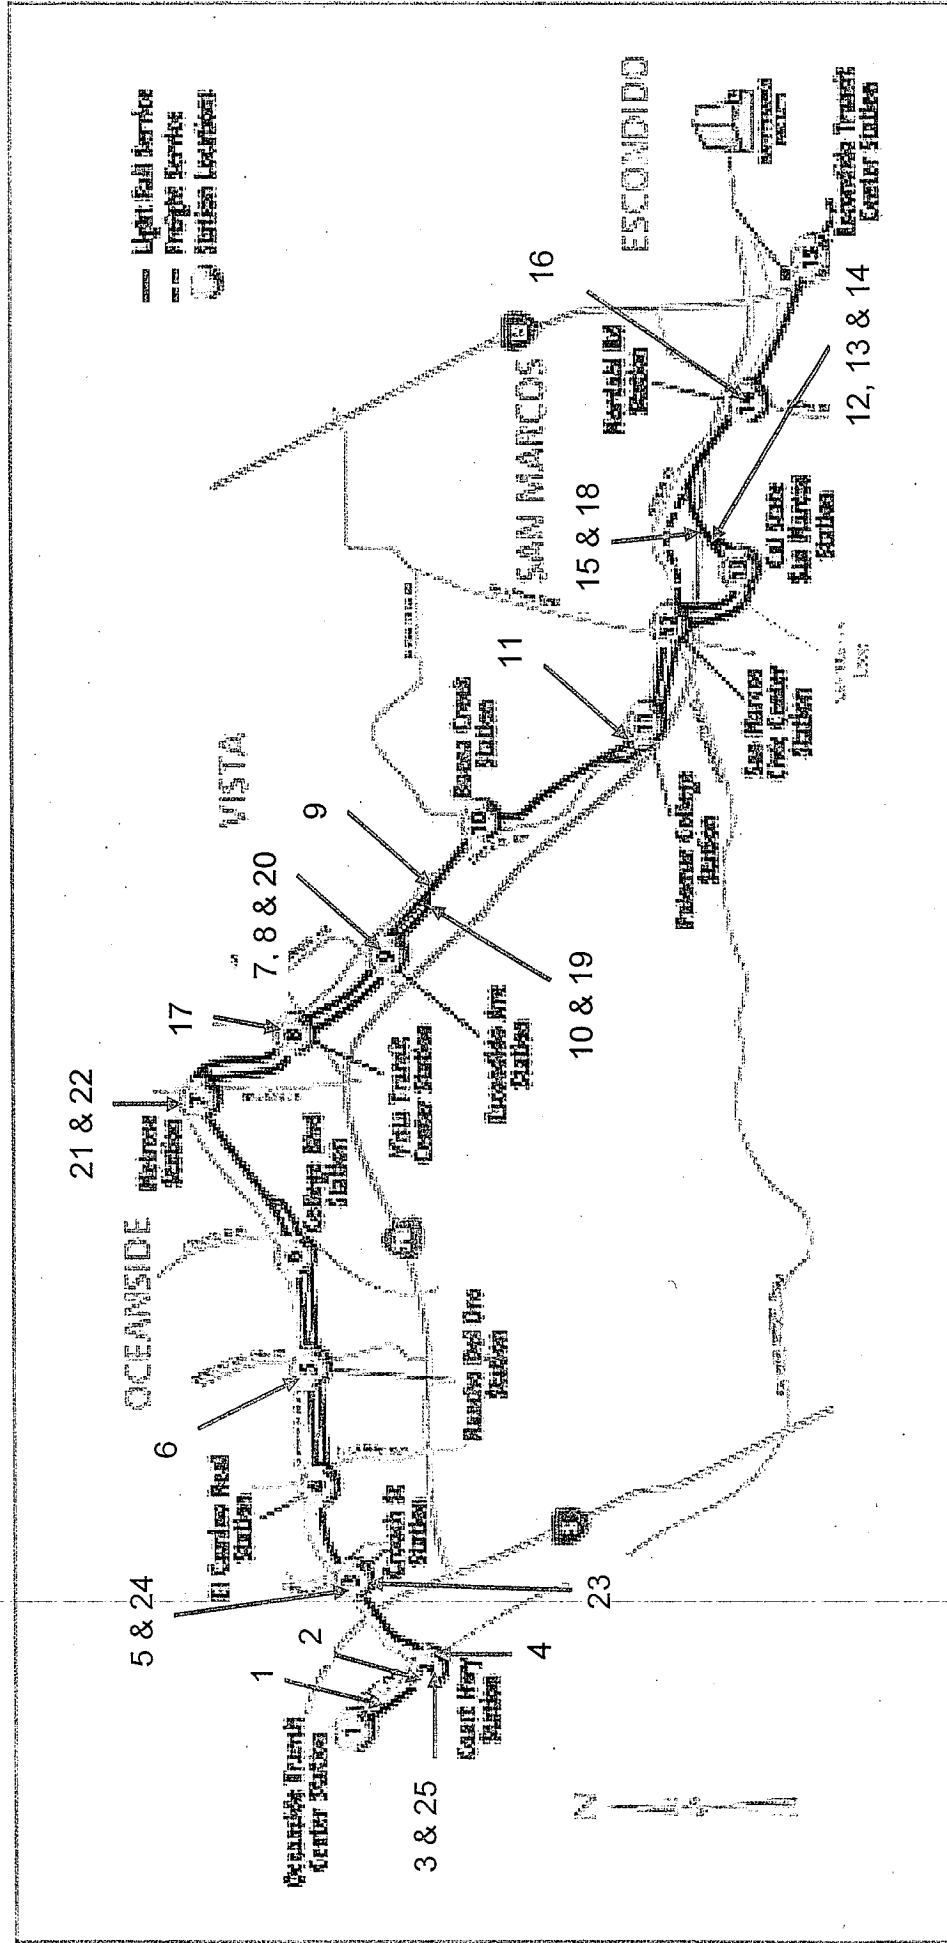
Figure 3 - Locations of Observed Discharges Along the Sprinter Rail Between November 30, 2007 & January 7, 2008

On November 30, 2007 (photos in Attachment 3):

1. Into storm drain inlet along the east side of the tracks that parallel Tremont Street near the Oceanside Transit Center Station in the City of Oceanside. Drainage from this inlet discharges into Loma Alta Creek (Photo No. 670).

2. Into storm drain inlet in drainage channel along the east side of tracks near the Coast Highway Station in Oceanside. This drainage discharges into Loma Alta Creek (Photo No. 679).

18. Into storm drain inlet near Shelley Circle in San Marcos and further downstream to Lake San Marcos. The drainage discharges into San Marcos Creek. This is the same inlet where discharges were observed on November 30, 2007 (listed as No. 14, above). See Photo No. 3.
