**CALIFORNIA REGIONAL WATER QUALITY CONTROL BOARD - SAN DIEGO REGION
WATERSHED MANAGEMENT PROGRAM**

FACILITY INSPECTION REPORT

Sprinter Rail Project
FACILITY OR DEVELOPER NAME (if different from owner)

FACILITY: North County Transit District Sprinter Rail (WDID)_9 37C322900 INSPECTION DATE: 12/3/07

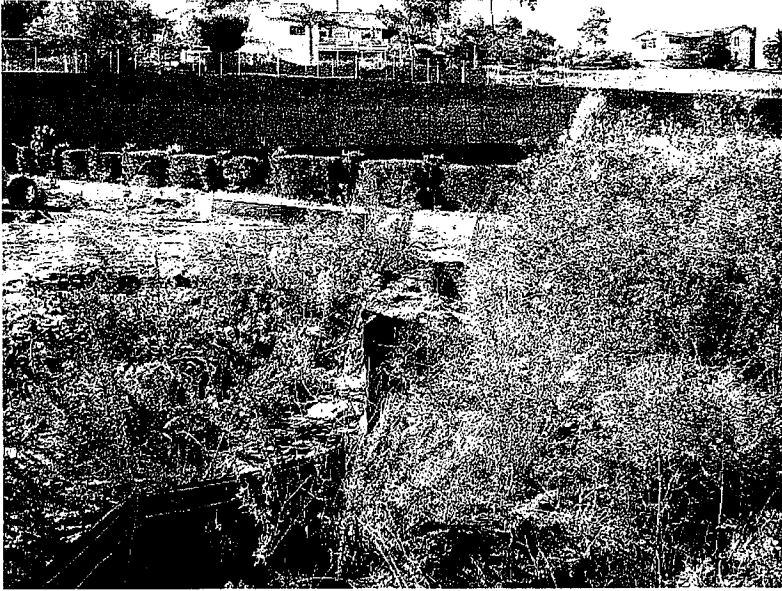
1. Silt fencing is collapsed from concentrated flows full of sediment. The storm drain inlet is off to the right of this photo.

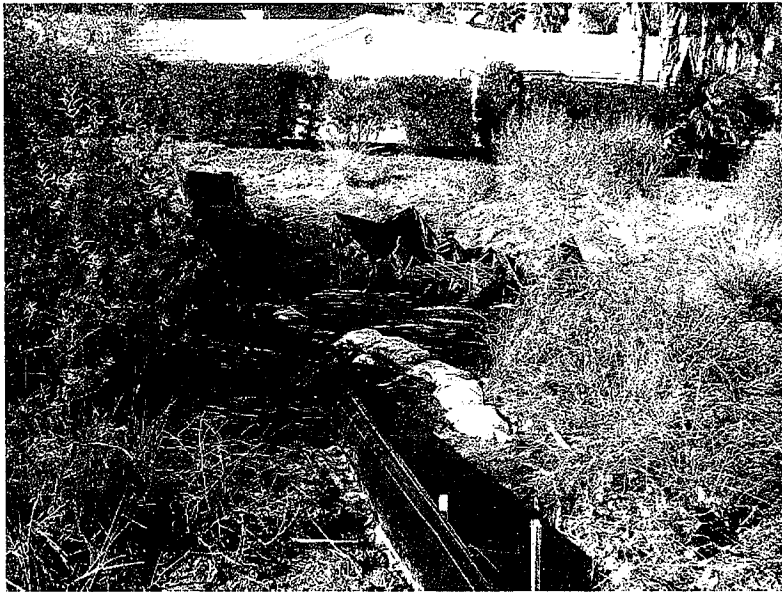
2. Multiple lines of silt fence have collapsed around this storm drain inlet.

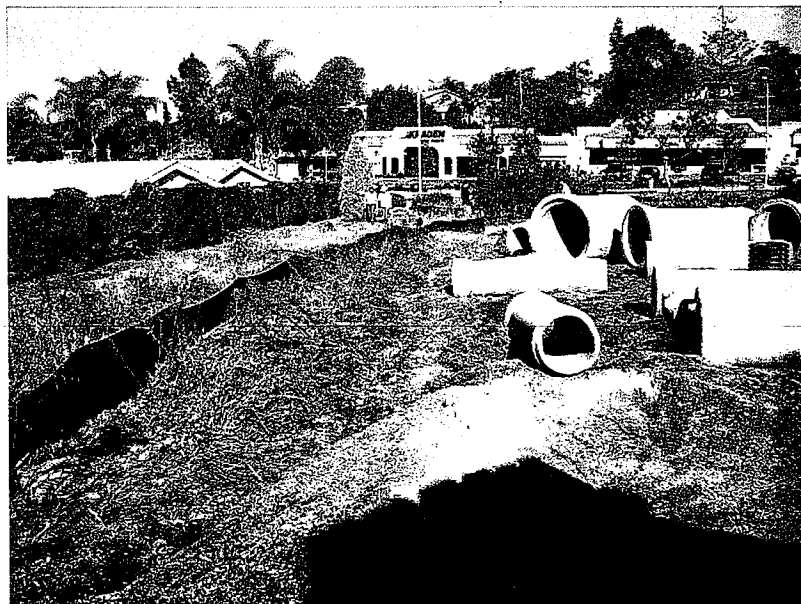
3. Concentrated flows of storm water run on discharge here through the construction storage yard.

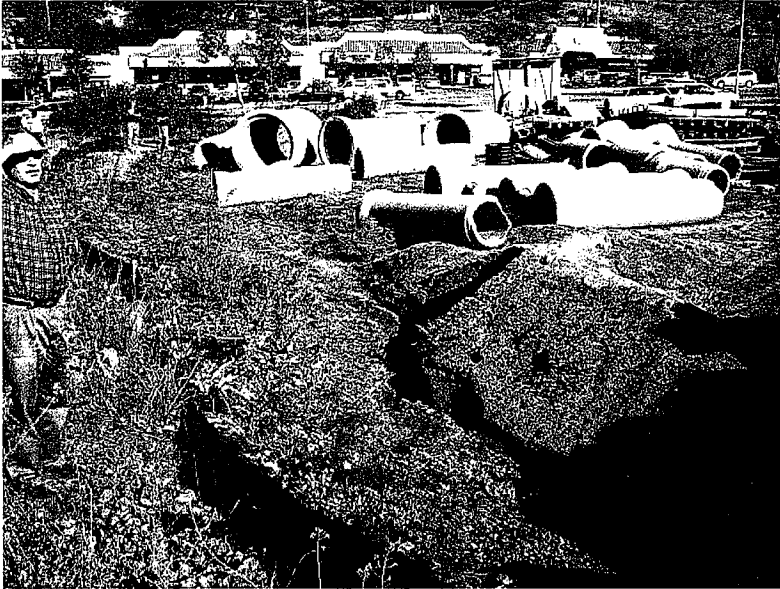
4. Concentrated run on flows have eroded away this dirt stockpile.

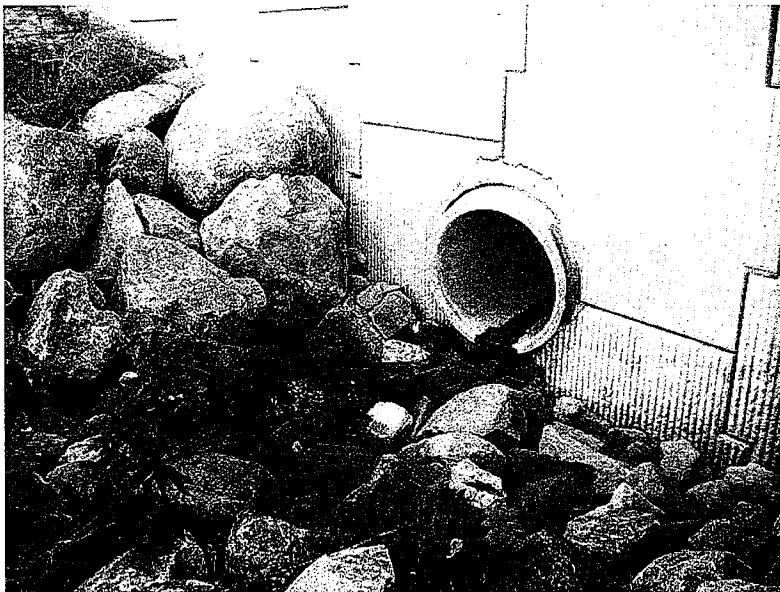
5. This culvert is the source of the run on coming through the storage yard.

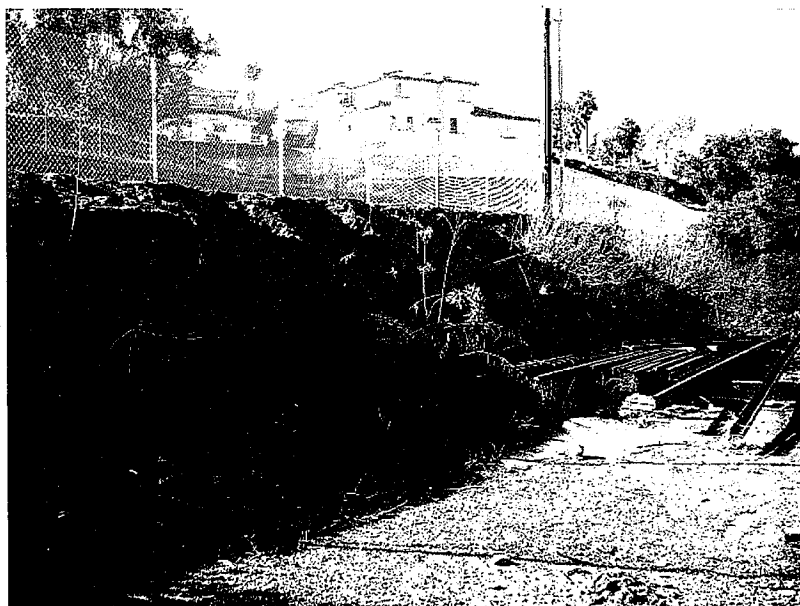
6. This slope is without erosion controls and is severely eroding away. This slope's lack of erosion control was also noted in the February 20, 2007 inspection.

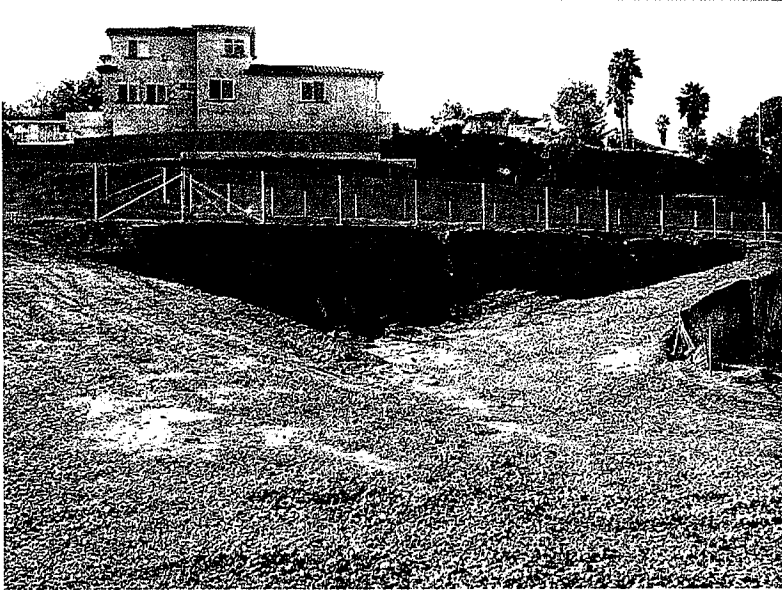
7. Another culvert that provides storm water run onto the construction storage yard is not redirected away from disturbed soils.

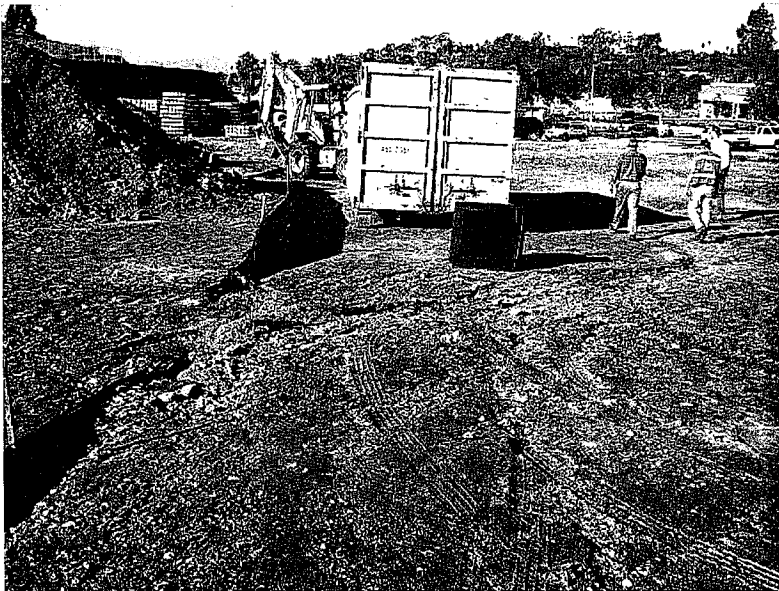
8. Silt fence has failed around this soil stockpile.
