**CALIFORNIA REGIONAL WATER QUALITY CONTROL BOARD - SAN DIEGO REGION
WATERSHED MANAGEMENT PROGRAM**

FACILITY INSPECTION REPORT

Sprinter Rail Project
FACILITY OR DEVELOPER NAME (if different from owner)

FACILITY: North County Transit District Sprinter Rail (WDID)_9 37C322900 INSPECTION DATE: 12/7/07

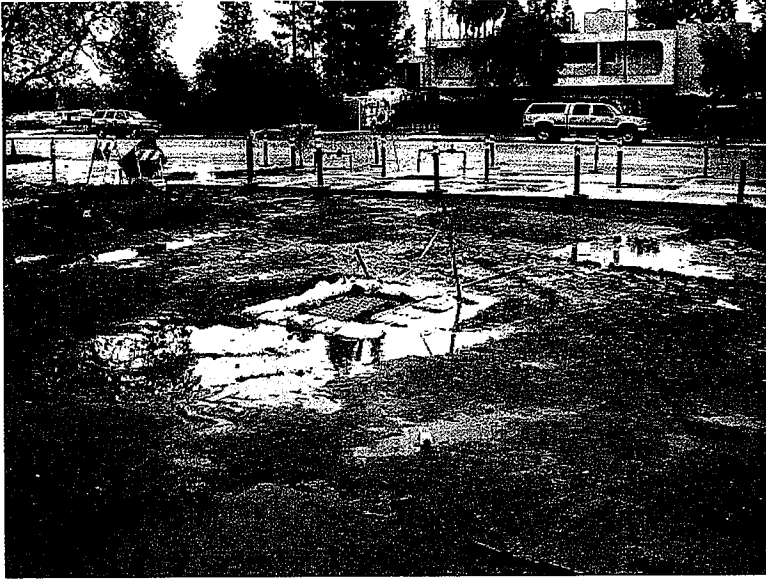
1. Escondido Transit Center in Escondido - This station is located on Valley Parkway near Quince Street. The station is near completion, but landscaping has not been installed. Photo 1 shows gravel bags protecting a storm drain inlet in the parking area. Only light rain was falling at this time and the water level was near the top of the gravel bags. This is of concern because it appears that water could overflow the gravel bags during a heavy rainfall event. Another gravel bag-protected drain in the parking area is shown in Photo 2. Photo 3 shows a hole in the ground where it appears that water has been draining to. This is suggested by the lack of ponding of water in this area and the large rill leading to the hole. It appears to be possible that sediment-laden water could be bypassing sediment controls and reaching storm drains through this hole. A similar situation was found at another storm drain in the parking lot. Again, it appeared that water had been draining onto a hole and possibly entering the storm drain or storm drain backfill or both. Slopes along the side of the tracks lacked erosion and sediment controls (Photo 4). Another storm drain with gravel bag protection is shown in Photo 5. A silt fence near the railroad tracks was almost completely dilapidated. This area also lacked erosion controls (Photo 6).

1. Gravel bags holding back
sediment-laden water.

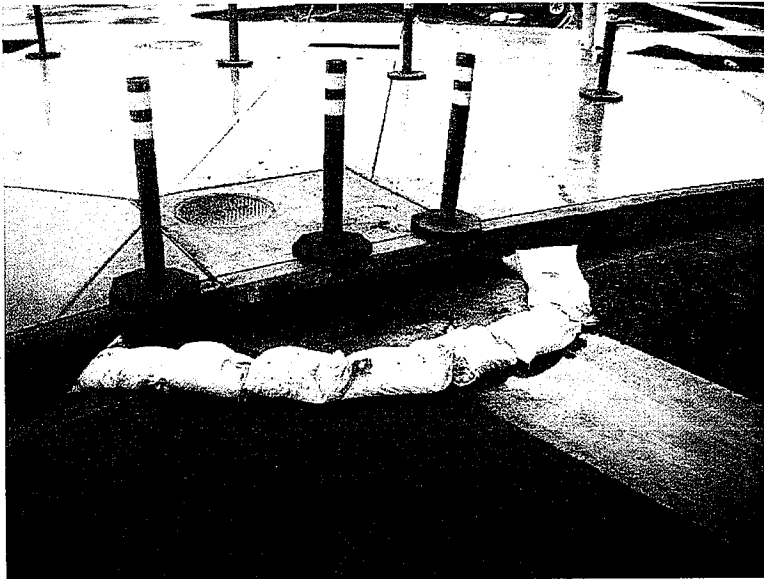
2. Parking lot drain inlet protected
with gravel bags.

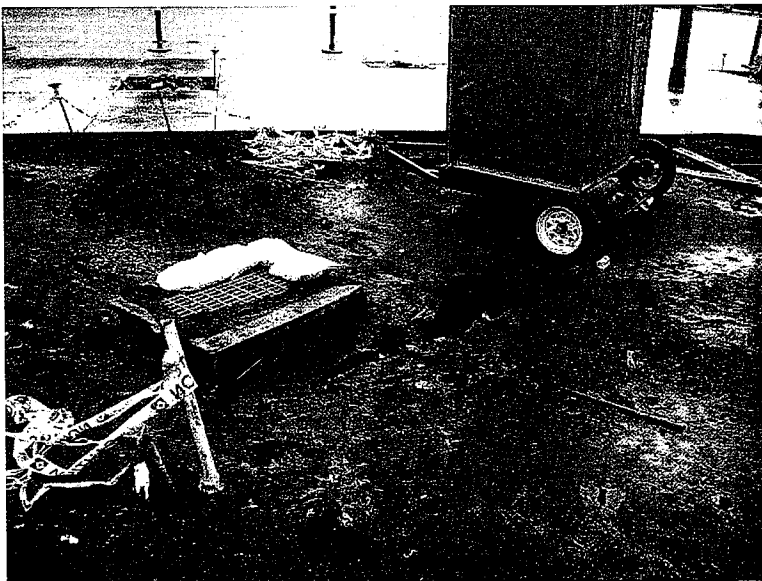
3. Rill leads to a hole in the
ground (below the port-a-potty)
where storm water appears to be
draining.

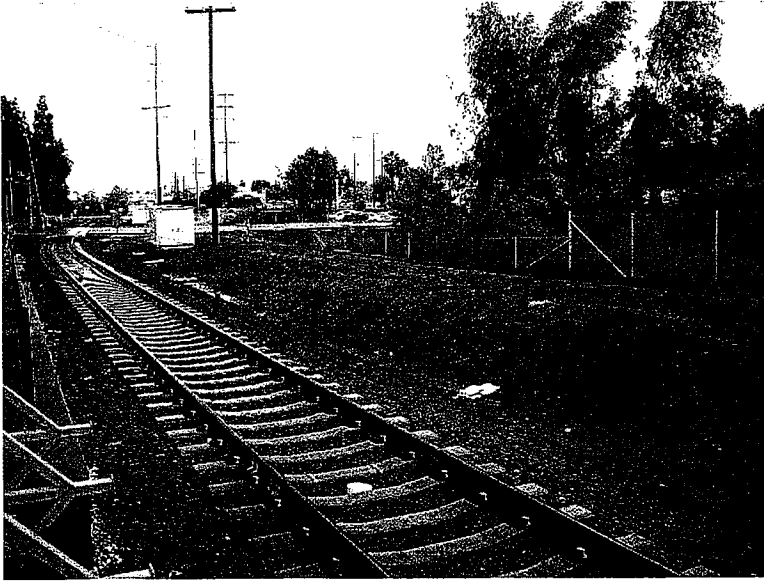
4. Slope lacks both erosion and sediment controls.

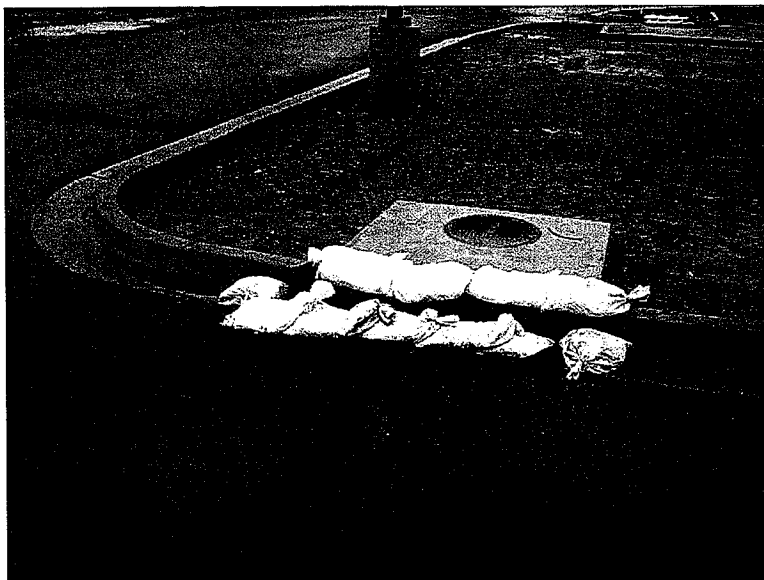
5. Gravel bags surrounding inlet in parking lot.

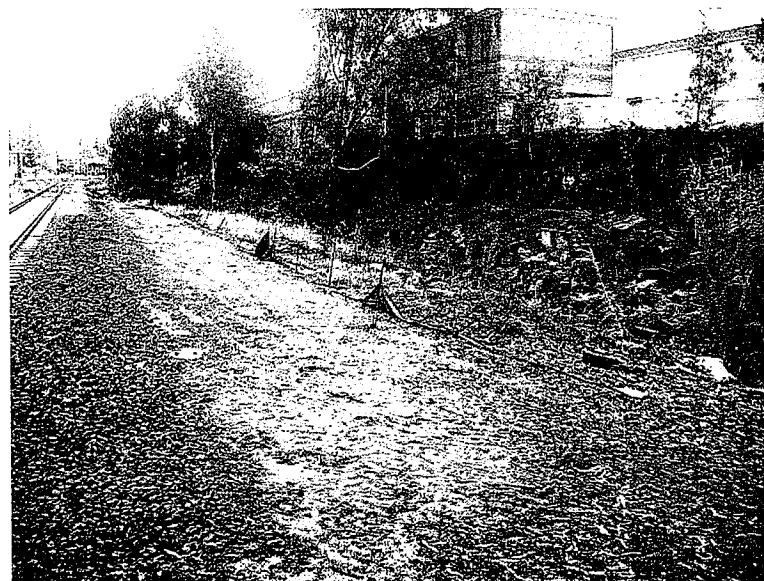
6. Silt fence in disrepair.

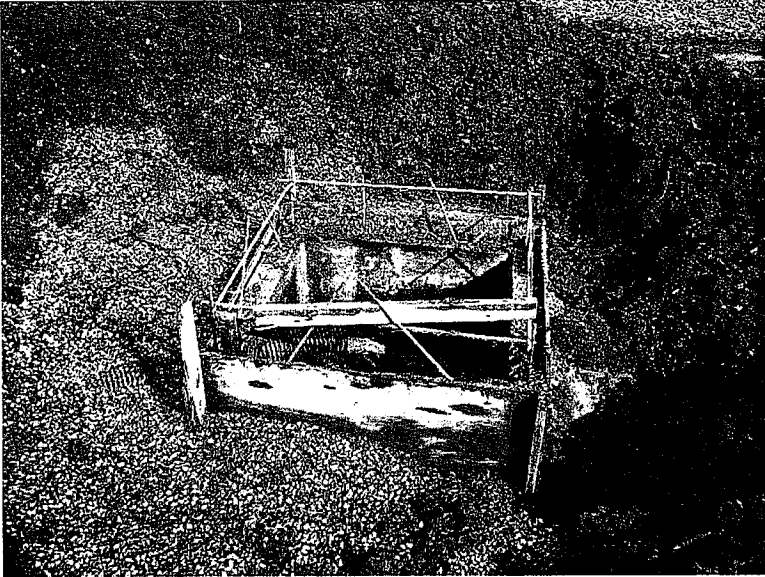
3. Nordahl Road Station in Escondido - This station is located at the intersection of Barham Drive and Mission Avenue. A drain that was under construction lacked inlet protection while bare soil that surrounded the drain was lacking erosion controls (Photo 7). Photo 8 shows a similar situation in which there is some inlet protection (rocks in front of the drain) but the protection is clearly inadequate. Photo 9 shows gravel bags that have been placed in front of a ponded area where a prior inspection had found the muddy pond to be bypassing the fiber rolls and flowing to the street. It is doubtful that the bags alone will be effective in preventing overflow during a rainfall event.

7. Drain still under construction, but inlet protection is needed and soil lacks erosion controls.

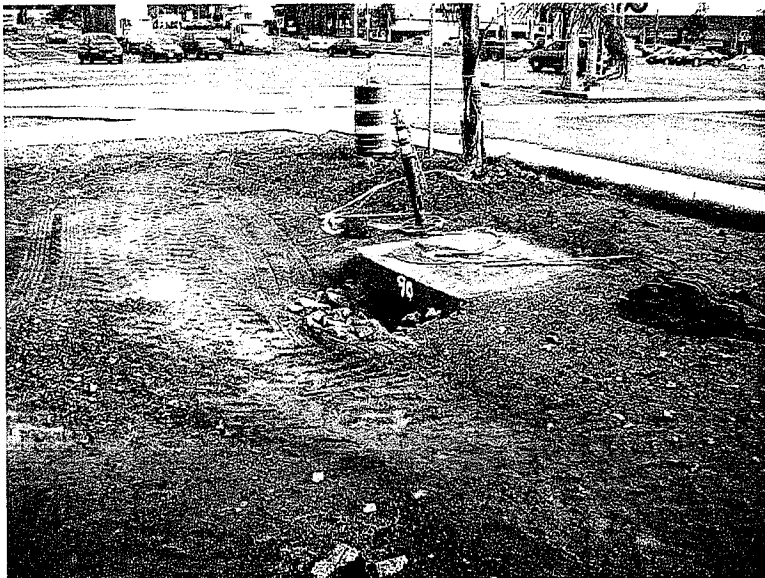
8. Rocks in front of storm drain inlet provide inadequate protection.

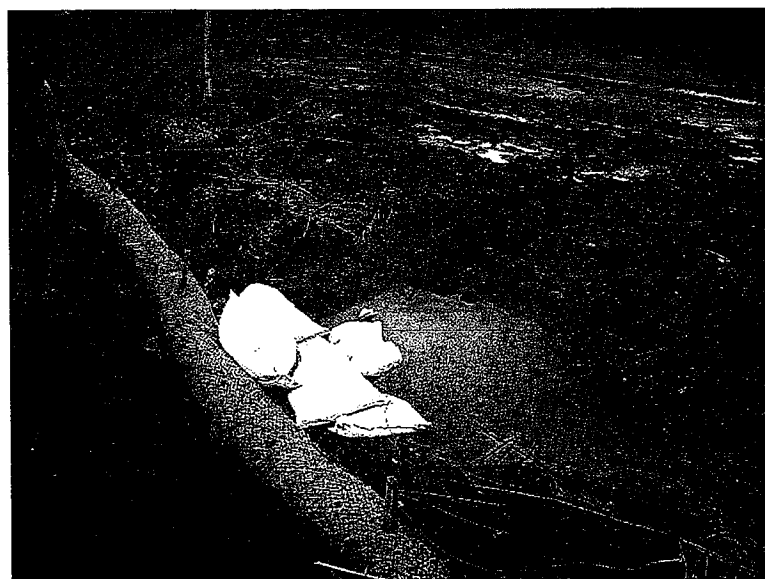
9. Gravel bags placed next to pond of turbid water to prevent overflow to the street.

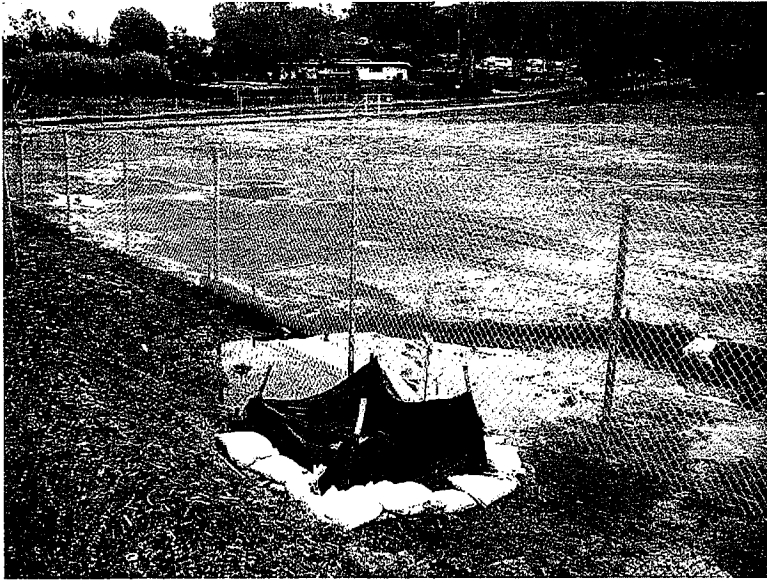
4. Barham Drive, east of Cal State San Marcos Station in San Marcos - This is a stretch of railroad tracks that run along Barham Drive between Cal State Marcos Station and Nordahl Road Station. Photo 10 shows a large field of exposed soil where storm water flows to a storm drain inlet that is protected by silt fence and gravel bags. Flows have been strong enough to knock down silt fences during past storm events, however, the inlet protection was holding up, so far, on this date. The field needs implementation of erosion controls as soon as possible. Further to the west of this area, fiber rolls were in need of maintenance. A section of fiber roll has been flattened to the elevation of the sidewalk (Photo 11).

10. Another area where soil is not stabilized.

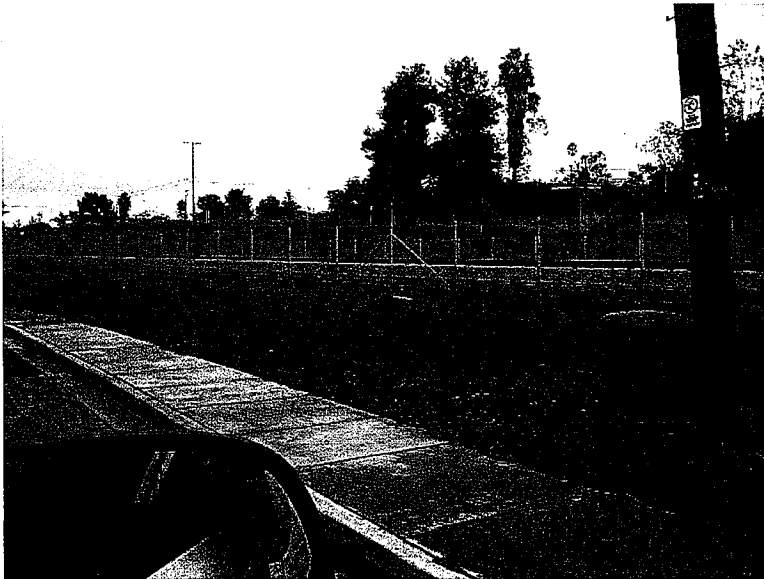
11. Fiber roll at toe of slope flattened to about the level of the sidewalk.

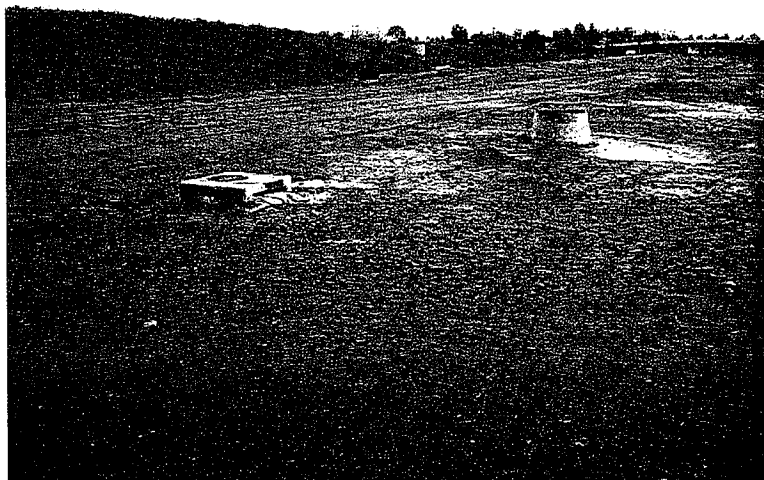
5. Near the Intersection of Barham Drive and Shelly Drive in San Marcos - This is a location near a stretch of tracks further to the west on Barham Drive. A large expanse of unstabilized soil was evident here. A storm drain inlet surrounded by soil continues to be inadequately protected (Photo 12).

12. Large expanse of unstabilized soil surrounding a storm drain with inadequate inlet protection.

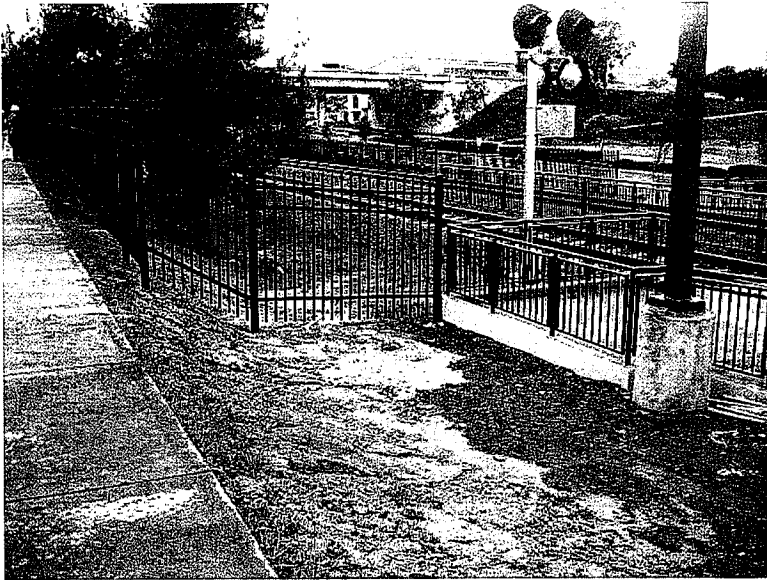
6. San Marcos Civic Center Station in San Marcos - This station is located near the intersection of San Marcos Boulevard and Mission Road near the San Marcos City Hall. The station appears to be near completion but in need of landscape. Photo 13 shows an area where soil is exposed and in need of stabilization. Further from the station, a strip of soil on one side of the tracks lacked stabilization and another side had been stabilized with hydroseed, but

13. Soil lacks stabilization.

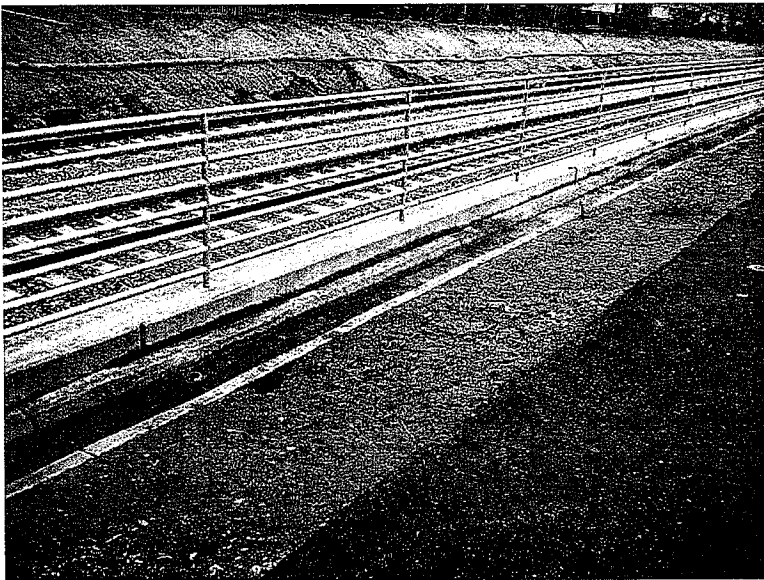
sections were slumping or sloughing off (Photo 14). At a location on Mission Avenue stabilization was needed in an area close to a storm drain (Photo 15).

14. Slopes on left side of picture exhibit hydroseeded areas that have slumped or sloughed off of the slope. Bare soil on the right side of picture lacks adequate stabilization.

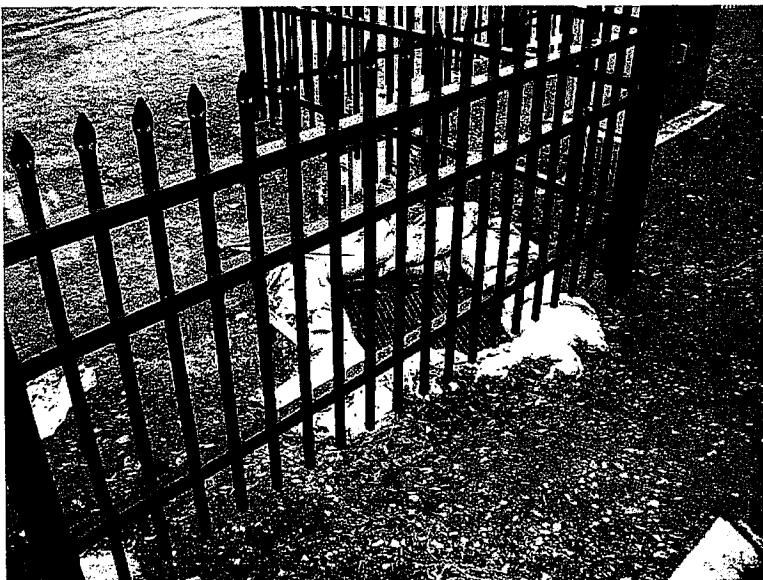
15. Gravel bags protecting inlet in an area that needs stabilization.

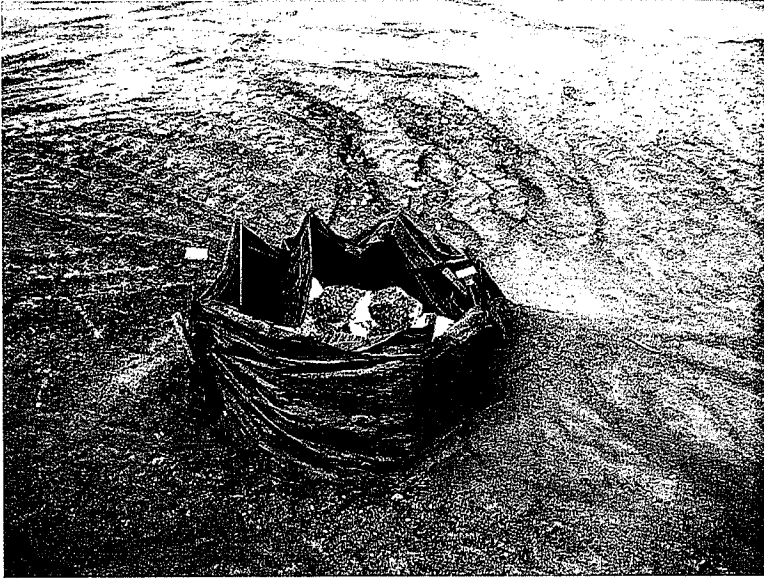
7. Buena Creek Station in San Diego County (Unincorporated) - This station is located at the intersection of Buena Creek Road and Santa Fe Avenue. Once again, station construction is near completion, but landscaping had not yet been installed. Photo 16 shows eroded soil near a drain inlet with dilapidated gravel bags. Stabilization is needed along with improved inlet protection.

16. Lack of erosion control in area surrounding storm drain inlet.

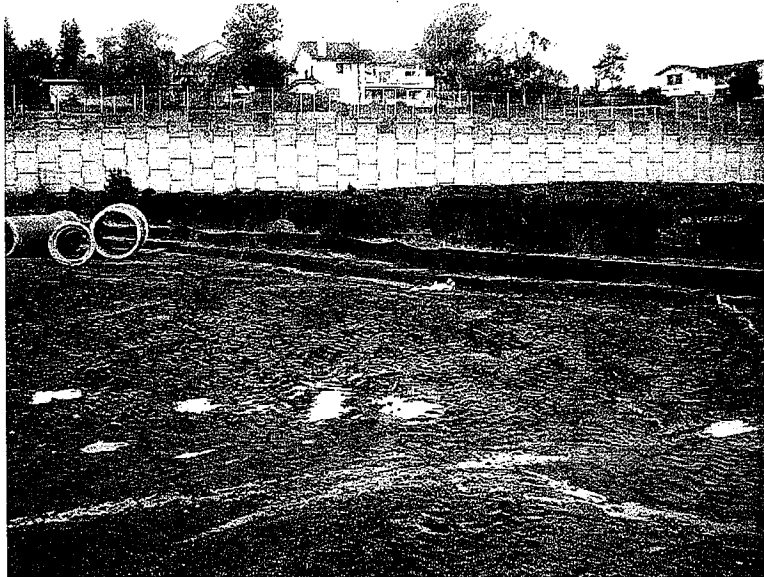
8. Mar Vista storage yard in Vista - This site is a storage yard located adjacent to the tracks at Mar Vista Drive. An outfall directs storm water from an off-site source onto the yard. NCTD has constructed an earthen channel to convey this water to a storm drain on the northwest corner of the site. This drain also handles the runoff from the rest of the site. Highly turbid water has been observed entering this drain during prior inspections. Rainfall had subsided and there was no flow of water occurring here during this inspection. No erosion controls have been employed in the earthen channel (Photo 17).

17. Channel leading from outfall at wall lacks stabilization or any erosion controls.

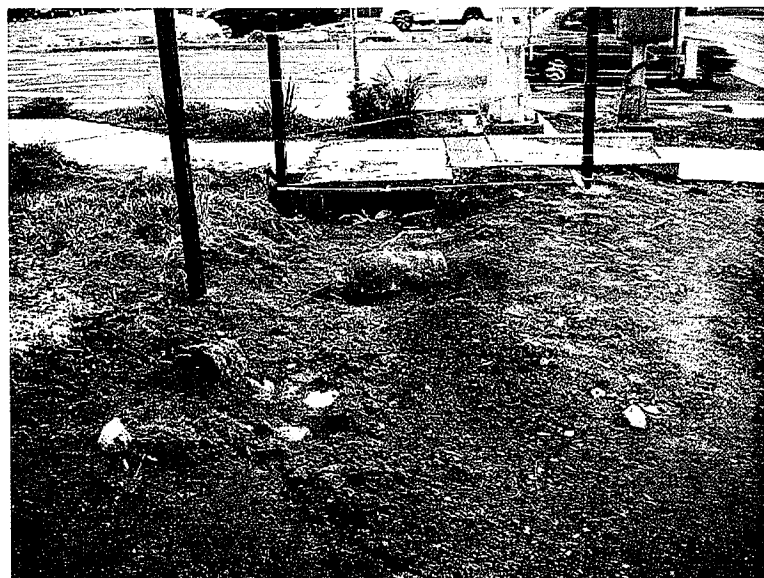
9. Vista Transit Center in Vista - The Vista Transit Center is located near the corner of Vista Village Drive and Santa Fe Avenue. A drain alongside of Vista Village Drive did not have any inlet protection and the soil outside the drain had no erosion or sediment controls (Photo 18).

18. No inlet protection and soil lacks stabilization.

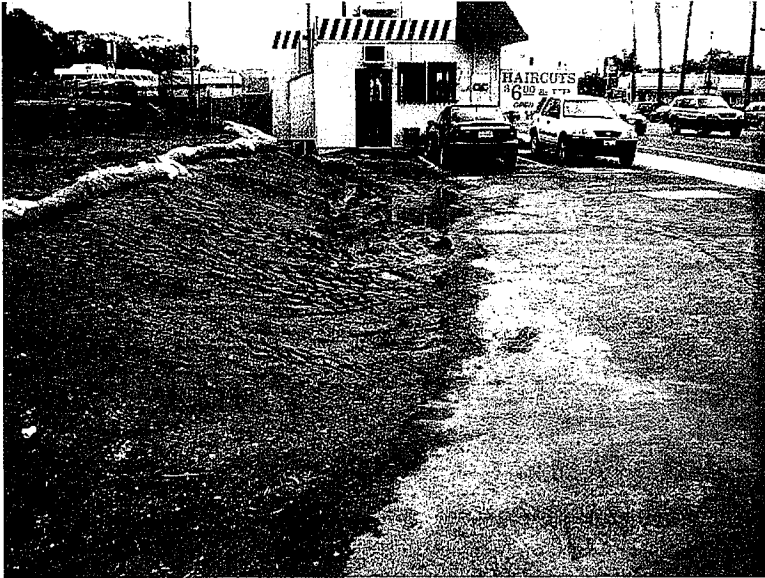
10. Crouch Street Station in Oceanside - This station is located near the intersection of Crouch Street and Oceanside Boulevard. Photo 19 shows a slope on the north side of the station where the lack of erosion and sediment controls has resulted in soil encroaching on the parking lot of an adjoining business establishment.

19. Lack of erosion control and inadequate sediment control on slope above a parking area. Soil is encroaching onto the parking lot.

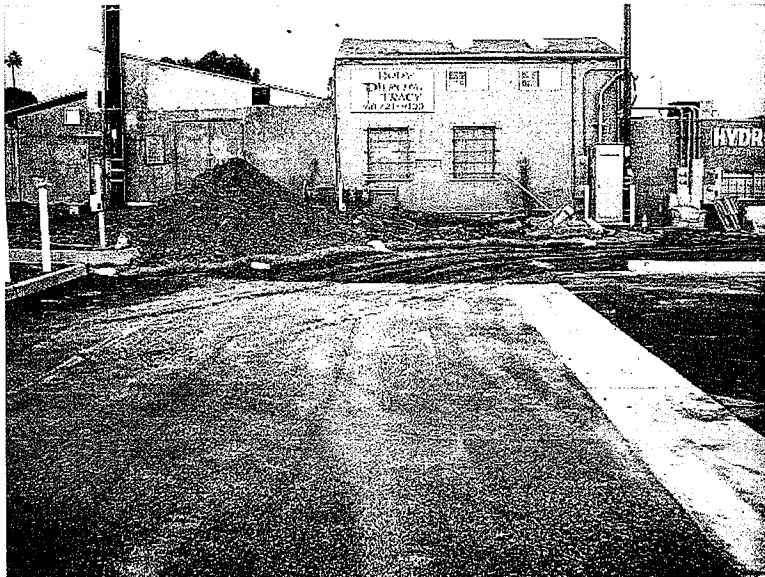
11. Coast Highway Station in Oceanside - This station is located southwest of the intersection of Coast Highway and Godfrey Street. Tracked sediment from a dirt field is shown in Photo 20. South of the station, there was an area of unstabilized soil where mud deposits have accumulated in front of a storm drain inlet (Photo 21). West of this area, a south-facing slope next to the tracks lacked erosion and sediment controls while the north-facing slope is in need of repair of eroded gullies (Photo 22). Another inlet closer to the station lacked adequate protection in an area where an earthen channel needs erosion controls, i.e., stabilization (Photo 23).

20. Sediment tracking on pavement with no tracking controls.

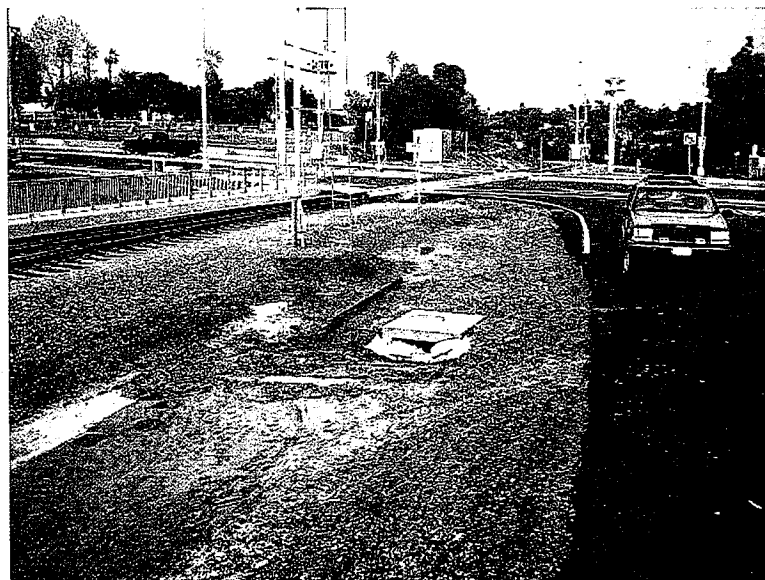
21. Soil near tracks lacks stabilization. Accumulated sediment is visible in front of the drain inlet.

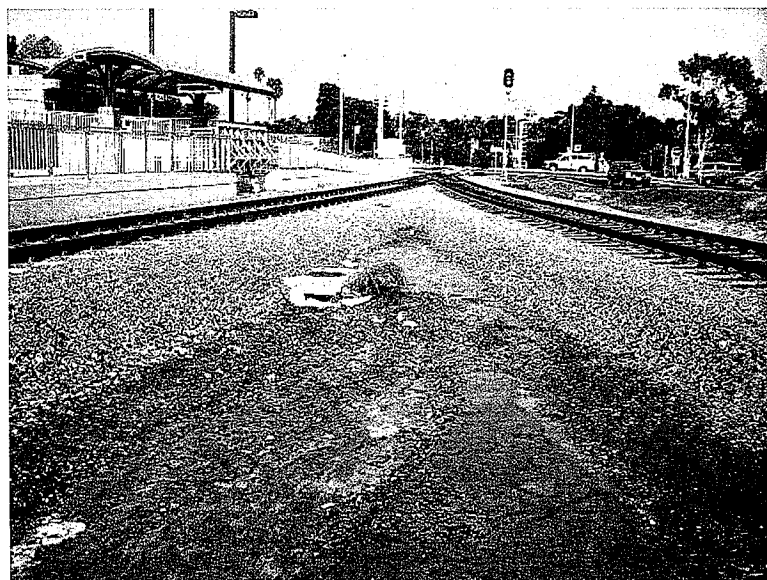
23. Inadequate inlet protection. Earthen channel lacks erosion controls.
