CALIFORNIA REGIONAL WATER QUALITY CONTROL BOARD - SAN DIEGO REGION
WATERSHED MANAGEMENT PROGRAM

FACILITY INSPECTION REPORT

FACILITY: North County Transit District Sprinter Rail (WDID) 9 37C322900 INSPECTION DATE: 12/19/07

On December 19, 2007, Peter Peuron and Lee Shenk of the Regional Board's Central Watershed Unit inspected the North County Transit District's (NCTD) construction of the Sprinter Rail. The following sites were visited.

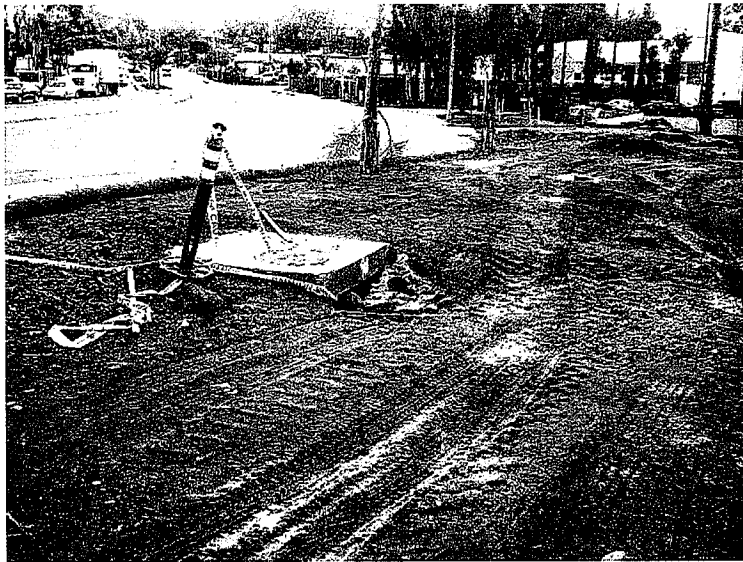
Photo 1 was taken at the Nordahl
Road Station.

1. **Nordahl Road Station in Escondido** - This station is located at the intersection of Barham Drive and Mission Avenue. A drain at the west side of the station which had during the last inspection (on December 7, 2007) been identified as lacking inlet protection was found to still be inadequately protected (Photo 1). Gravel bags sit in a depression in front of the drain allowing for easy entry of storm water flows. In addition, there are no erosion controls in the area around the drain.

1. Poorly protected storm drain inlet and surrounding soil with no erosion controls.

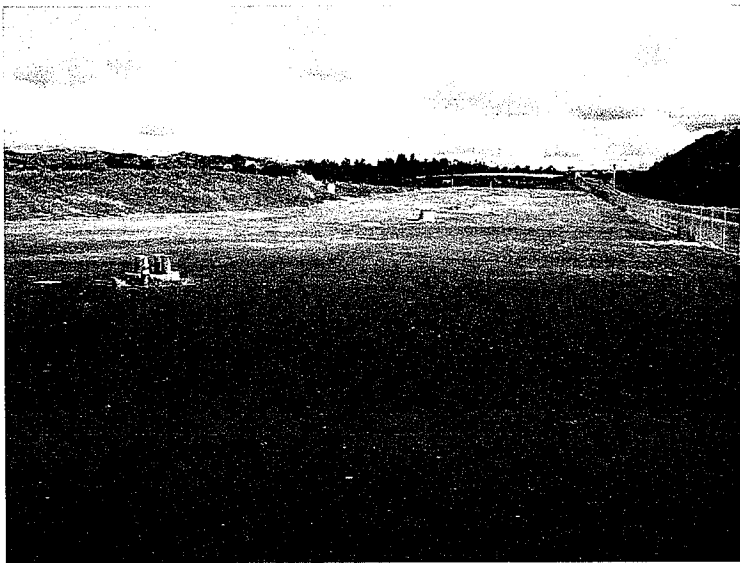
2. **Near the intersection of Barham Drive and Shelly Drive in San Marcos** - This is a location near a stretch of tracks further to the west on Barham Drive. The large area of unstabilized soil found in past inspections (e.g., on November 30, 2007 and December 7, 2007) persists at this location without any erosion controls (Photo 2). A storm drain inlet surrounded by soil continues to be inadequately protected, the same situation observed during the December 7, 2007 inspection (Photo 3). The inadequacy of the inlet protection is shown by the sediment that sits on top of the bags. A slope between the barren field and the tracks exhibits rills (Photo 4).

2. Wide area south of the tracks which lacks erosion controls.

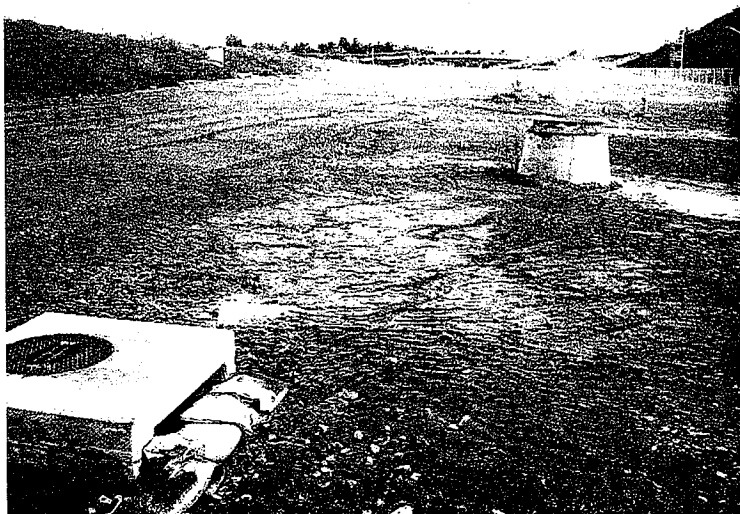
3. Inlet continues to have inadequate protection. Gravel bags show evidence of being over-topped by sediment.

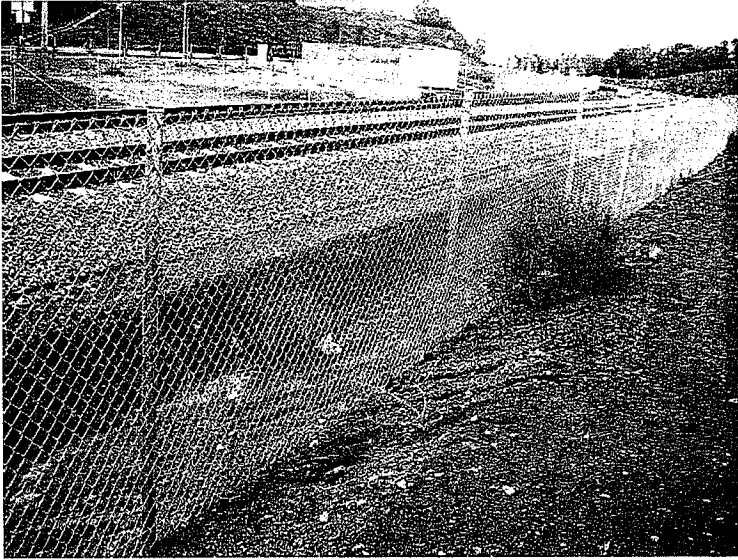
4. Rills discharging to ditch that runs along the tracks.

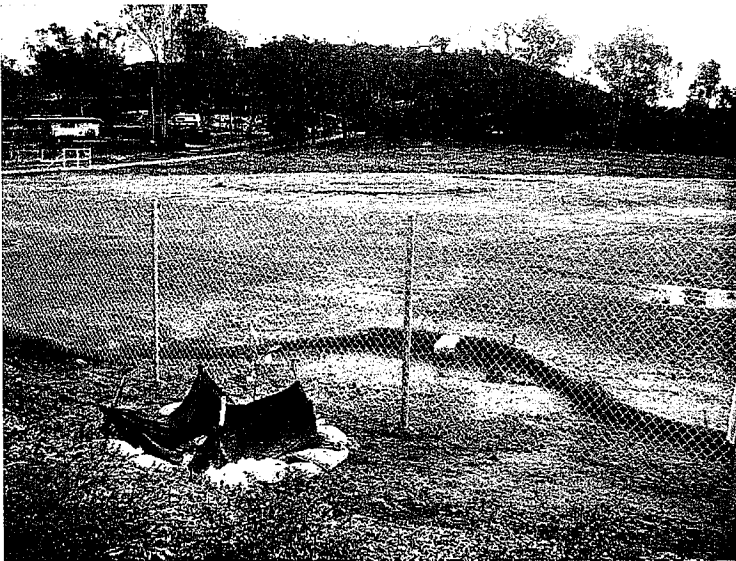
3. **Barham Drive, east of Cal State San Marcos Station in San Marcos** - This is a stretch of railroad tracks that runs along Barham Drive between Cal State Marcos Station and Nordahl Road Station. The property has been used by NCTD as a storage yard. The yard continues to lack stabilization as observed during prior inspections (Photos 5 and 6). Inlet protection is in need of maintenance (as it was during the inspection on December 7, 2007).

5. Field south of tracks previously used to store equipment continues to lack erosion controls.

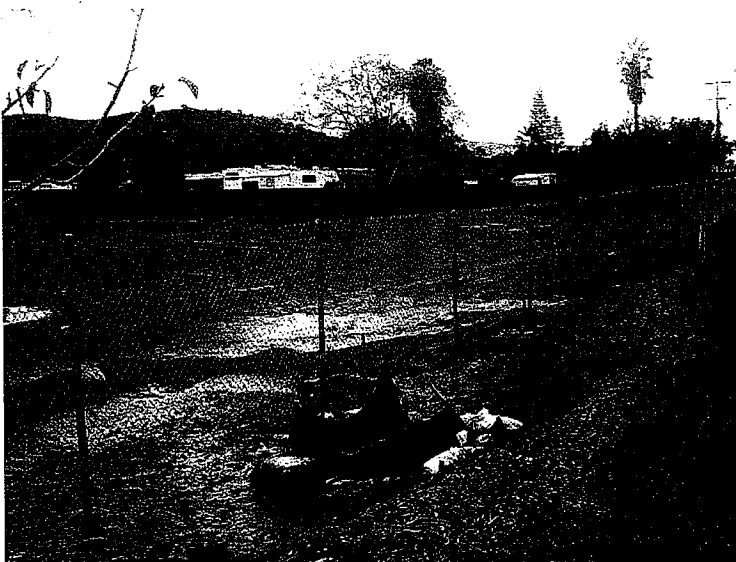
6. Another view of the unstabilized field (looking to the west).

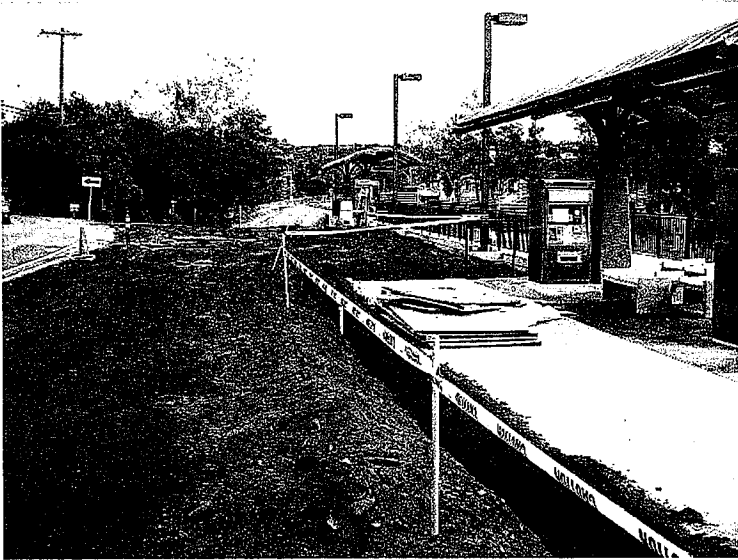
Photo 7 was taken at the Buena Creek Station.

4. **Buena Creek Station in San Diego County (Unincorporated)** - This station is located at the intersection of Buena Creek Road and Santa Fe Avenue. Station construction is near completion, but landscaping has not yet been installed. Photo 7 shows an area of bare soil that is still without sediment or erosion controls (as it was during the inspection on December 7, 2007).

7. Continued lack of erosion and sediment controls next to station.

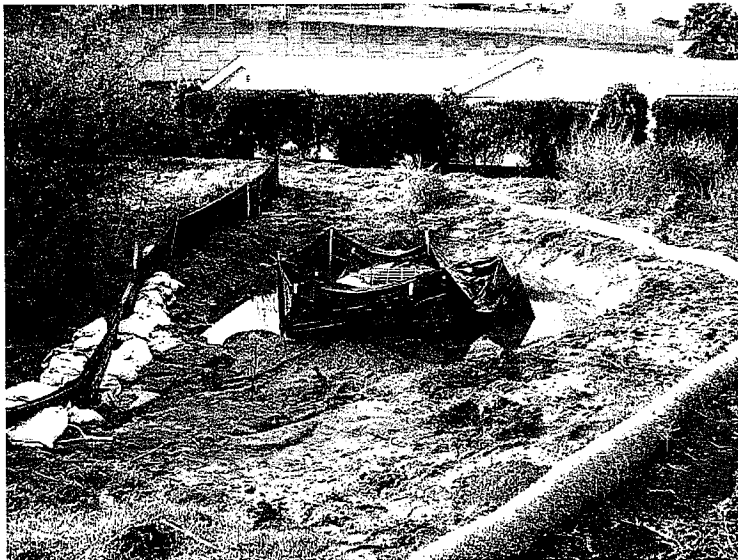
5. **Mar Vista storage yard in Vista** - This site is a storage yard located adjacent to the tracks at Mar Vista Drive. An outfall directs storm water from an off-site source onto the yard. NCTD has constructed an earthen channel to conduct the discharge from the outfall to a storm drain located on the northwest corner of the property. Erosion controls had yet to be employed in the earthen channel (A picture of the channel was taken, but it did not develop properly). The storm drain inlet in the northwest corner of the yard is shown in Photo 8. Photo 9 shows the yard looking to the southeast. Once again there was no stabilization of a wide area of exposed soil.

8. Silt fence and gravel bags in need of maintenance after the storm.

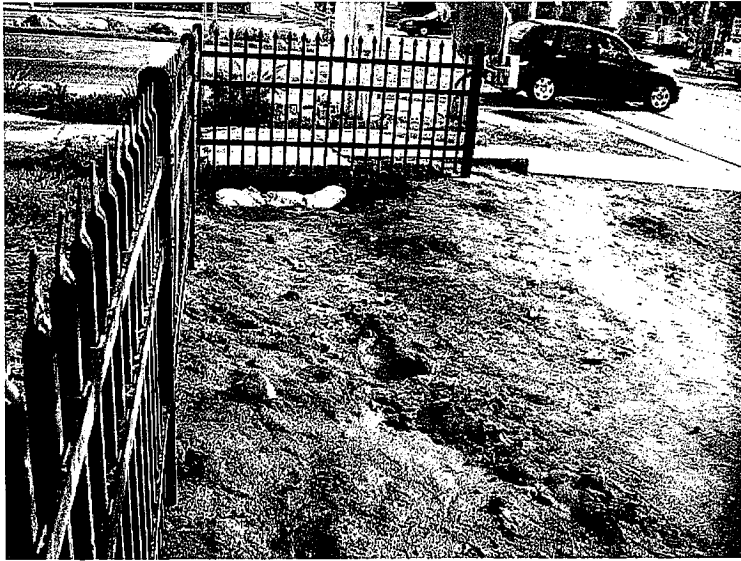
6. **Vista Transit Center in Vista** - The Vista Transit Center is located near the corner of Vista Village Drive and Santa Fe Avenue. A drain which previously did not have any inlet protection (inspection on December 7, 2007) was protected by gravel bags, however soil in front of the inlet continues to be exposed (i.e. not stabilized) as shown in Photo 10. Photo 11 shows the north parking area. Cement bags which had previously been leaking (inspection on November 27, 2007) have been removed.

10. Soil in front of storm drain lacks erosion controls.

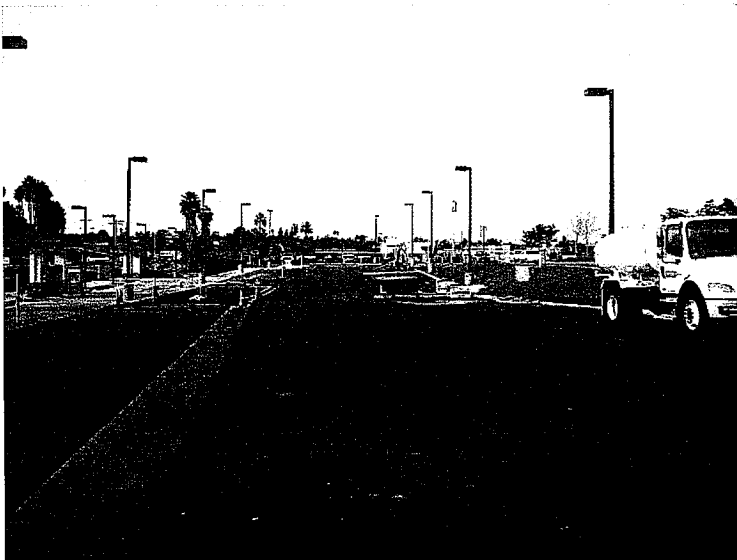
11. Bags of cement which had been leaking have been removed from the parking lot.

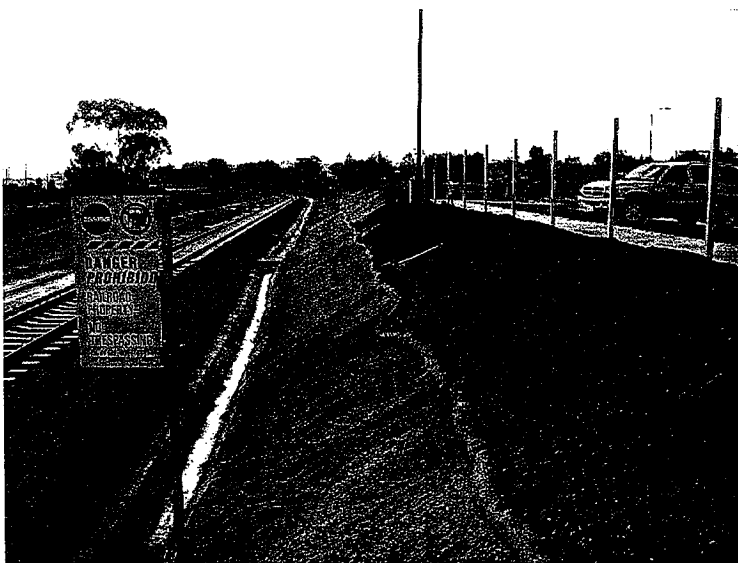
Photo12 was taken at Melrose Station.

7. **Melrose Station in Oceanside**. This station is on the southwest corner of Melrose Drive and Oceanside Boulevard next to a convenience store. The headwaters to Loma Alta Creek flow adjacent to the south side of the tracks. South-facing slopes were found to have not been stabilized during prior inspections. Photo 12 shows that a south-facing slope has been hydroseeded, but the upper half of the slope is covered with soil that was removed from a ditch that was recently dug out in order to install an irrigation line. Some of the soil has also rolled into the storm drain ditch at the toe of the slope.

12. Soil that was removed at the top of the slope for installation of an irrigation pipe has covered hydroseed all the way down to the fiber roll at mid-slope.
