Subject: Valencia Project Site – Meeting with CRWQCB, Follow up Requirements

INSPECTOR'S REPORT

Project: Valencia		Date: 12/24/14	Hours: 3
Developer: Anderson		Project No.: GR-1691	
Location: San Altos		Inspector: Harper	Contract Day:
Weather: Clear/warm			
MANPOWER AND EQUIPMENT			
Grading Contractor:	Underground Contractor:	Other Contractors:	
Koloa Pacific	Koloa Pacific	TVD, BCA Development, Surveyors, Cal West	
Equipment: various	Equipment: Various	Equipment: Various	
Remarks: Developer's Supervisor Onsite: <input checked="" type="checkbox"/> Y <input type="checkbox"/> N			
TVD placing silt fence on lots 1 through 5. William advised that by end of day, they should have silt fence at lots 67 through 73. Crew also filling rills at north area of site and performing housekeeping. Koloa continues to grade roads and Cal West cleaning bio basin #18 by dewatering to lot 56, which was fortified with extra gravel bags. Dwayne on site for BCA, William onsite for TVD with appx 10 workers from Labor Ready.

Subject: May 15, 2015 Sampling at Valencia Construction Site

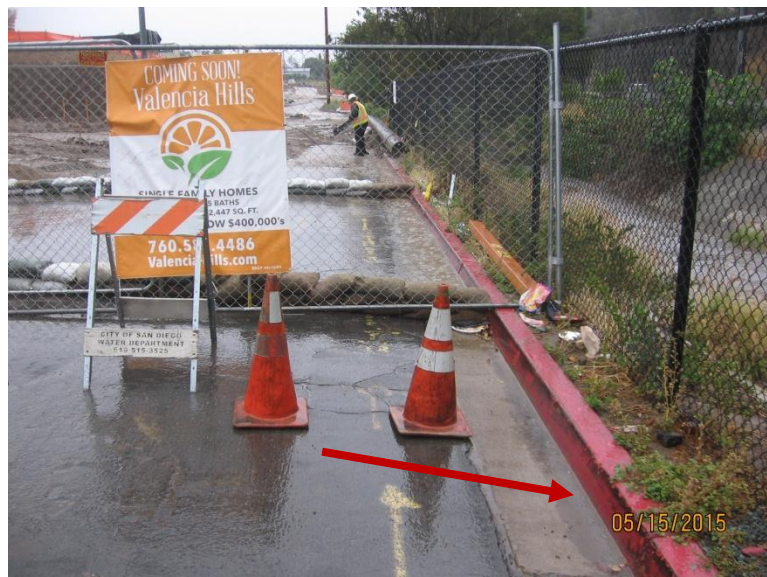
Photo 1. Site Valencia_Akins

Per the City's request, D-MAX collected samples of runoff from the Valencia construction site. Runoff was observed discharging from the construction site only at the Akins Avenue entrance/exit sampling location (site Valencia_Akins, Figure 1 and Photo 1). Because gravel bag check dams were positioned along Akins Avenue from the site discharge point down to the nearest storm drain inlet, a sample was also taken downstream of the last set of gravel bags, just before the water entered the inlet (site Akins_Inlet, Figure 1 and Photo 2).

Each sample was collected and analyzed for turbidity and pH using a calibrated field meter. The Valencia_Akins site had a turbidity value that exceeded the numeric action level of 250 NTU. Unprotected loose sediment observed along the site perimeter near the Akins entrance likely contributed to the high turbidity levels. Photo 3a shows the project area near the Akins inlet during the rain event on 5/15/2015. Photo 3b is a close-up photo of the same area two days earlier. It appears that the loose sediment observed on 5/13/2015 was not sufficiently cleaned up or protected prior to the rain event.

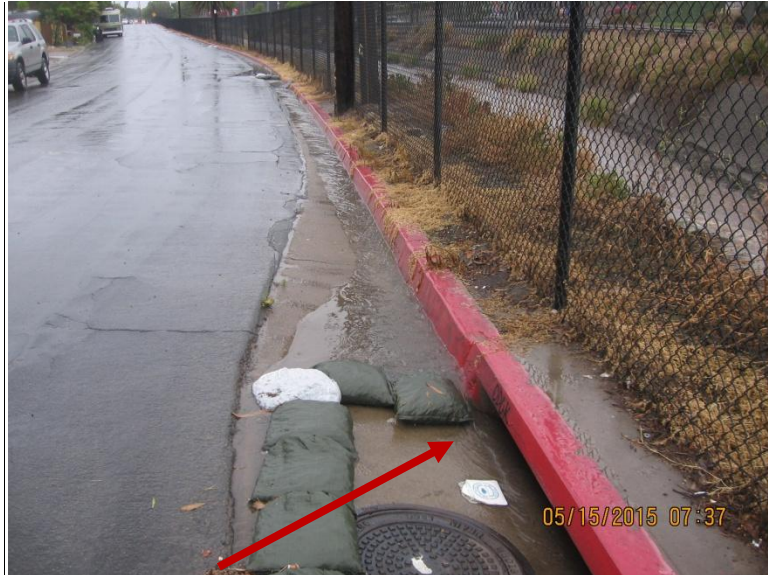
Photo 2. Site Akins_Inlet

The sample collected at the Akins_Inlet site downstream of the Akins entrance had a turbidity value below the numeric action level. This decrease in turbidity between the Valencia_Akins and Akins_Inlet locations may be due to a combination of sediment settling out at the gravel bag check dams and the runoff from Akins Avenue comingling with the site runoff. Results are summarized in the table below, and photos of the samples in clear containers are presented as photos 4 and 5.

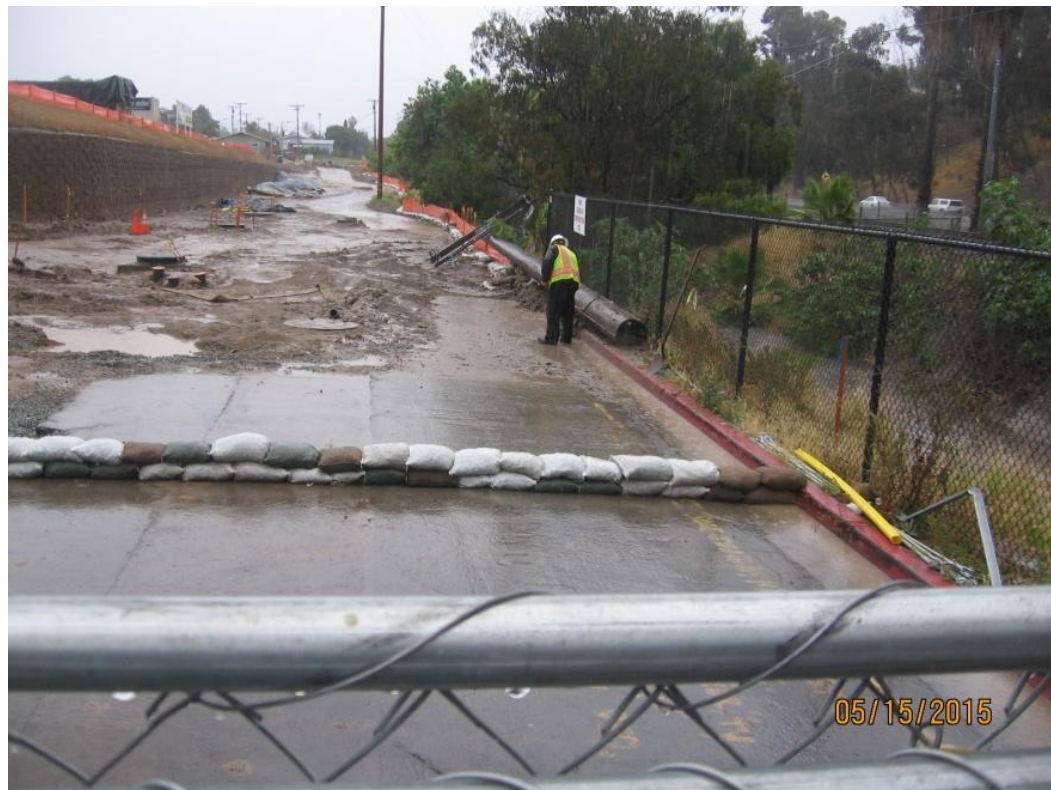
Photo 3a. Project area at the Akins Ave entrance/exit during rain event

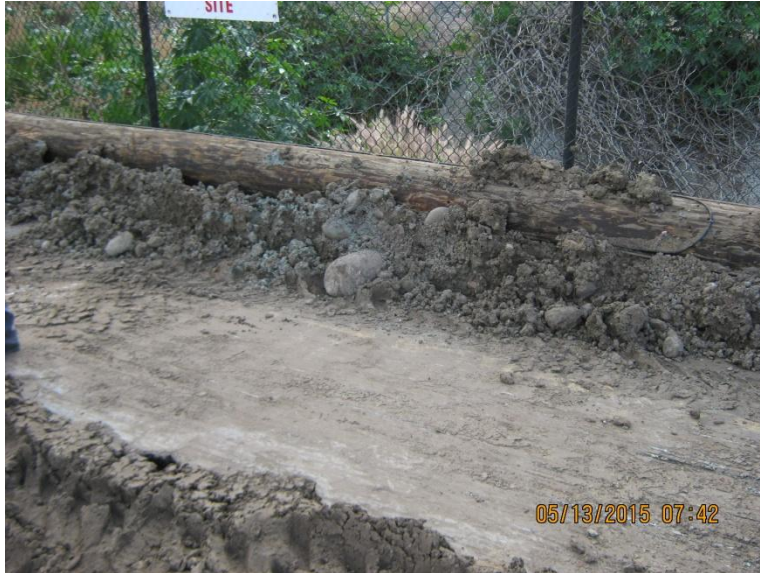
Photo 3b. Project area at the Akins Ave entrance/exit on 5/13/2015. (Same telephone pole as seen in photo 3a)

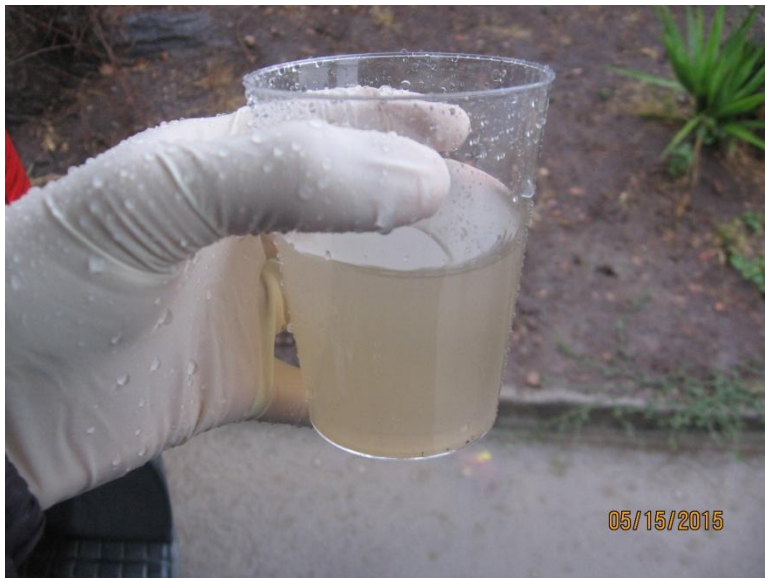
Photo 4. Sample from Site Valencia_Akins

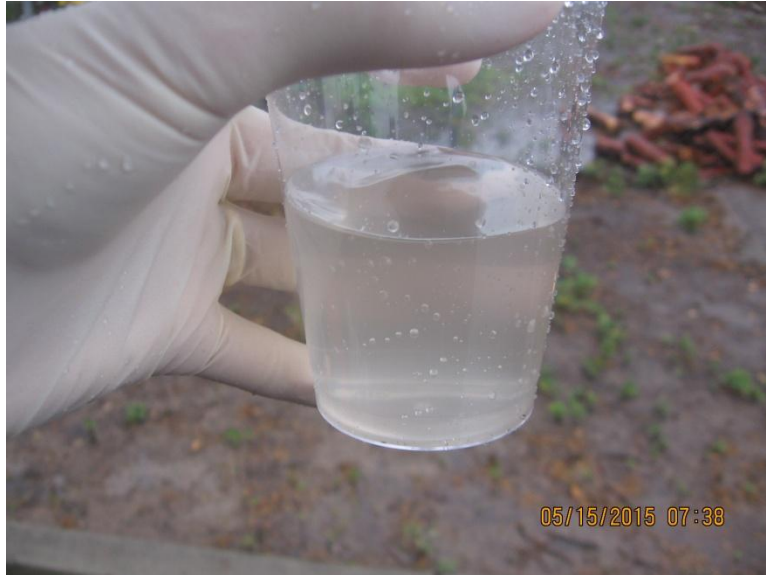
Photo 5. Sample from Site Akins_Inlet
