RE: NOTICE OF VIOLATION NO. R9-2008-0147 & REQUIRED TECHNICAL REPORT

**Subject Site: Culvert and Riprap at Santiago Road, East of John Warner Road,
Temecula, CA**

FACILITY INSPECTION REPORT

FACILITY: Parcel Map 35039 WDID/401 File #: 07C-015 INSPECTION DATE/Time: October 01, 2008

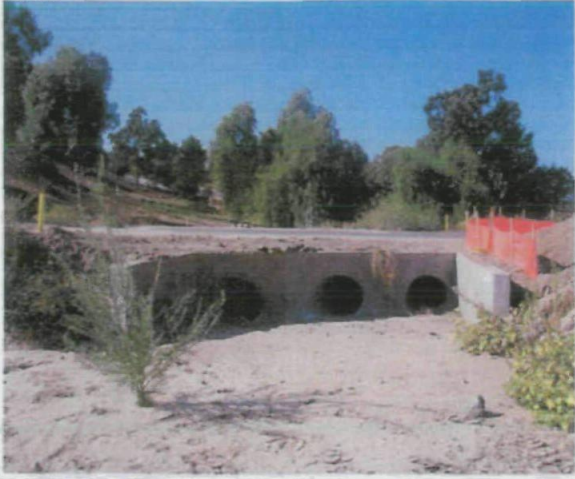
- The property has been graded and subdivided into 3 lots that are for sale.
- The proposed culvert from the original NWP 29 submittal appears to have been built; *located just east of John Warner Rd & under Santiago Rd*

Figure 1. Looking downstream towards the culvert and Santiago Road.

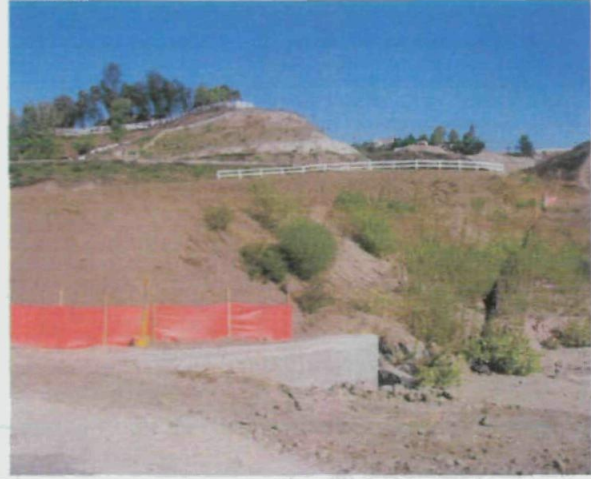
- Rip rap fill has been added upstream and adjacent to the culvert on what appears to be the Southeast corner of the subdivided property
 - Photos are available at S:\Watershed Protection\North Unit\Photos\01 Oct 2008 Riverside County\07C-015 Graded Lots Parcel Map 35039

Figure 2. Southeast corner of graded lots on the upstream side of culvert.

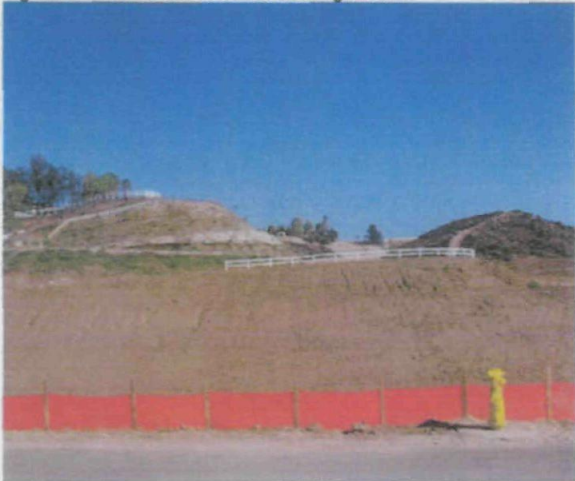
Figure 3. Graded lots North of Santiago Road.

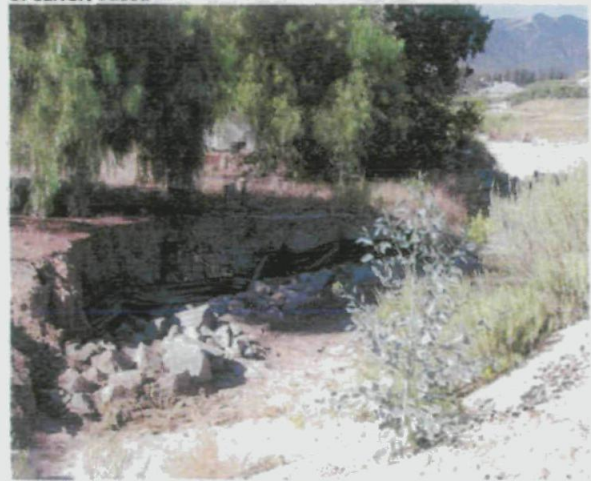
- The culvert is causing downstream bank erosion.
- Rip rap fill has been added to the creek in what appears to be an attempt to reduce erosion along Santiago Road and the property along the Southern creek bank.

- Rip rap fill has been added downstream of the culvert at the culvert outlet
 - Rip rap fill has been added downstream of the culvert on the Southern bank of the streambed in what appears to be an attempt to control erosion of the bank. The Southern side of the stream appears to be private property.

Figure 4. Rip-rap fill and erosion of Southern bank downstream of culvert outlet.

- Determine the responsible party for the fill activities
- Take enforcement measures against responsible party to remediate fill activities and prevent further erosion

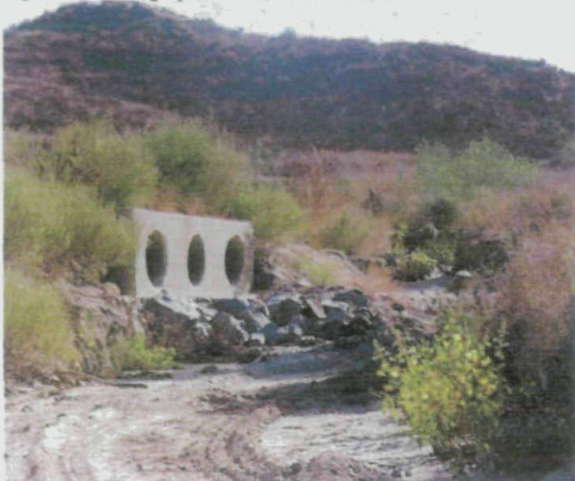
Figure 5. Looking upstream at culvert outlet.

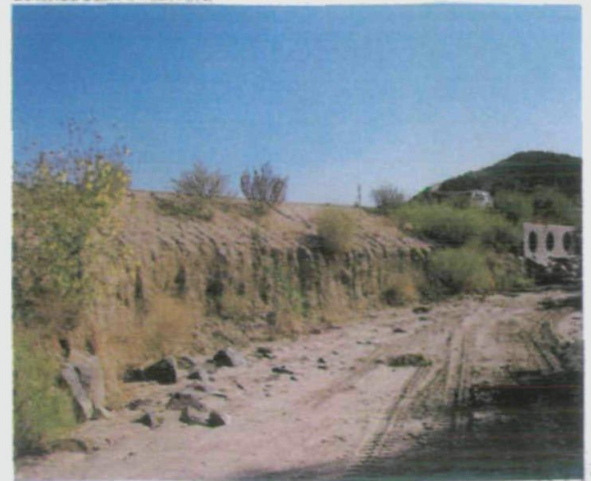
- Rip rap fill has been added downstream of the culvert on the Northern bank of the streambed adjacent to Santiago Road. It appears that the rip rap fill is in place in an attempt to protect the road by preventing erosion of the bank. The rip rap appears to have been inundated with sediment.

Figure 6. Rip-rap fill and erosion of the Northern bank downstream of culvert.
