# Subject: NOTICE OF VIOLATION NO. R9-2008-0113 & REQUIRED TECHNICAL REPORT

Facility: International Iron Products, 10883 Thornmint Road, San Diego, CA 92127

#### NOTICE OF VIOLATION NO. R9-2008-0113

#### FACILITY INSPECTION DATA ENTRY FORM

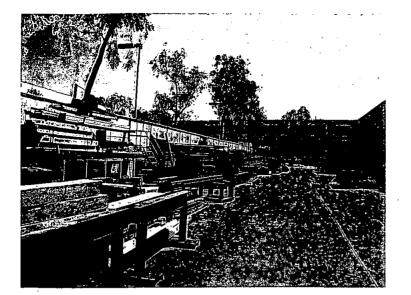
1. View of the east side of the facility, looking south. Steel Ibeams are stored, generally with adequate elevation, but no overhead protection.

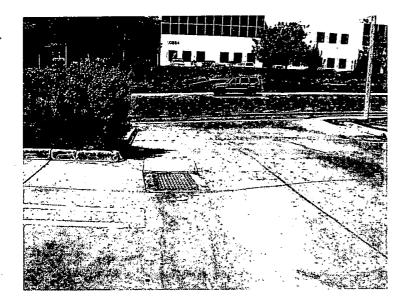
The subject facility stores a large amount of unfinished steel products in an outdoor, paved environment where there is a potential for a significant degree of contact between these materials and stormwater. The Best Management Practice (BMP) of covering these materials using tarps during each rain event may not be effective if the stored steel is not covered in time, or rain events are not adequately anticipated. Without collection and analysis of samples, however, it is much more difficult to gauge the effectiveness of BMPs because there is no stormwater sampling data available to assess actual impacts. Additional concerns have arisen based on observations during the inspection on August 7, 2008 which included stains on pavement leading up to a storm drain (see Photo 7 of the attached inspection report).

indicates that they do daily cleanup of work areas and twice weekly cleanup of the entire facility. There is also a significant amount of storage of steel beams on the west side of the facility (Photo 6). Just beyond the gate on the west side of the facility, there is a storm drain (Photo 7). The drain appears to be in a location where it would intercept most or all of the site's runoff. Virtually the entire site is paved and therefore, it should be possible to obtain enough flow during rain events to get water samples. There was a stain leading from the west side of the site, and into the drain. The stain's reddish tinge may be due to the presence of iron in the runoff. After walking the site, I reviewed the SWPPP. The SWPPP has a detailed site map and it includes recent documentation of stormwater training. Some of the critical BMPs listed in the SWPPP are: "daily cleaning of work areas", "twice weekly general cleanup of entire shop and yard", "tarping excess steel during rain (kept by paint booth)", and "using socks to contain water from reaching drains". These BMPs have the potential to be effective at minimizing impacts to the municipal stormwater sewer system if they are properly implemented. However, because of the complete lack of sampling data and also because of the stain that was observed in front of the western discharge point, there is some question as to whether BMPs are adequate. It is important to note that this facility has an unusually large amount of materials that are stored outdoors. Therefore ineffective BMP implementation could result in unusually large discharges of pollutants during rain events.

7. Storm drain located at the northwest corner of the property. Samples are collected in front of the drain.

Based on the above concerns, there is a critical need to obtain stormwater samples at the subject site. Therefore, pursuant to California Water Code (CWC) section 13267 and 13383, the San Diego Regional Water Quality Control Board (SDRWQCB) directs you to submit a **Required Technical Report (RTR)** received at the SDRWQCB no later than **5:00 PM, July 1, 2009**. The RTR is required due to the violations noted in the enclosed NOV and in consideration of the need to obtain data in order to evaluate the effectiveness of current BMPs. The RTR will be reviewed to assess the need for further possible enforcement actions. The RTR shall include the following:
