Subject: Notice of Violation No. R9-2010-0014

The Heights Development - Poway, California

FACILITY INSPECTION REPORT

FACILITY.	. Heights bevelopment Project Ciwqs#.	INSPECTION DATE/Time: 10/1/09 9:30 am to 11 am
FACILITY	HEIGHTS DEVELOPMENT PROJEC	T FIELD VISIT October 1, 2009
		sh (SDRWQCB), Peter Peuron (SDRWQCB), Malik Tamimi (City of Poway Ost (City of Poway Engineering), Geoff Sherman (Excel Realty Holdings)
City of Po	oway	Malik Tamimi Stormwater Program Administrator (858) 668-4653
NAME OF CO	PERMITTEE	CONTACT NAME AND PHONE #
	LE WATER QUALITY LICENSING REQUIREMENTS MS4 URBAN RUNOFF REQUIREMENTS NPDES NOS. GENERAL PERMIT ORDER NO. 99-08-DWQ, NPDES N GENERAL PERMIT ORDER NO. 99-06-DWQ, NPDES N GENERAL OR INDIVIDUAL WASTE DISCHARGE REQUIREMENTS GENERAL OR INDIVIDUAL WAIVER OF WASTE DISCHARGE REQUIREMENTS SECTION 401 WATER QUALITY CERTIFICATION CWC SECTION 13264	O. CAS000002 – CONSTRUCTION O. CAS000003 - CALTRANS UIREMENTS
	INSPECTION	TYPE (Check One)
A1	"A" type complianceComprehensive inspection in which	samples are taken. (EPA Type S)

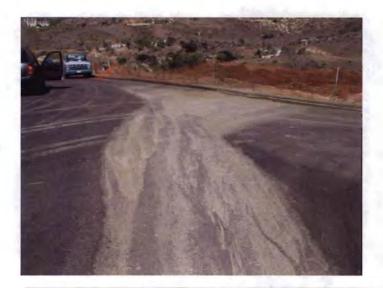
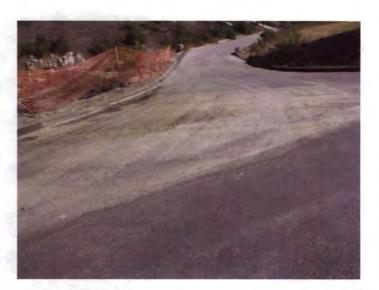
Sediment on road at entrance of site is evidence of a discharge to the MS4. Pursuant to 10/1/09 email, the City and the Developer were notified that this was evidence of a discharge of sediment to the MS4 and that the sediment should be cleaned up and actions should be taken to prevent such a situation in the future. See confirmation email from Geoff Sherman 10/2/09 9:35 am.

- Sediment on road at entrance of site is evidence of a discharge to the MS4. What caused this? Whatever caused
 it should be corrected so not to create a condition where sediment is discharged again. The sediment should be cleaned
 up so that the sediment on the street is not discharged to the MS4. See picture 1 & 2

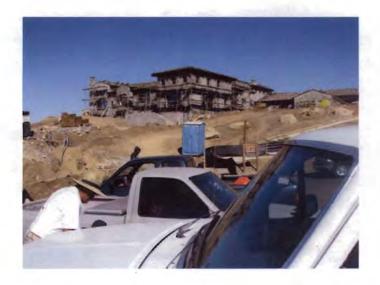
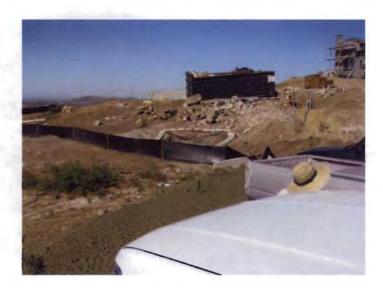
The area around the home construction should be "buttoned up" with regards to protection from run off and erosion and sediment discharges. The trash container should be covered. Piles of material should be secured to prevent erosion and the drive-way should be protected to prevent erosion and sediment discharges. The site should be in compliance with any City requirements as well as the Gen Construction Storm water permit requirements.

- 2. The area around the home construction should be "buttoned up" with regards run off and erosion. The trash container should be covered. Piles of material should be secured to prevent erosion and runoff. The site should be in compliance with any City requirements as well as the Gen Construction Storm water requirements. See photos 3 and 4.

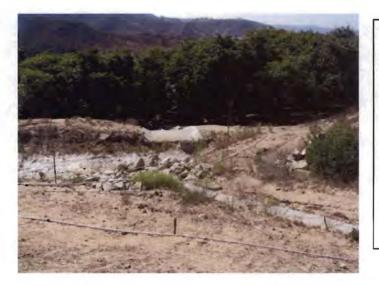
Sediment was present on the spillway located in the detention basin nearest the home at the top of the hill. The presence of sediment is evidence of a historical release of sediment from the detention basin. This may be further evidence that the basin is too small for the amount of flow directed towards the basin. The developer was asked to clean the spillway and clear the area around the standpipe and to clear the standpipe orifices such that the basin can operate as designed for detention and retention. See confirmation email from Geoff Sherman 10/2/09 9:35 am.

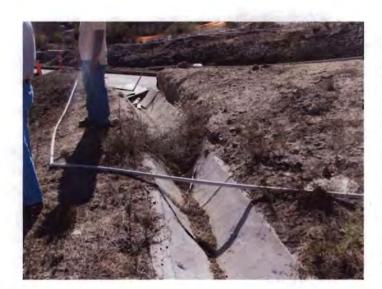
Material in drainage swales. The developer was notified that the swales should be cleaned out and remain clear of debris so as not to discharge debris and sediment during a storm event. See confirmation email from Geoff Sherman 10/2/09 9:35 am.

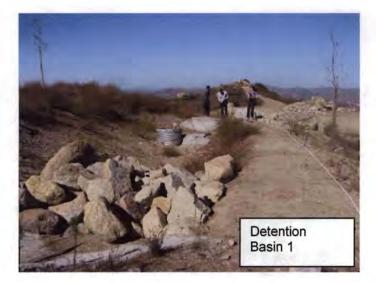
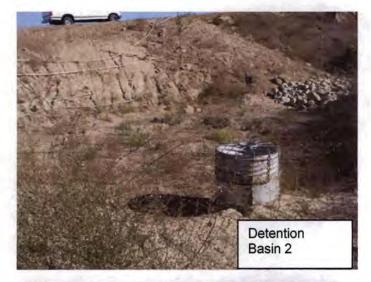
The detention basins currently in place are shown in the pictures to the left. Per map included in the Water Quality Technical Report submitted by Bill Yen & Associates Detainment Treatment Point 1, 2, and 3 are pictured to the left.

The City explained during this site visit that the Basins were designed to handle peak flows and were not designed to be post-construction treatment control BMPs. Reports from Kristin Schwall (RB Construction Storm Water Inspector) indicate that the basins were designed using runoff from the section of the road that drains to the basin without consideration of the hillside runoff contributions. Therefore, the basins were designed too small. The City explained that the basins were never intended to be used as treatment control BMPs. Consequently, the project did not have post construction treatment control BMPs in the Water Quality Technical Report at the time of project approval. The Regional Board identified this violation at their June 23, 2009 meeting and site visit. The Regional Board issued the City NOV R9-2009-0120 for failing to implement their SUSMP program as required by Order No. R9-2007-001.

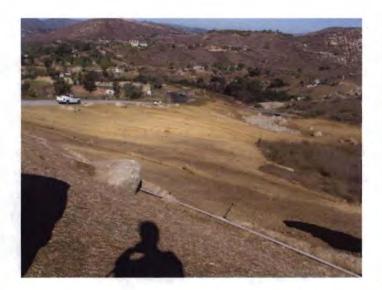
This piece of the site is located east of the entrance road. City of Poway issued a corrective work notice to the developer for incorrect installation of BMPs (e.g fiber rolls were not trenched in or staked appropriately). As a result of the corrective work notice, the developer installed the BMPs as directed by the City and installed a fiber blanket as seen in the forefront of the photo. When asked the purpose of the rock placed at the toe of the slope, the developer responded because they did not have anywhere else to put it.

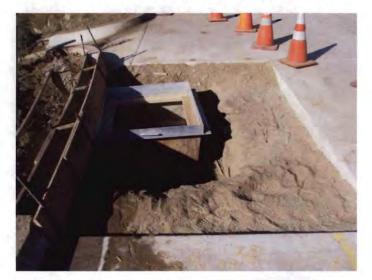
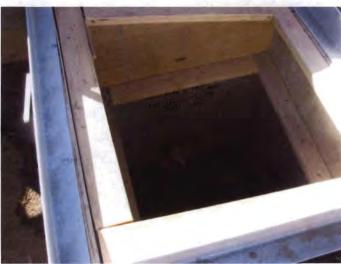
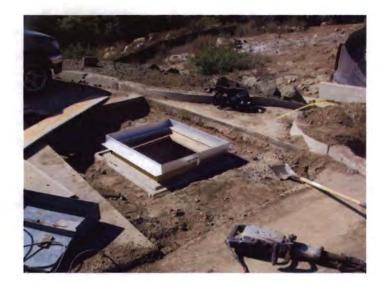
Post Construction BMPs for the Heights Subdivision

High Rate Media Filter vaults installation, waiting for the cement decks to be poured and arrival of filter media. Filters not operational at time of inspection (Start of rainy season 10/1/09).

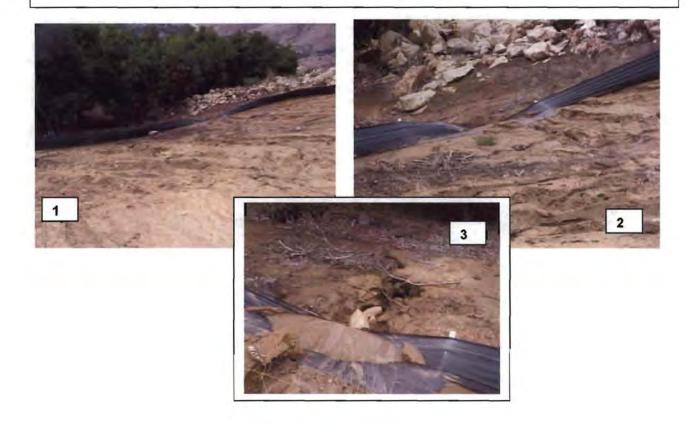
Photo 1 below shows the hillside downgradient from the newly constructed tennis courts. The slope is unprotected from stormwater which resulted in erosion as seen in photo 2 and 3. The silt fence failed as seen in photo 3, causing a discharge of sediment beyond the property border.

- 1. The slopes around the home at the top of the hill need to be protected from erosion by installing BMPs (e.g. bonded fiber matrix, fiber rolls, fiber blankets, etc.) to stabilize the slope next to the tennis court and the slope upgradient from the garage. The developer did email me on 12/10/2009 with photos showing installation of fiber rolls on both the slope downgradient of the tennis courts and the slope to the side of the garage.

- 2. Silt fences failed at a few locations around the home (e.g. downgradient from the pool and down gradient from the tennis courts). The fences should be fixed before the next rain event.

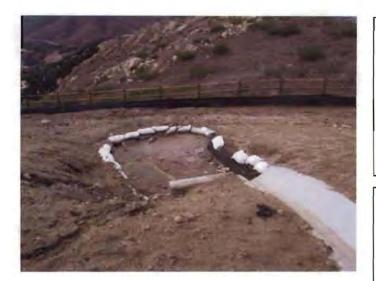
This sediment basin is located at the rear of the home. It is full after the significant rain event on 12/07/09 and needs to be cleaned out before the next rain event. The surrounding slope is not protected against erosion. The silt fence at the toe of this slope (pictured below) needs repair in many places. Sediment that accumulated in front of the silt fence should be removed, the silt fence mended, and reinstalled.

- 3. The detention basin located in the rear of the home, is full of sediment after the rain event on 12/7/2009. It should be cleaned out in preparation for any future rain events.

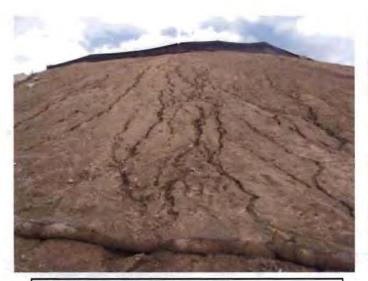
The slope shown in the left photo is next to the garage. The slope is unprotected which resulted in erosion as seen by the rills on the hillside. The drainage ditch shown on the right is filled with sediment near the discharge as indicated by the red arrow. The blue arrow shows erosion beneath the concrete drainage swale. This erosion undercut the drainage swale completely day lighting on the other side (indicated by the small blue arrow) where the pvc pipe is.

- Areas where erosion has undercut the concrete drainage swales should be fixed and the slopes upgradient of the
 erosion stabilized before the next rain event.

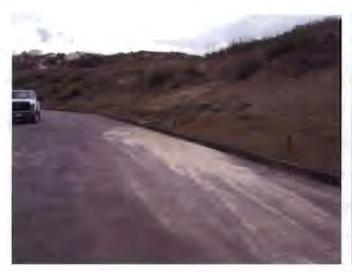
Two areas on the road where erosion controls failed resulting in a discharge of sediment to the road. The developer and their contractors were aware of these erosion failures once we arrived at the site and were preparing to clean up the sediment and resecure the erosion control BMPs.

- 5. Sediment on road at entrance of site is evidence of a discharge to the MS4. The cause of the failure (failure of bonded fiber matrix area or sand bag failure, etc) should be corrected so not to create a condition where sediment is discharged again. The sediment should be cleaned up so that the sediment on the street is not discharged to the MS4.
