**Subject Site: Hanson Aggregates, 9225 Camino Santa Fe, San Diego, CA 92121
(WDID No. 9 371014663)**

**RE: NOTICE OF VIOLATION NO. R9-2010-0060 &
REQUIRED TECHNICAL REPORT**

FACILITY INSPECTION DATA ENTRY FORM

FACILITY: Hanson Carroll Canyon

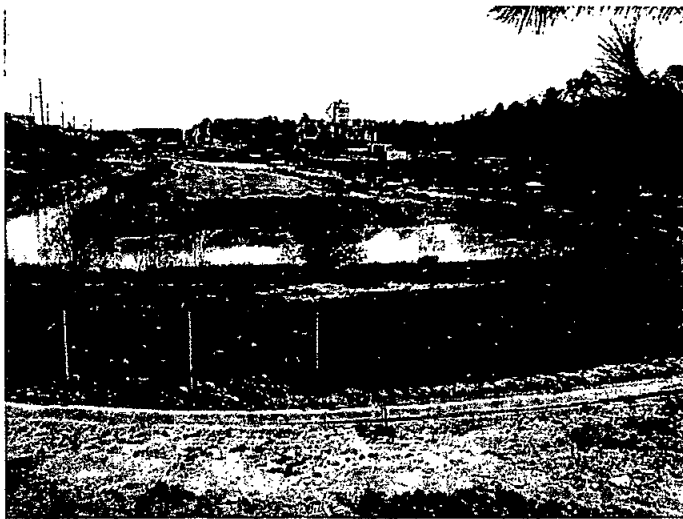
I arrived at the site and observed the sediment detention basin which is located near the front gate of the facility adjacent to Camino Santa Fe. As shown in Photo 1, there was a significant amount of turbid water in the basin. I proceeded to the outfall where water from the basin is discharged to Carroll Canyon Creek. Turbid water was flowing out of the outfall as shown in Photo 2. This outfall is located at the bottom of the north bank of Carroll Canyon Creek and it discharges directly into the creek. Photo 3 shows turbid water that had ponded just outside the outfall. Photo 4 and 5 show a turbidity plume that formed at the point where the turbid water being discharged from the outfall mixes with water in the creek. I proceeded back to the front gate where I had parked and encountered Henry Pimentel, Production Supervisor for Hanson who asked me what I was doing. I explained that I was there to see if they were continuing to discharge sediment-laden water from their sediment basin and since I had confirmed that a discharge was occurring, I would need to meet with Jud Harvey, the plant manager, and complete my inspection. I also explained the problem with the sediment basin to Henry and made the point that the facility is required to prevent these discharges from occurring. I then drove to the facility's administrative offices and met with Jud Harvey and David Chong, the Environmental Health and Safety manager for the facility. I told Jud that they should be preventing any turbid discharges from occurring and Jud repeated the point he had made last week to the effect that attempting to reconfigure the basin during the rainy season would be a problem. Over the course of the inspection, we discussed what options were available for terminating the sediment discharge. Jud said they planned to enlarge the basin, but needed to wait until there was no threat of rain. I explained to Jud that it was technologically feasible to prevent the discharge from occurring because they can either use active treatment (floculant) or store the water in a Baker tank (or tanks). Therefore, there is no reason for the facility to be discharging sediment. Even if they implement a long-term fix, such as an upgraded basin, they must implement interim measures to prevent discharges in violation of the Basin Plan. Jud, and David and I went to the sediment basin and the outfall and I showed them the same conditions shown in Photos 2 through 4. On the way back to the administrative office, we stopped at a location where, during the inspection in December, sediment had been observed to be encroaching into the creek area. Turbid water was again ponding in a depression in the road and seeping into the the area of the north bank of Carroll Canyon Creek. Photo 6 shows the ponded water and Photo 7 shows sediment that has accumulated on the other side of a rock berm (a berm that is intended to trap sediment). It did not appear that the sediment had reached the creek at this location, but it is necessary to remove sediment in this area to prevent it from reaching the creek in the future. Further up the road (This is the main road at the facility which runs from the front gate to the main office.) there was another flow of turbid water occurring (Photos 9 and 10). Piles of rock material have been placed along the road to trap sediment, but the turbid water was reaching the creek at the location shown in Photo 11.

1. View of the facility, looking east from Camino Santa Fe. Highly turbid water is evident in the sediment basin.

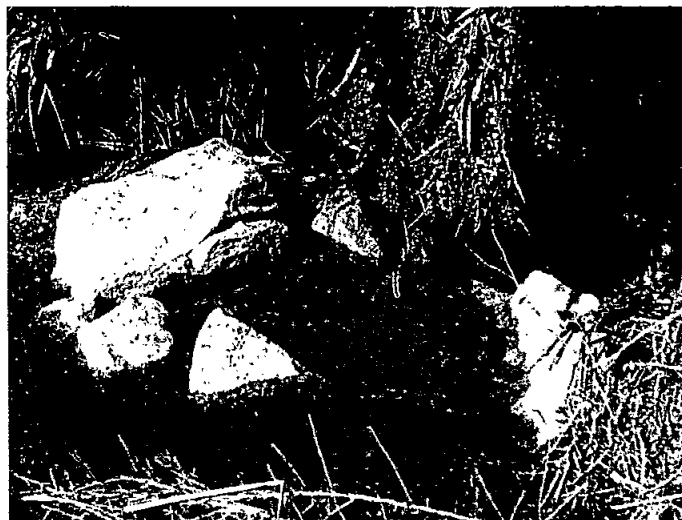
3. Turbid water pooled just outside the outfall.

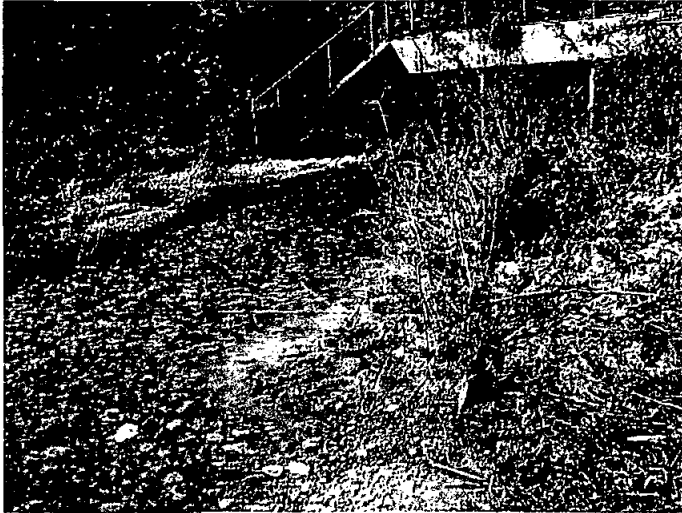
4. Turbidity plume where water discharged from the outfall enters Carroll Canyon Creek.

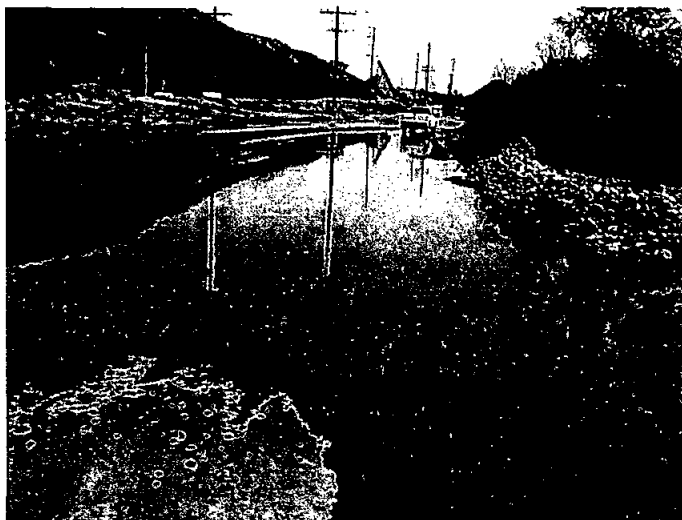
6. A view of the area along the road where sediment had encroached into the creek area when the road was flooding.

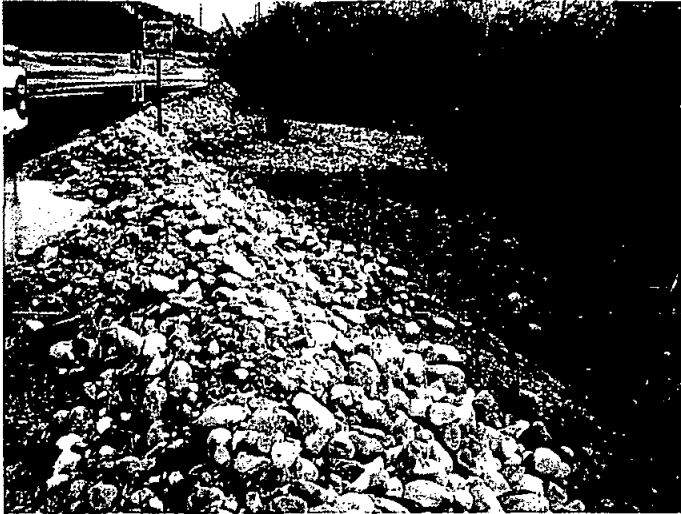
7. Sediment has accumulated on the stream side of the rock berm.

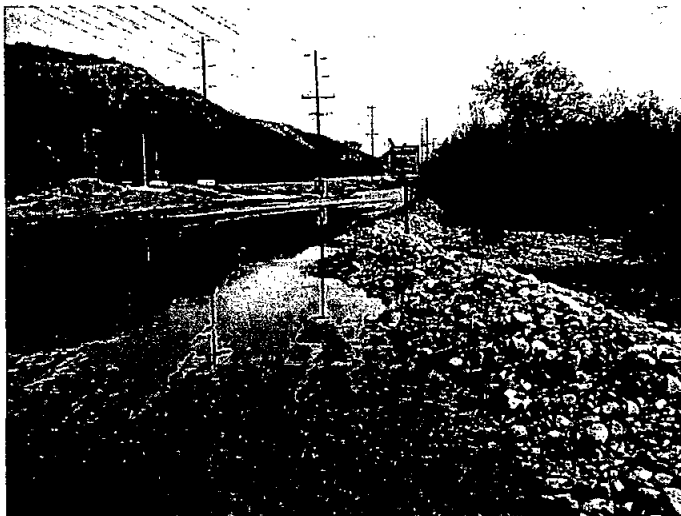
8. Sediment has accumulated on the road. This sediment should be removed since it may be washed into the creek during a subsequent storm event.

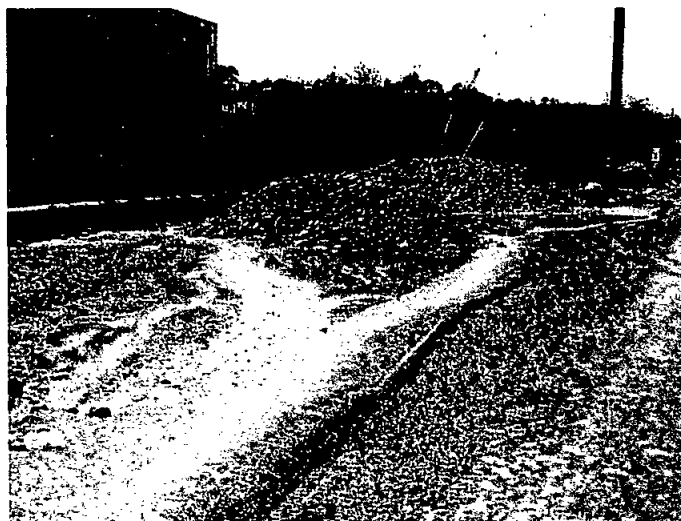
On March 1, 2010, turbid water that exceeded the Basin Plan Water Quality Objective of 20 Nephelometric Turbidity Units (NTUs) was observed to be discharging from a road adjacent to the facility's administrative office directly into Carroll Canyon Creek. Visual observations which are documented in an inspection report (Attachment 2) demonstrate that this discharge is in violation of the Basin Plan Standard.

9. Turbid water discharging in front of the quarry's administrative office.

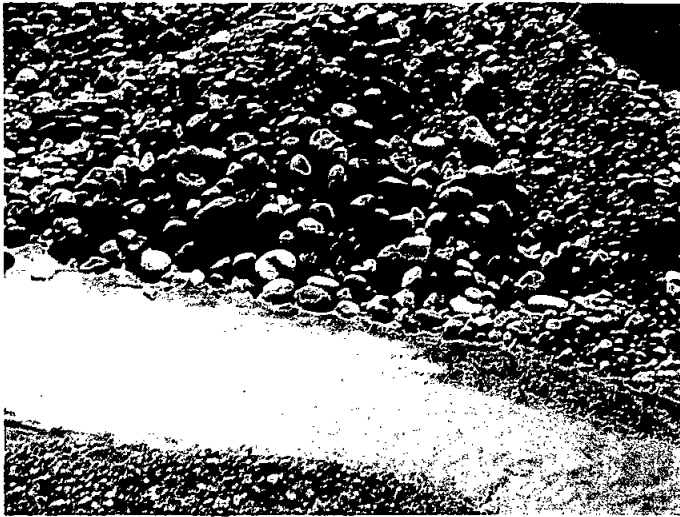
10. Another view of the runoff that is discharging to the creek in front of the administrative office.

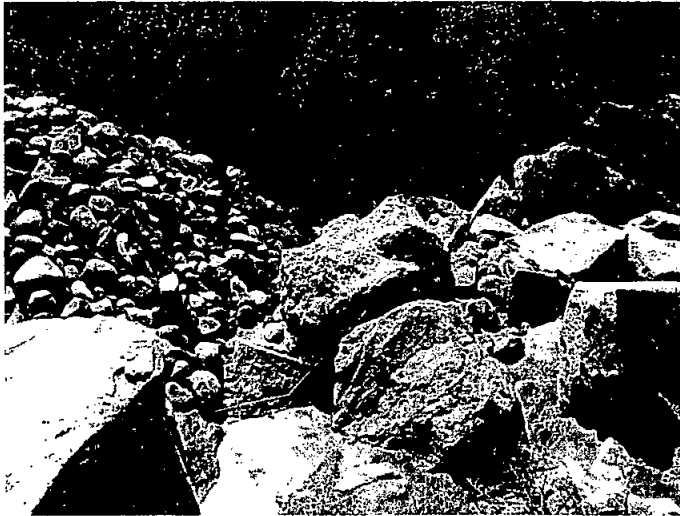
11. Location where turbid water shown in Photo 9 enters the bank area of Carroll Canyon Creek

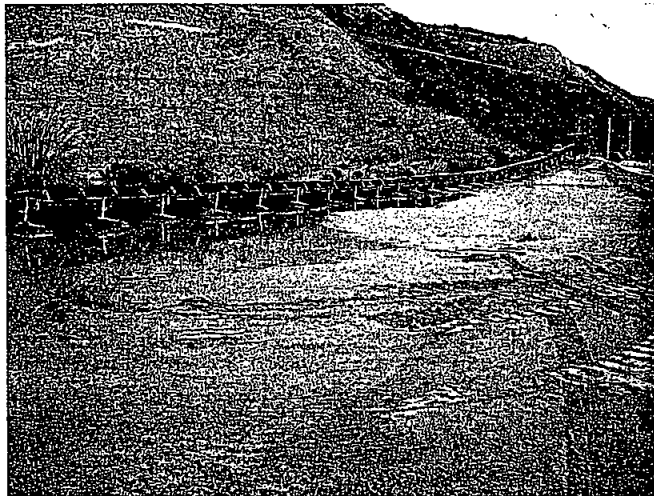
Sediment Discharge Area No.1: Dirt road running along the north side of Carroll Canyon Creek. A few hundred yards west of the office, we observed a location along the road with a significant accumulation of sediment and standing water (Photo 2). The road actually runs parallel and adjacent to Carroll Canyon Creek at this point. Photos 3 and 4 show the south side of the road where it appears that flowing water has dislodged fiber rolls. Standing water located east of the fiber rolls appears to have been retained by a rock berm. Therefore, while the rock berm (which extends all the way back to the office area) appears to have prevented sediment-laden water from reaching the creek, the failed fiber rolls may have allowed turbid water to reach the creek. Photo 5 shows the north bank of Carroll Canyon Creek just beyond the area of the fiber roll breach. There did not appear to be any significant sediment accumulation in this area however.

2. A low point in the road leading to the processing facility. Water and sediment collects here. Carroll Canyon Creek is located on the right side of the road.

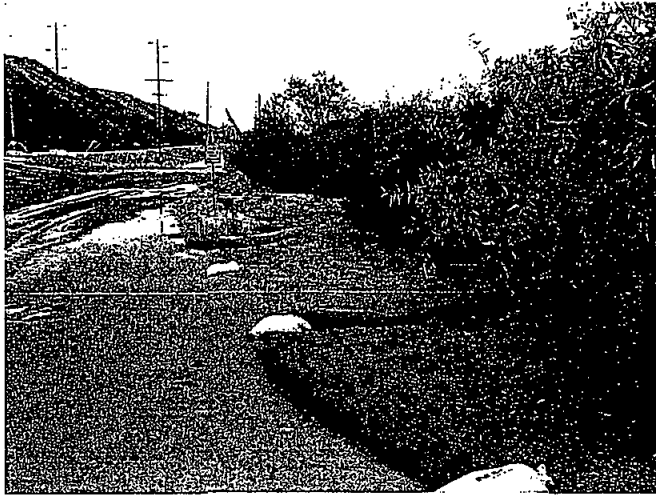
4. Fiber rolls appear to have been dislodged by storm water flows.

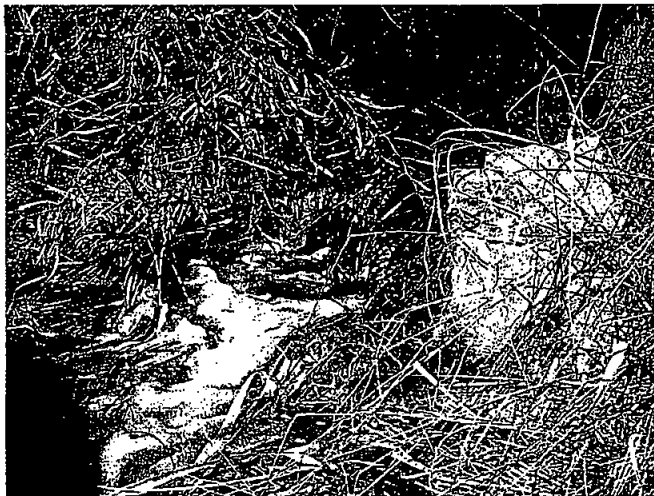
8. Turbid water being released from the outfall that leads to the detention basin.

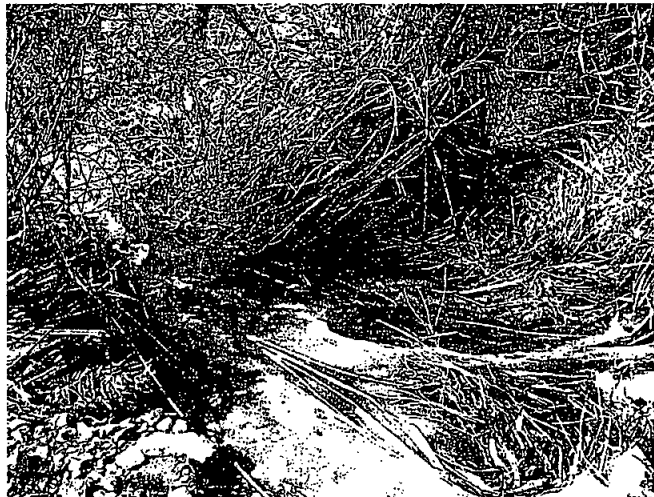
9. A view of the turbid water just beyond the outfall prior to entering Carroll Canyon Creek.

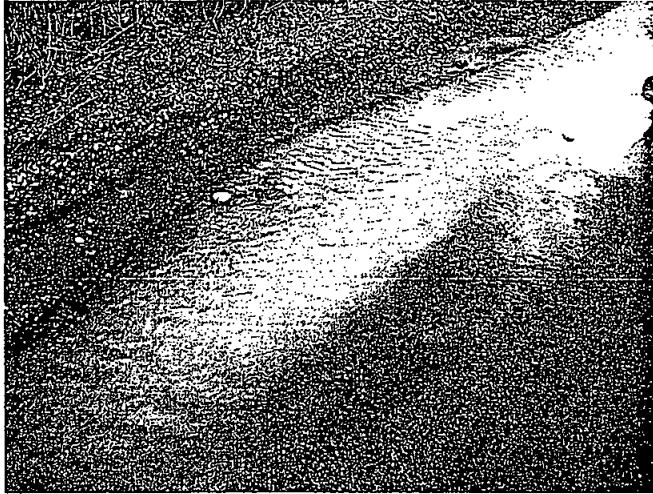
13. Closer view of quarry runoff..
