SUBJECT: RAMONA LANDFILL INSPECTION REPORT

Landfill Inspection Report

RAMONA LANDFILL INSPECTION

June 17, 2011

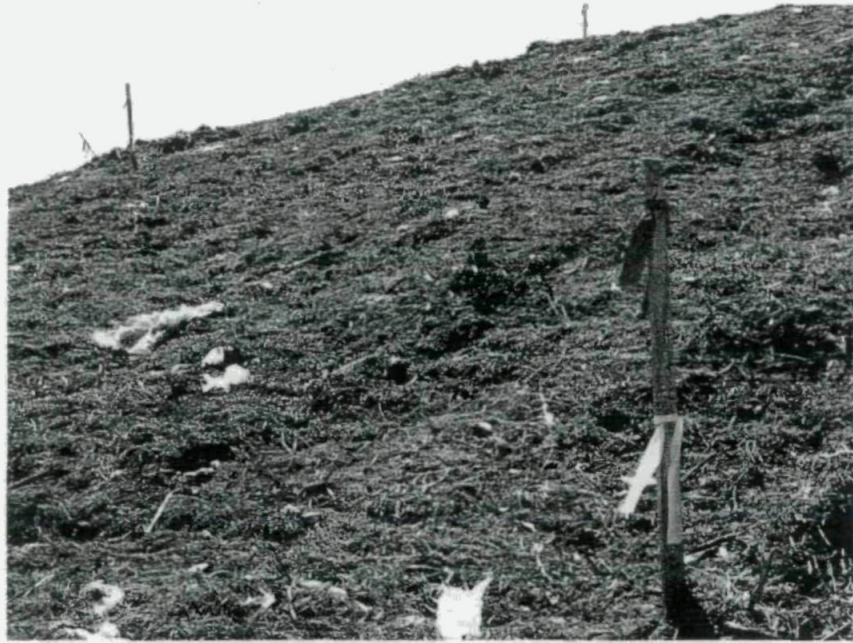
Plastic contaminated green waste on final landfill cover.

Enclosed is a copy of our June 17, 2011 inspection of the Ramona Landfill. During the inspection, contaminated green waste was observed on the northern sideslope and a small portion of the eastern sideslope. The use of contaminated green waste on the final cover is a violation of Title 27 California Code of Regulations Section 21090(a)(3)(A)(1)a which states that the vegetative layer of the final cover shall not contain waste. Mr. Tom Gardner indicated that the contaminants would be picked out of the contaminated green waste. All of the contamination would need to be removed in order to comply with Title 27.

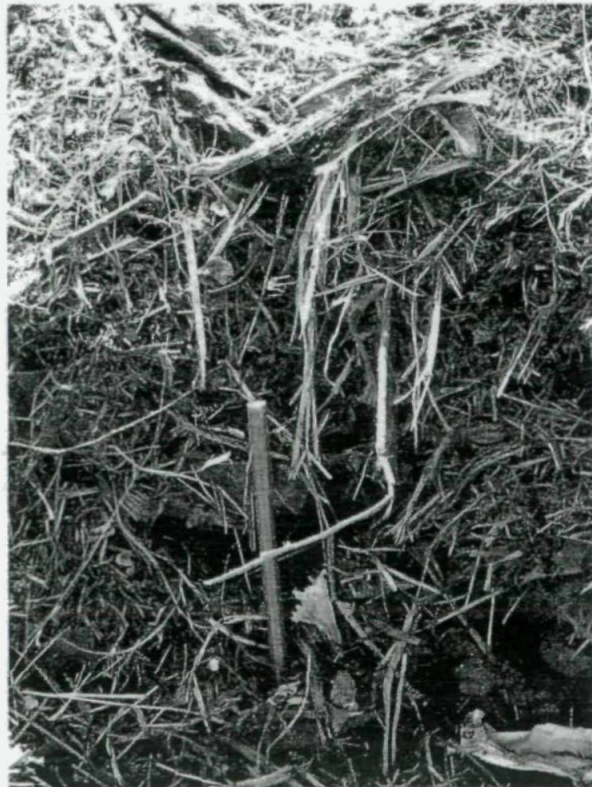
Thickness of contaminated green waste approximately 9".

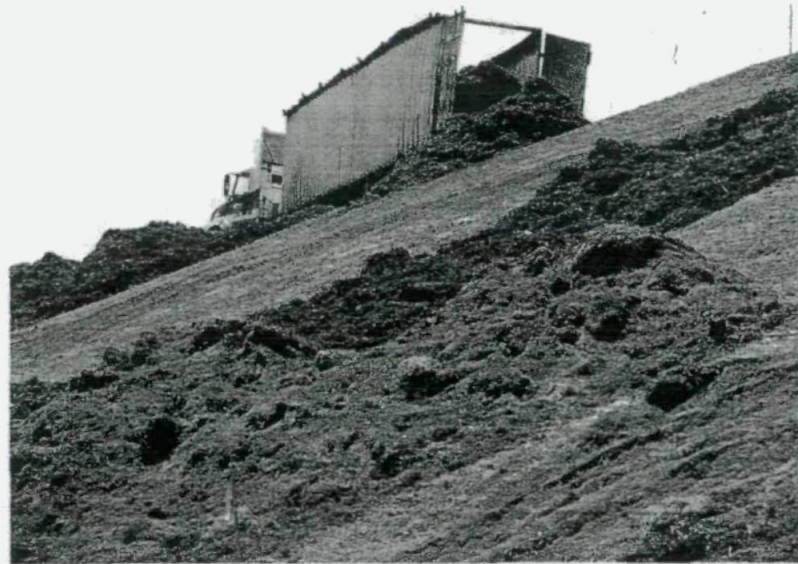
Contaminated green waste being received during inspection.

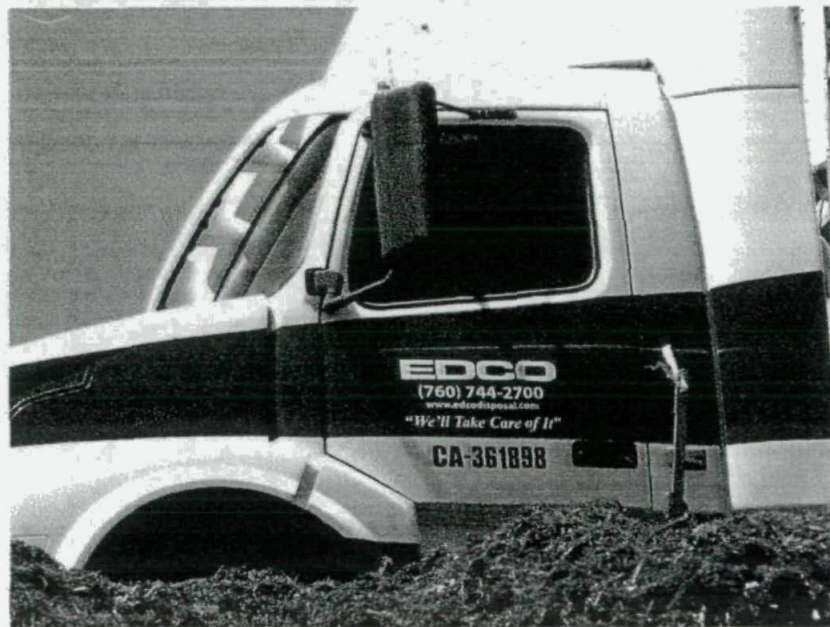
The contaminated green waste delivered by EDCO.

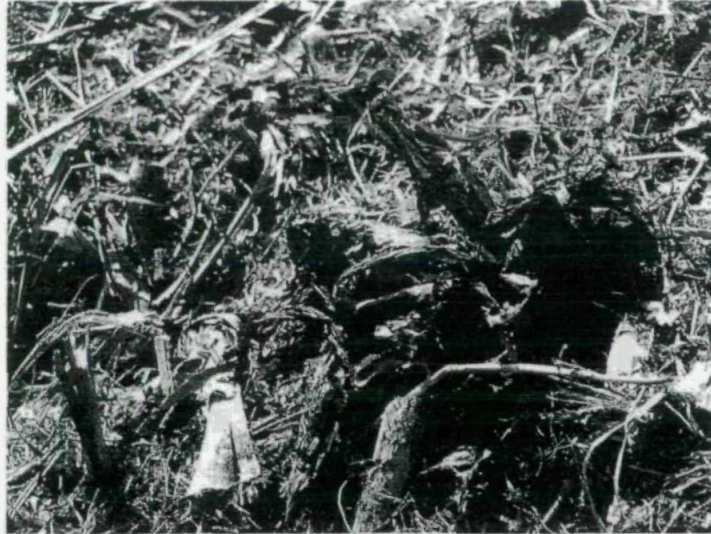
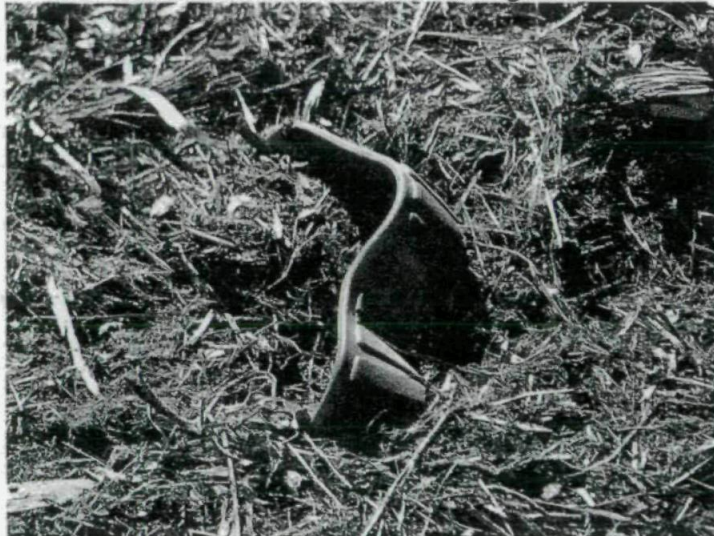
Plastics contaminating

the green waste.
