Subject: Landfill Cover Areas of Concern, Mission Avenue Landfill, City of Oceanside, San Diego County, California

Landfill Inspection Report

Mission Avenue Landfill June 26, 2012 Inspection Pictures

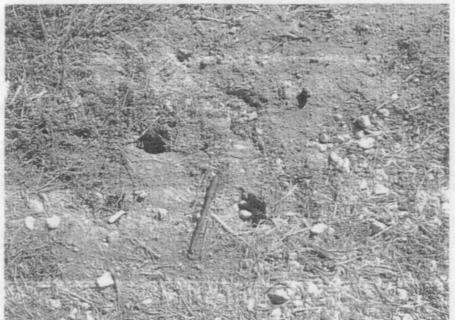
The RWQCB inspector was not able to locate MW-4 or MW-5 during the inspection, therefore the conditions of these wells are unknown. The surface drainage channels were clear of debris and sediment. With one exception the condition of the landfill cover appeared intact. The one exception was the presence of a few rodent holes in the landfill cover in the northeastern portion of the main waste area of the landfill, refer to attached pictures. These features may serve as preferential downward migration pathways for surface water, are considered to be areas of concern, and need to be addressed prior to the rainy season.

Rodent holes and mounds observed in the Landfill cover in the vicinity of the northeastern portion of the main waste area adjacent to the football field.

During the inspection, numerous rodent holes and mounds were observed northeast of the main waste area in the final landfill cover; refer to attached landfill inspection report. These landfill cover conditions are areas of concern warrant corrective action in a timely manner, but no later than October 31, 2012. Once addressed, please submit a letter report describing the date(s), nature and location of the actions implemented to correct the areas of concern.

Please take steps to correct this area of concern as soon as possible, but no later than (

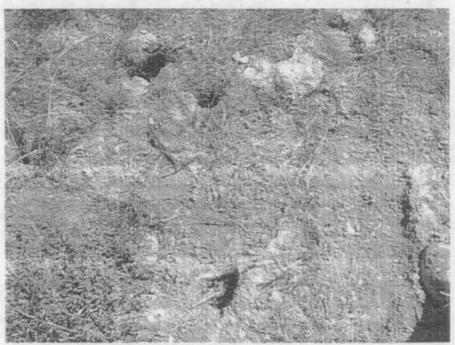
Rodent holes observed in the Landfill cover in the vicinity of the northeastern portion of the main waste area adjacent to the football field.

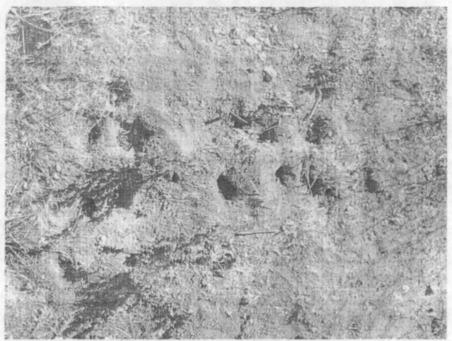
Rodent holes observed in the Landfill cover in the vicinity of the northeastern portion of the main waste area adjacent to the football field.

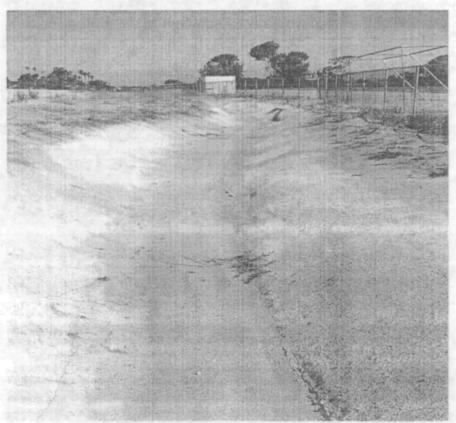
Surface water drainage channel along the northeastern portion of the main waste area of the Landfill.

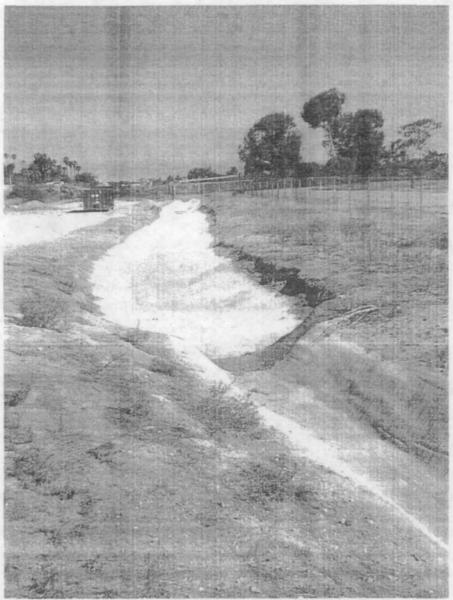
Surface water drainage channel along the northeastern portion of the main waste area of the Landfill.
