Subject: Poway Landfill Inspection Report

Landfill Inspection Report

Name of Facility: Poway Landfill
Owner: County of San Diego
Operator: County of San Diego
Facility Address: 14600 Poway Rd
RB Inspector: Kelly Dorsey

Date: 5/15/2012
WDR No.: 94-165
Inspection Type: B
Mgr./Sup. Of Site: Jason Forga

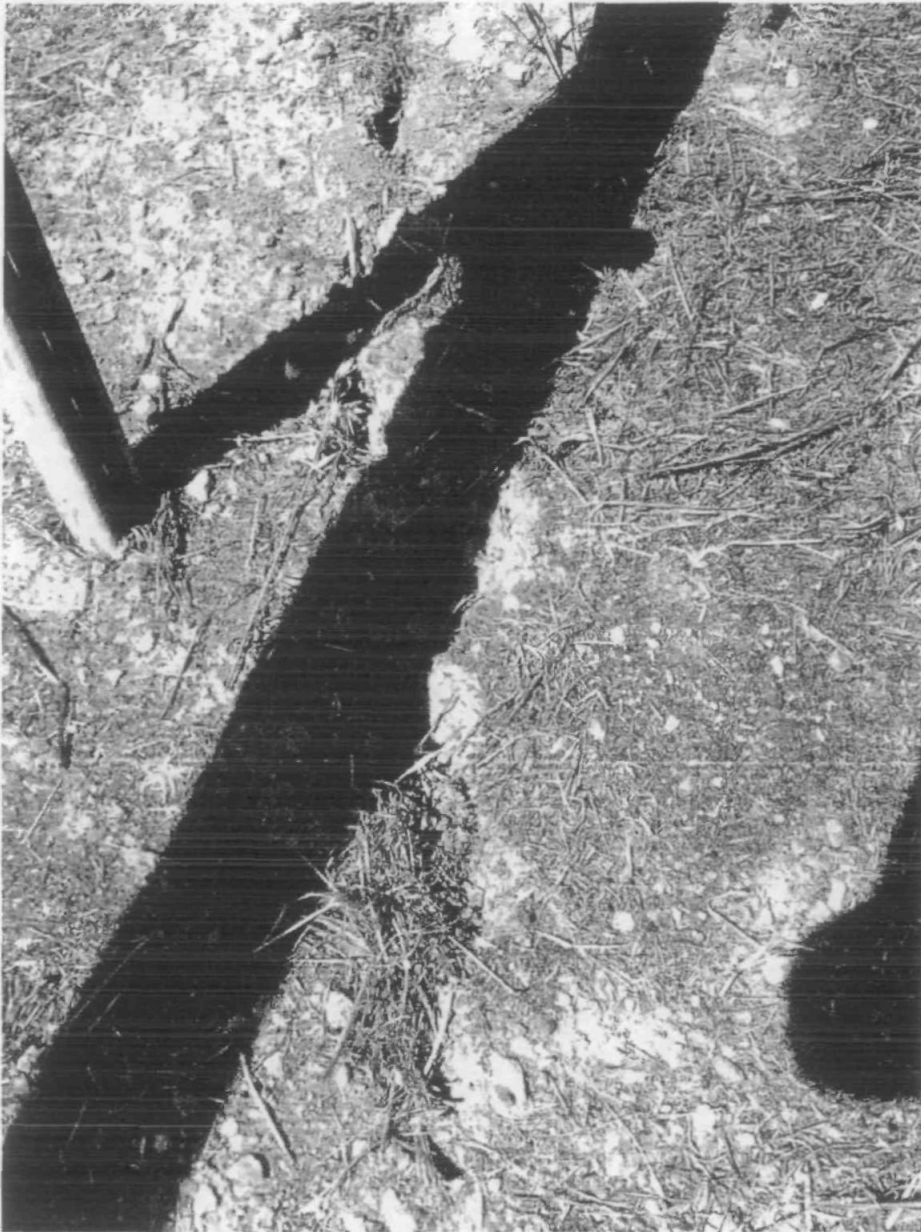
Crack in landfill CAP (see location on aerial photo)

Please monitor and repair the crack in the cap (see photo and map). As stated in previous inspection reports, the crack could allow water to infiltrate into the waste during rain events and could be an indication of slope stability issues. Please inspect for and repair all animal burrows in the cap. Additionally, it is apparent that the bait stations are not adequate to address the issue of burrowing animals at the landfill, please consider using an additional or alternate method. The concrete apron on one of the PVP probes is cracked (Possibly PVP-8, wells are not marked). Repair the cracks (see photo) and make sure all wells are clearly marked with the name of the monitoring location. Some of the drainage channels have sediment fill that will need to be cleared prior to the rainy season (see pictures). Please clear the drainage channels by October 15, 2012.

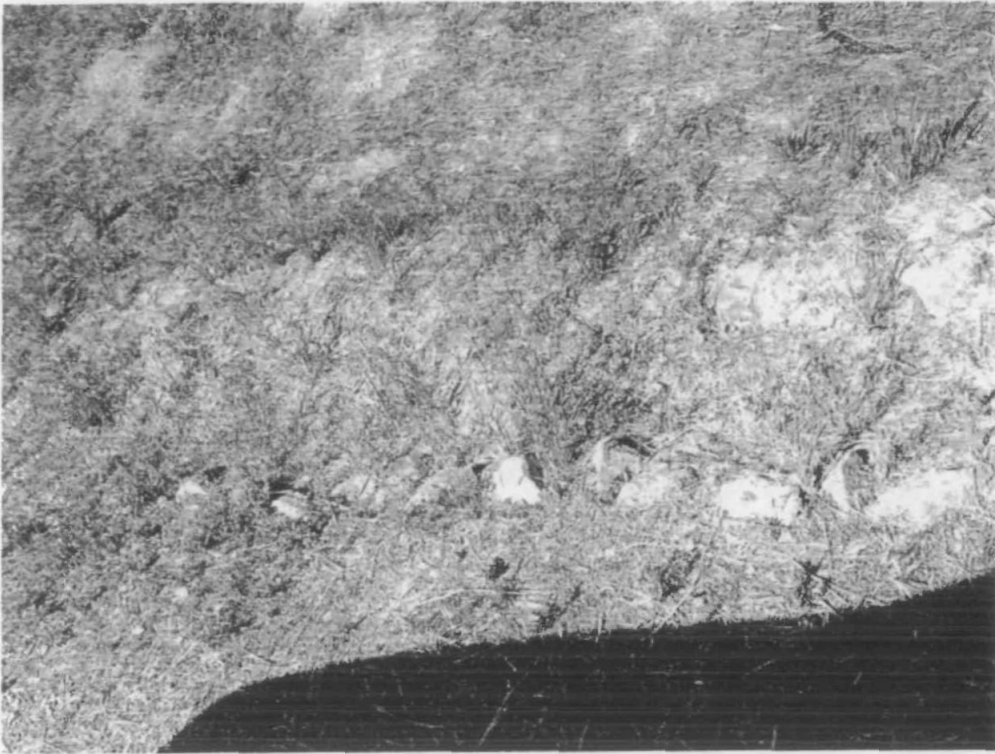
Sediment filled drainage channel (Note the rocks are almost completely buried).

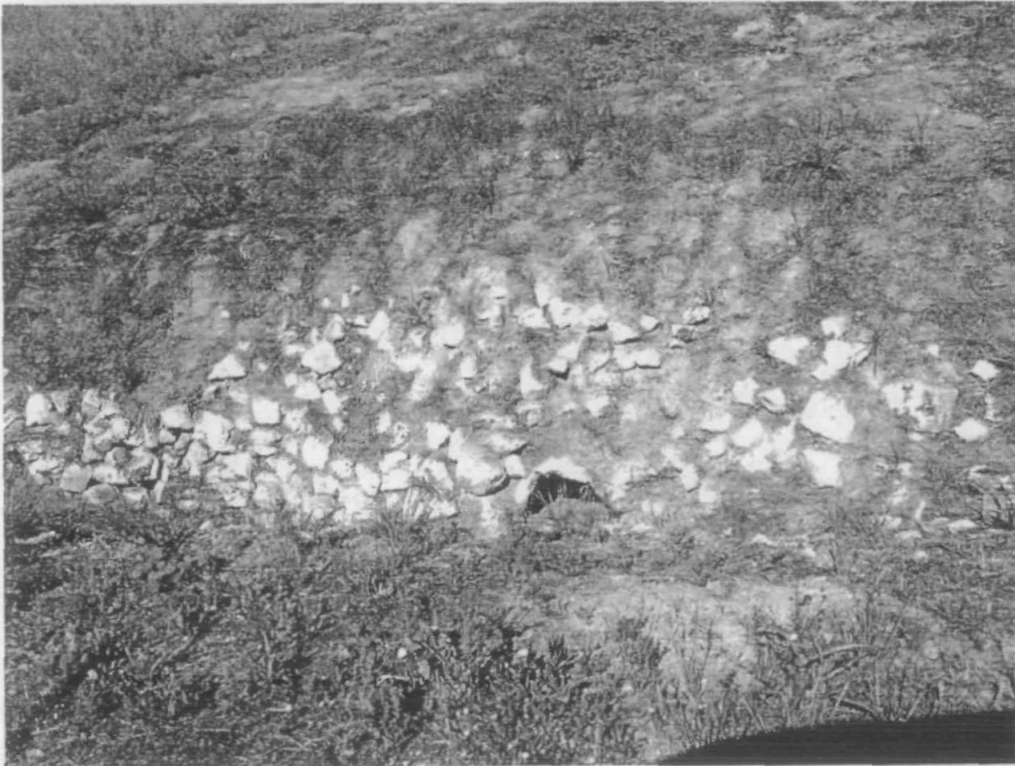
Sediment in drainage culvert.

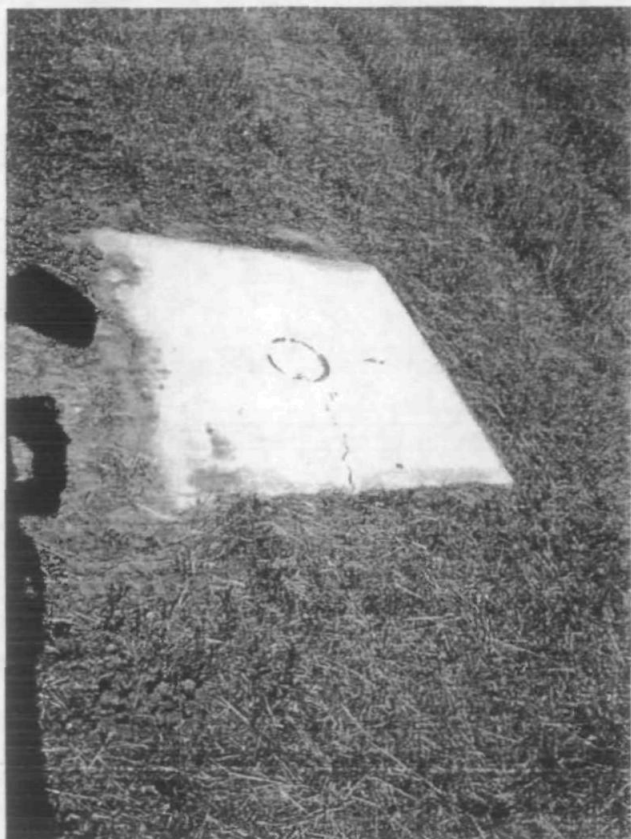
Cracked concrete apron at PVP well.

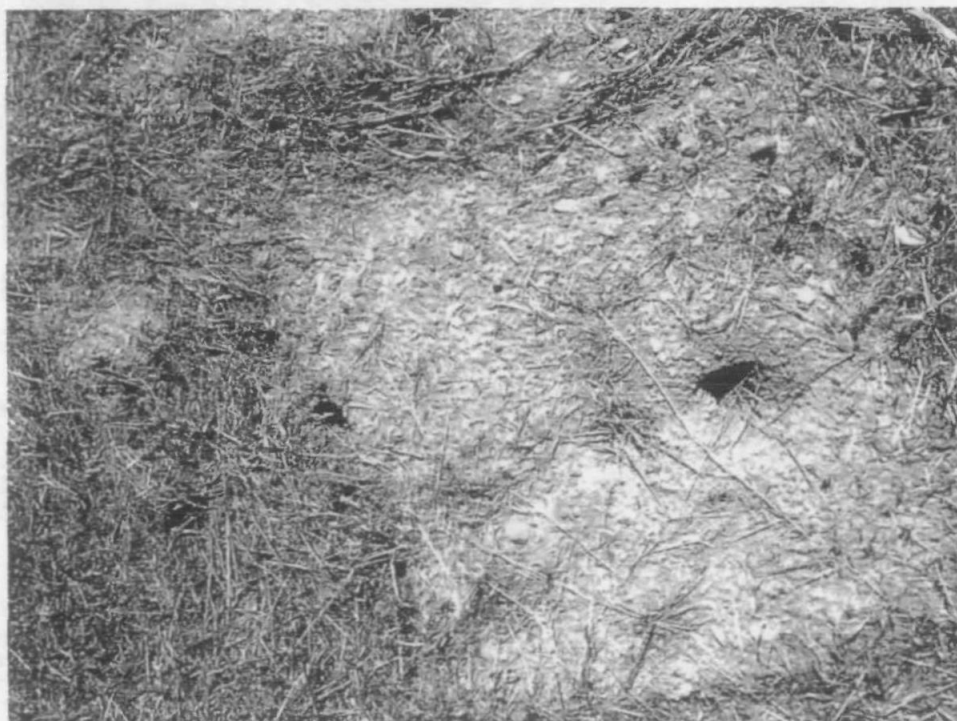
Animal burrows.

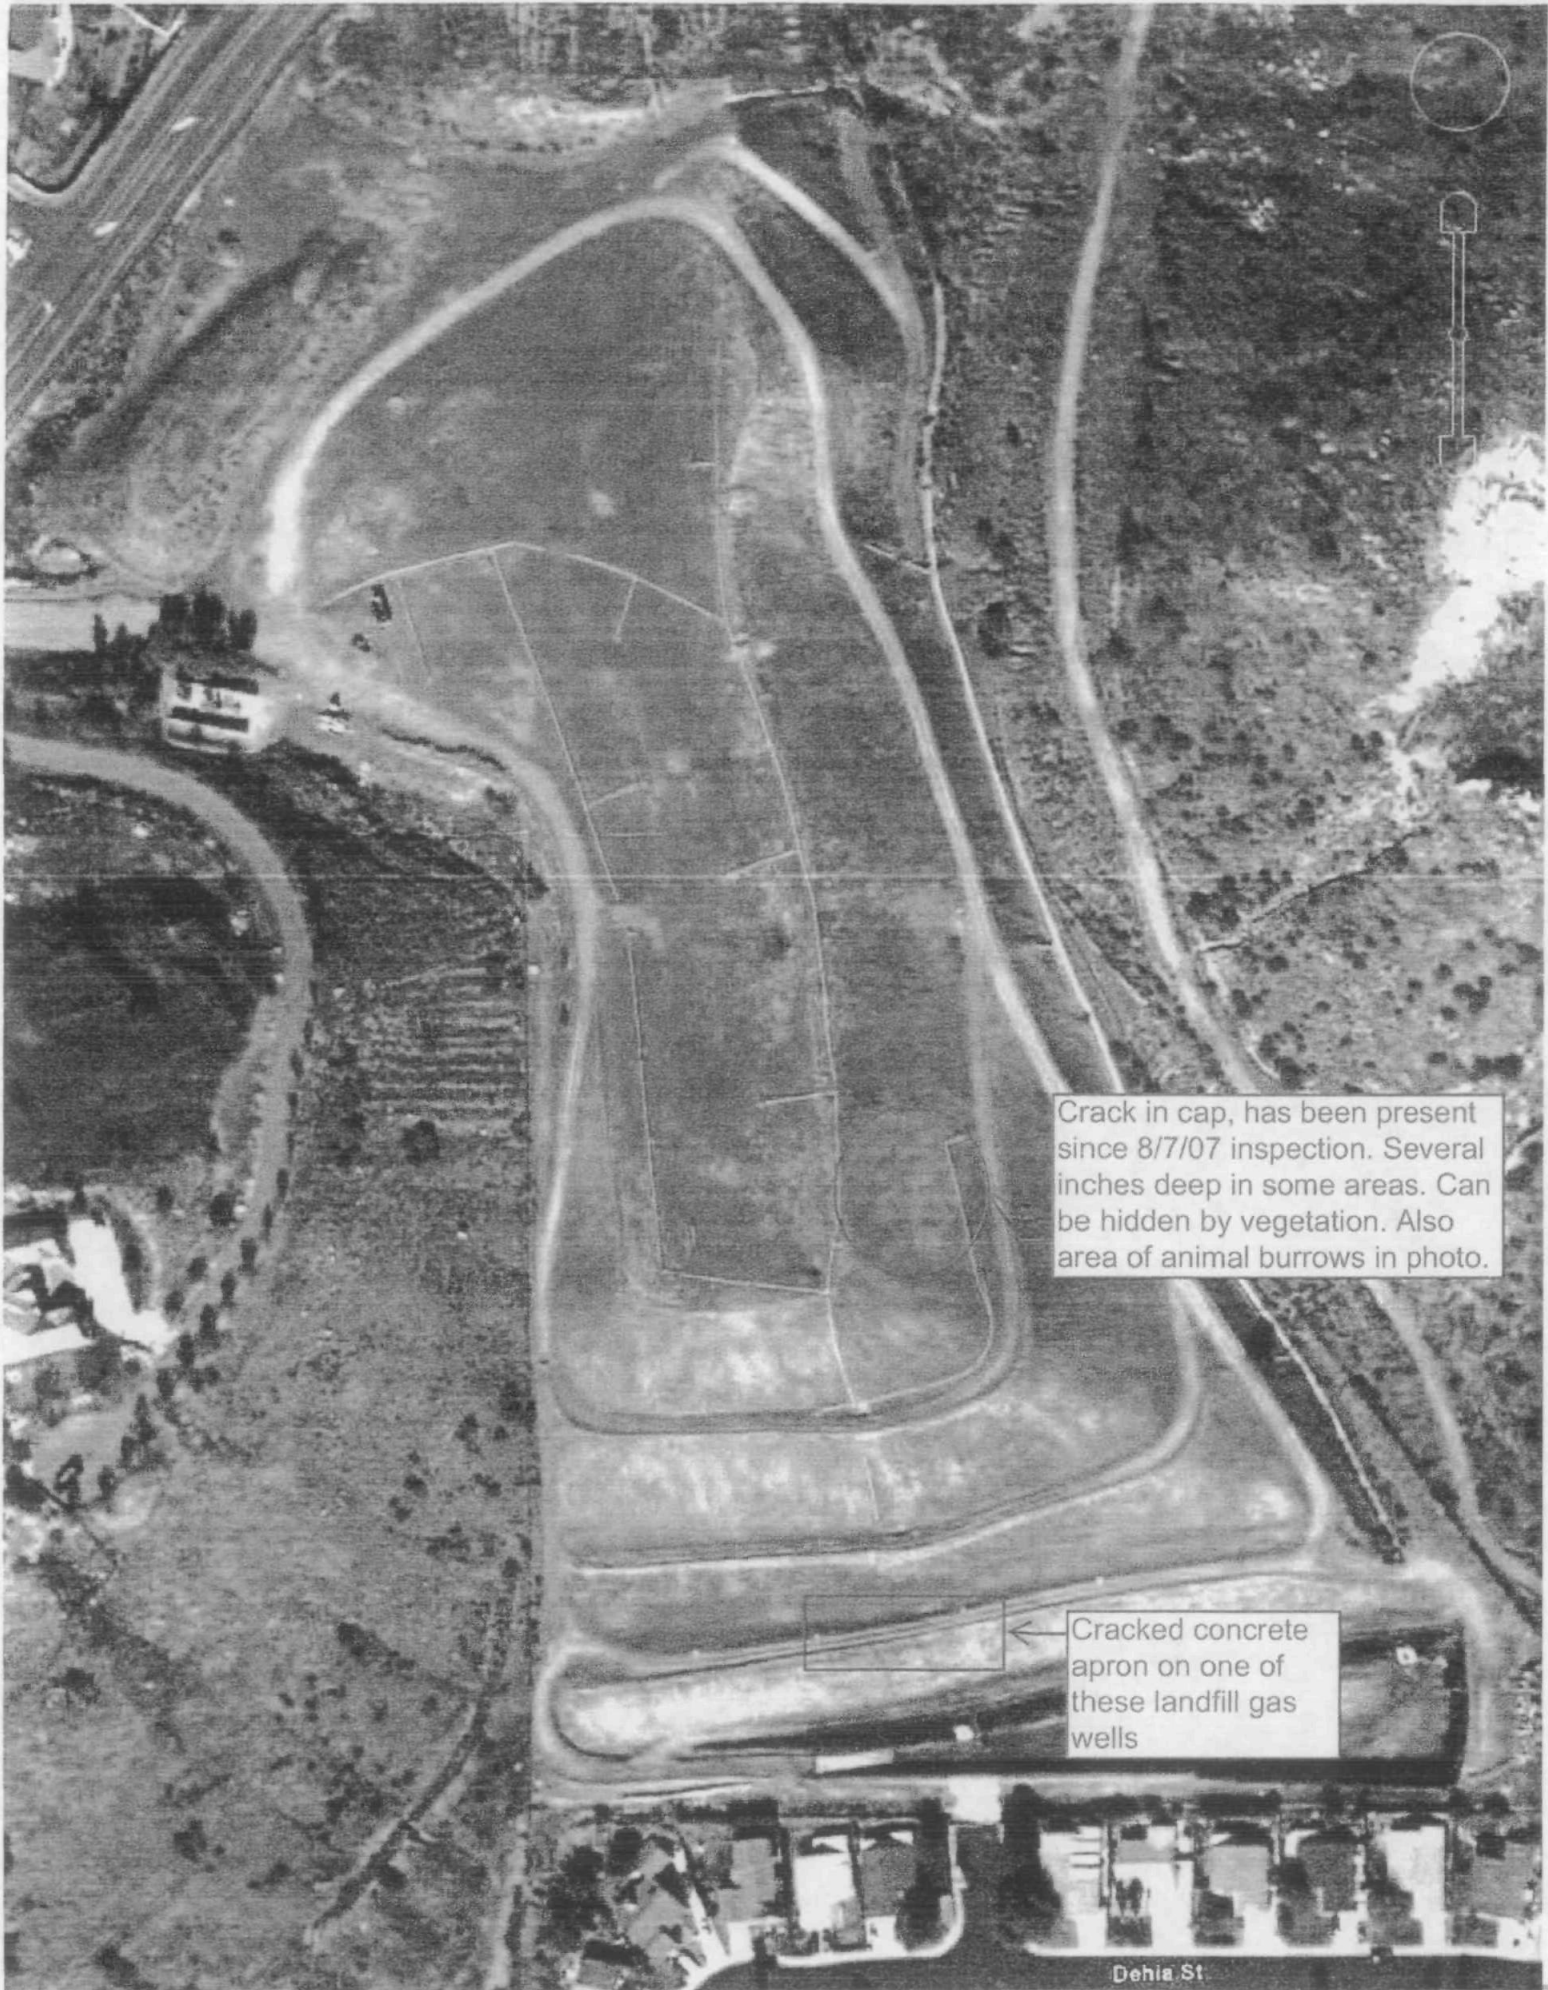
Crack in cap, has been present since 8/7/07 inspection. Several inches deep in some areas. Can be hidden by vegetation. Also area of animal burrows in photo.

← Cracked concrete apron on one of these landfill gas wells
