California Regional Water Quality Control Board, San Diego Region

December 18, 2014

**Subject: Inspection of Gillespie Landfill
Order No. R9-2012-0001 and Monitoring/Reporting Order No. R9-2012-0002**

Gillespie Landfill

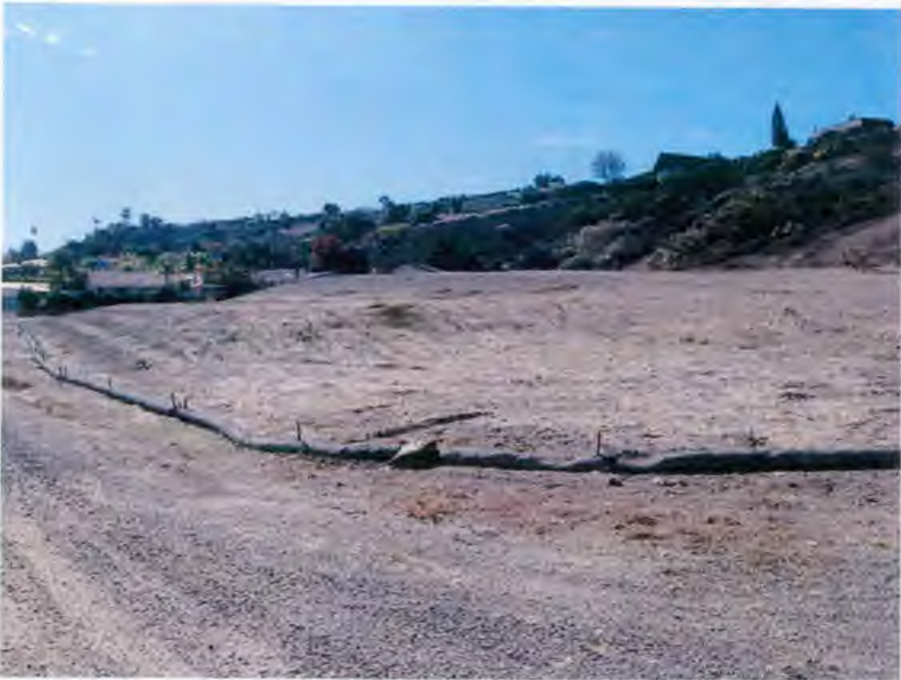
1. San Diego Water Board inspectors, Mr. Alex Cali and Ms. Leah Canada, were accompanied by County of San Diego staff, Mr. Jason Forga.
2. The perimeter drains were observed to be free of debris (Figures 2 and 3).
3. Groundwater monitoring wells were observed in good condition, capped, and locked.
4. The landfill cover was observed to have significant surface cracking.
5. San Diego Water Board staff observed straw wattles in fair condition surrounding the soil stock pile on the western portion of the Facility. These BMPs should be evaluated for short-term performance and replacement as necessary (Figure 1).

Figure 1- Soil Stockpile with surrounding BMPs

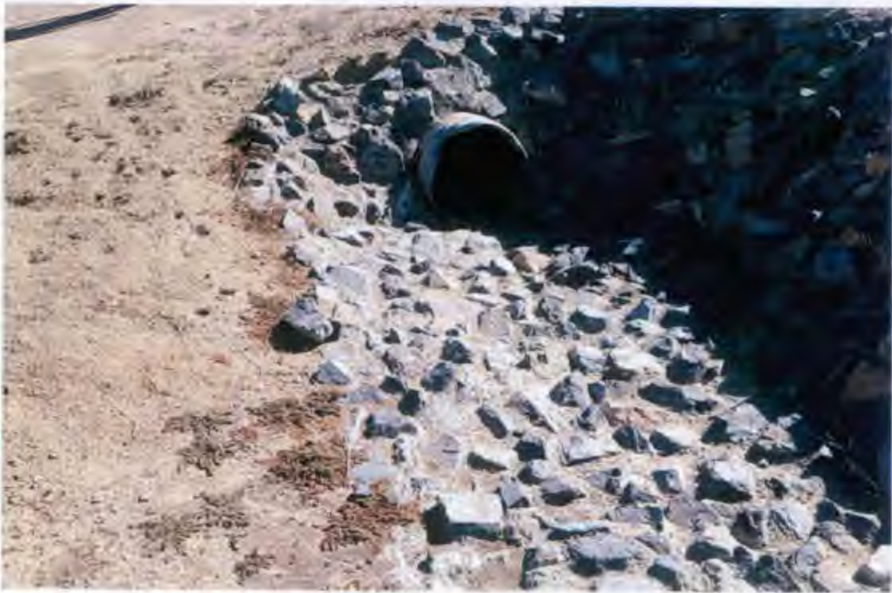
Figure 2- Southern Perimeter Drain

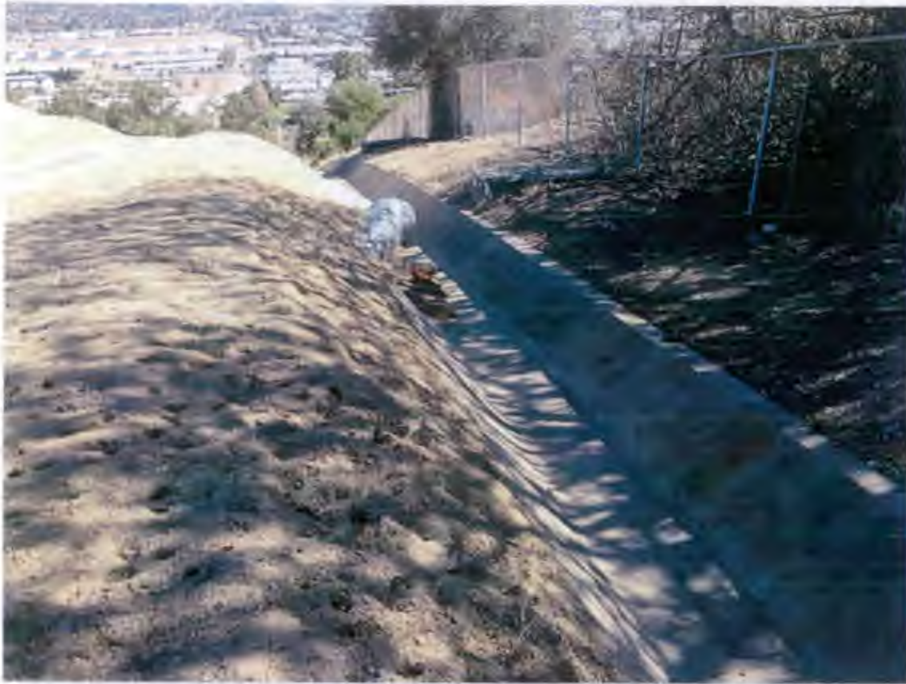
Figure 3- Southern Perimeter Drainage Channel

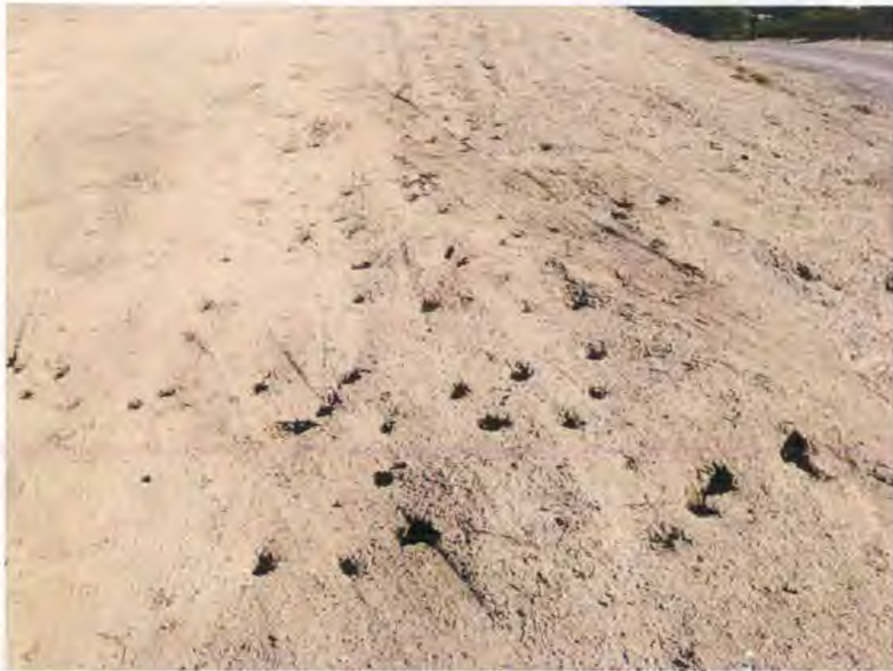
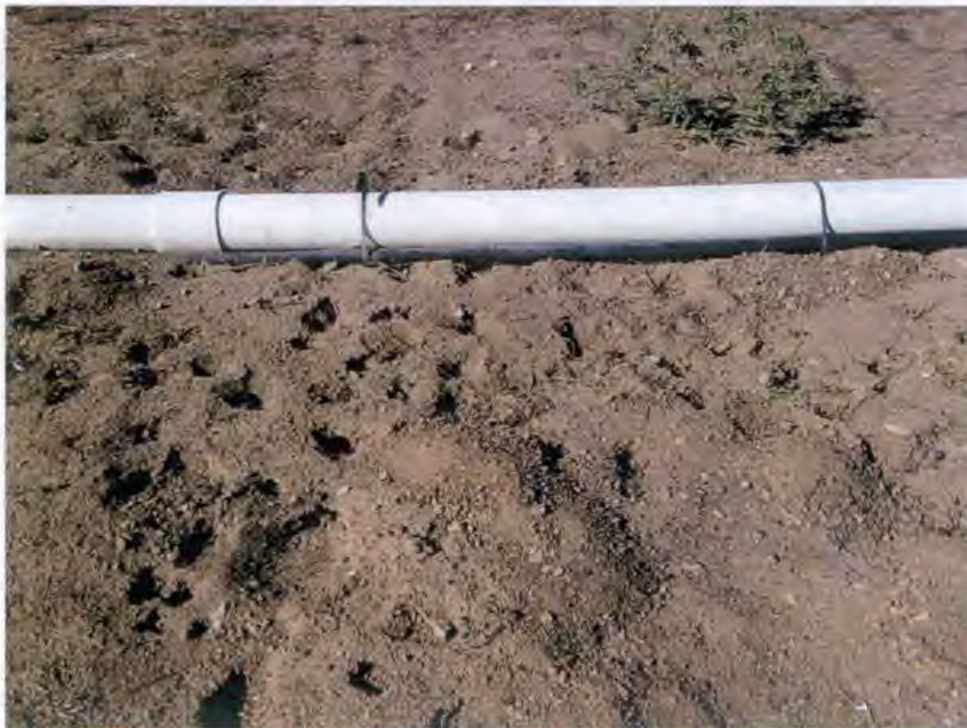
1. San Diego Water Board Staff observed an extensive rodent intrusion presence on the landfill cover and near landfill gas lines (Figures 5 and 6). The condition of the cover due to the rodent issues may impair the integrity of the landfill cover. The condition of the cover is in non-compliance with sections C.4.c.iii and C.4.d.ii of Order No R9-2012-0001. Provide photographs of the maintenance documenting that it has occurred and submit with a re-certification report which must be received by the San Diego Water Board 30 days after completing the mitigation measures. Also, identify new measures to help control the rodent problems.

Figure 5- Southeast Landfill Slope

Figure 6- Southeast Landfill Slope

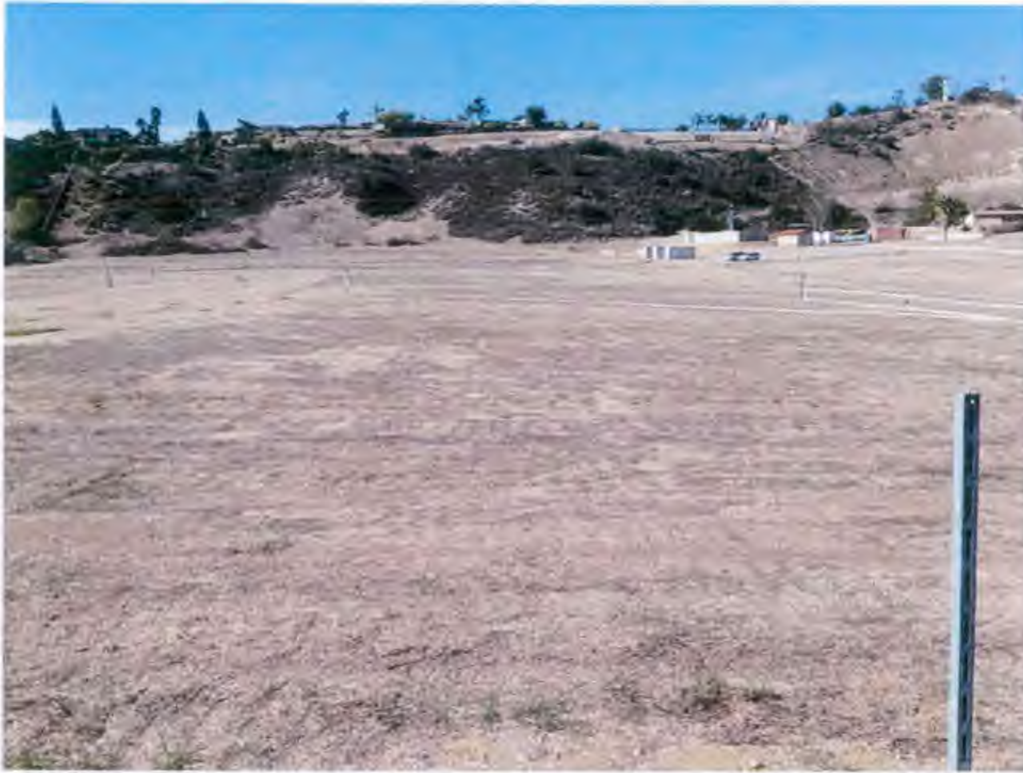
Figure 7- Landfill Cover Facing West

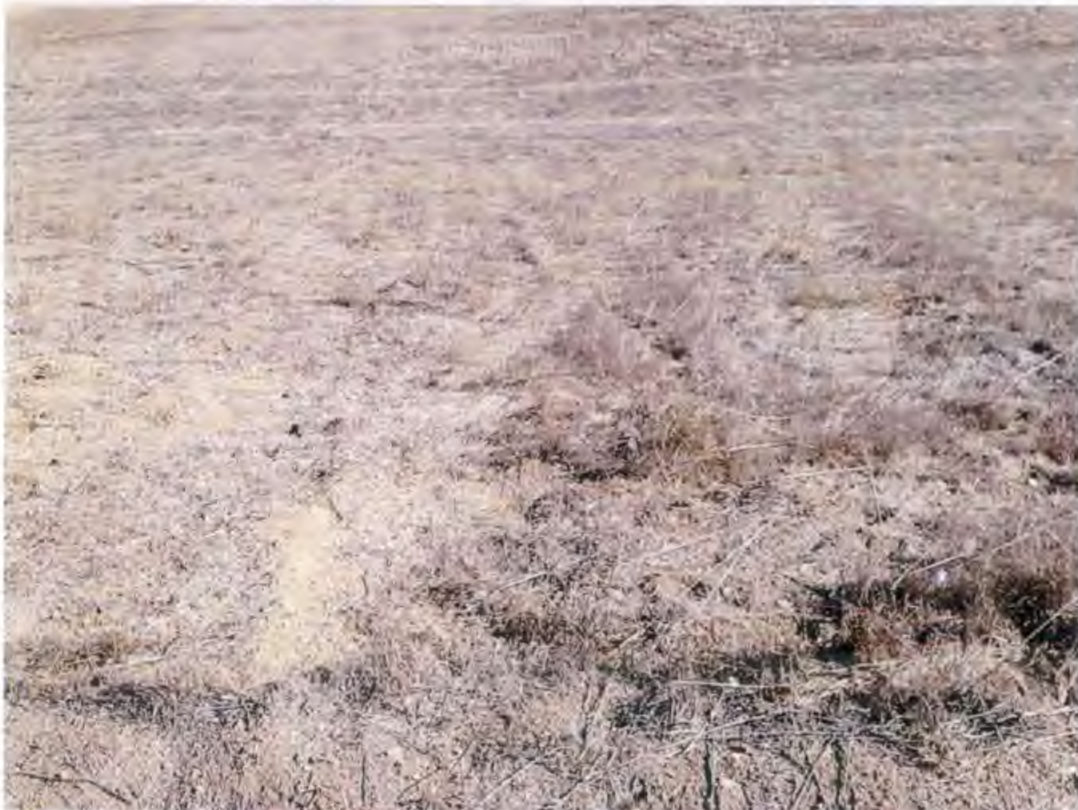
Figure 8- Closer View of Landfill Cover with Grass Vegetation
