California Regional Water Quality Control Board, San Diego Region

**NOTICE OF VIOLATION**  
**No. R9-2015-0050**

El Camino Real Road Widening Project  
PIN No. SM-832587:lwalsh

**FACILITY INSPECTION REPORT**

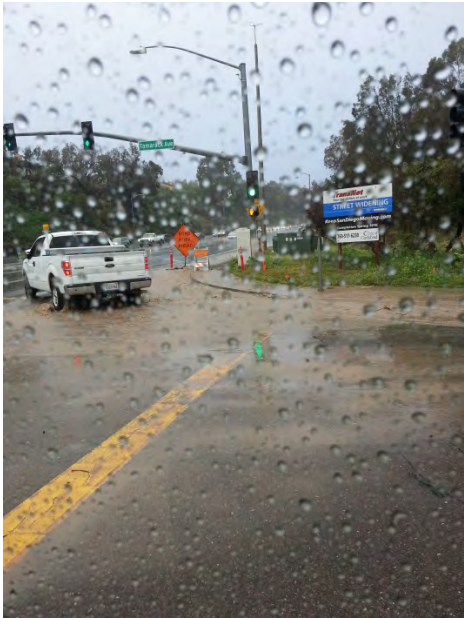
- c. Observation:** On March 2, 2014, the San Diego Water Board inspector observed a major discharge of sediment laden water to the MS4. See Attachment1 – Photos 1 and 2. The discharge of sediment laden water from the site is evidence that the City failed to use proper controls, structures, and management practices at the site that achieves best conventional treatment (BCT) for conventional pollutants. During the March 2, 2015 site inspection, the San Diego Water Board inspector observed a lack of effective erosion controls and runoff controls required by the CGP. Soil stabilization (e.g. soil tackifiers, hydroseed, etc.) technologies were not deployed in conjunction with runoff controls at the site. Without soil stabilization BMPs, in place, in addition to runoff controls the site did not meet BCT. See Attachment 1 – San Diego Water Board Facility Inspection Report dated March 2, 2015 Photos 1 through 16.

**Photo 1:** Mobilized sediment in storm water discharged from El Camino Real Road Widening Project. Sediment laden water flows along El Camino Real and across Tamarak. (view is north along El Camino Real at 0700 hours). Discharge from site boundary see Attachment No. 1 - 3-02-15 City of Carlsbad Incident Summary Photo at 0745 and 0930

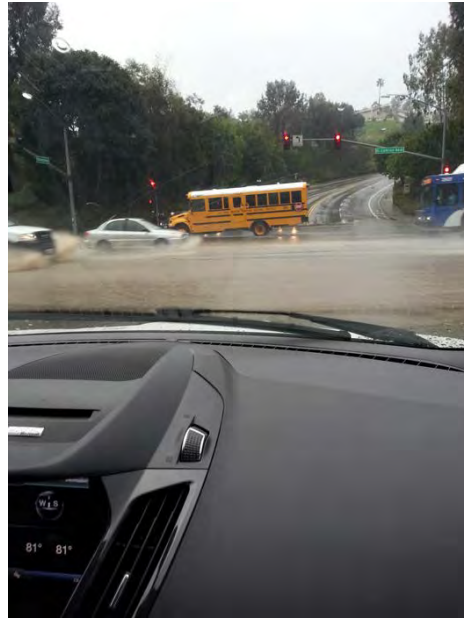
**Photo 2:** Evidence showing significant amount of sediment discharged from the site as seen in sediment laden spray from vehicles. This discharge flows downstream of Photo 1 and Photo 2 draining into Agua Hedionda Creek and Agua Hedionda Lagoon. (view is west along Tamarak with El Camino Real as the cross street at 0700 hours).

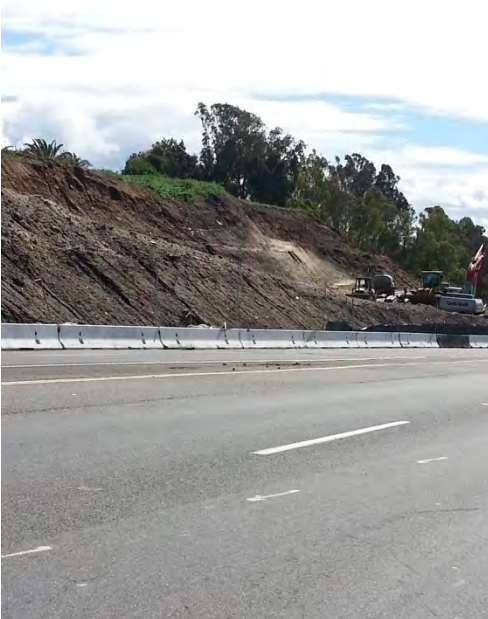
Linear sediment controls were not present on all slopes along the toe of the slope, face of the slope, and at the grade breaks of exposed slopes to comply with the sheet flow lengths stipulated in Table 1 of Attachment D in Order No. 2009-0009-DWQ. See Attachment 1 - Photos 3 through 6, 11, and 13 through 16.

**Photo 3:** Project site located east of El Camino Real. Slopes unprotected from erosion. Soil stabilizer(s) not in place. Linear sediment controls not in place. (view is east along El Camino Real at the north end of the site at 1130 hours).

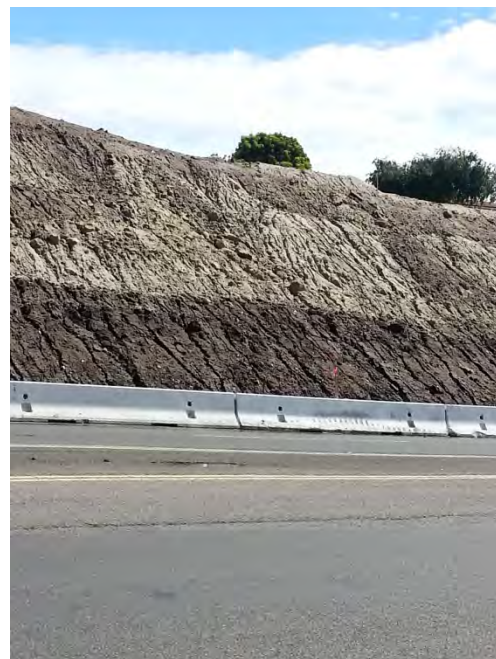
**Photo 4:** Evidence of significant erosion on steep slopes as the result of slopes being unprotected from erosion, of soil stabilizer(s) not being used, and failure to install linear sediment controls. (view is east along El Camino Real at the north end of the site at 1130 hours).

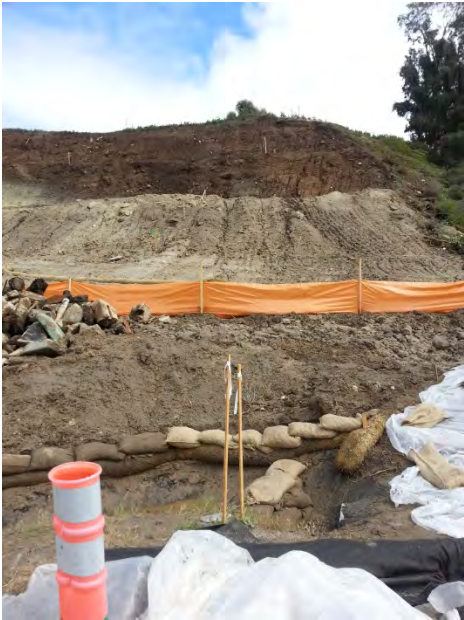
**Photo 5:** Project site slopes unprotected from erosion. Soil stabilizer(s) not in place. Linear sediment controls not in place. Silt fence and gravel bag berms installed after rain event (See Attachment No. 1 - 3-02-15 City of Carlsbad Incident Summary Photo at 0745 and 0930 – silt fence not installed) (view is east perpendicular to El Camino Real at the south end of the site at 1130 hours).

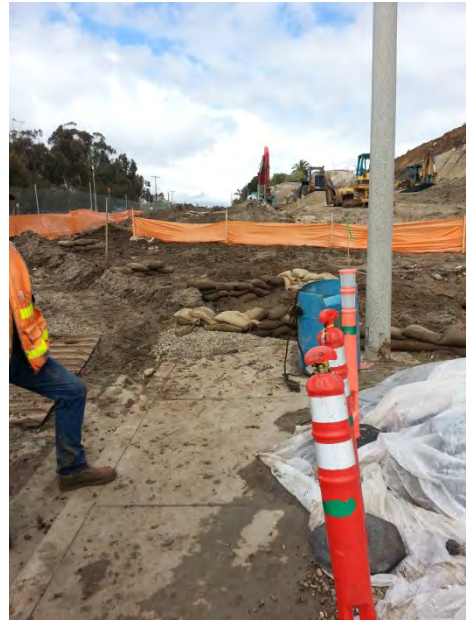
**Photo 6:** Check dams installed after rain event. Evidence of sediment discharged on the sidewalk. Discharge the result of lack of, insufficient amount, and ineffective installation of check dams and no silt fence prior to rain event. See Attachment No. 1 - 3-02-15 City of Carlsbad Incident Summary Photo at 0745 and 0930.

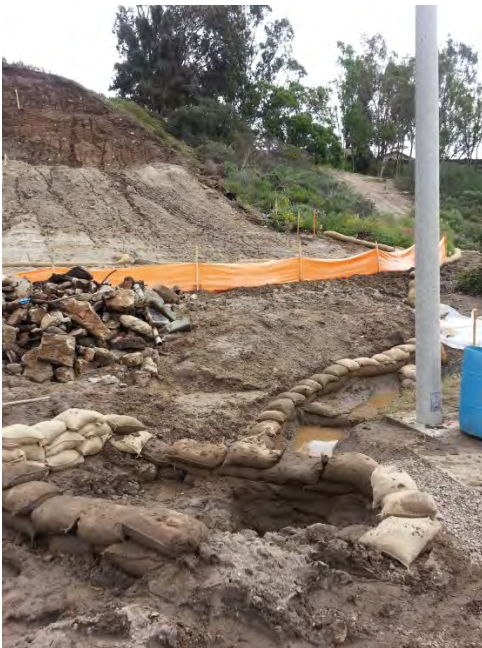
A sediment basin bermed with sand bags was in place at the downgradient end of the site located east of El Camino Real. Sediment basins are to be designed pursuant to CASQA Construction Stormwater BMP Handbook. The sediment basin on site was not present prior to the rain event and the one constructed on March 2, 2015 after the rain event was not designed in compliance with the CASQA Handbook. For before rain event see Photos at 0745 in Attachment 2 - March 2, 2015 City of Carlsbad El Camino Real Road Widening Project Incident Summary Report, Job 3957, WDID# 937C371534. For after rain event, see Attachment 1 - Photos 7 and 8.

**Photo 7** Sedimentation basin constructed after rain event. See Attachment No. 1 - 3-02-15 City of Carlsbad Incident Summary Photo at 0745 and 0930 – sedimentation basin not installed) Sedimentation basin not designed in accordance with CASQA Construction BMP Guidance Handbook as required by CGP.

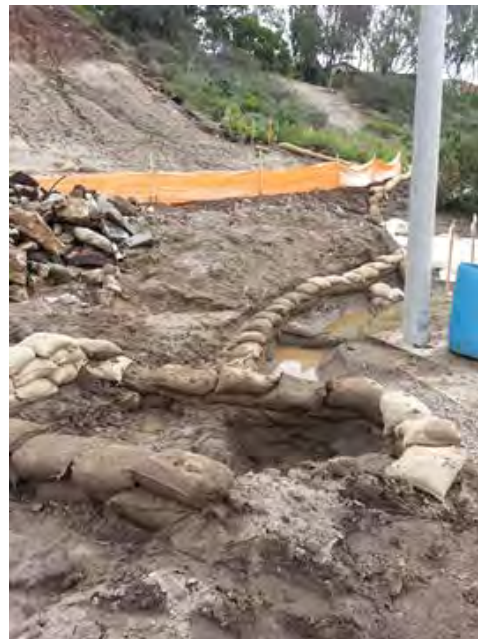
**Photo 8:** Sedimentation basin is extremely shallow and not designed in accordance with CASQA Construction BMP Guidance Handbook as required by CGP.

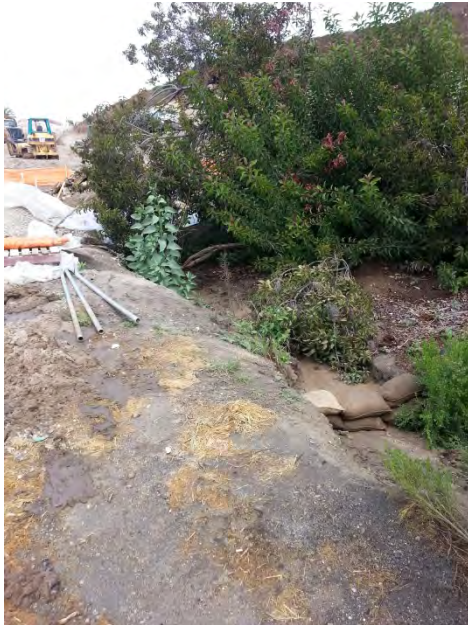
**Photo 9** Lack of perimeter controls, inadequate run-on controls, lack of erosion in conjunction with sedimentation controls, and lack of soil stabilization controls resulted in a discharge of sediment and sediment laden water from the site. Discharge of sediment beyond the gravel bag dike and sediment deposited as seen in Photo 10 is evidence that sediment was discharged from the site to the unnamed tributary to Agua Hedionda Creek and Agua Hedionda Lagoon. (view is at south end of the site at the discharge point looking north).

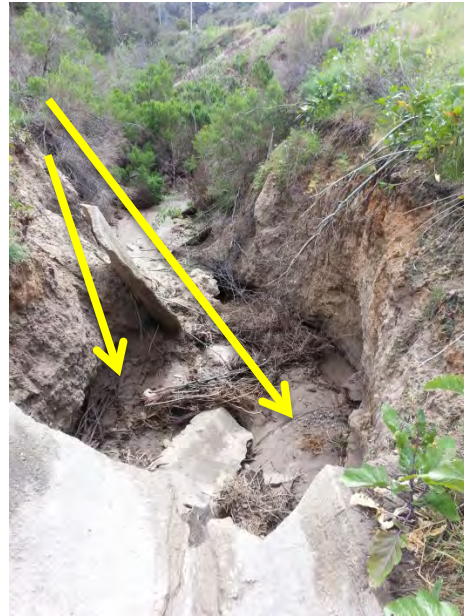
**Photo 10** Discharge of sediment traveled along concrete v-ditch shown in Photo 9 to discharge to earthen bottom unnamed tributary as seen here to Agua Hedionda Creek and Agua Hedionda Lagoon. Photo Evidence shows discharge from the site caused or contributed to hydromodification in this receiving water. This project is also required to comply with San Diego Water Board Water Quality Certification 08C-074. (view south of the site, in the unnamed tributary to Agua Hedionda Creek and Agua Hedionda Lagoon at the point where the concrete v-ditch discharges into the earth bottom receiving water).

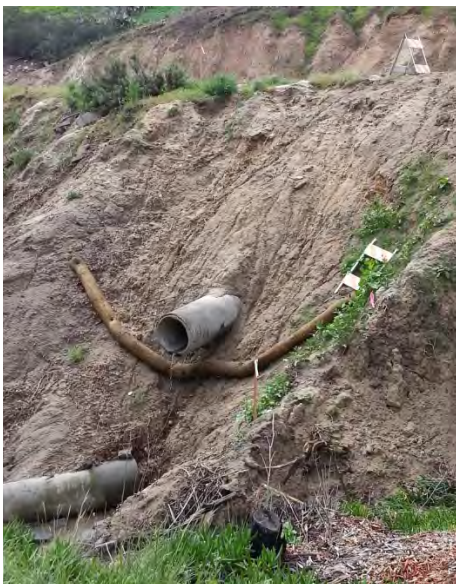
**Photo 11** Lack of perimeter controls, inadequate run-on controls, lack of erosion in conjunction with sedimentation controls. (view is south of Photo 10 in the unnamed tributary to Agua Hedionda Creek and Agua Hedionda Lagoon).

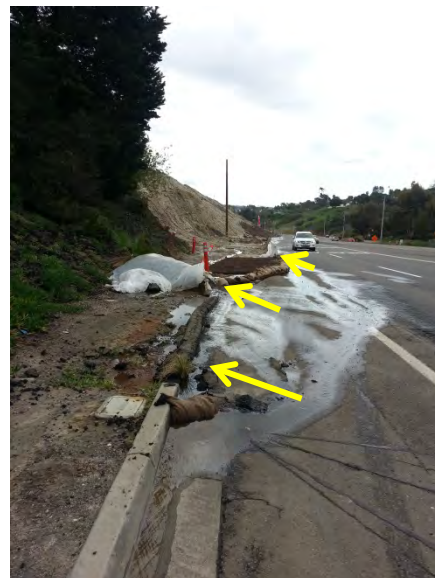
- d. **Observation:** During the March 2, 2015 inspection, the San Diego Water Board inspector observed a lack of effective perimeter controls (see Attachment - Photo 12) and inlet protection (see Attachment - Photos 9 and 16) in place at the site. Run-on to the site inundated the sites perimeter controls causing significant erosion resulting in a significant discharge of sediment from the site to an unnamed tributary to Agua Hedionda Creek and Agua Hedionda Lagoon. Further, the San Diego Water Board inspector observed a lack of erosion control BMPs in conjunction with sediment control BMPs throughout the site. Erosion controls BMPs include both runoff controls and soil stabilization controls. Order 2009-0009-DWQ defines erosion control BMPs as vegetation, such as grasses and wildflowers, and other materials, such as straw, fiber, stabilizing emulsion, protective blankets, etc. placed to stabilized areas of disturbed soils, to reduce loss of soil due to the action of water or wind, and prevent water pollution." CASQA Construction BMP Guidance Manual defines erosion control as "any source control practice that protects the soil surface and prevents soil particles from being detached by rainfall, flowing water, or wind. See Attachment 1 - Photos 3 through 6, 9, 11, and 13 through 15.

- b. **Observation:** During the March 2, 2015 inspection, the San Diego Water Board inspector observed areas of the site unprotected and under protected from run-on. The portion of the site located east of El Camino Real was inadequately protected from run-on (see Attachment 1 - Photo 12) and the portion of the site located west of El Camino Real was not protected from run-on (see Attachment 1 - Photos 13 through 15). A lack of effective run-on protection caused excessive erosion throughout the site. Lack of proper run-on controls contributed to a significant discharge of sediment and sediment laden water to the unnamed tributary to Agua Hedionda Creek and Agua Hedionda Lagoon. See Attachment 1 - Photos 12 through 15.

**Photo 12** Ineffective perimeter controls and protection from run-on. Storm water run-on flow pattern seen here. Breached perimeter and run-on controls shown by yellow line. Perimeter controls and run-on protection was reinforced after the rain event (See Attachment No. 1 - 3-02-15 City of Carlsbad Incident Summary Photo at 0745 and 0930)

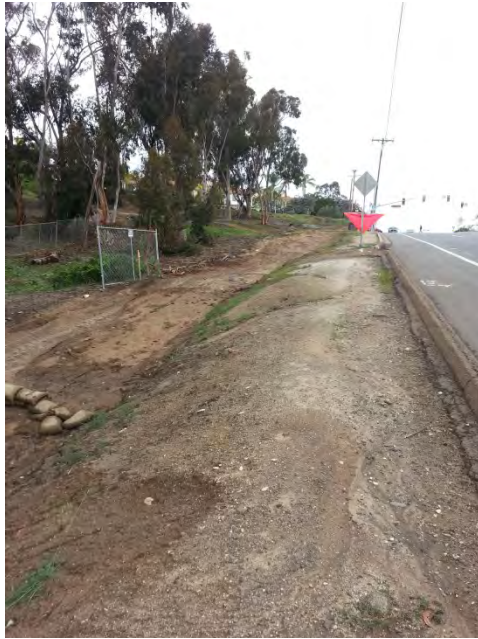
**Photo 13** Lack of perimeter controls, lack of run-on controls, lack of erosion controls, lack of erosion controls in conjunction with sedimentation controls, and lack of soil stabilization controls. (view at north end of the site located on the west side of El Camino Real looking north).

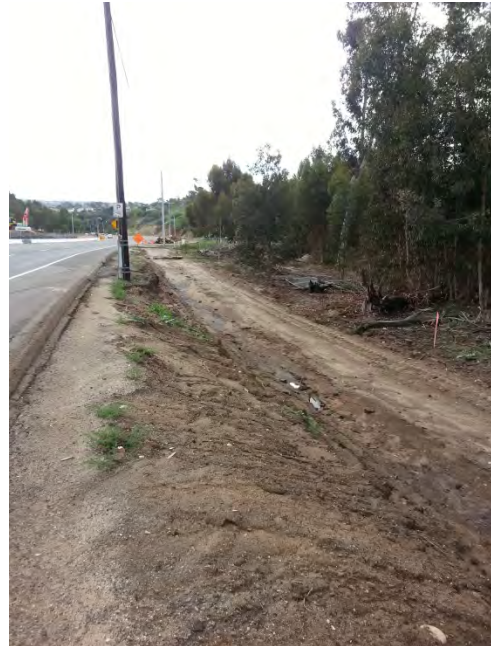
**Photo 14** Lack of perimeter controls, lack of run-on controls, lack of erosion controls, lack of erosion controls in conjunction with sedimentation controls, and lack of soil stabilization controls. (view at north end of the site located on the west side of El Camino Real looking south).

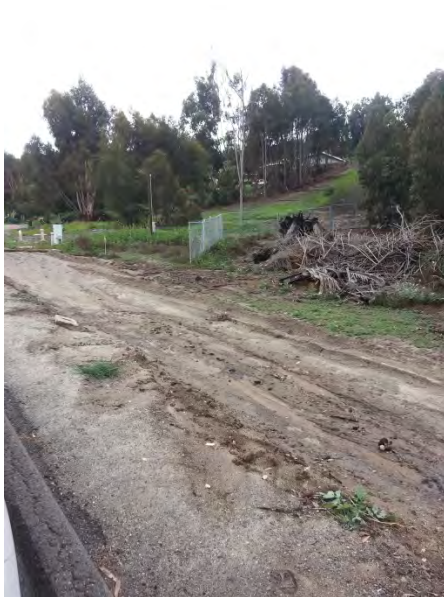
**Photo 13** Lack of perimeter controls, lack of run-on controls, lack of erosion controls, lack of erosion controls in conjunction with sedimentation controls, and lack of soil stabilization controls. (view at south end of the site located on the west side of El Camino Real looking south toward inlet structure shown in Photo 16). This photo documents rilling evidence of erosion on this portion of the site due to an overall lack of perimeter controls, erosion and sedimentation controls.

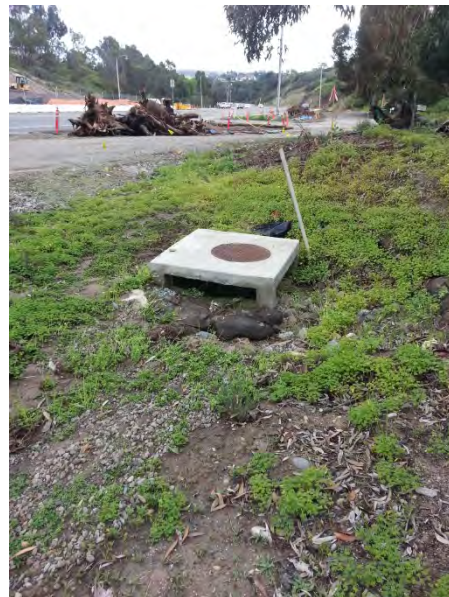
**Photo 14** Unprotected inlet. This inlet is located directly down gradient of site shown in Photo 15. Erosion and sedimentation shown in Photos 13-15 are evidence of a discharge of sediment and sediment laden storm water to the MS4.

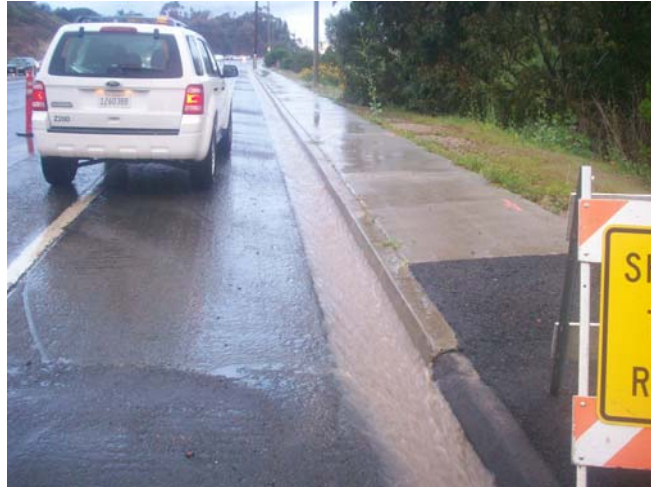
Time:	0740	By:	S. Grandberry
Discharge flowing south on ECR from the project site.

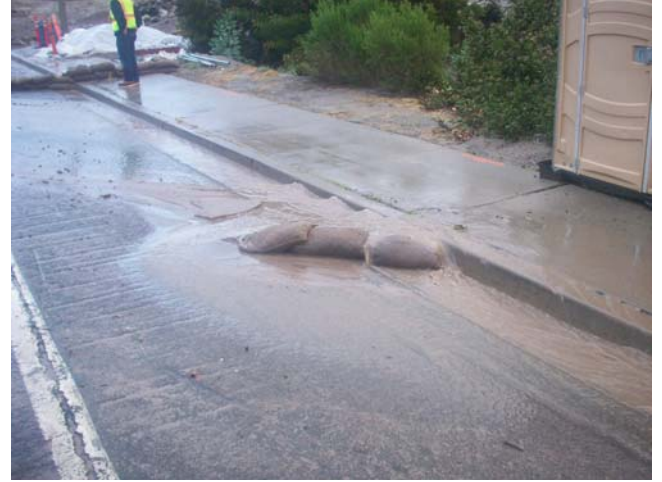
Time:	0740	By:	S. Grandberry
Discharge flowing over and around chevrons on of ECR.

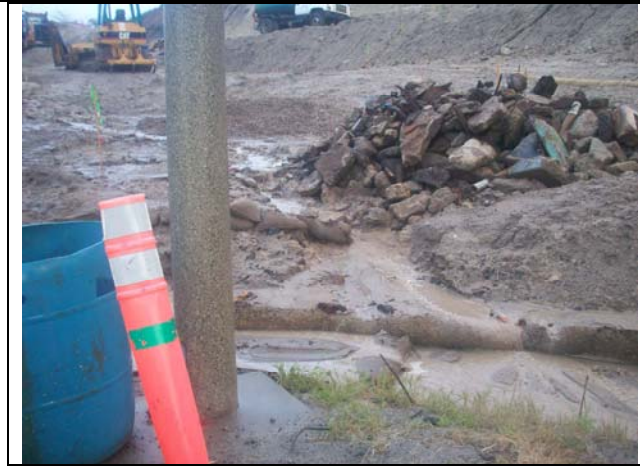
Time	0745	By	S. Grandberry
Ineffective BMP placement resulted in several breaches throughout the site.

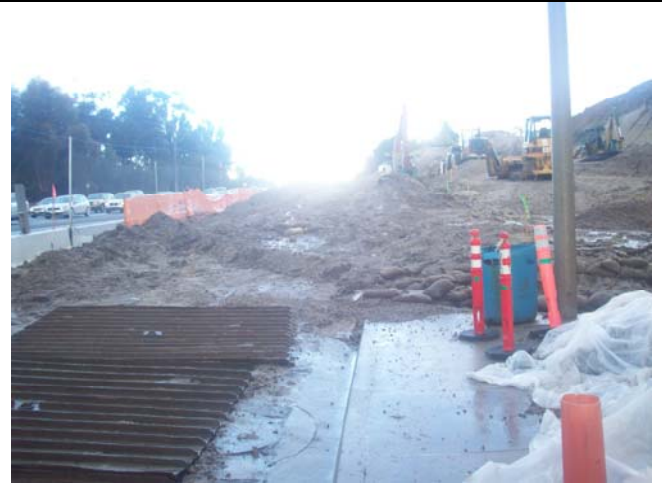
Time	0745	By	S. Grandberry
Lack of BMP stockpiles throughout the site resulted in relocation of BMPs to breached areas.

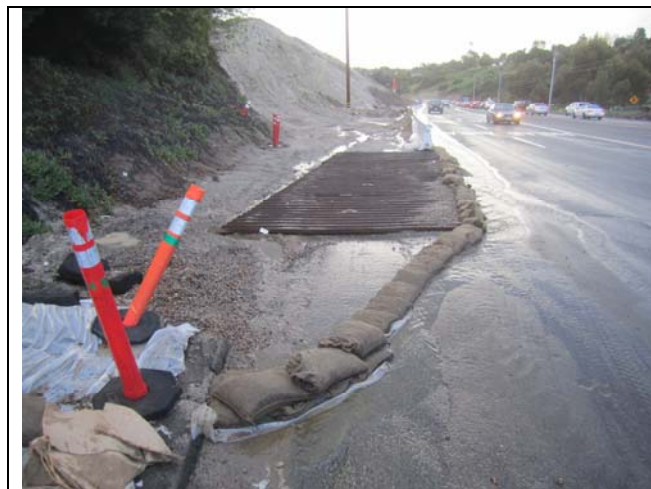
Time	0930	By:	D. Carlin
Northernmost run-on protection where rainfall overwhelmed diversion and flowed behind K-Rail resulting in primary sediment discharge.

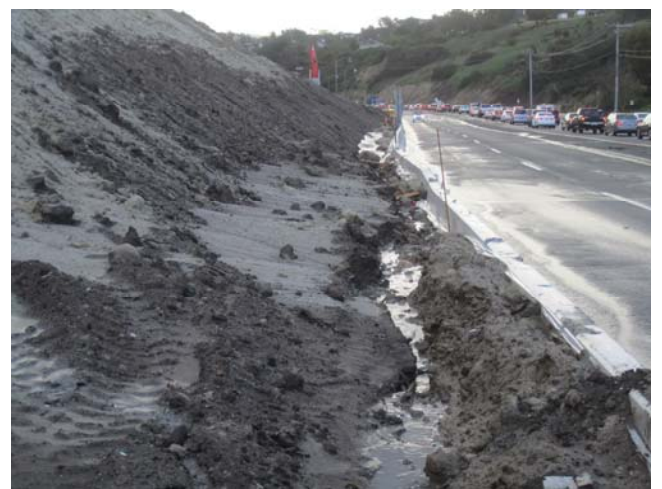
Time:	930	By :	D. Carlin
Sediment accumulated behind K-rail from slope erosion. Resulted in sediment flowing out of K-rail lifting holes onto ECR.

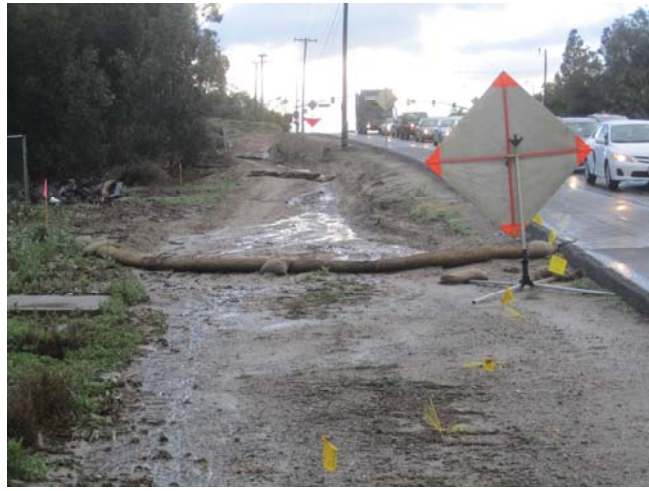
Time:	1030	By:	D. Carlin
View of area behind ECR curb line just south of Chestnut. BMP's intact, prior to being supplemented. No runoff identified from this area.

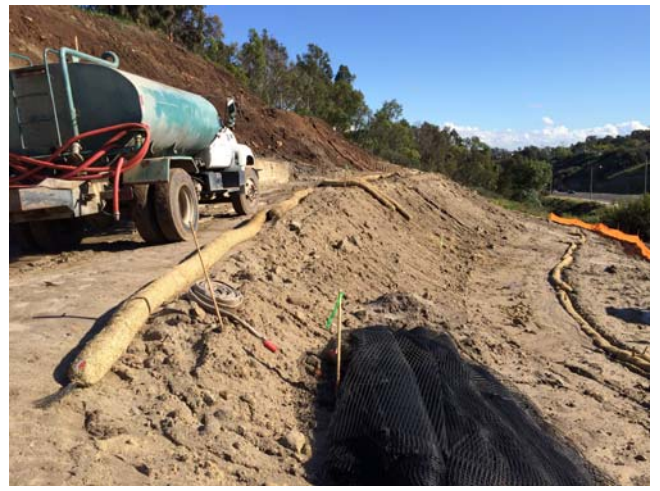
Time:	1500	By :	D. Carlin
View of project site near end of shift as crew began installation slope protection BMPs.
