TECHNICAL MEMORANDUM

Re: Corrective Action Work Plan for Barge Dredged Material Spill
San Diego Shipyard Sediment Site, North Shipyard, San Diego, California

SUBJECT: **SUPPLEMENTAL INCIDENT REPORT**
SCOW SEDIMENT LEAKAGE

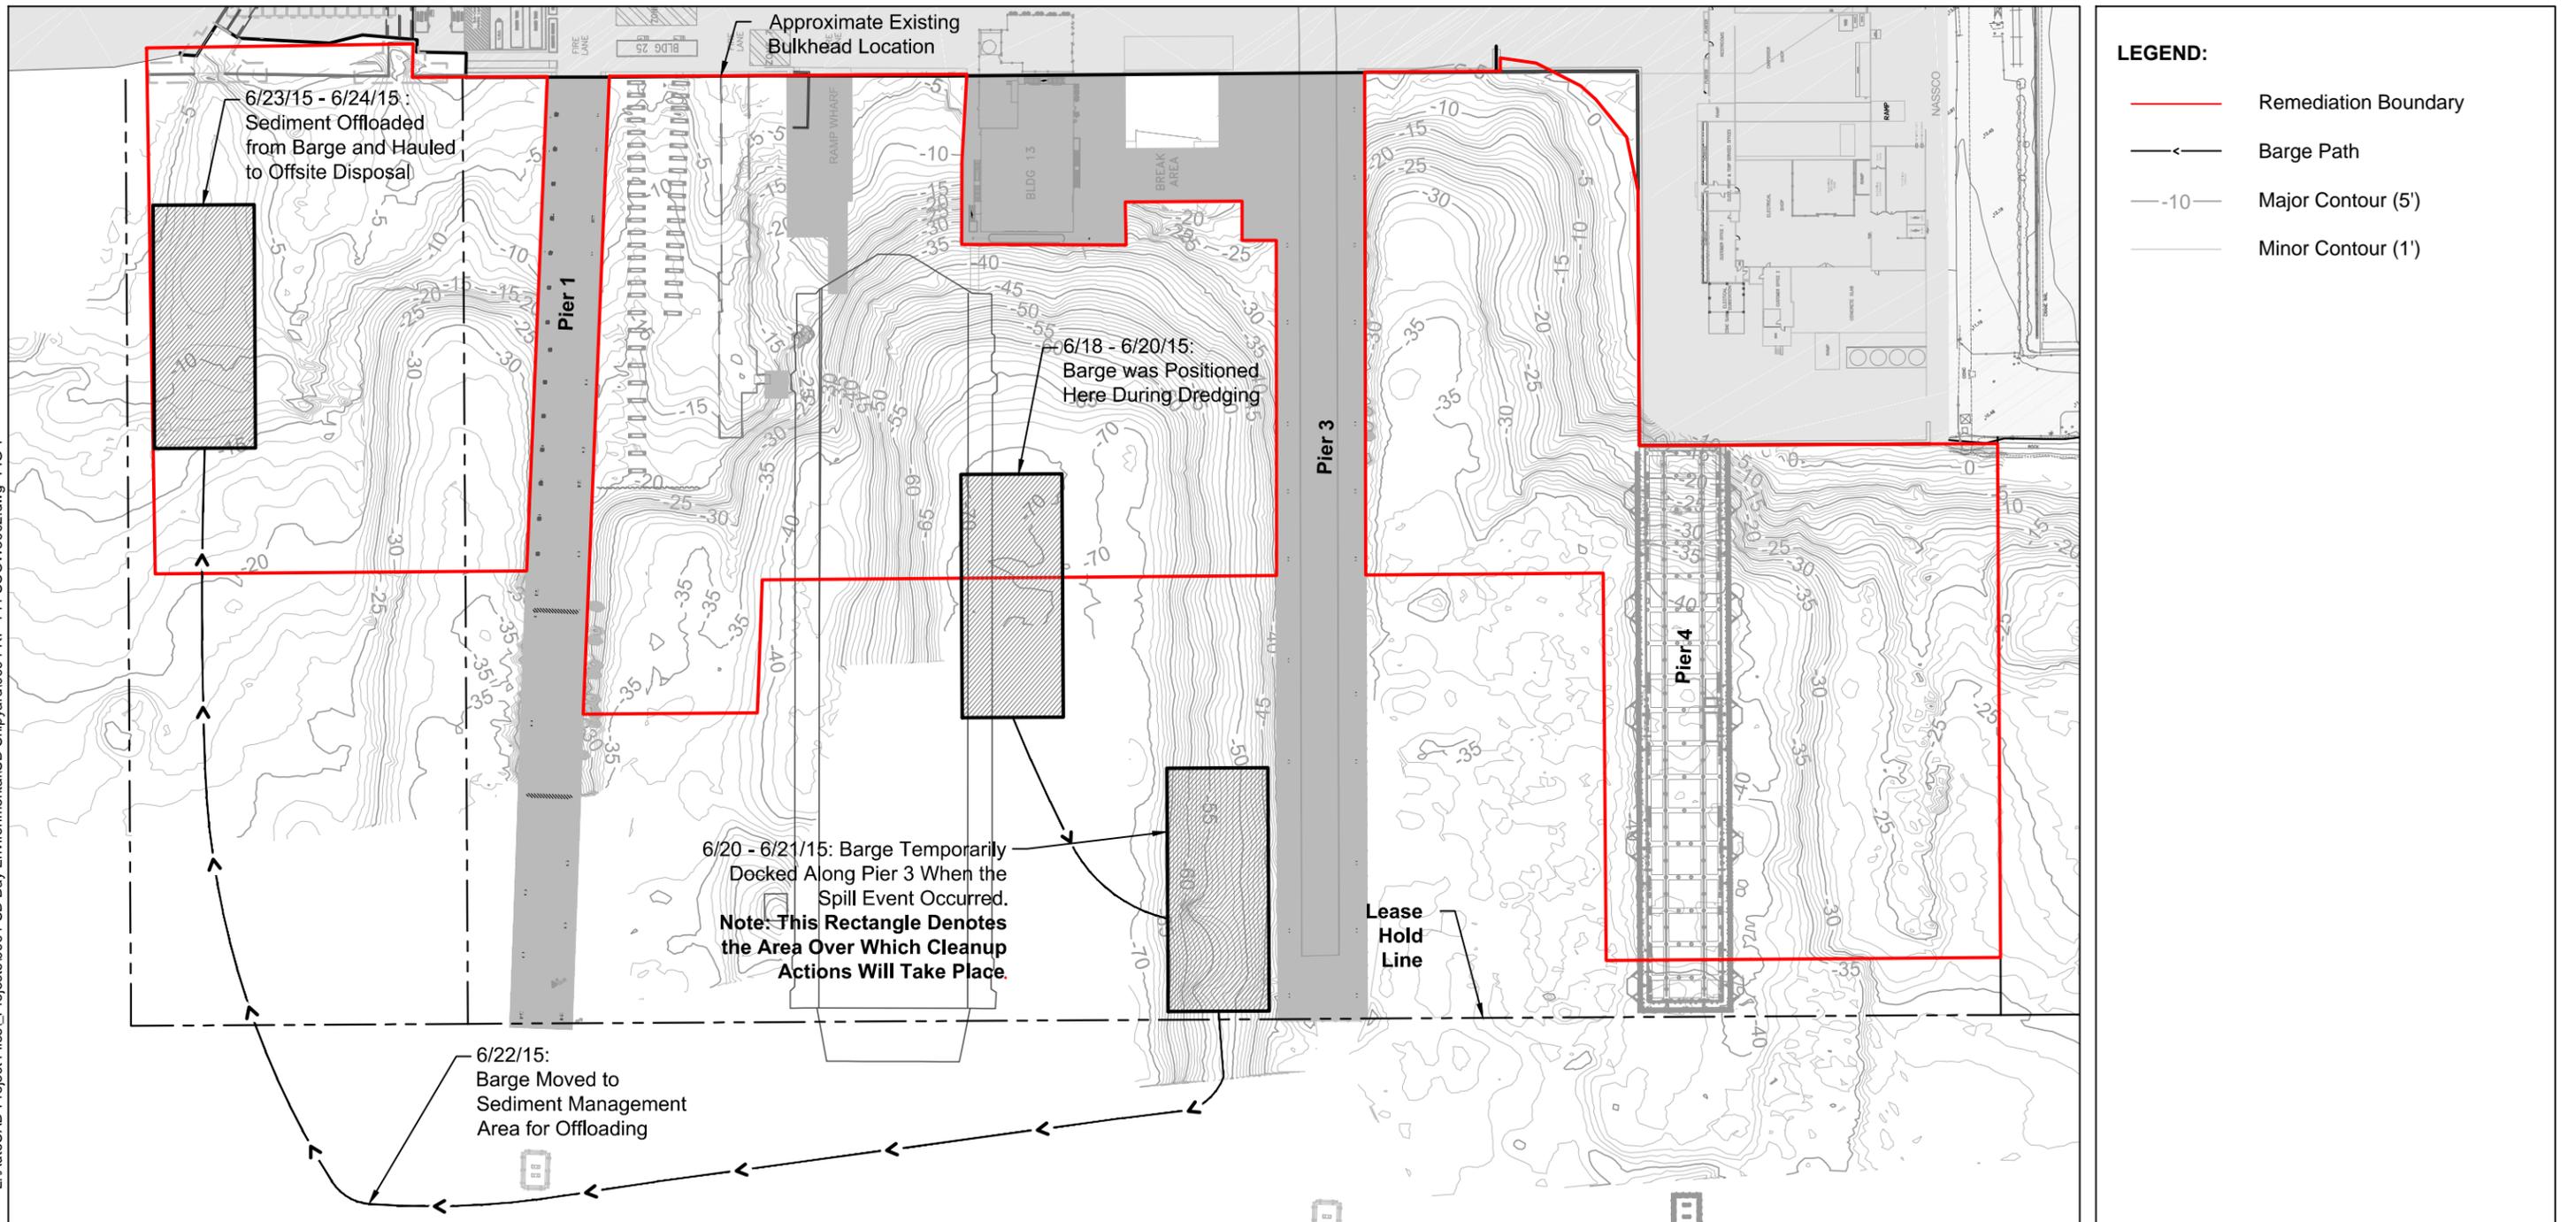
Figure 1
 Movement and Positioning of 3002 Barge, and Spill Cleanup Area
 San Diego Shipyard Sediment Site - North Shipyard

Based on a RES internal evaluation, an estimated 250 cubic yards of dredged sediment was released from the RES 3002 (as shown in Figure 1). RES has identified a boundary of approximately 40 feet by 200 feet within which the misplaced material had fallen. The spill removal activities will include removing all misplaced material, as well as removing an additional 1-foot overdredge below the original bathymetry within the identified 40-foot by 200-foot area. The dredging of the misplaced material as well as overdredge will generate approximately 500 to 800 cubic yards of material removed from the area.

The area of the spill delineated on Figure 1 will be targeted by cleanup dredging. Material will be removed to below the pre-existing subgrade elevation, sufficient to accomplish full

removal of the spilled material. RES will evaluate historical bathymetric surveys of the potential spill areas (including the route of barge to the offloading location [Figure 1]), and conduct additional surveys as necessary to evaluate whether further leakage occurred during movement or outside of the identified spill area. The evaluation will include comparing the historical bathymetric survey elevations with post-spill bathymetric survey elevations (where applicable) to evaluate whether any significant increases in elevation are noted.

Spill removal will be verified by a post-removal bathymetric survey and one post-dredge confirmation sample to provide verification of cleanup. The location of the confirmation sample will be in the center of the dredge area rectangle (Performing one sample in the cleanup area is consistent with the sampling approach used throughout the remedial dredging, as the cleanup area is within one of the Theissen polygon areas originally used in characterizing the site for the project's Cleanup and Abatement Order). The confirmation sample will be tested for primary contaminants of concern, outlined in Section A.2.a of the Cleanup and Abatement Order, consistent with post-dredge sampling throughout the project, so as to demonstrate that the dredging meets the objective of removing sediments to the CAO-mandated concentrations.

All standard environmental protection elements will be in place during the sediment removal process including the deployment of a double silt curtain to fully surround the dredge area. Water quality monitoring will also be performed, consistent with the monitoring provision of the Waste Discharge Requirements. Anchor QEA will verify and document that environmental protection measures are instituted throughout the work.

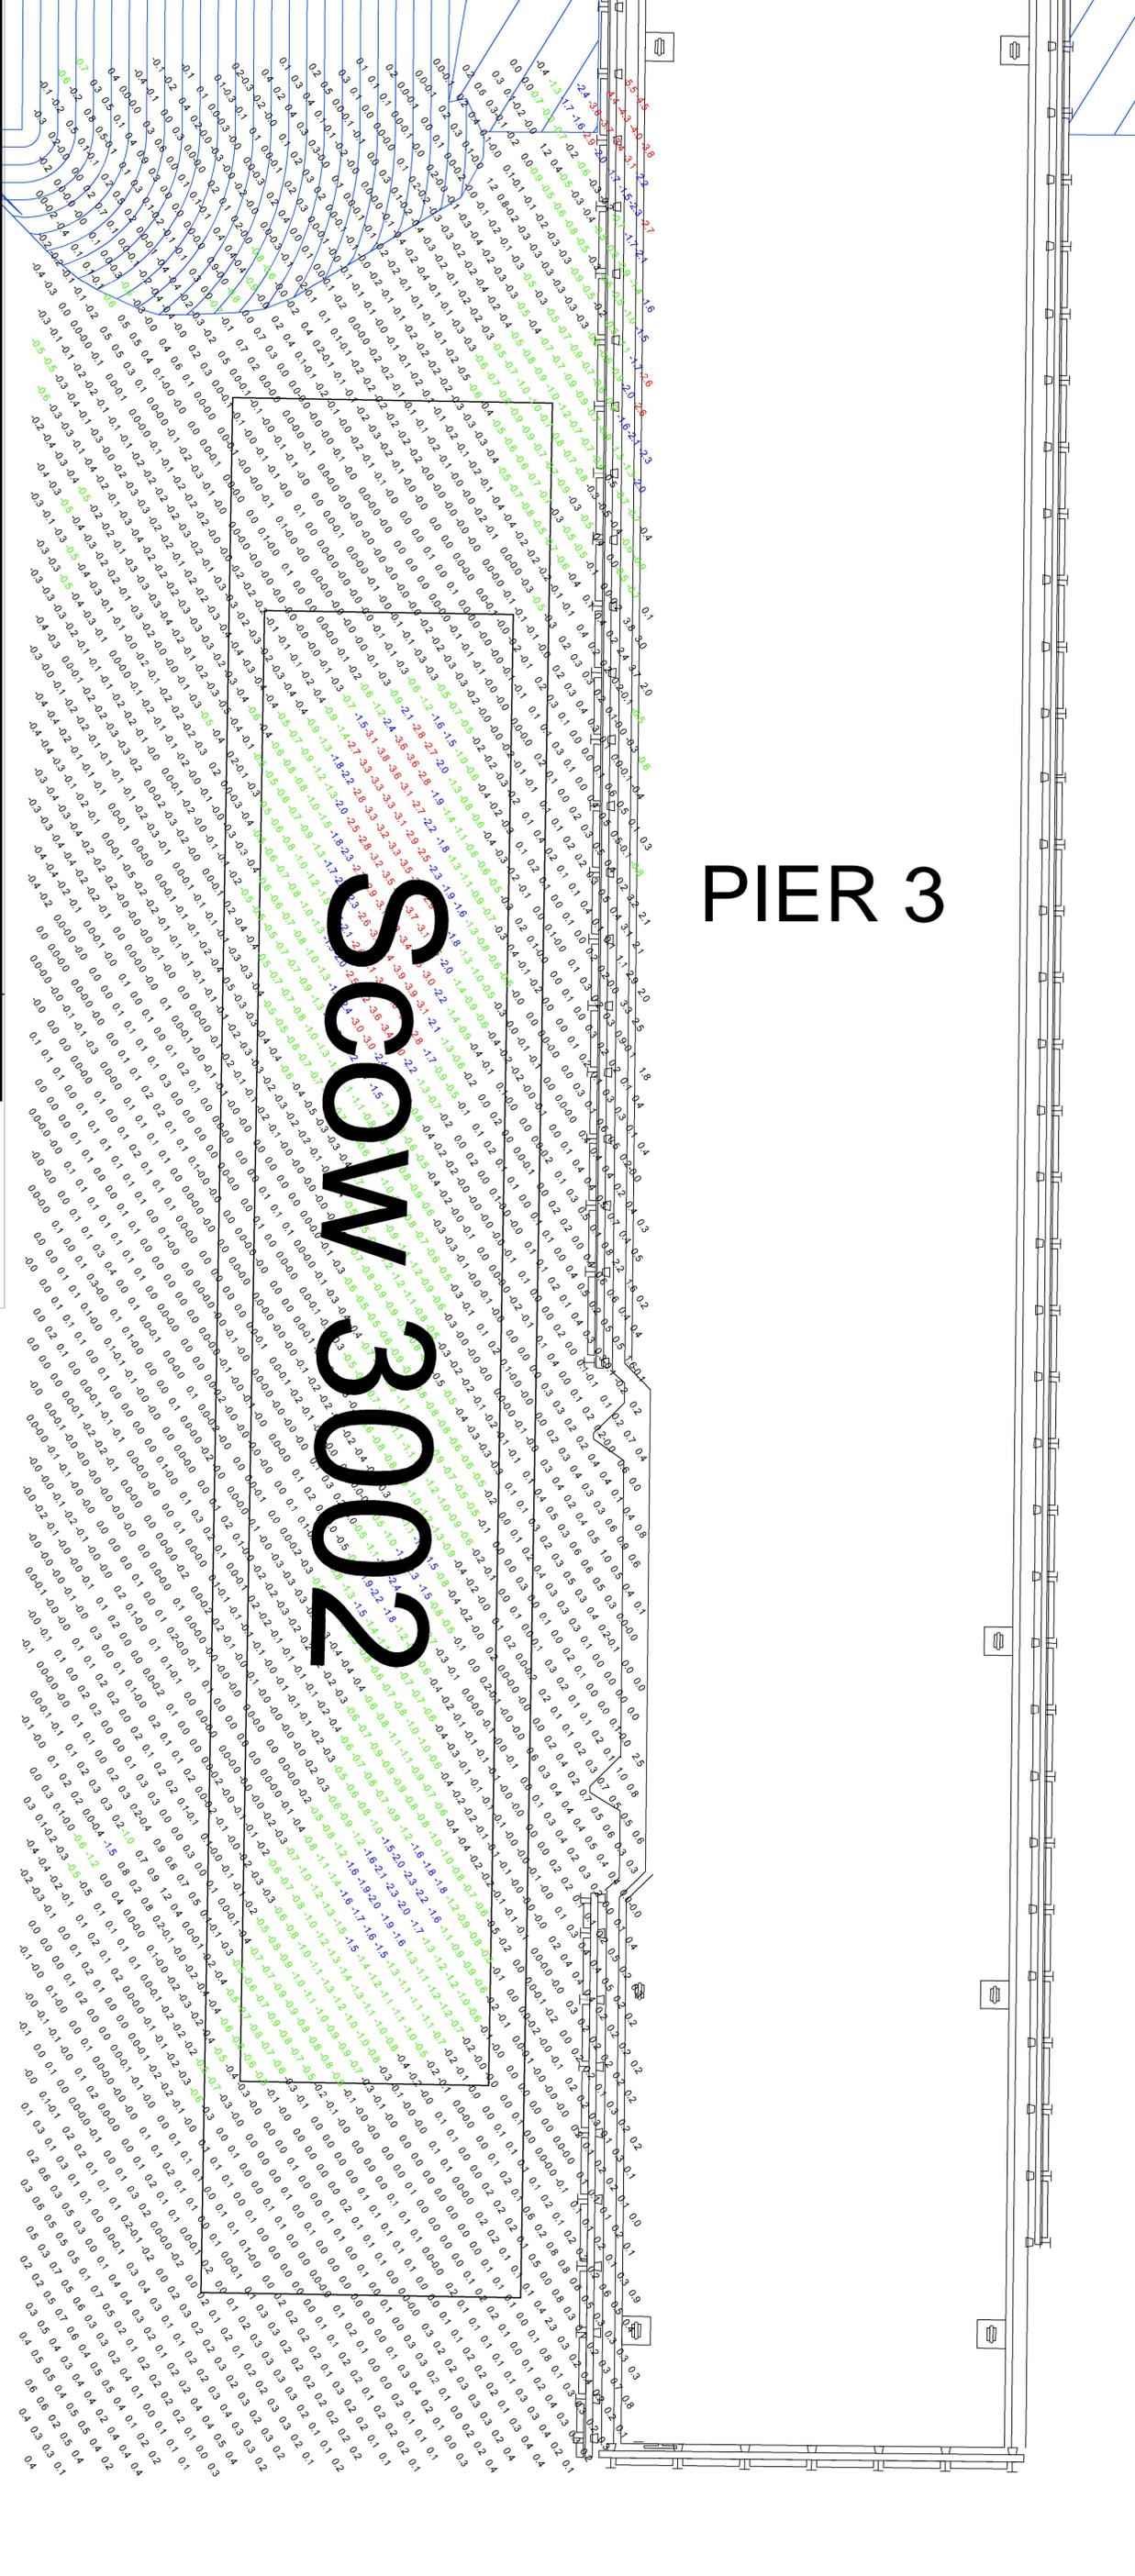
ATTACHMENT 2
BATHYMETRIC SURVEY INDICATING AREA
OF SPILL

After final clean out, the 3002 scow was shifted to the RES pier. Survey data analysis begins in-house. During the course of delta comparisons (the overlay of the 6/23/15 survey over an earlier 5/18/15 survey), it was confirmed that an apparent row of material approximately 20'-40' x 180'-190' existed above previous elevations in the footprint of where the 3002 Scow had been previously moored. Volume calculations subsequently performed on the area in question produced a net increase of approximately 250 cubic yards.

R.E. Staite Engineering is preparing a dredge management plan for removal of the leaked sediments. It is necessary to remove these sediments prior to 9/28/15. The plan will follow and incorporate all protocols associated with the CAO including deployment of silt curtains, post dredge surveys, handling, storage and discharge of sea water and truck transportation to the Otay landfill.
