**CALIFORNIA REGIONAL WATER QUALITY CONTROL BOARD  
SAN FRANCISCO BAY REGION**

**July 2, 2014**

**Cleanup Team Staff Report**

**Basis for Recommendation to Adopt Initial Site Cleanup Requirements Orders (SCRs)  
Naming:**

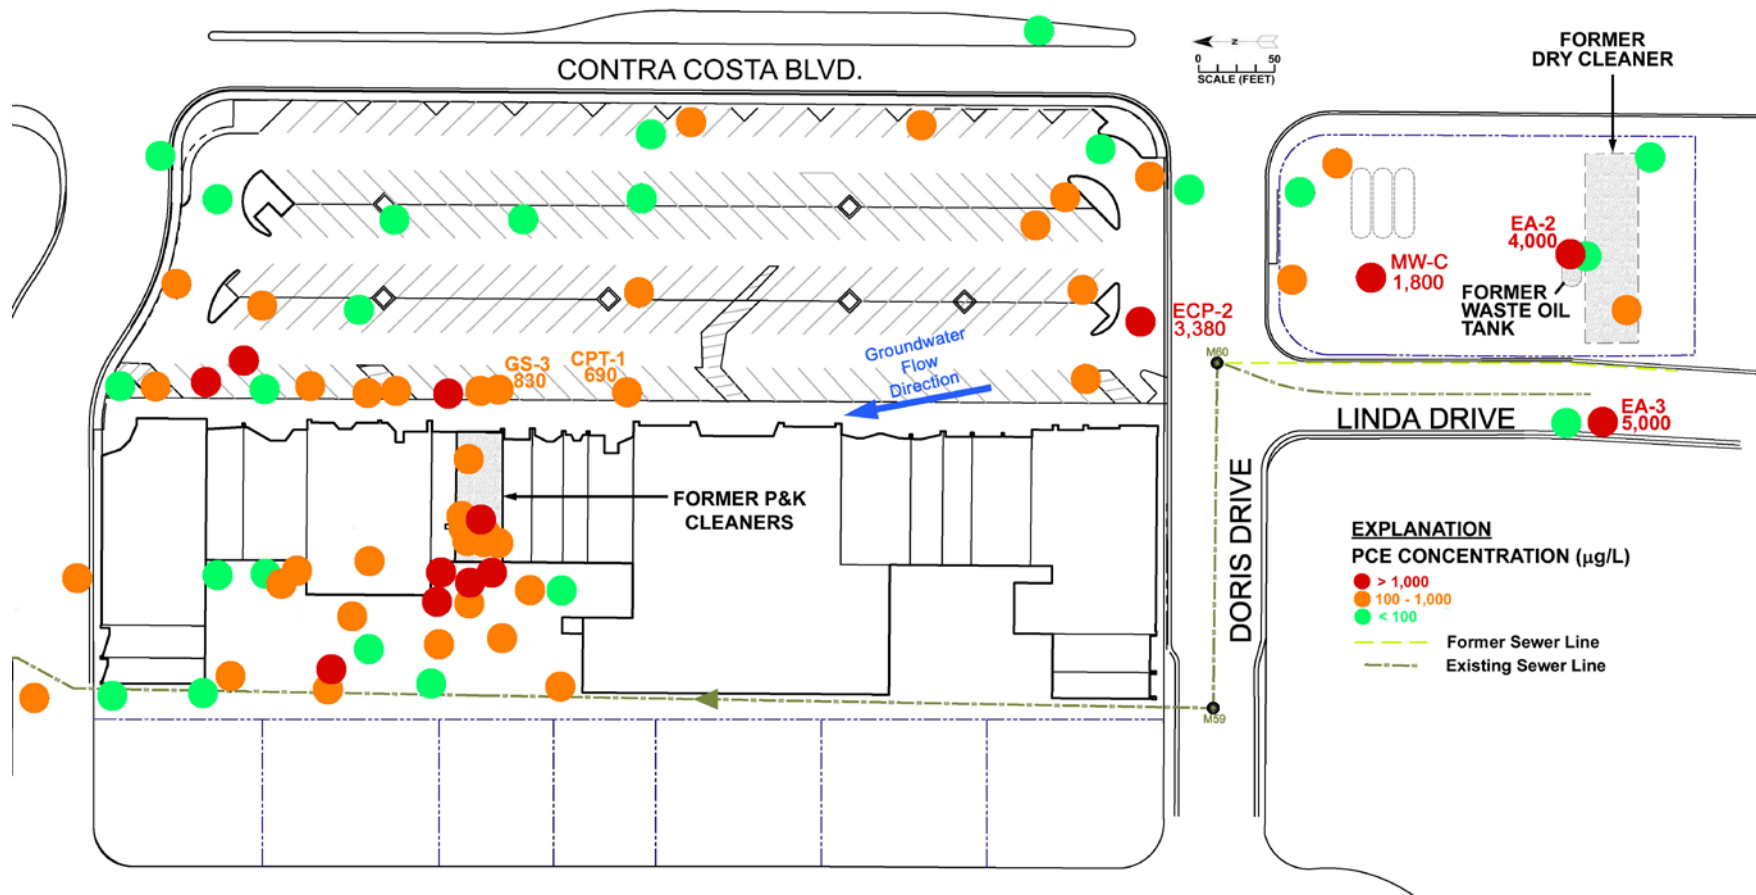
**Figure 3: Maximum PCE Concentrations in Groundwater at 1643 and 1705 Contra Costa Boulevard and Immediate Vicinity, Pleasant Hill, Contra Costa County**

The historical maximum detections of critical CVOCs associated with both sites are listed in Table 1. Groundwater data indicates the CVOC plume from Site 2 has commingled with the CVOC plume from Site 1 (Figure 3).

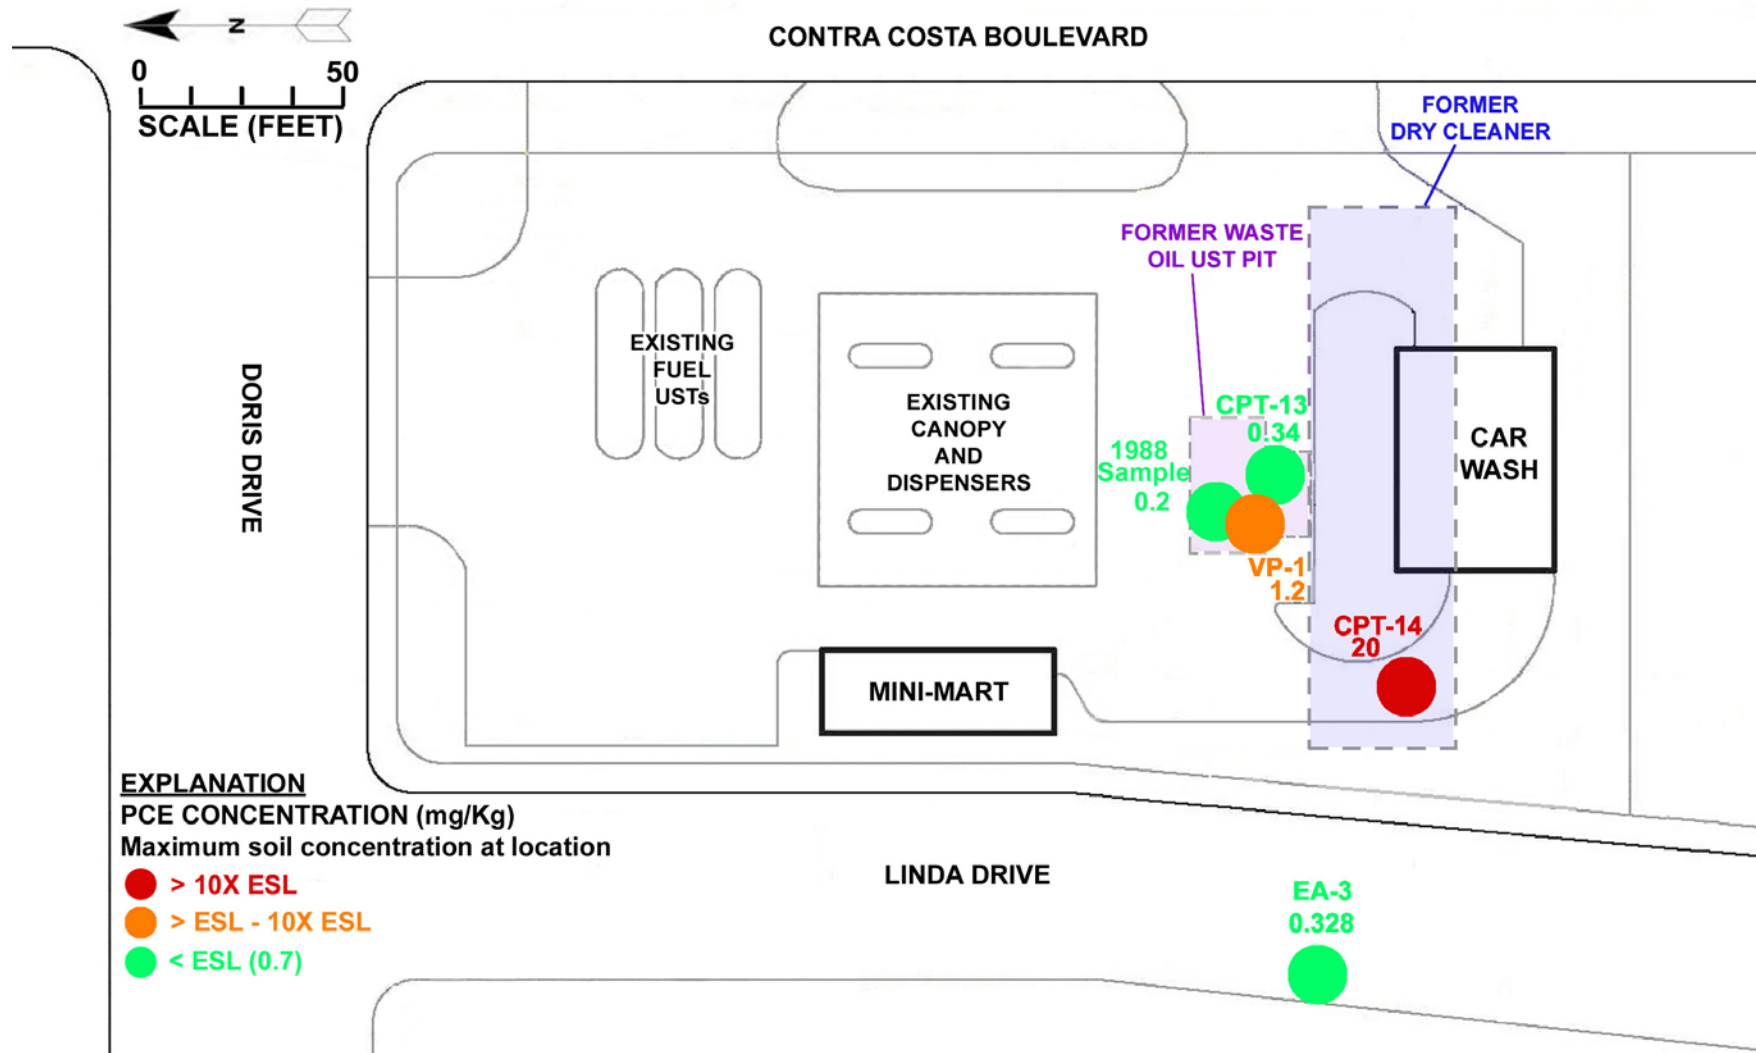
**Figure 4: Maximum PCE Concentrations in Soil at 1705 Contra Costa Boulevard and Immediate Vicinity, Pleasant Hill, Contra Costa County**

High CVOC soil concentrations generally reflect a specific release point/area. Figures 4 and 7 show the maximum concentrations of PCE and TCE detected in various soil samples collected within and near the former steel waste oil UST.

A soil sample collected within the tank pit at 10 feet below grade in 1988 contained 0.2 mg/kg of PCE and 0.035 mg/kg of TCE. In December 2011, a soil sample collected at a depth of five feet within the former waste oil UST excavation from vapor probe boring VP-1 contained PCE and TCE at 1.2 mg/kg and 1.4 mg/kg, respectively. Another soil sample collected at a depth of 9.5 feet from boring CPT-13, which was also advanced adjacent to/within the former waste oil UST pit, contained PCE at 0.34 mg/kg and TCE at 0.21 mg/kg, respectively.

The soil data depicted on Figures 4 and 7 indicates a distinct CVOC release from the former steel waste oil UST.

High CVOC soil concentrations generally reflect a specific release point/area. As shown on Figure 4, the maximum detected concentration of PCE from a soil sample collected within the footprint of the former dry cleaner is 20 mg/kg, from boring CPT-14.

The soil data depicted on Figures 4 and 7 likely reflects a distinct CVOC release from the former dry cleaner.

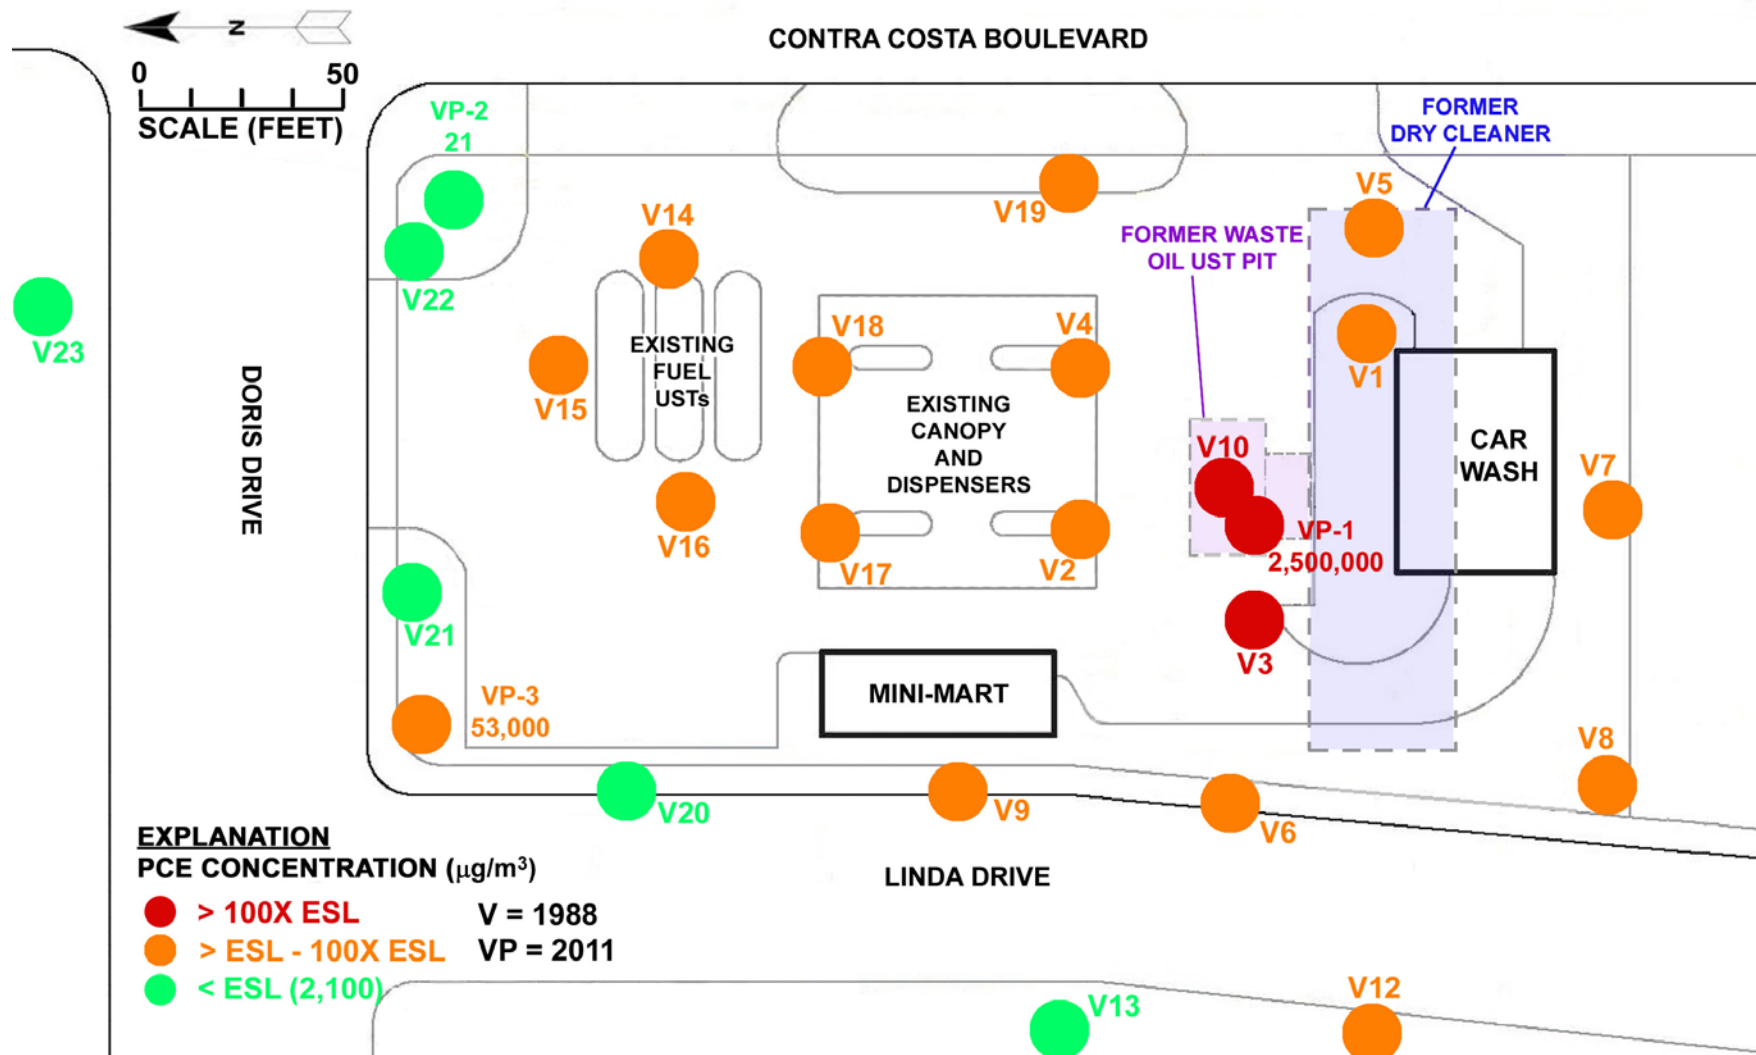
**Figure 5: Maximum PCE Concentrations in Soil Vapor at 1705 Contra Costa Boulevard and Immediate Vicinity, Pleasant Hill, Contra Costa County**

High soil vapor concentrations generally reflect a specific release point/area. Figures 5 and 8 show the maximum concentrations of PCE and TCE detected in various soil vapor samples collected within and near the former steel waste oil UST.

In May 1988, very high concentrations of PCE (up to 3,247,500  $\mu\text{g}/\text{m}^3$ ) and TCE (up to 109,500  $\mu\text{g}/\text{m}^3$ ) were detected in a soil vapor sample collected from probe V10, which was advanced directly within the former waste oil UST pit. In contrast, the maximum PCE concentrations detected in V2 and V3, two 1988 soil vapor probes advanced about 25 feet north and 25 feet west of V10, were 40,800  $\mu\text{g}/\text{m}^3$  and 900,000  $\mu\text{g}/\text{m}^3$ , respectively.

Soil vapor sampling conducted by Chevron in 2011 revealed the highest concentrations of PCE and TCE in soil vapor (e.g., 2,500,000  $\mu\text{g}/\text{m}^3$  and 2,100,000  $\mu\text{g}/\text{m}^3$ , respectively), from VP-1, a soil vapor point installed less than 10 feet away from V10.

The soil vapor data depicted on Figures 5 and 8 indicates a distinct CVOC release occurred from the former steel waste oil UST.

High soil vapor concentrations generally reflect a specific release point/area. Figures 5 and 8 show the maximum concentrations of PCE and TCE detected in various soil vapor samples collected within and around the former dry cleaner.

In 1988 four soil vapor probes were installed on the former dry cleaner parcel. The maximum detected concentrations of PCE and TCE were 19,347 µg/m<sup>3</sup> and 1,095 µg/m<sup>3</sup>, respectively, from vapor probe V1 located approximately 25 feet east of EA-2. These

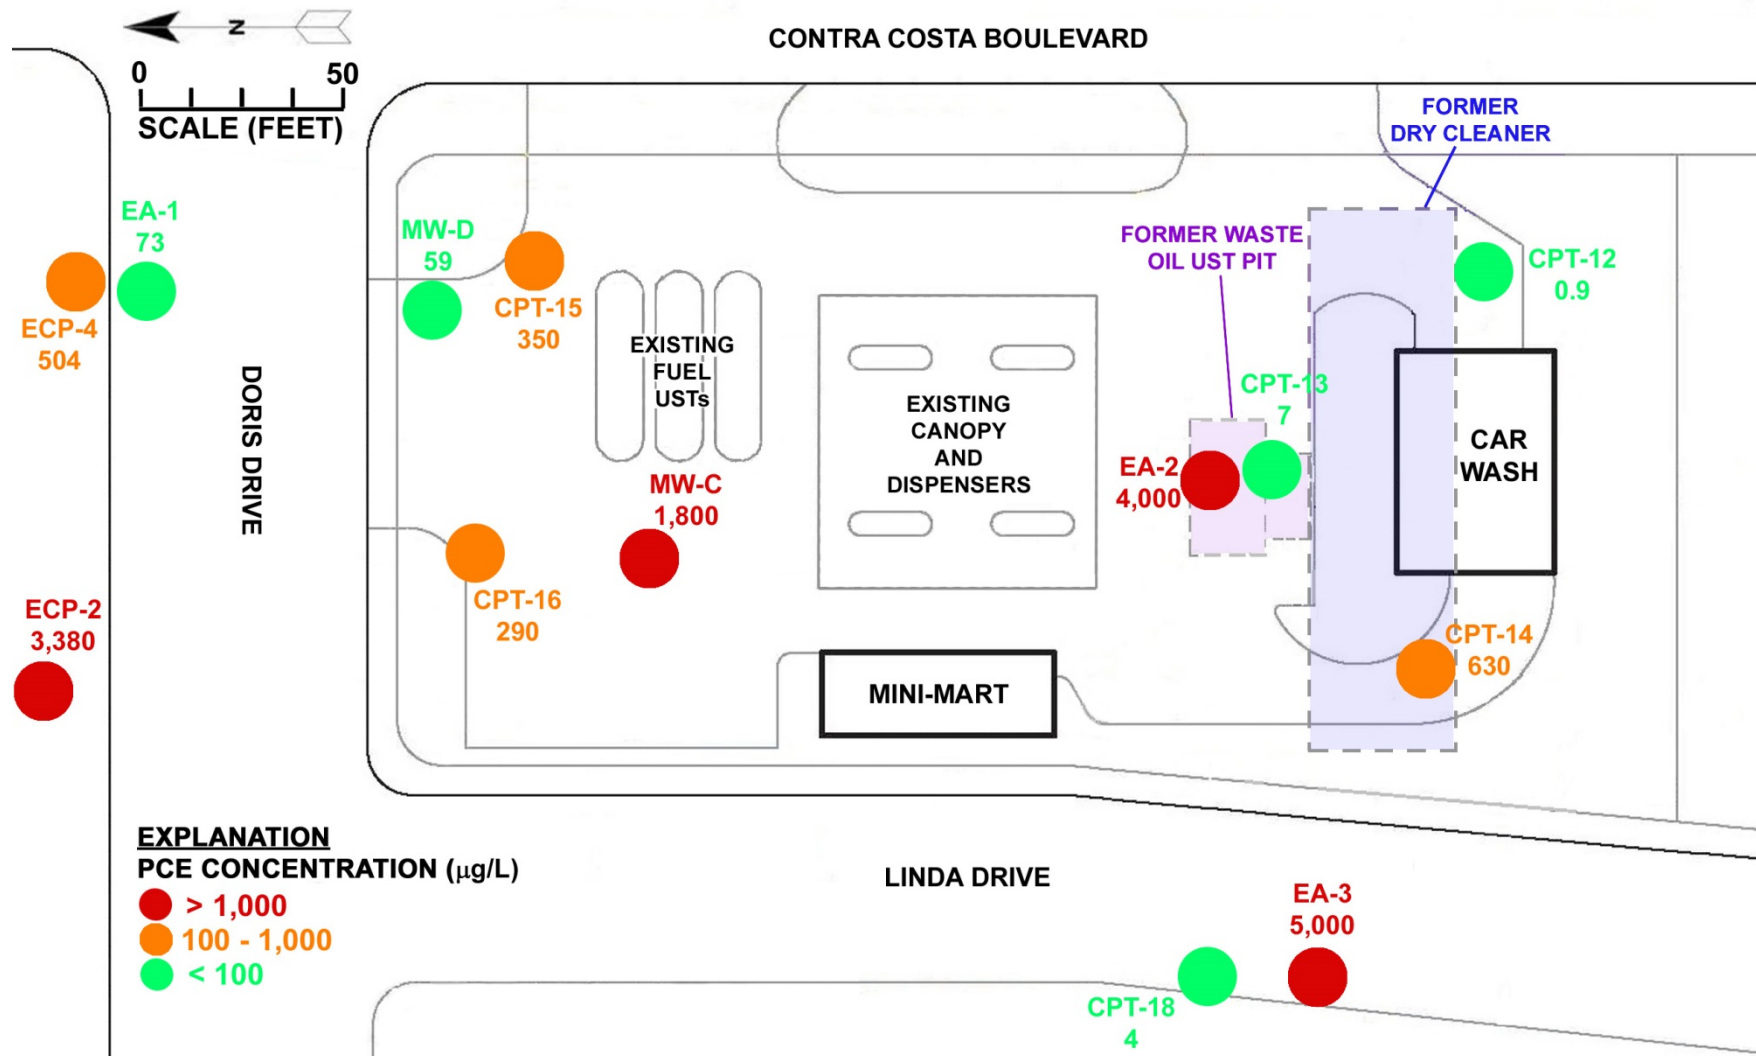
**Figure 6: Maximum PCE Concentrations in Groundwater at the 1705 Contra Costa Boulevard Property and Immediate Vicinity, Pleasant Hill, Contra Costa County**

High groundwater concentrations generally reflect a specific release point/area. Figures 6 and 9 show the maximum concentrations of PCE and TCE detected in various groundwater samples collected within and near the former steel waste oil UST.

Based on the above information and the groundwater data depicted on Figures 6 and 9, Staff conclude that a distinct CVOC release from the former steel waste oil UST occurred.

High groundwater concentrations generally reflect a specific release point/area. Figures 6 and 9 show the maximum concentrations of PCE and TCE detected in various groundwater samples collected within the former dry cleaner footprint. The maximum concentrations of PCE and TCE detected in groundwater were from samples collected and analyzed from CPT-14 were 630 µg/L and 8 µg/L, respectively.

The groundwater data depicted on Figures 6 and 9 generally indicates a separate and distinct CVOC release from the former dry cleaner on Site 2.
