Draft Memorandum

To: Orange County Coastkeeper
From: Anchor Environmental, L.L.C.
Date: April 13, 2005
Re: Review of Structural Components and Existing Conditions
Rhine Channel, Newport Beach, California

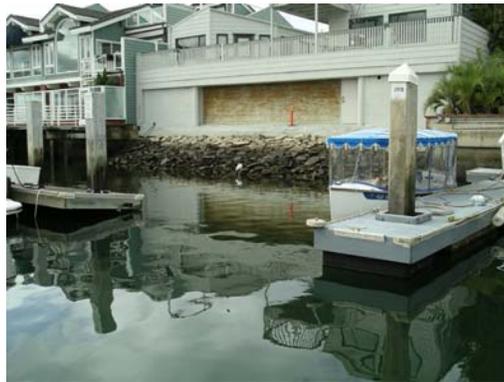
One section of the bank is armored by rip rap instead of the concrete slab. The rip rap bank is about 60 feet long and appears to be in stable condition.

Photo 4. Rip rap at station 5+75

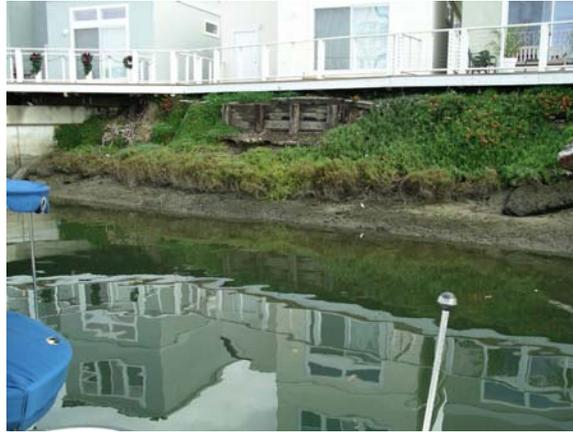
On the east side of R2 from station 4 +50 to 6+00, an area of natural slope extends into the channel (photo 5). The bank contains some concrete debris and a timber bulkhead. The timber bulkhead is supported by soldier piles on 5 foot centers with wood laggings. The slope rises above the high water mark to the underside of a wood deck in front of private residences.

Photo 5. Natural slope at station 4 + 50 of Reach 2

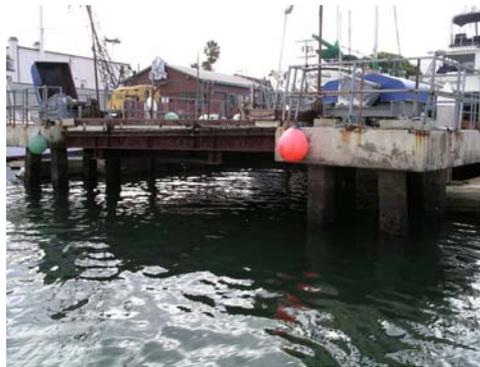
Two boat ramps are located near station 13+00 along R1. One is on the east side and one is on the west side of the channel. At station 16+00 in R1 on the west side there is a boat lift operated by a boatyard. And as depicted in photo 7, a sinker lift is located on the west side of the channel near station 18+00. The sinker lift has approximately 5 feet of clearance at mid-tide and has very little access underneath. Sonar images depict what appears to be a large debris field in the waterway near the sinker lift. Old boat parts, container doors, and perhaps a car are speculated to be in this debris field.

Photo 7. Sinker lift near station 18+00

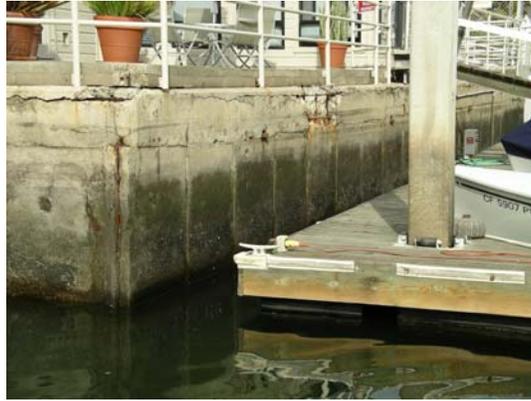
Specifically on the west side R2 near station 7+00, disintegrating concrete in the cap has exposed rebar supports (photo 8). Spalling of the concrete is also prominent.

Photo 8. Bulkhead failure at station 7+00

The bulkhead appears to be structurally sound along most of its length with some cracking and deterioration of the outer surface material evident in many areas. There are three main locations where the integrity of the bulkhead appears to be in poor condition. Of the approximately 5,000 feet of concrete bulkhead, about 390 feet appear to be failing. This represents approximately 8 percent of the total length of bulkhead along the channel. However, if material is to be dredged near the bulkhead, measures may be needed to either shore up the failing portions or reconstruct the sections entirely.

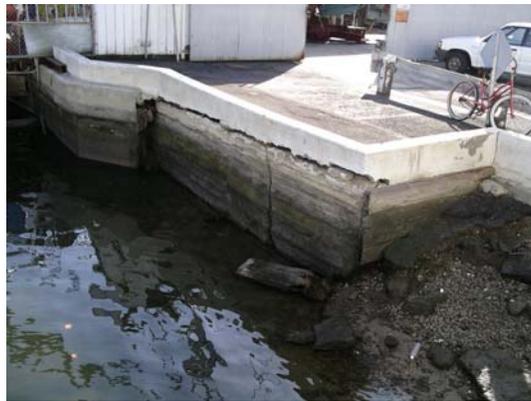
Finally, on the west side of R1 near station 11+50, the bulkhead is cracking and the cap appears to be deteriorating (photo 9).

Photo 9. Bulkhead failure at station 11+50

For the most part, the bulkhead is in stable condition and should withstand the effects of activity in the channel related to sediment remediation. About 390 feet (8 percent) of the bulkhead is in poor condition or completely failing, and would require shoring or complete replacement if work is to be conducted that would jeopardize the bulkhead integrity.

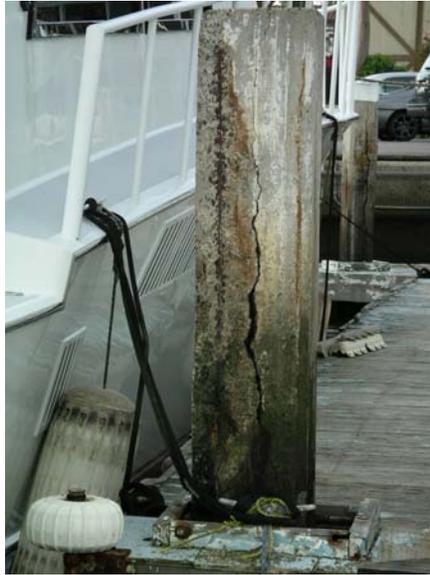
Some of the floating piling appear to be in poor shape. Any disturbance of these piling during construction will likely require full replacement of the piles. Photo 10 shows excessive cracking of the concrete on the west side of R2 from station 7+50 to 11+00.

Photo 10. Cracks in concrete piling

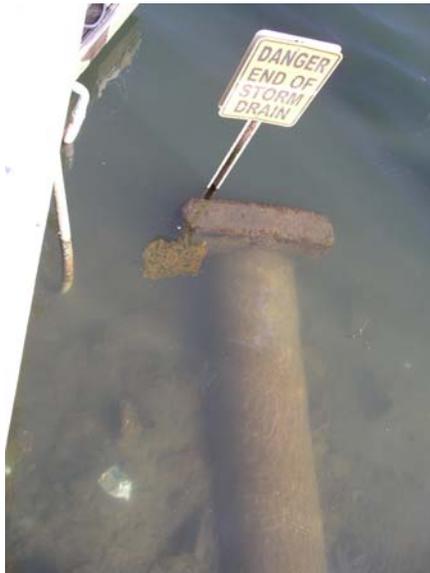
Storm drains release into the channel in various locations along the bulkhead. The stormwater is discharged directly into the channel. Photo 11 shows an exposed outfall pipe on the west side of the channel, off of 26th Street, near station 12+00.

Photo 11. Exposed storm drain

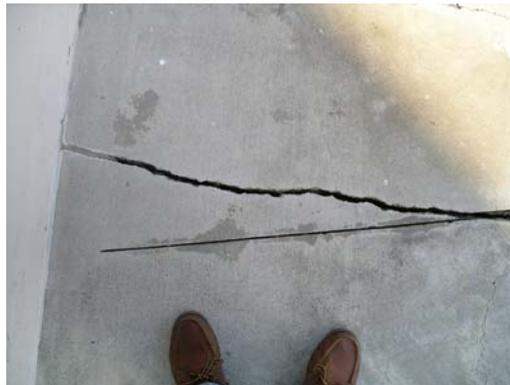
Some locations around the perimeter of the channel have superficial cracks in the apron or sidewalk above the bulkhead (Photo 12). There is also evidence of deterioration of the concrete that appears not to affect structural integrity of the bulkhead. If dredging operations and heavy machinery are working in the vicinity of these areas, attention will need to be paid to prevent worsening of the condition. In some areas, repairs or reconstruction will need to take place if significant damage is done.

Photo 12. Cracks in sidewalk

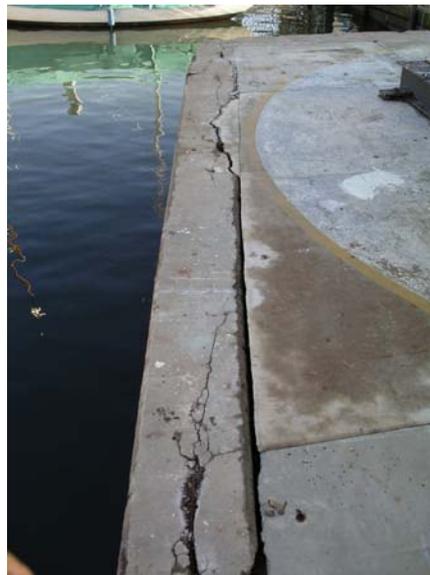
Photo 13. Cracks in apron
