INTERIM REPORT TO THE
CALIFORNIA STATE BOARD OF FORESTRY
AND FIRE PROTECTION

**HILLSLOPE MONITORING
PROGRAM:**

***MONITORING RESULTS
FROM
1996 THROUGH 1998***

JUNE 1999
SACRAMENTO, CALIFORNIA

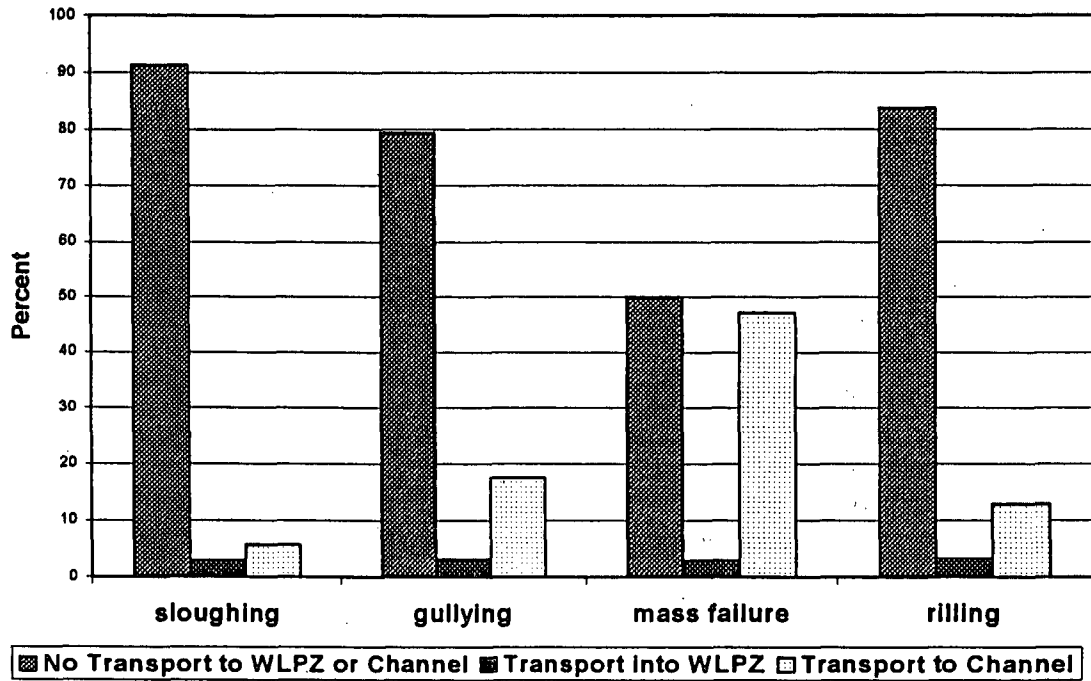
The location of sediment deposition resulting from these various types of erosion features is of critical concern when addressing protection of beneficial uses of water. Figure 3 displays the sediment deposition categories for the various types of erosion features previously described above. Only 6% of the sloughing features were found to have transported sediment to the channel; another 3% had material transported into the WLPZ. For gullying, about 18% of features had sediment transported into the channel, with another 3% deposited in the WLPZ. Mass wasting resulted in sediment transported into the channel 47% of the time, and material entering the WLPZ an additional 3% of the time. Finally, rilling features had sediment deposited in channels 13% of the time, with an additional 3% deposited in the WLPZ.

Figure 4. Sediment deposition sites for erosion features produced from current THPs and associated with road transects (percent of the number of occurrences for each feature type).

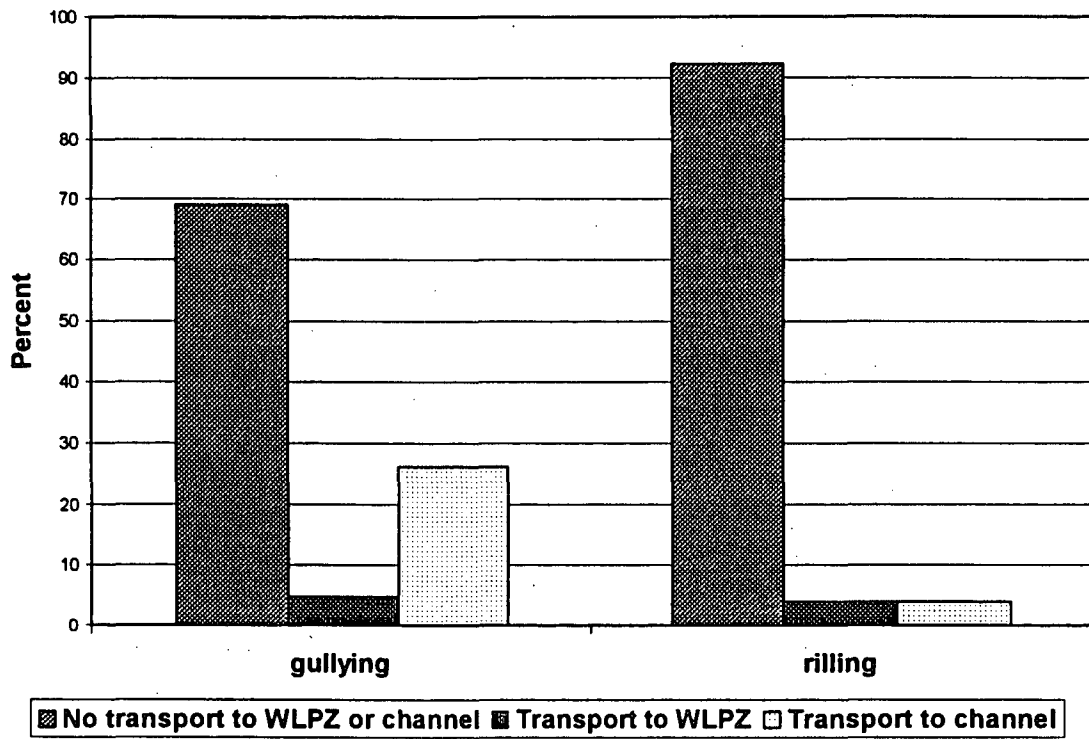
Figure 4 shows the frequency of sediment deposition sites for rilling and gullying. Sloughing and mass failures are not included because of the small number of occurrences. Approximately 4% of the rills deposited sediment into watercourses; another 4% deposited material into the WLPZ.¹¹ For gullying, 26% deposited material into channels, with another 5% depositing material into the WLPZ.

Figure 5. Sediment deposition sites for rilling and gullyng produced from current THPs and associated with skid trail transects.

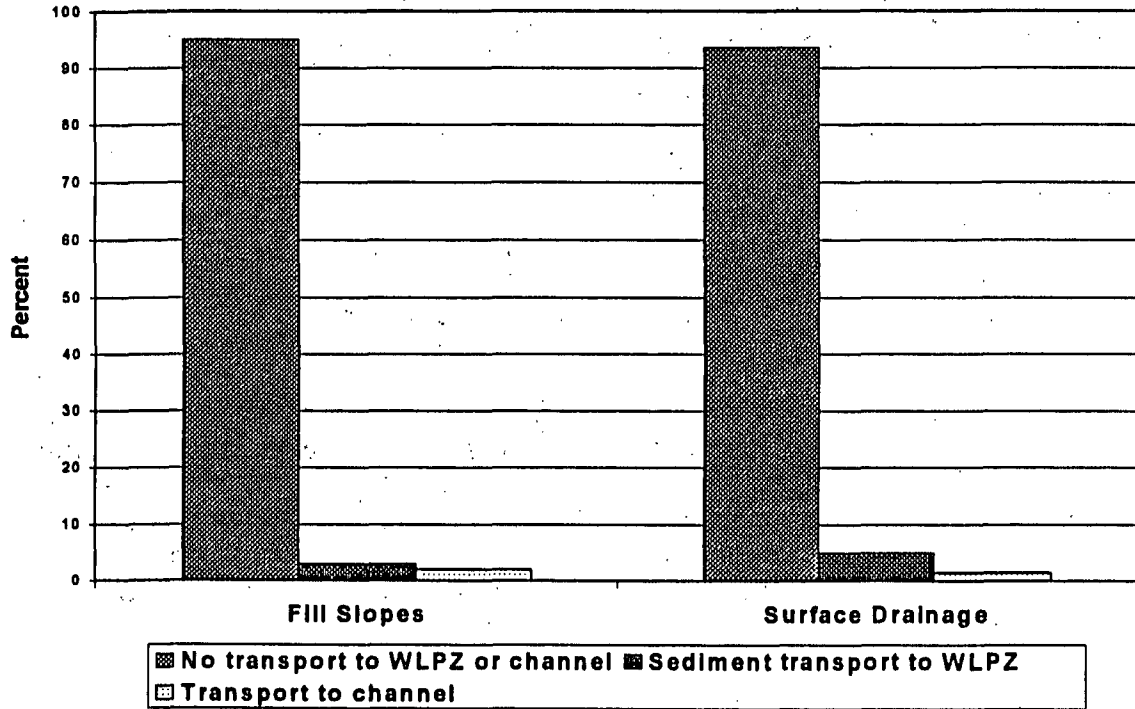
The location of sediment deposition originating from landing surfaces and fill slopes was also evaluated (Figure 5). For fill slopes, 2% of the time material entered channels, with another 3% reaching the WLPZ. Similarly for surface drainage, 1.5% reached channels, with another 5% reaching the WLPZ.

Figure 6. Sediment deposition sites associated with landing fill slopes and surface drainage.

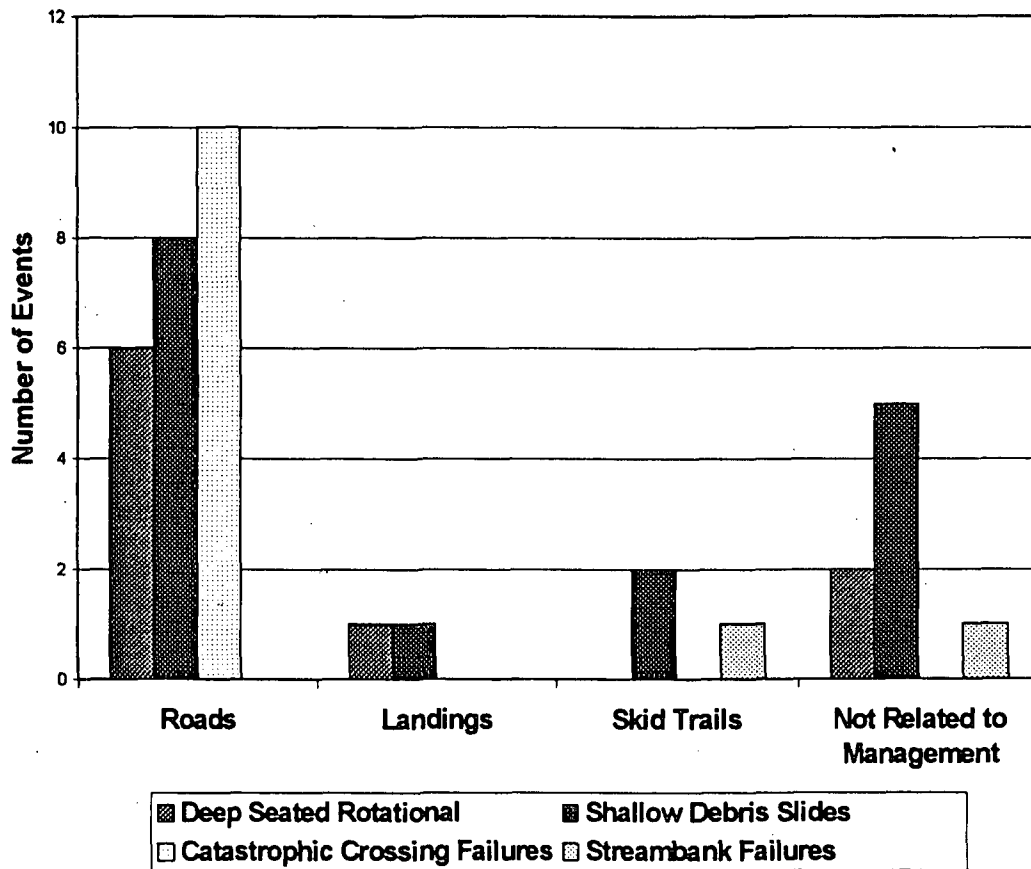
Figure 7. Causes of large erosion events and type of feature.
