REDWOOD NATIONAL PARK REHABILITATION STUDY

(Test Area 1 and 2)

REHABILITATION METHODS AND COST ANALYSIS

November 1977

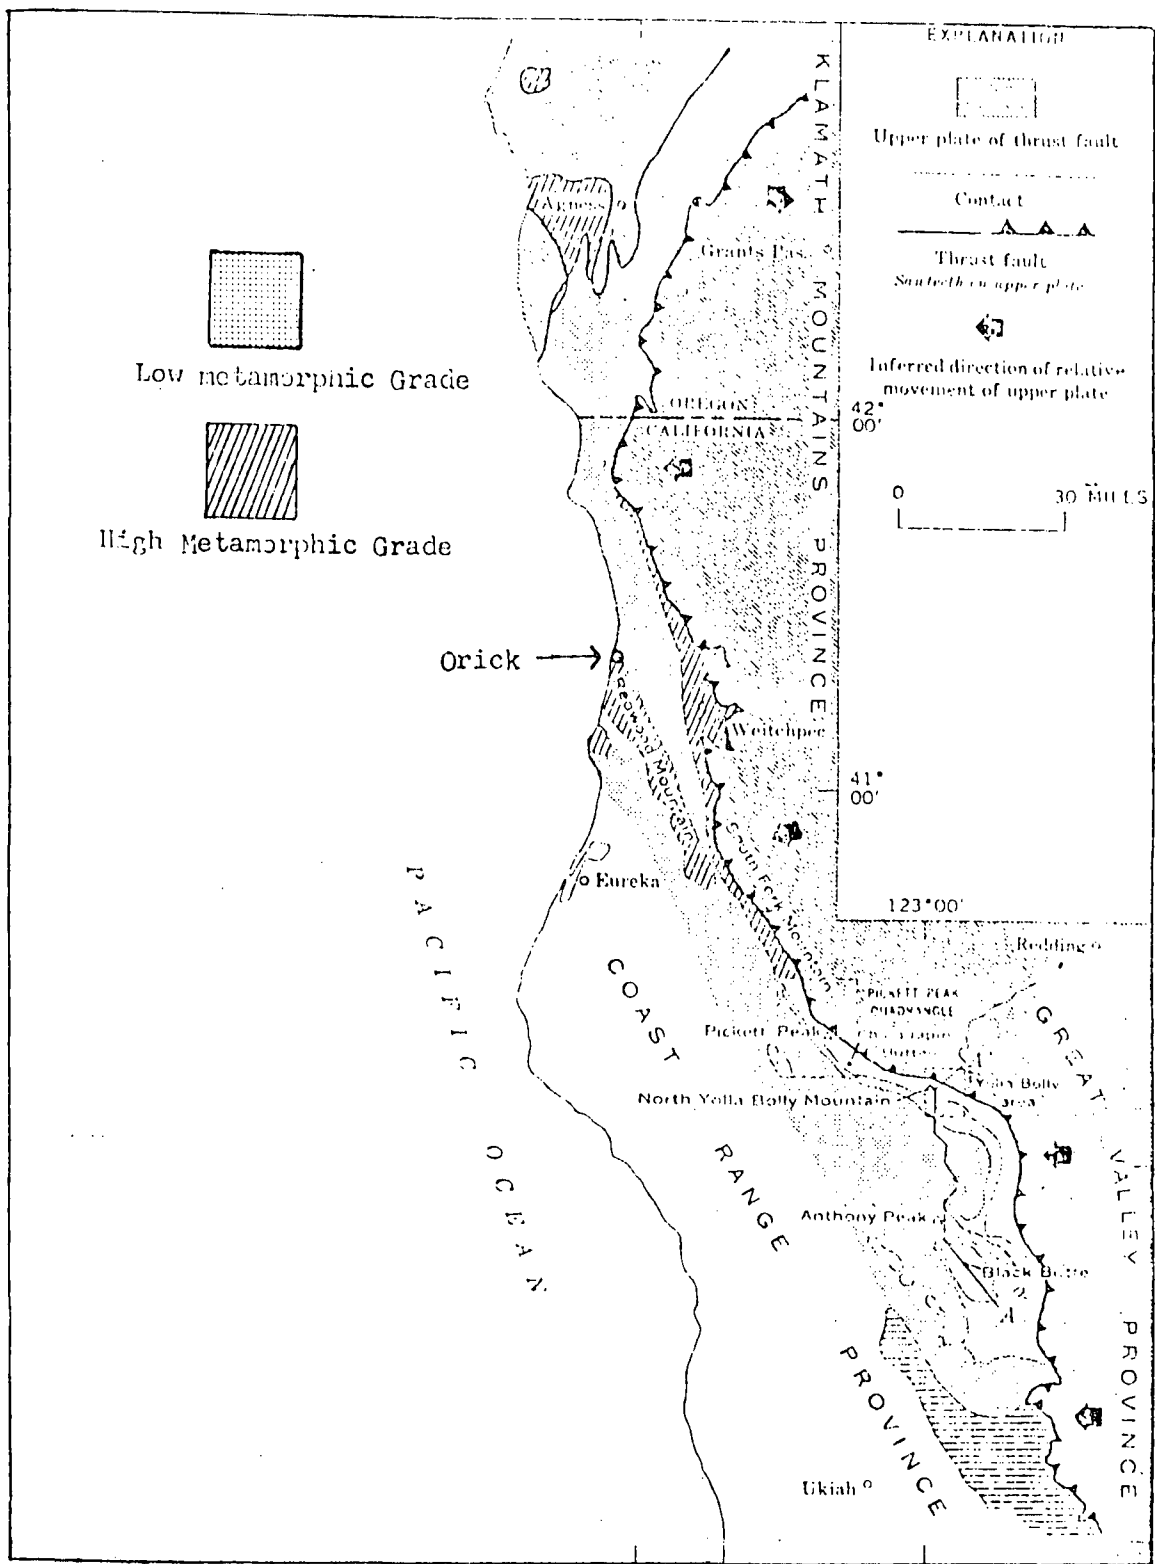
Figure 8. Map showing location of geologic provinces and trends in the degree of rock metamorphism (modified after Blake and others, 1967).

scale thrust faulting (Figure 8). A predictable succession of general rock characteristics is associated with this faulting. Approaching the fault from the west an increase in metamorphic grade occurs, with rock types going from unmetamorphosed (or slightly metamorphosed) grey sandstone and shale, to highly metamorphosed quartz mica schist<sup>1</sup>. Rock mineralogies change in response to the eastward increase in metamorphism. Rock competency characteristics are often controlled by rock mineralogy (schistose and micaceous rocks generally are less competent than only slightly metamorphosed sandstone). Incompetent rocks should be, and are, found proximal to the fault.

Locally (Redwood Creek, Orick, and surrounding areas), the same general pattern exists. This is complicated slightly by the presence of high grade metamorphic rocks in the Redwood Mountain area (Figure 8). This region (metamorphic outlier<sup>1</sup>) is composed of rock types which typically are found near the Klamath/Coast Range Province boundary thrust fault. This outlier is of particular interest since land, currently being negotiated to be incorporated into Redwood National Park, is located within its boundaries. Particular problems (slumping and landsliding) associated with the lack of rock competency can be expected to occur in this area. Studies by Nolan and others (1976) support this conclusion.
