File: HUMBOLDT COUNTY 1973

BRIDGE REPORT

REDWOOD CREEK
Humboldt Co. Road 6L200
(Chezem Road)

Bridge No. 4C-121
Post Mile 1.49

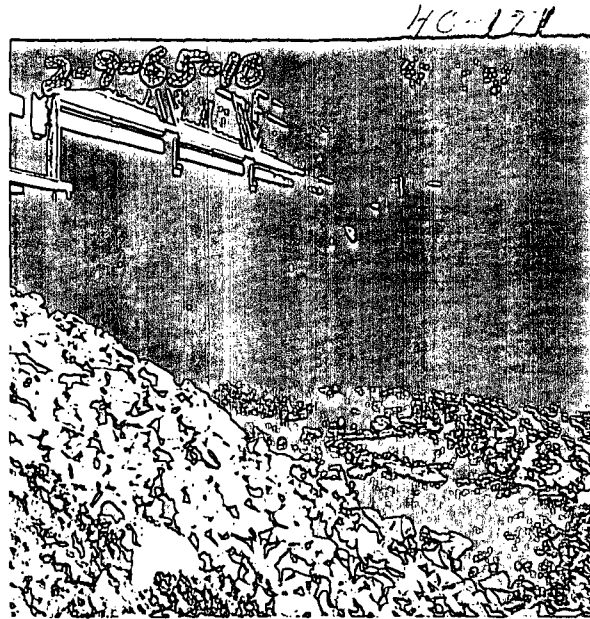
Looking across creek @ bank protection around abutment-2

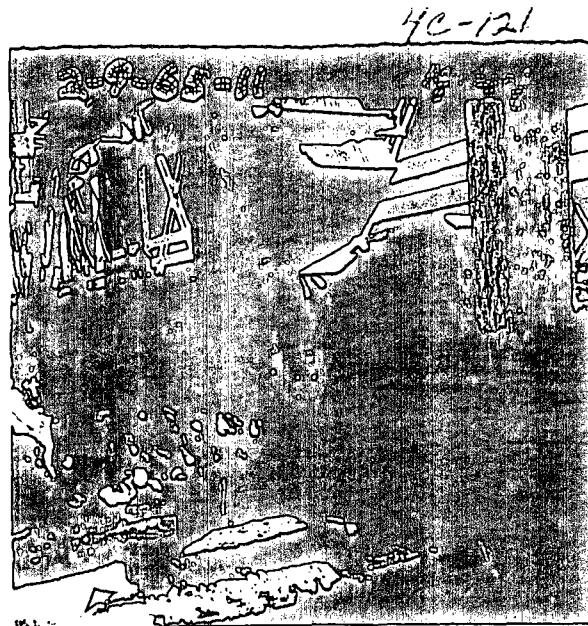
Repaired bearing assembly for left truss @ abutment-1

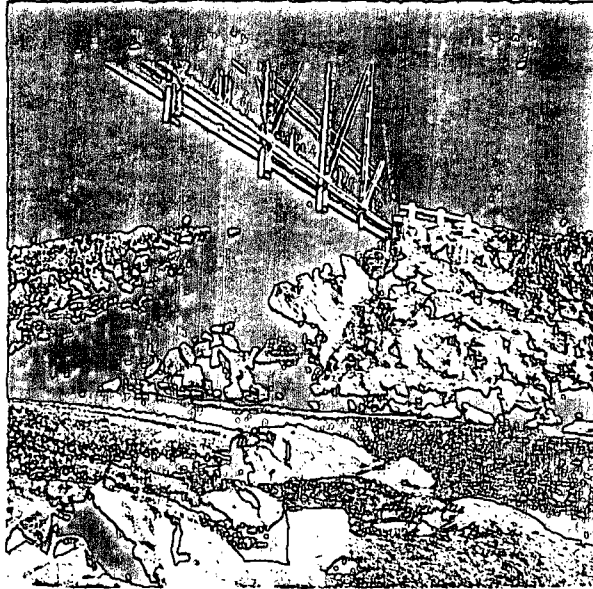
Abutment 2 -Note riprap

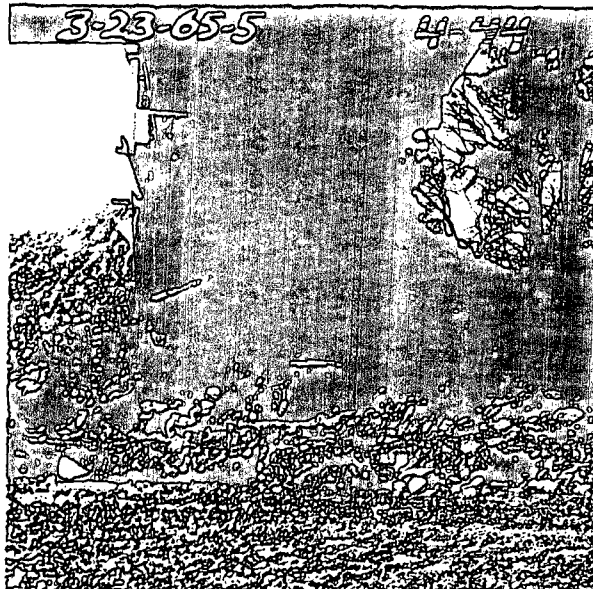
Abutment 1-Note new embankment
with no bank protection

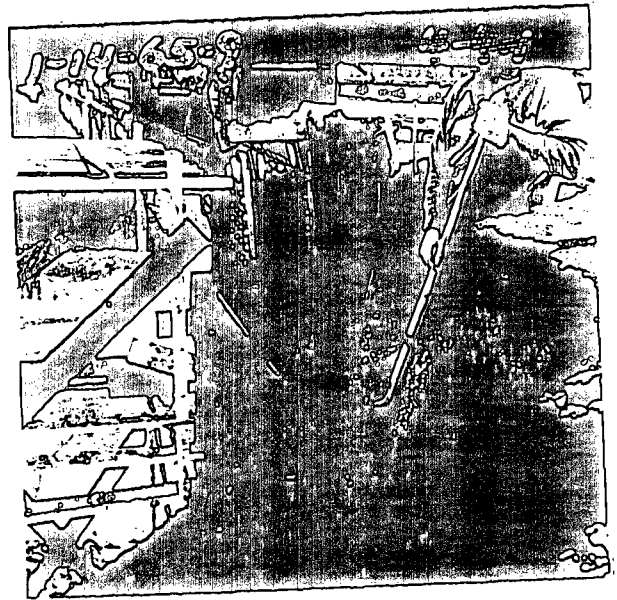
Partial dig out below truss shoe.
Removed concrete taken out by
bare hands.

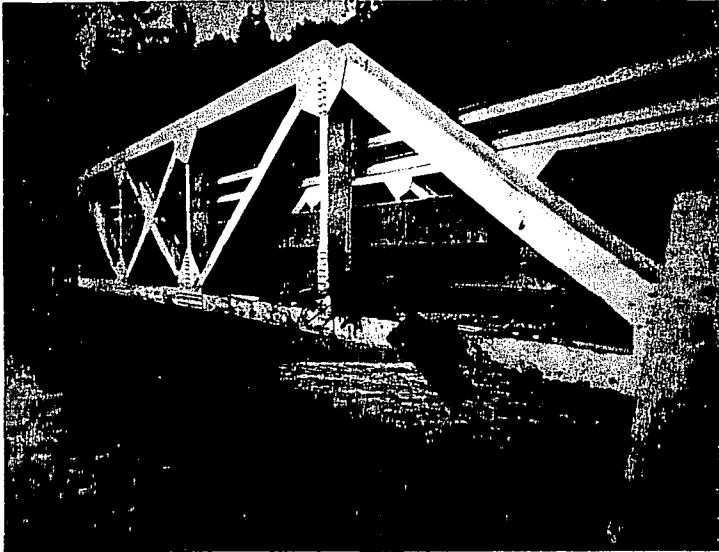
US side.
Note drift on
truss, and
bends in truss
lower chord.

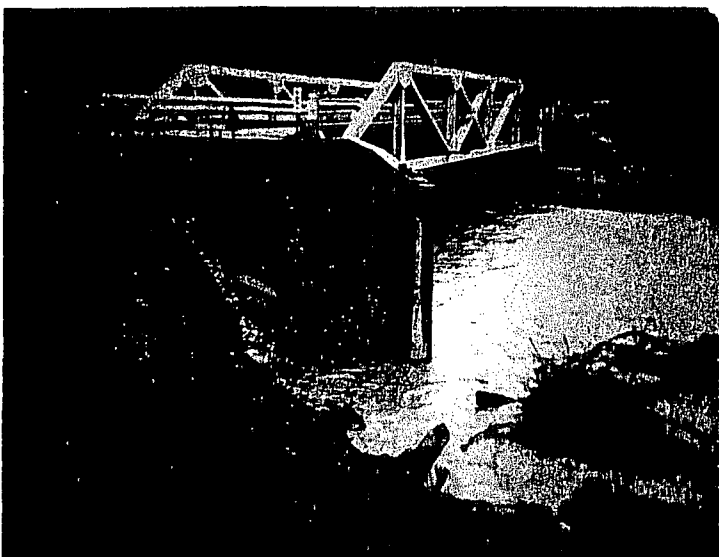
DS side.
Note drift at
lower chord
in truss.
Also note embank-
ment erosion
and displaced
rock riprap.
