Elk County Water District  
P.O. Box 54  
Elk, California 95432  
Charles Acker, Manager  
Phone: 707-877-3474  
Fax: 707-877-1833  
[cacker@mcn.org](mailto:cacker@mcn.org)

re: Water Quality Information  
Greenwood Creek

**Subject: 1998 "El Nino" Storm Damage  
B&R File No. 2189**

### THE EFFECT OF FLOODING ON ECWD WELLS

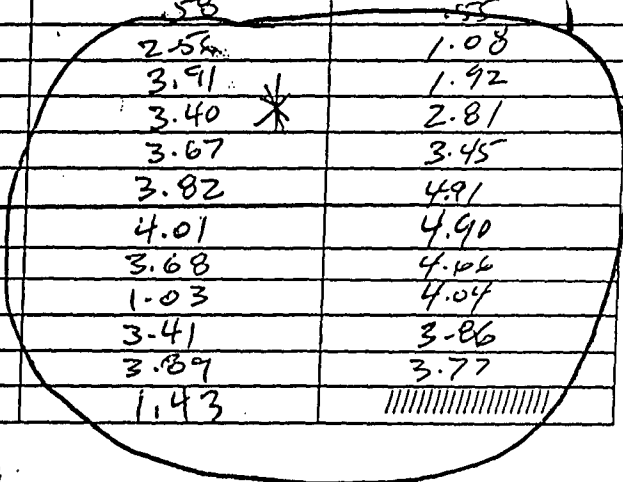
Elevated turbidity levels

Incidents of turbidity greater than 1.0 NTU: YES! * DAS NOTIFIED 3/24			
Martin Ross notified @ DAS		Boil Order out 3/25	
Date of Incident	3/22	→	3/31
Value	2.56	→	3.41
Duration	10 DAYS IN MARCH continued into April
