STATUS OF THE EMERALD CREEK LANDSLIDE, REDWOOD NATIONAL PARK

E.M. Babcock, R.G. LaHusen, R.D. Klein, and D.K. Hagans

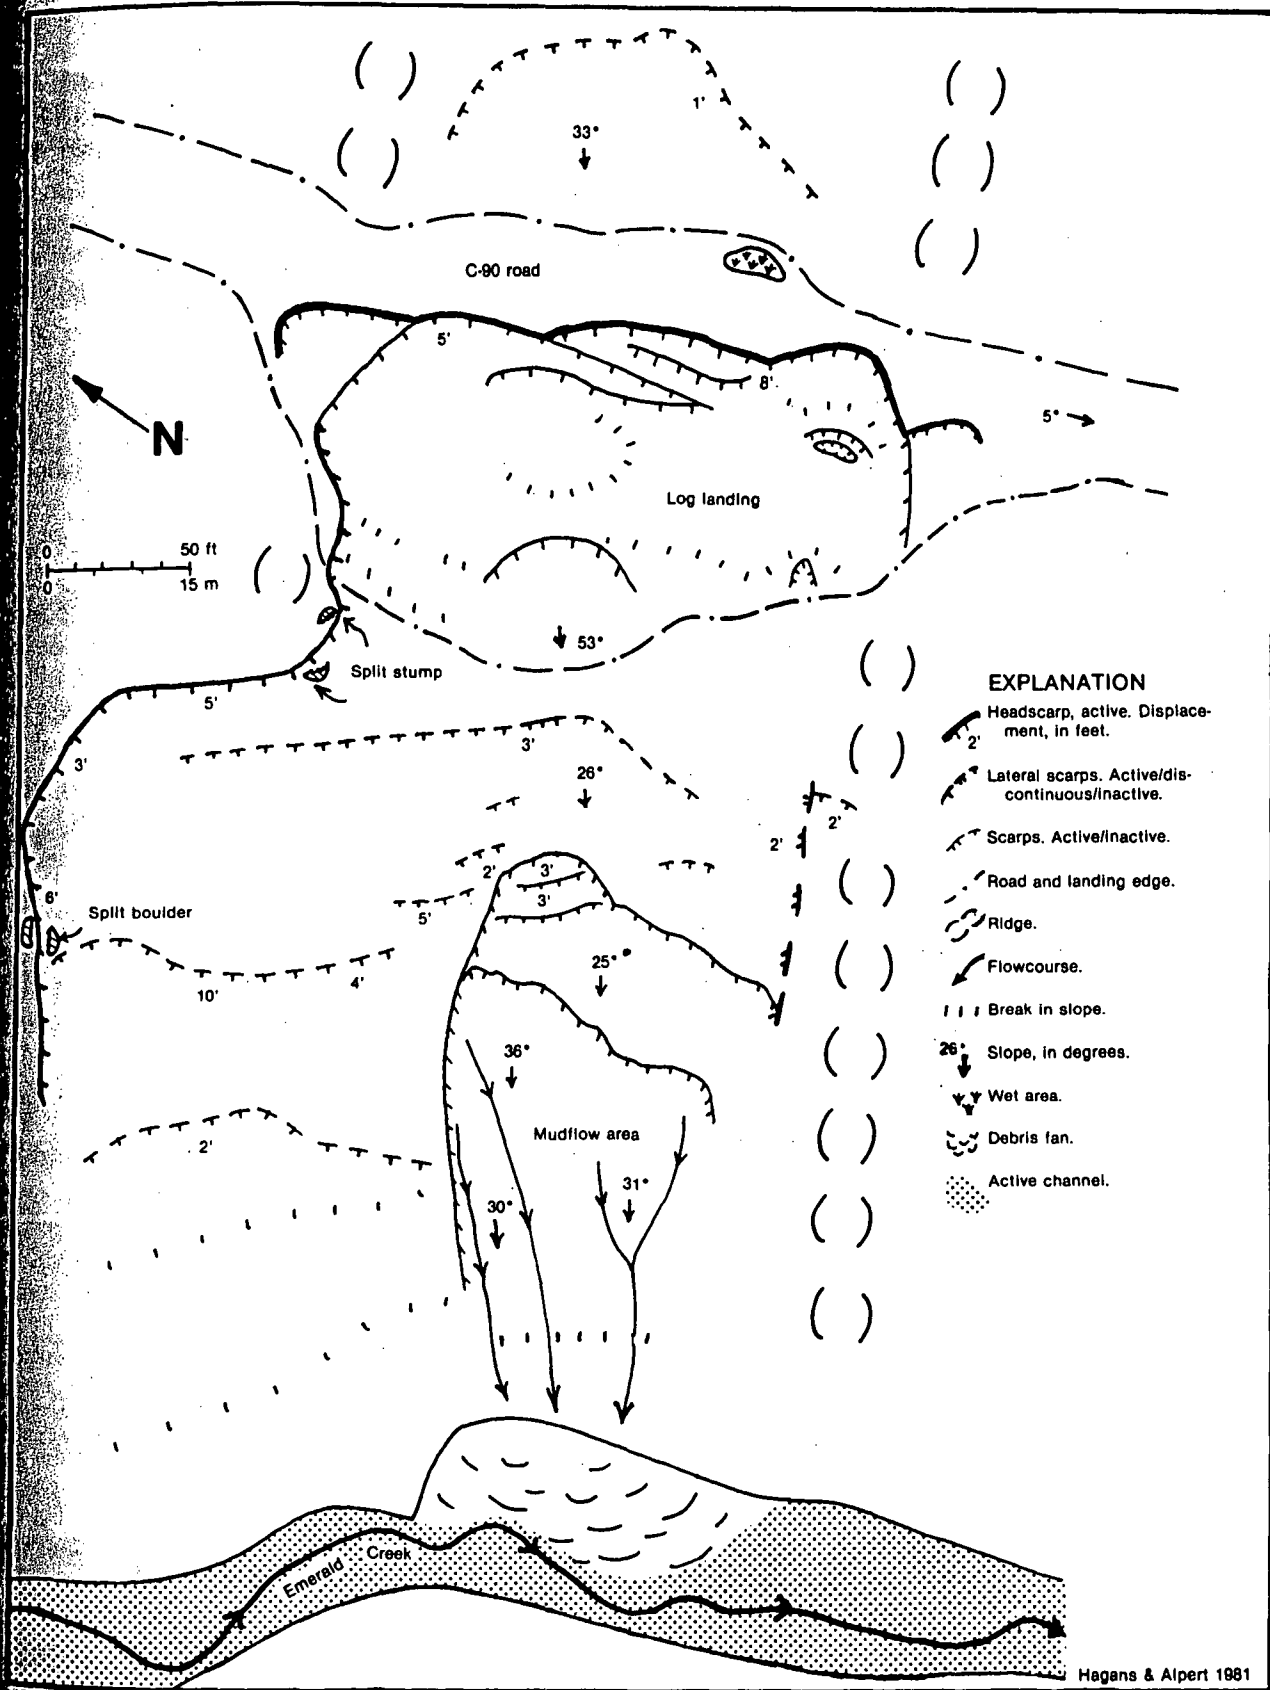
Figure 2

By 1981 (Fig. 2) the headscarp was 5 to 8 ft high, and the landing edge had dropped a total of 17 ft since construction. Downslope of the road several old growth redwoods had fallen and the soil mantle was further destabilized by root upheaval. The north lateral scarp was continuous with the headscarp and showed evidence of recent activity. From the headscarp down to the 100-ft-wide mudflow, the south lateral scarp was discontinuous and defined by enechelon ground tears. From the top of the mudflow the creek, the south margin was a well-defined 3-ft lateral scarp.

Plan Map Before Treatment, Summer 1981, Emerald Creek Landslide, R.N.P.

The depth of failure appears to be shallower than previous interpretation suggested. Evidence is not clear whether a deep-seated slip surface ever existed (Fig. 3) or what its downslope extent may be. If it is present, the lack of measurable movement on the mudflow and old headscarp system (Fig. 2) show it was inactive in 1981-82. The shallow failures observed possibly could represent the adjustment of surface blocks on a deeper failure. Evidence of a shallow slip surface include the initiation of movement early in the wet season, the observed depth of the bent piezometers, and the observed translational gliding of blocks which Fig. 9 also illustrates. The toe of this failure plane is probably at the break in slope at the top of the mudflow.

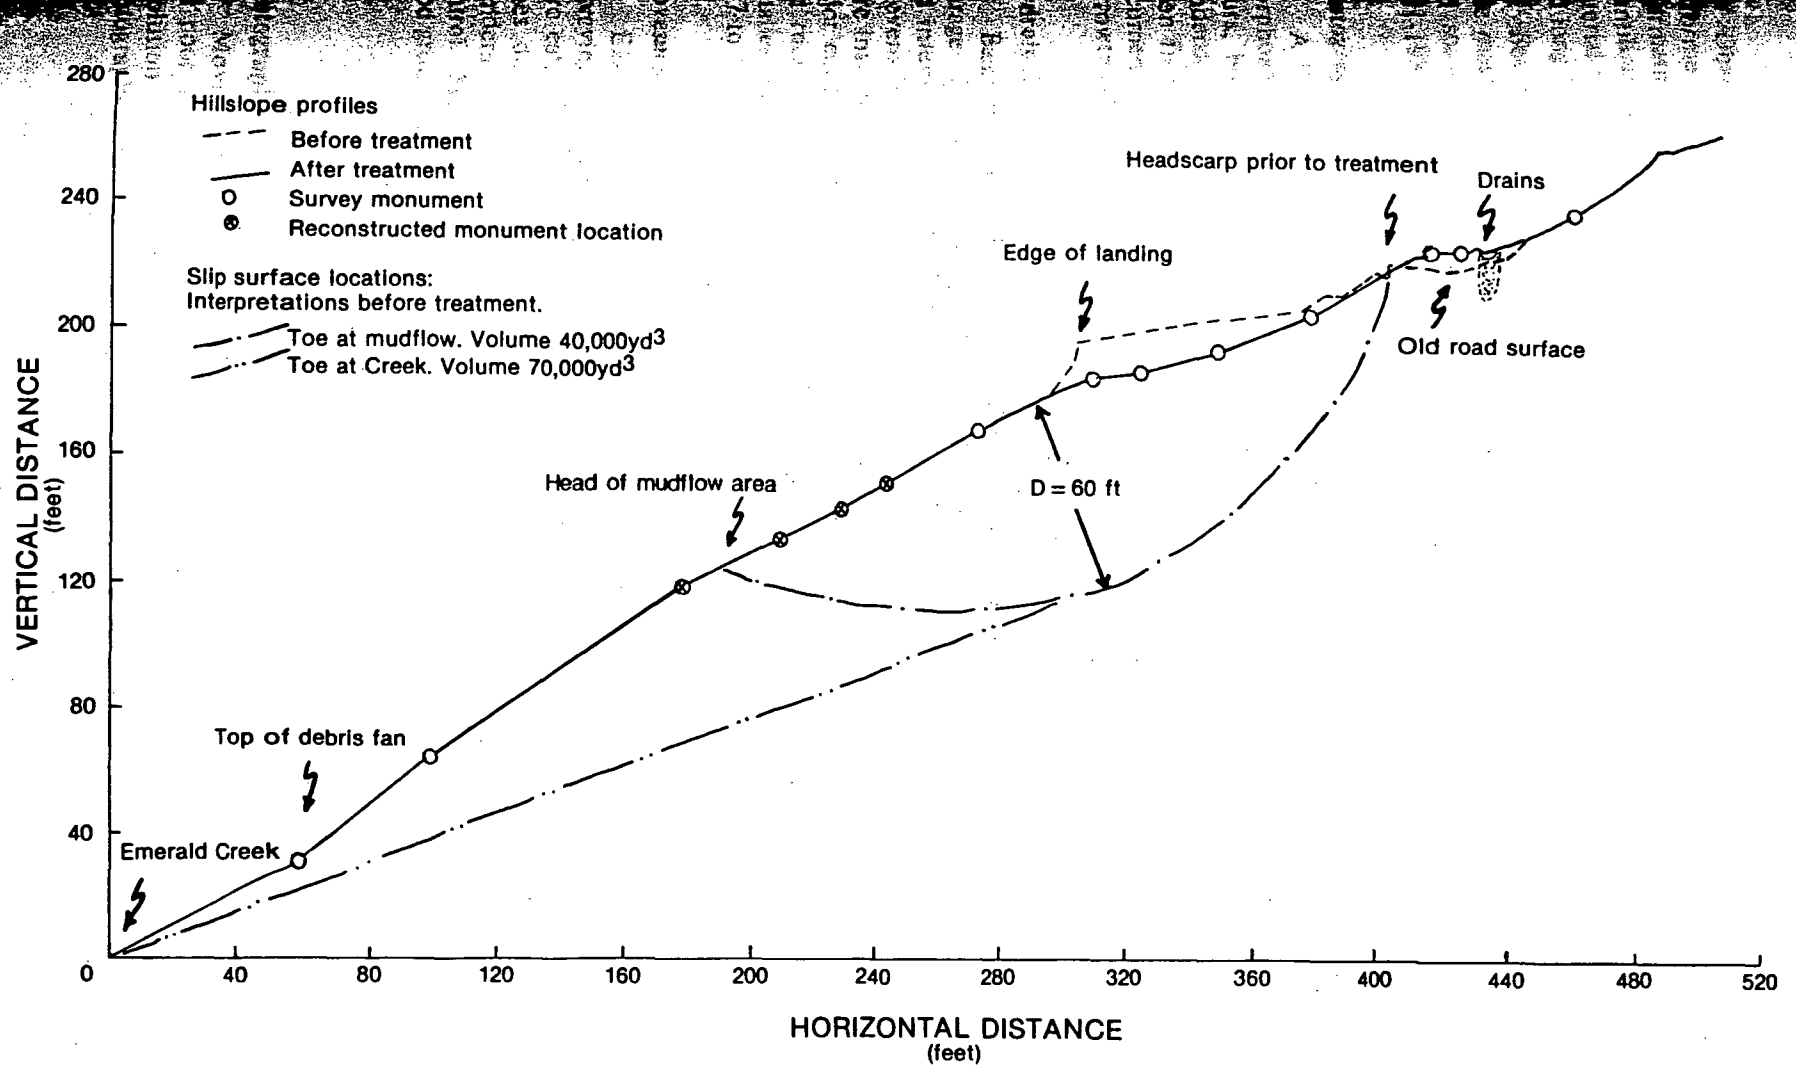
Figure 3

Treatment was desirable as both a corrective and preventive measure. In order to reduce the weight of the hillslope, the largest possible volume of landing material was removed while keeping within monetary and time limits. Fig. 3 shows the hillslope profile before and after the excavation of 7,000 yd³ (between 1/10 and 1/6 of the total landslide volume).

Profile Before and After Treatment, Summer 1981, Emerald Creek Landslide, R.N.P.

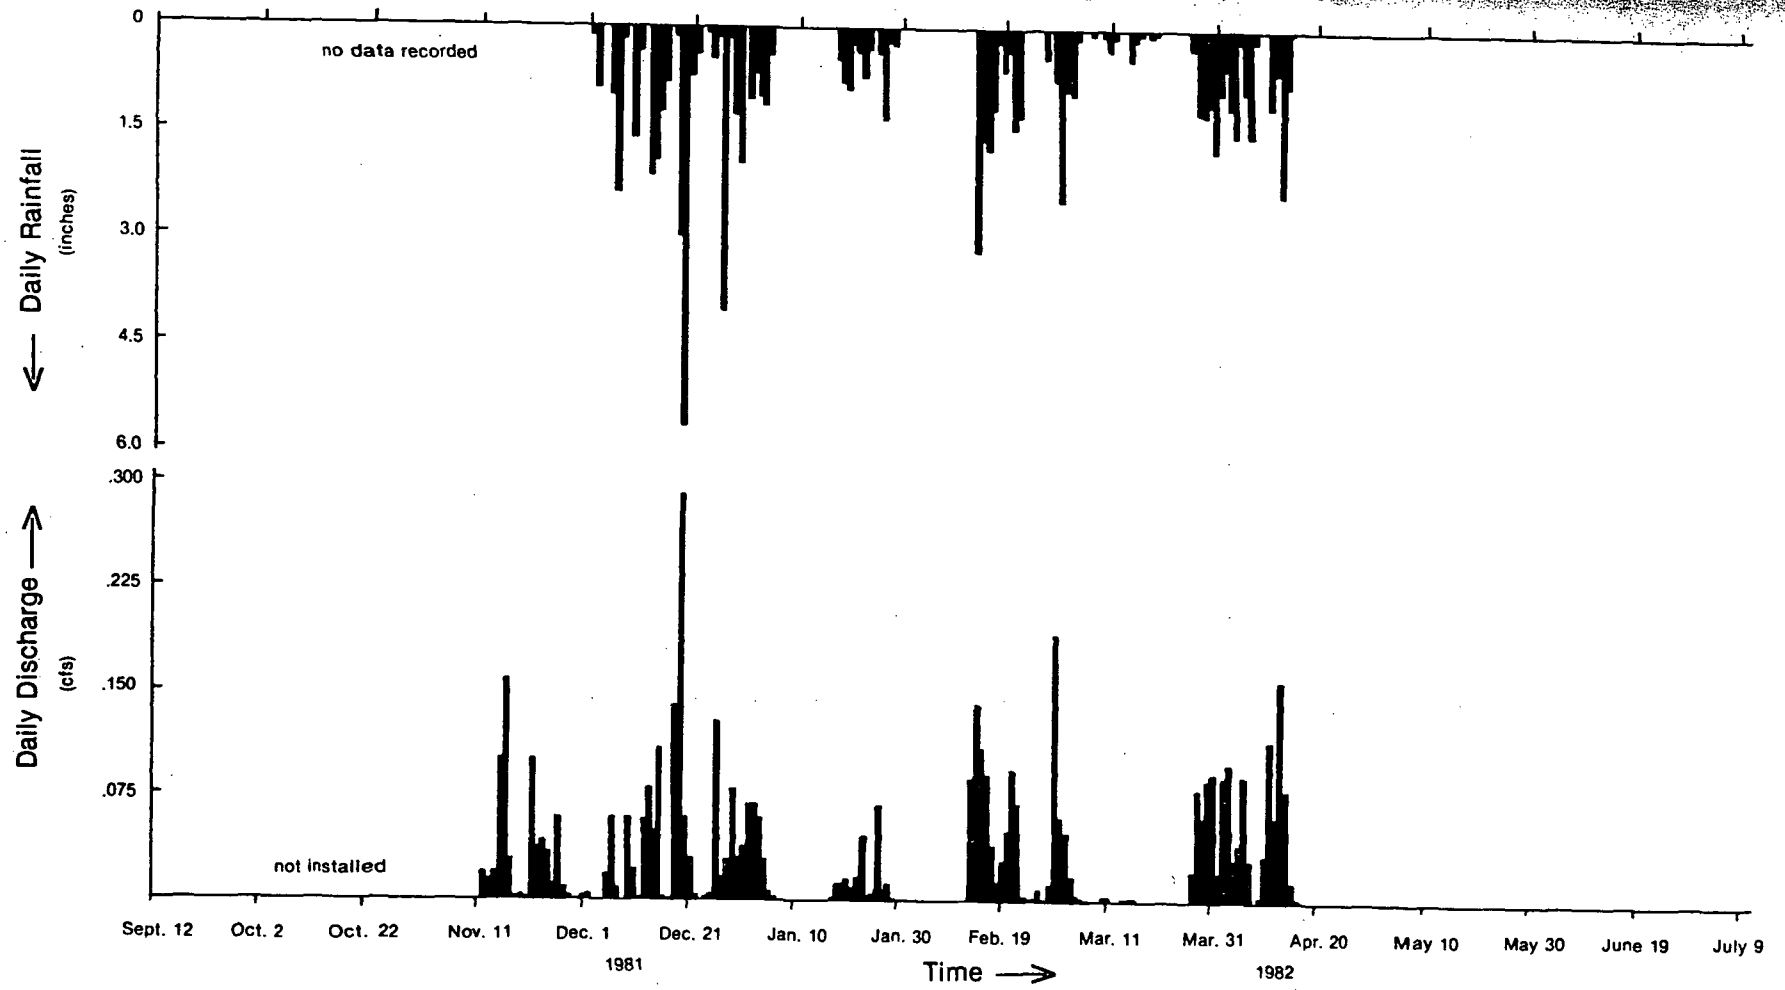
Figure 4

Total rainfall of 1982 was 105 in, whereas the average rainfall for the basin was 80 in (Janda et al. 1975). Daily totals, periodic totals, and daily cumulative totals of rainfall are plotted in Fig. 4, 5, and 10, respectively. The greatest 24-hr storm total was 5.7 in or .24 in/hr on 19 December (Fig. 4). That storm lasted 80 hrs at an average intensity of 0.12 in/hr. Fig. 10 shows rainfall was distributed in three distinct periods: 11 November 1981 to 4 January 1982, it rained nearly constantly, averaging 0.91 in/day; 4 January to 13 April, a longer period with the same amount of rain but with three dry periods of two to three weeks in length, averaged 0.44 in/day; and 14 April to 26 August no significant rain fell.

Daily Rainfall Totals and Average Daily Discharge of Surface Water Drain
During Winter 1981-82, Emerald Creek Landslide, R.N.P.

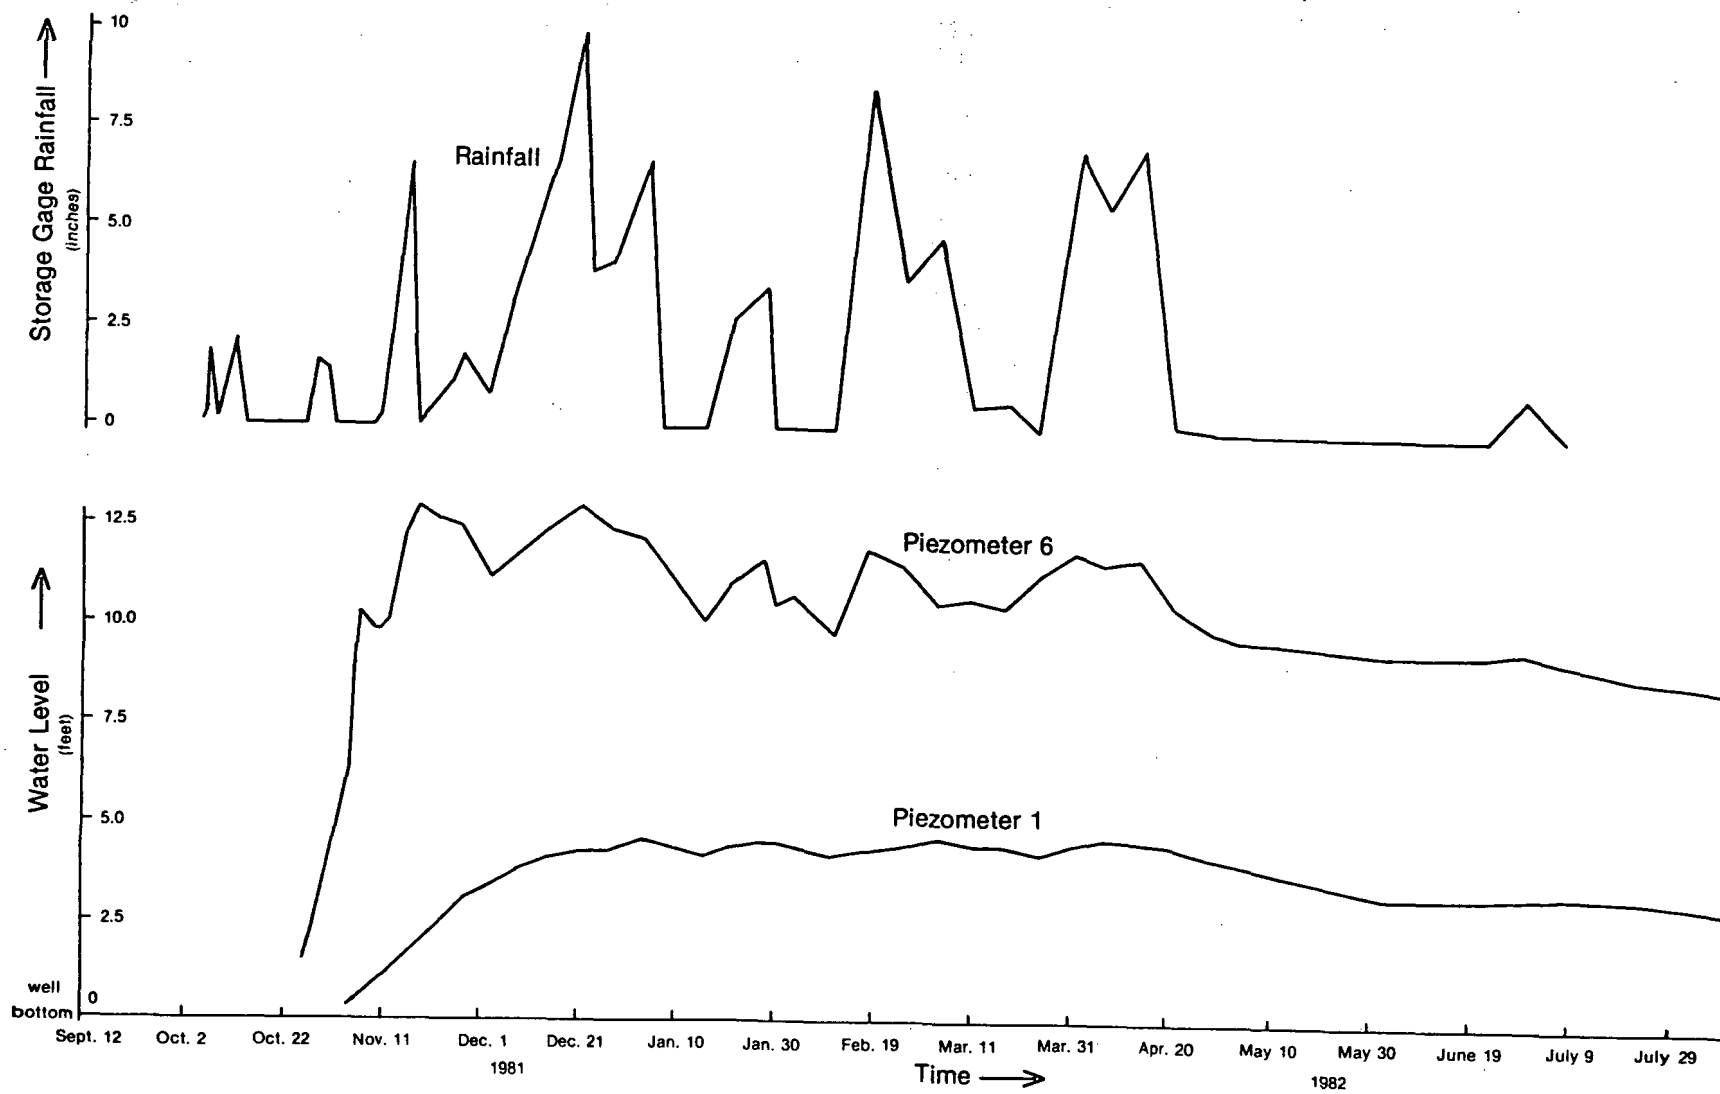
Many peak water levels in the piezometers were missed due to the periodic measurements (Fig. 4, 5). Continuous data would have allowed some correlation with rainfall and mass movement rates. Most piezometers were dry except during periods of high rainfall. Only two showed measurable water throughout the winter. P-6, located in a wet clayey area on the excavated landing area (Fig. 6), was artesian with water levels 2 - 4 ft above ground most of the winter and responded strongly to rainfall (Fig. 5). P-1 is in a clayey seep on the road cut bank 50 ft higher in elevation than P-6 (Fig. 6), and responded more to the overall wet season than specific storms. P-1 may tap an unconfined aquifer and reflect the groundwater table, whereas P-6 is in a confined aquifer which is probably a perched water zone.

Figure 5
 Periodic Measurements of Rainfall and Water Levels During Winter 1981-1982,
 Emerald Creek Landslide, R.N.P.

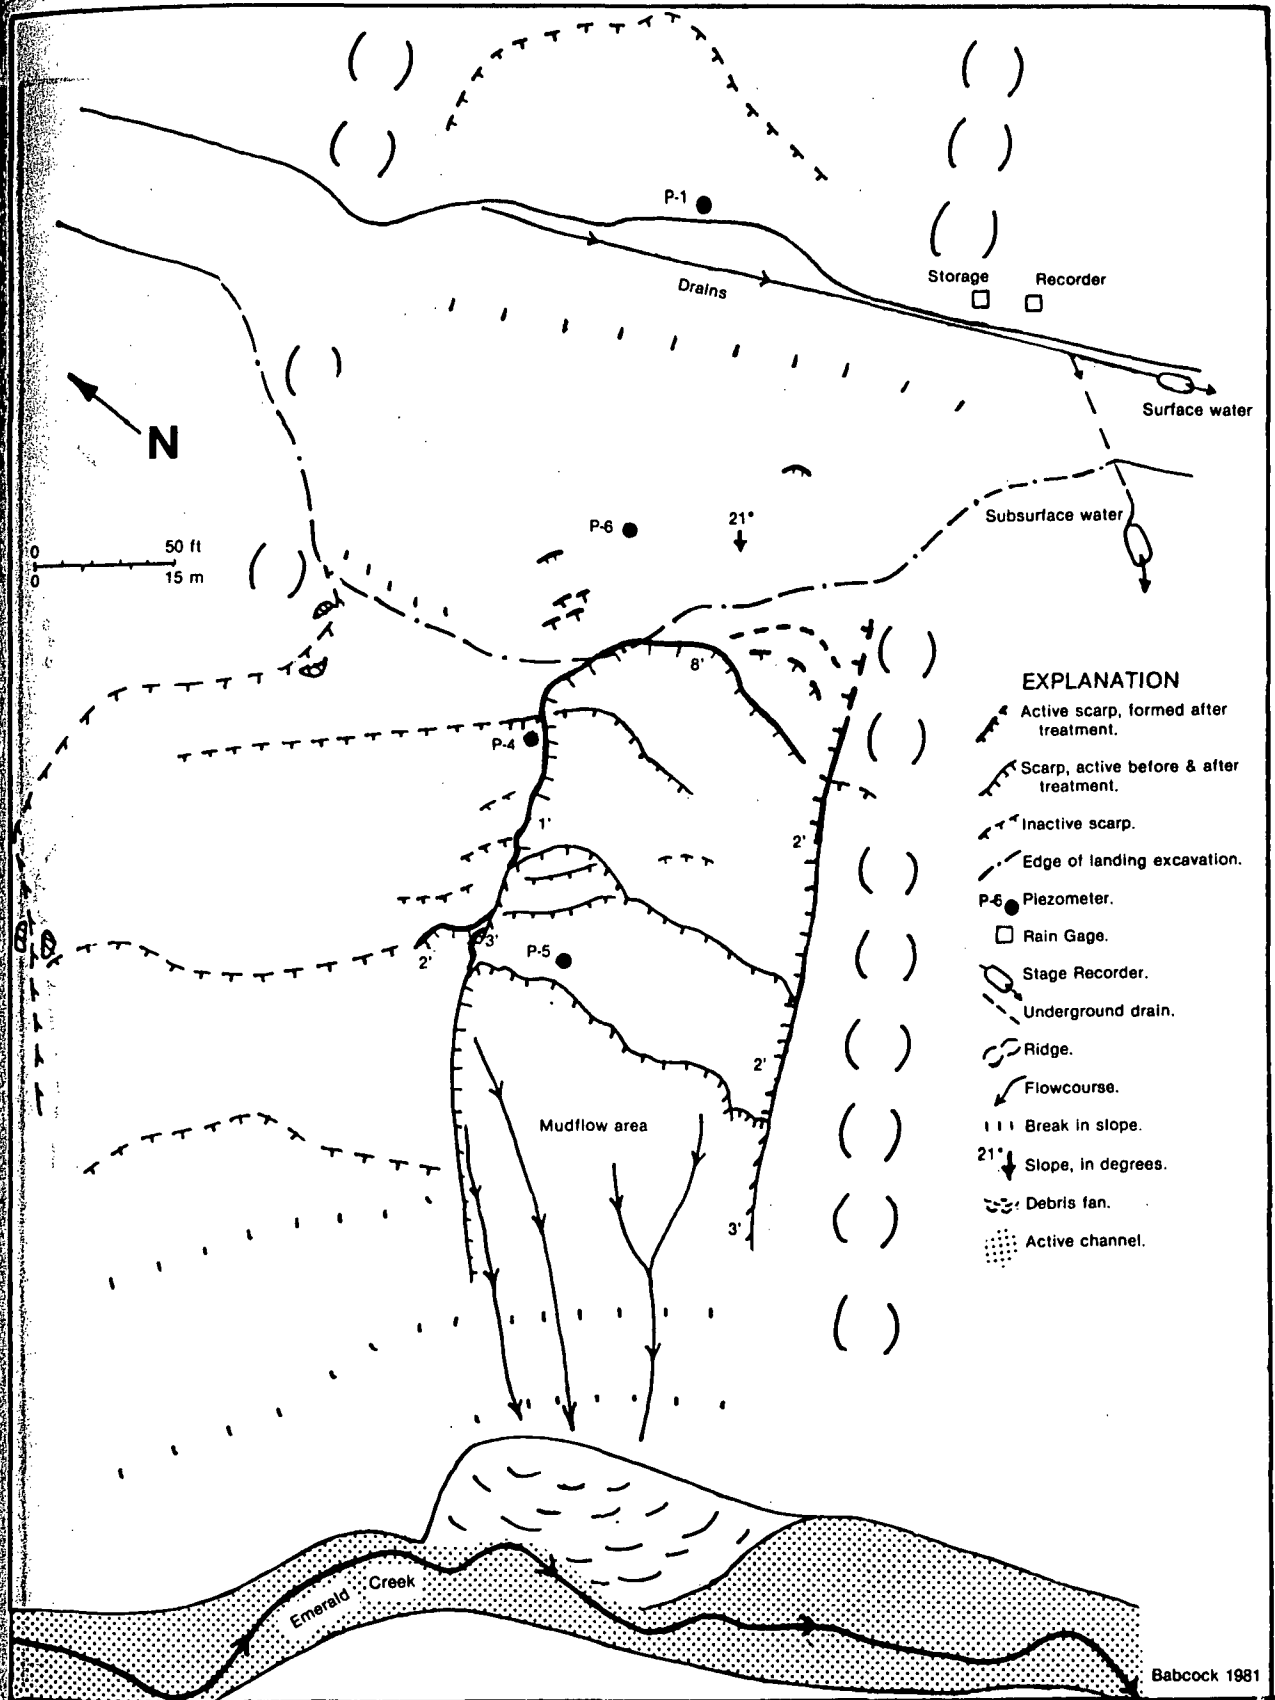
Figure 6

Two piezometers acted inadvertently as inclinometers. On 12 November, after 12.9 in of rain to date, the 717.7-ft deep hole of P-5 (Fig. 6) was pinched at 12 ft deep. Four days later it was 6 ft deep. At this time an 8 to 10 ft headscarp formed at the edge of the excavated area, downhill of the original headscarp and uphill of the "inclinometers" (Fig. 6). The south lateral scarp had extended uphill to the new headscarp. By 16 December, after 27.6 of rain, P-4, the 15-ft deep piezometer 77 ft uphill of P-5 (Fig. 6), was pinched at 6 ft deep.

**Plan Map Showing Change of Scarps, November 1981, Emerald Creek Landslide, R.N.P.
Rain-to-date 22 in. Average Movement 3.5 ft.**

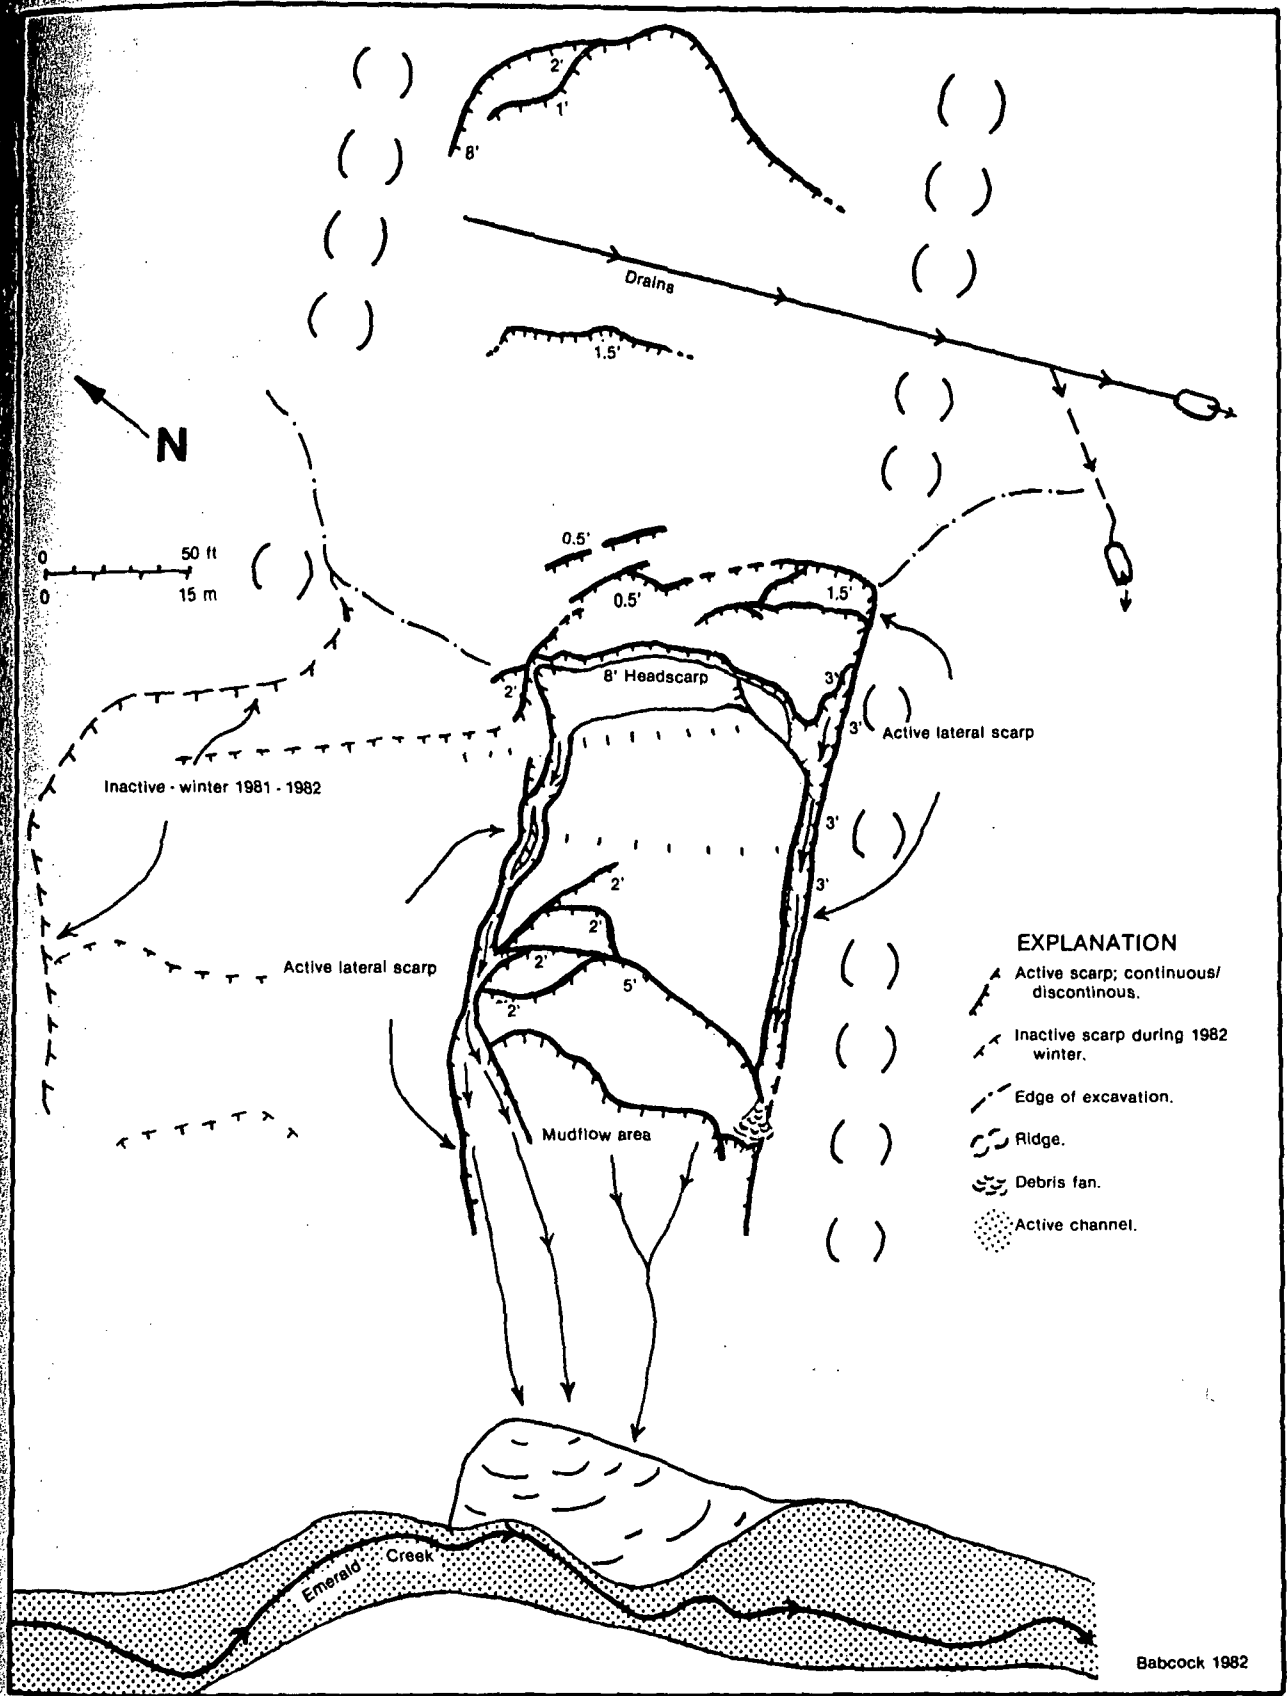
Figure 7

By February, 1982, after 75 in of rain, blocks of material downslope of the new headscarp and above the mudflow area moved 13 ft or more according to surveyed monuments. The final scarp map (Fig. 7) and the map of monument movement after the winter (Fig. 8) illustrate overall slide changes. No measurable displacement occurred at the old headscarp. A new headscarp had formed and migrated slightly uphill. The south lateral scarp became continuous and well-defined up to the new headscarp. No change occurred on the north lateral scarp. The major movement was translational, downhill sliding of blocks (Fig. 9) in part defined by pre-existing scarps (Fig. 2). Maximum total movement was 21.2 ft horizontally and 10.6 ft vertically. The magnitude of distance moved was probably influenced by the relatively wet winter (25 in above the basinwide average). The mudflow area was altered by fluvial processes, but showed no mass movement. In 1981, the slide mass seems to include a smaller area than before treatment.

Plan Map Showing Scarps After Winter 1981-1982, Emerald Creek Landslide, R.N.P.
Total Rain 105 in. Average Movement 18 ft.

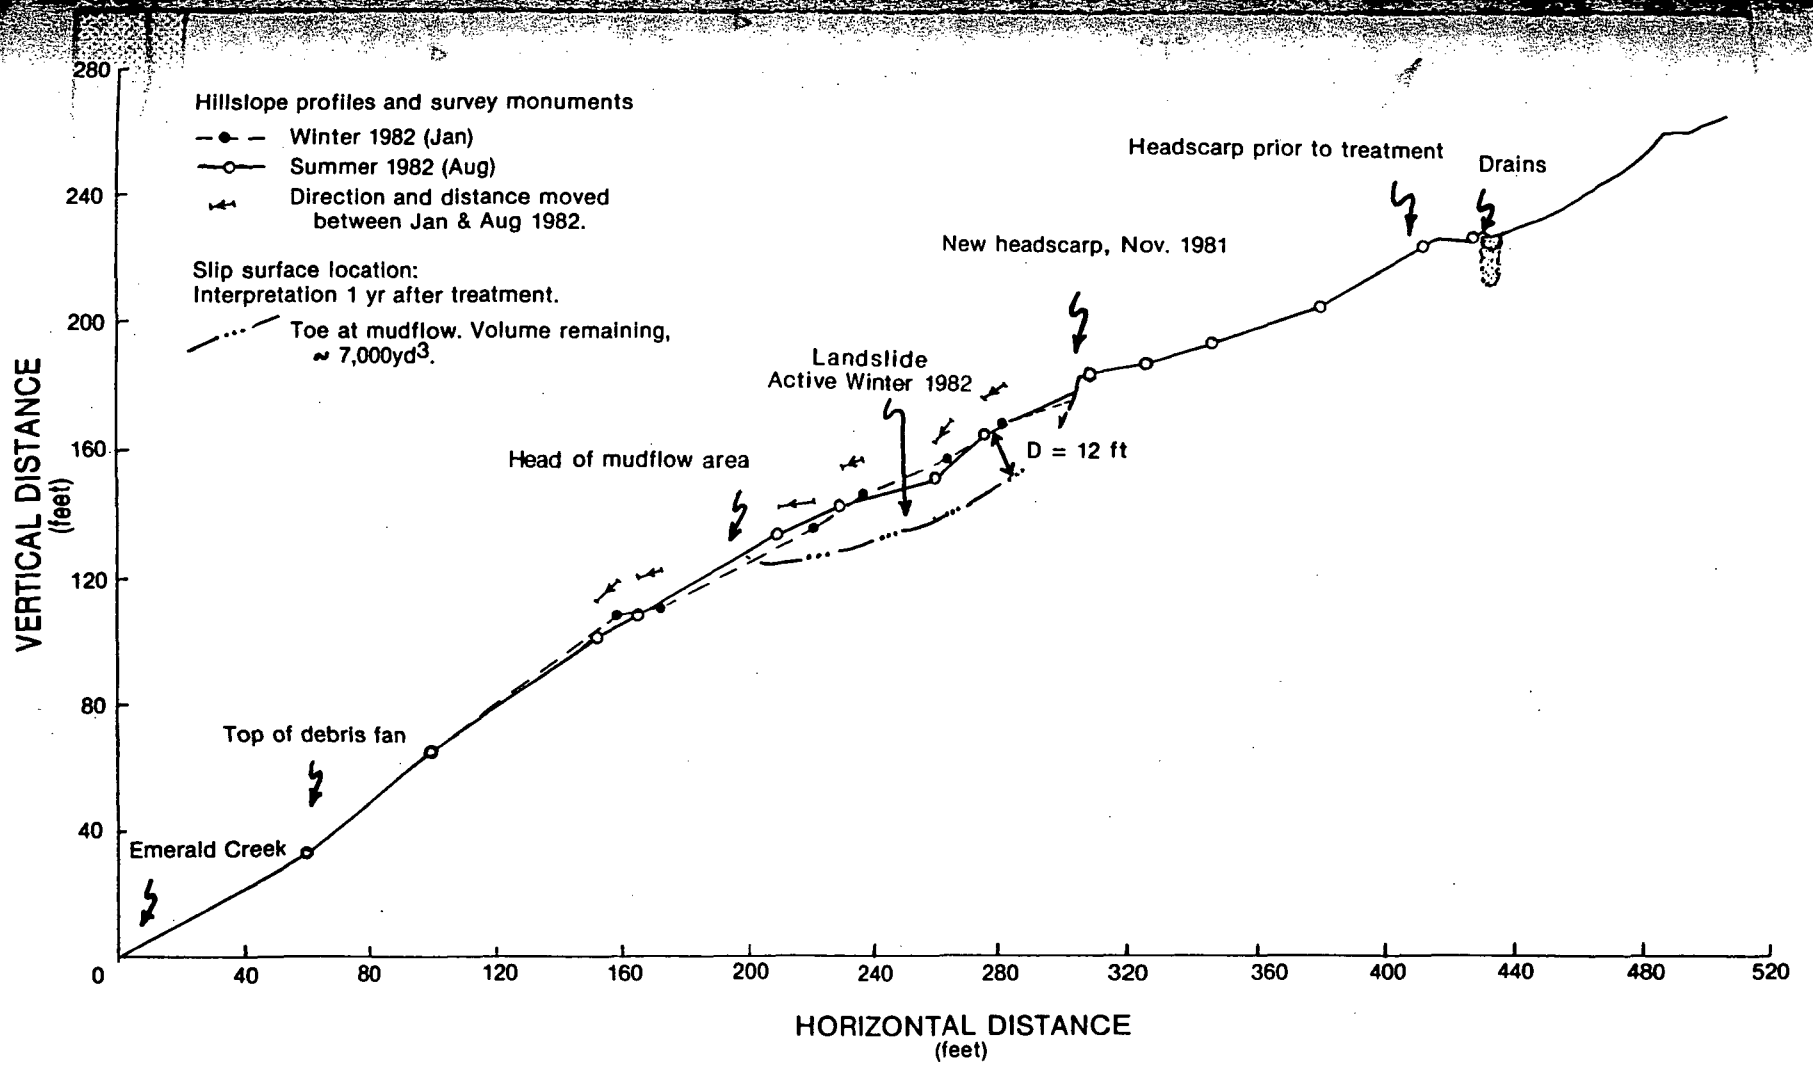
Figure 8

Monument Movement and Slope Profiles in January and August, 1982, Emerald Creek Landslide, R.N.P., With Present Interpretation of Failure Plane

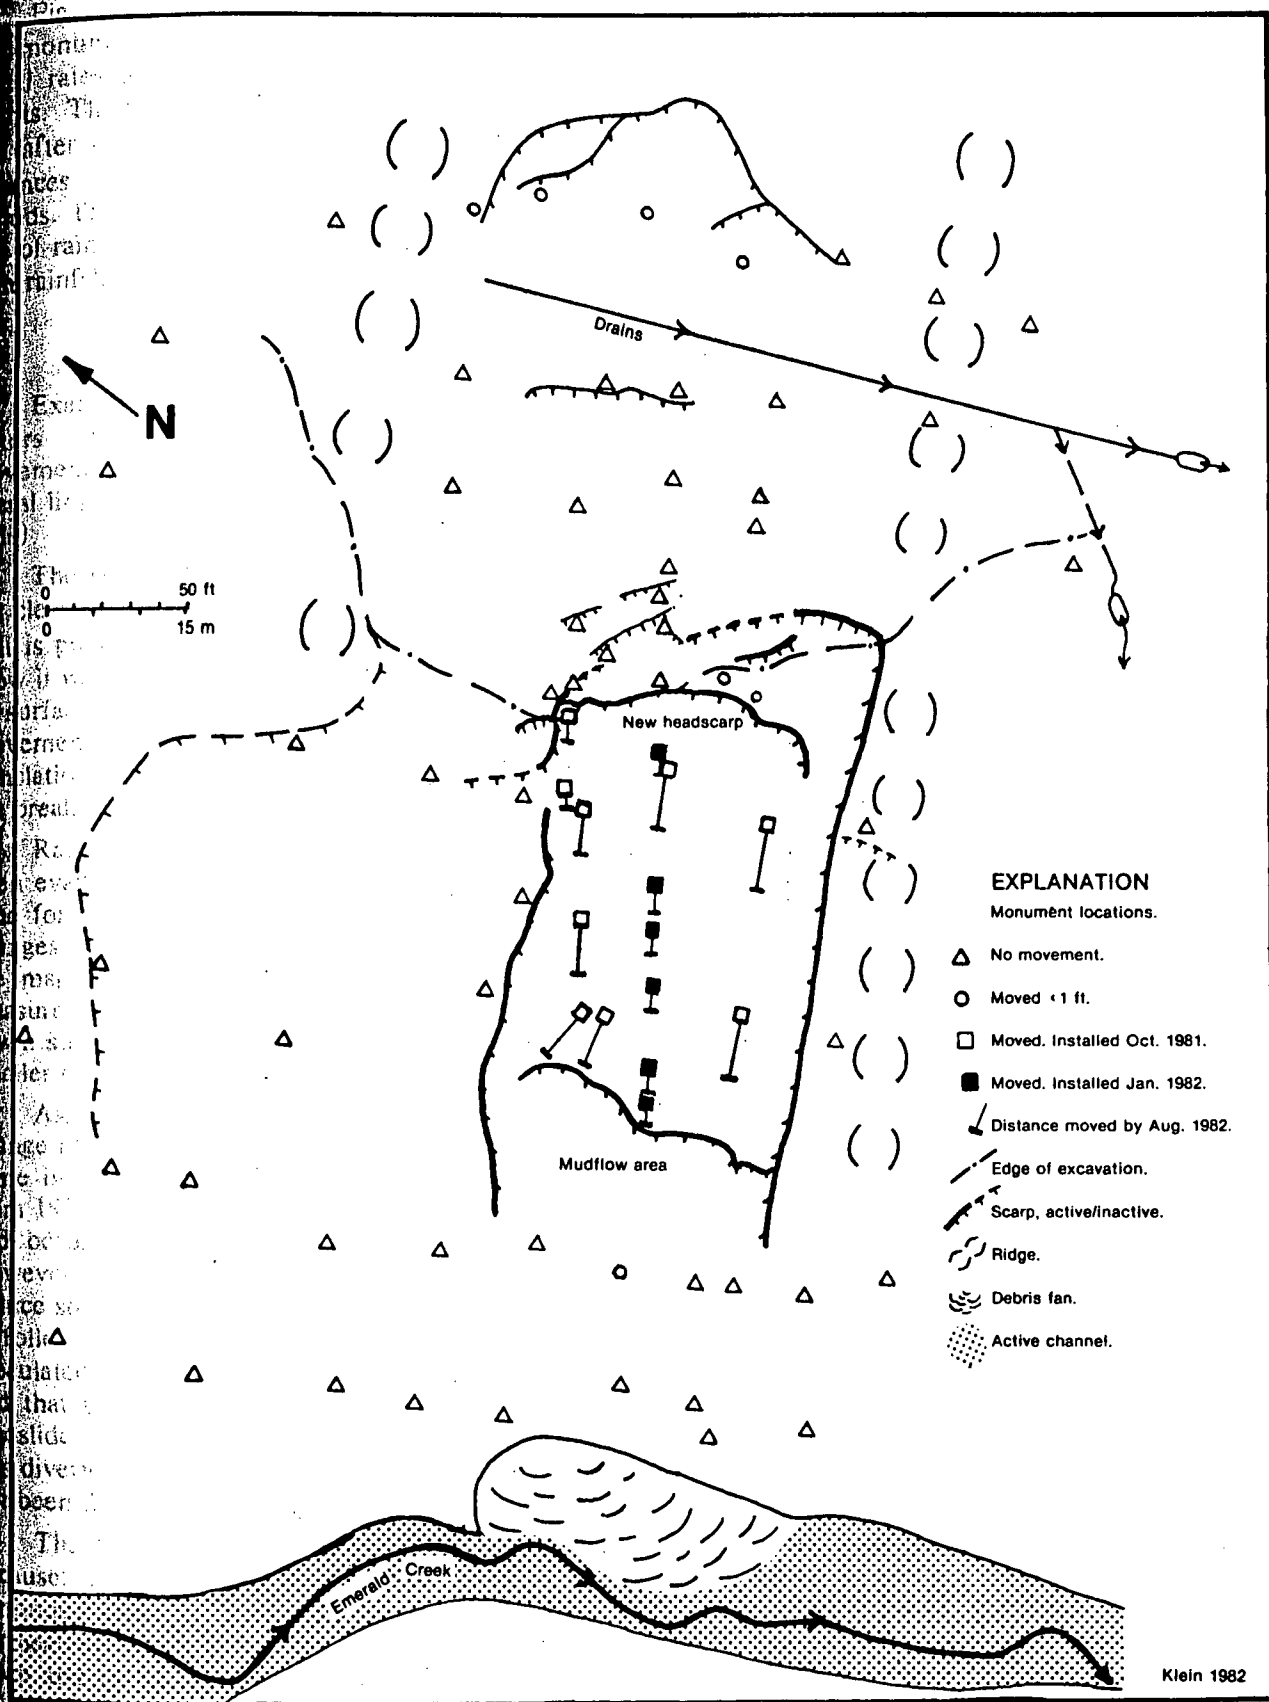
Figure 9

Plan Map Showing Total Monument Movement After Winter 1981-1982, Emerald Creek Landslide, R.N.P.

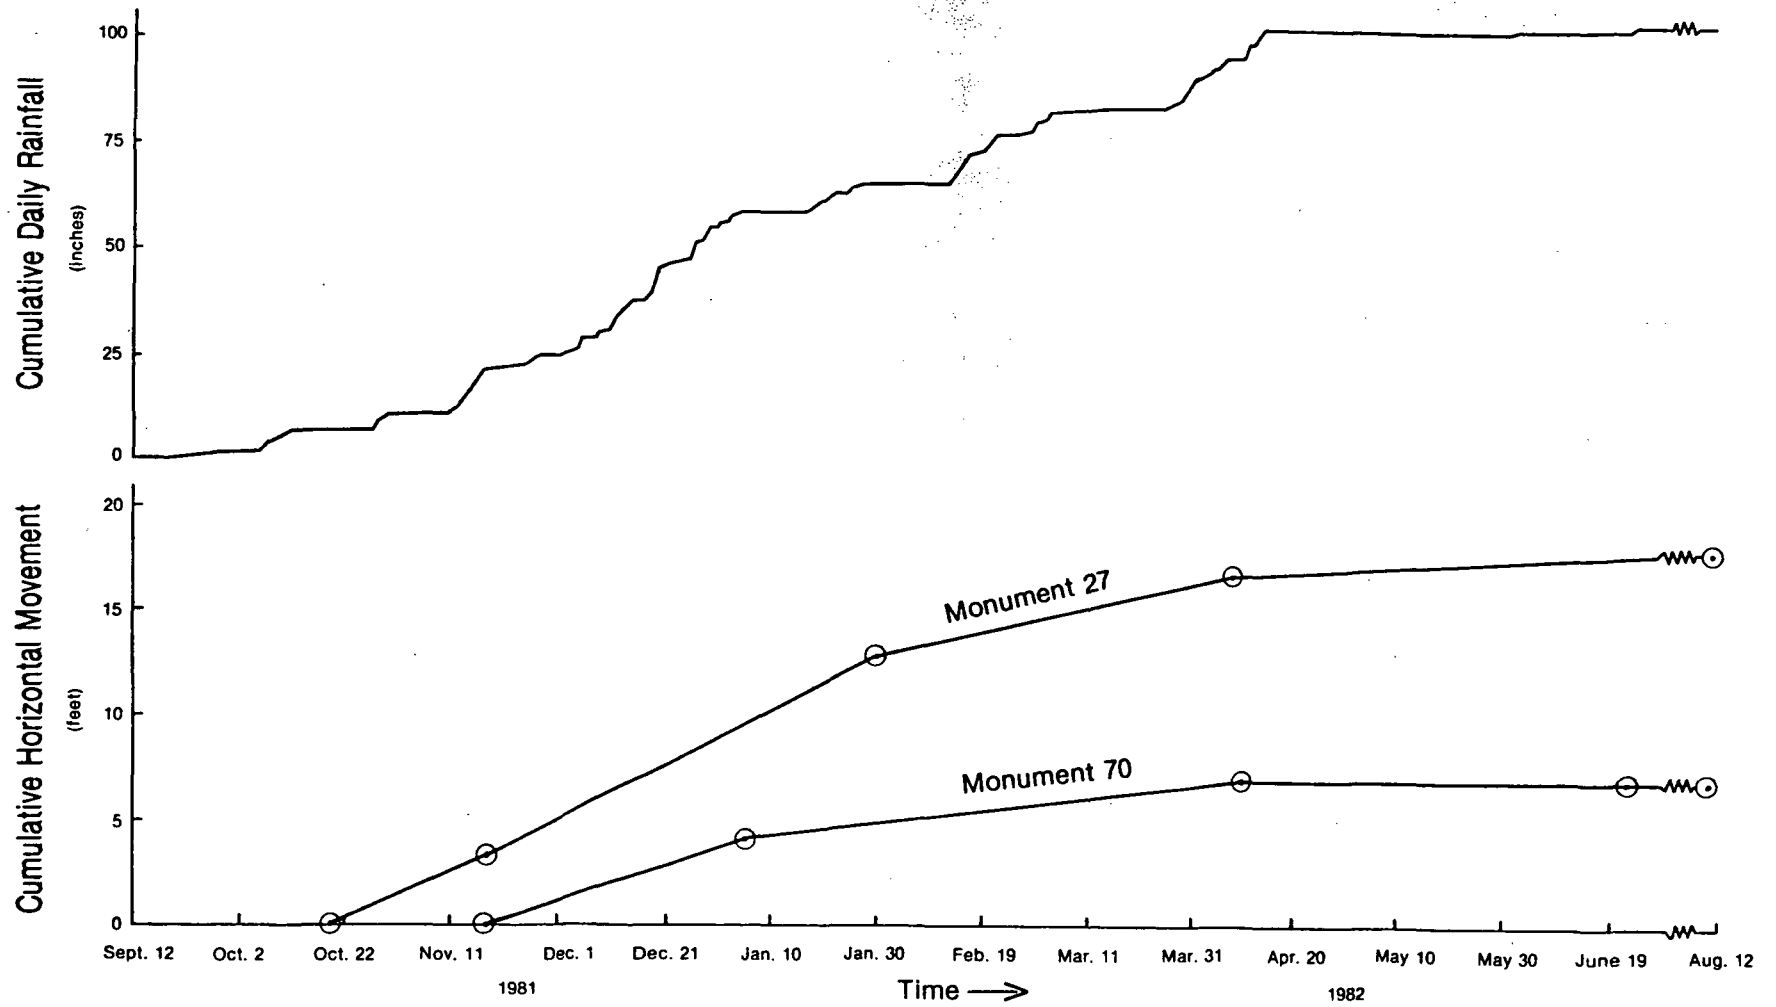
Figure 10

Fig. 10 shows time plotted against cumulative rainfall and the cumulative horizontal movement of monuments. The slopes of the line segments drawn between monument distances do not indicate actual rates of movement, since movement was observed to be dependent upon individual rainfall events. The slopes of the line segments are partly dependent on when measurements occurred before and after a major storm. The slopes could be called "averaged movement rates". Representative distances of monument movement were 12.8 ft, 2.5 ft, and 0.5 ft, respectively, for the three rainfall periods. The "averaged movement rates" mimic the seasonal rainfall distribution (e.g., the averaged rate of rainfall within a period of time). Although surveyed infrequently, movement correlates strongly with rainfall. The effect of antecedent soil moisture on slide movement has not been evaluated.

Cumulative Rainfall and Horizontal Movement of Two Monuments During Winter 1981-1982, Emerald Creek Landslide, R.N.P.
