Mad River Watershed Erosion Investigation

JUNE 1982

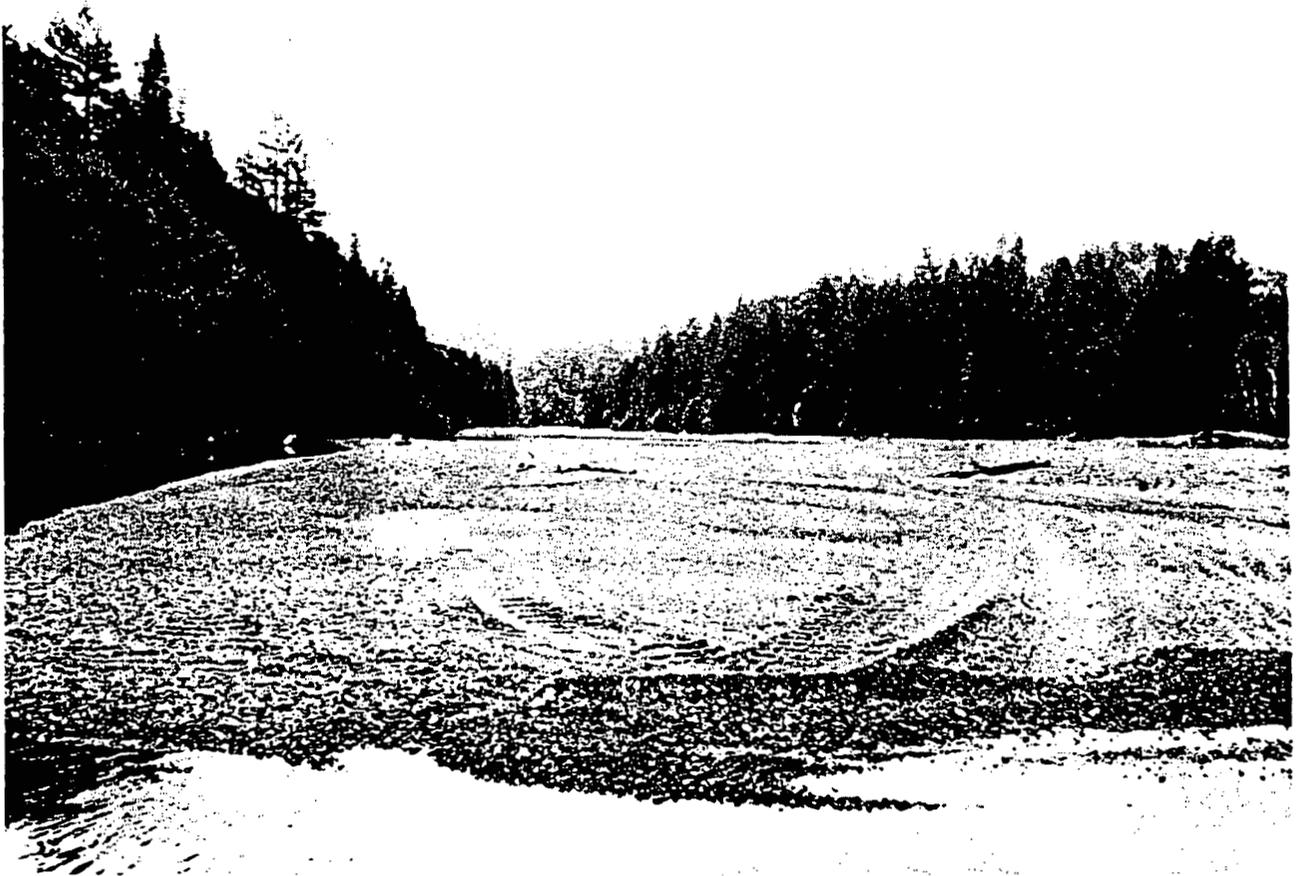
Photograph 1

Aggradation (raising) of the riverbed in the lower reaches of the basin above Blue Lake. Sediment in the river channel is a result of rapid erosion and sediment transport during high flows. Aggradation can bury bridges and roads, cause frequent shifts of the river channel, and destroy fish spawning sites.

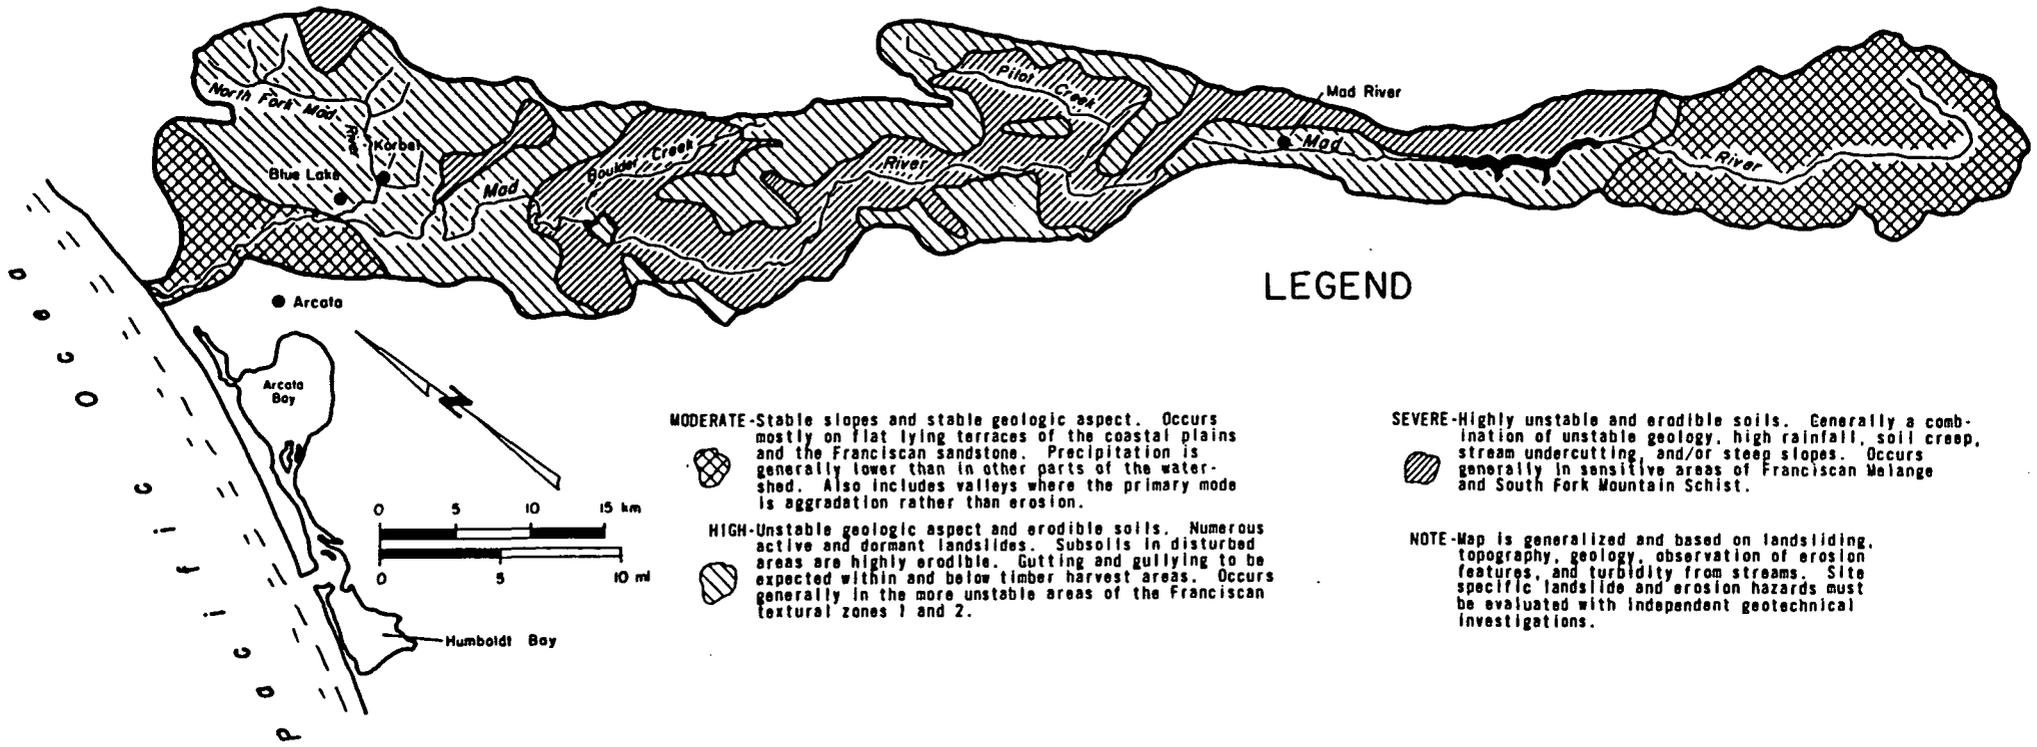
Instability and Erosion Hazard Map Mad River Basin

The "Instability and Erosion Hazard Map" (Figure 15) shows the potential for sediment yield from general areas within the basin. This map is not intended to be site specific. Potential hazard was determined from turbidity measurements, geology, landslides, and field observations. These factors were considered independently for each section of a grid system. Each section is about 1.6 km² (1 mi²), and ratings were assigned according to the degree of hazard. The total of the values for each grid section was used for the overall hazard rating.

In terms of distribution, severe hazard conditions generally correspond closely with areas underlain by Franciscan melange and South Fork Mountain Schist. Severe conditions also occur on the western flank of South Fork Mountain. Moderate hazard conditions occur only in the headwaters of the basin and in the coastal plains near the mouth. The rest of the basin has high erosion hazard potential.
