May Creek Culvert Outlet

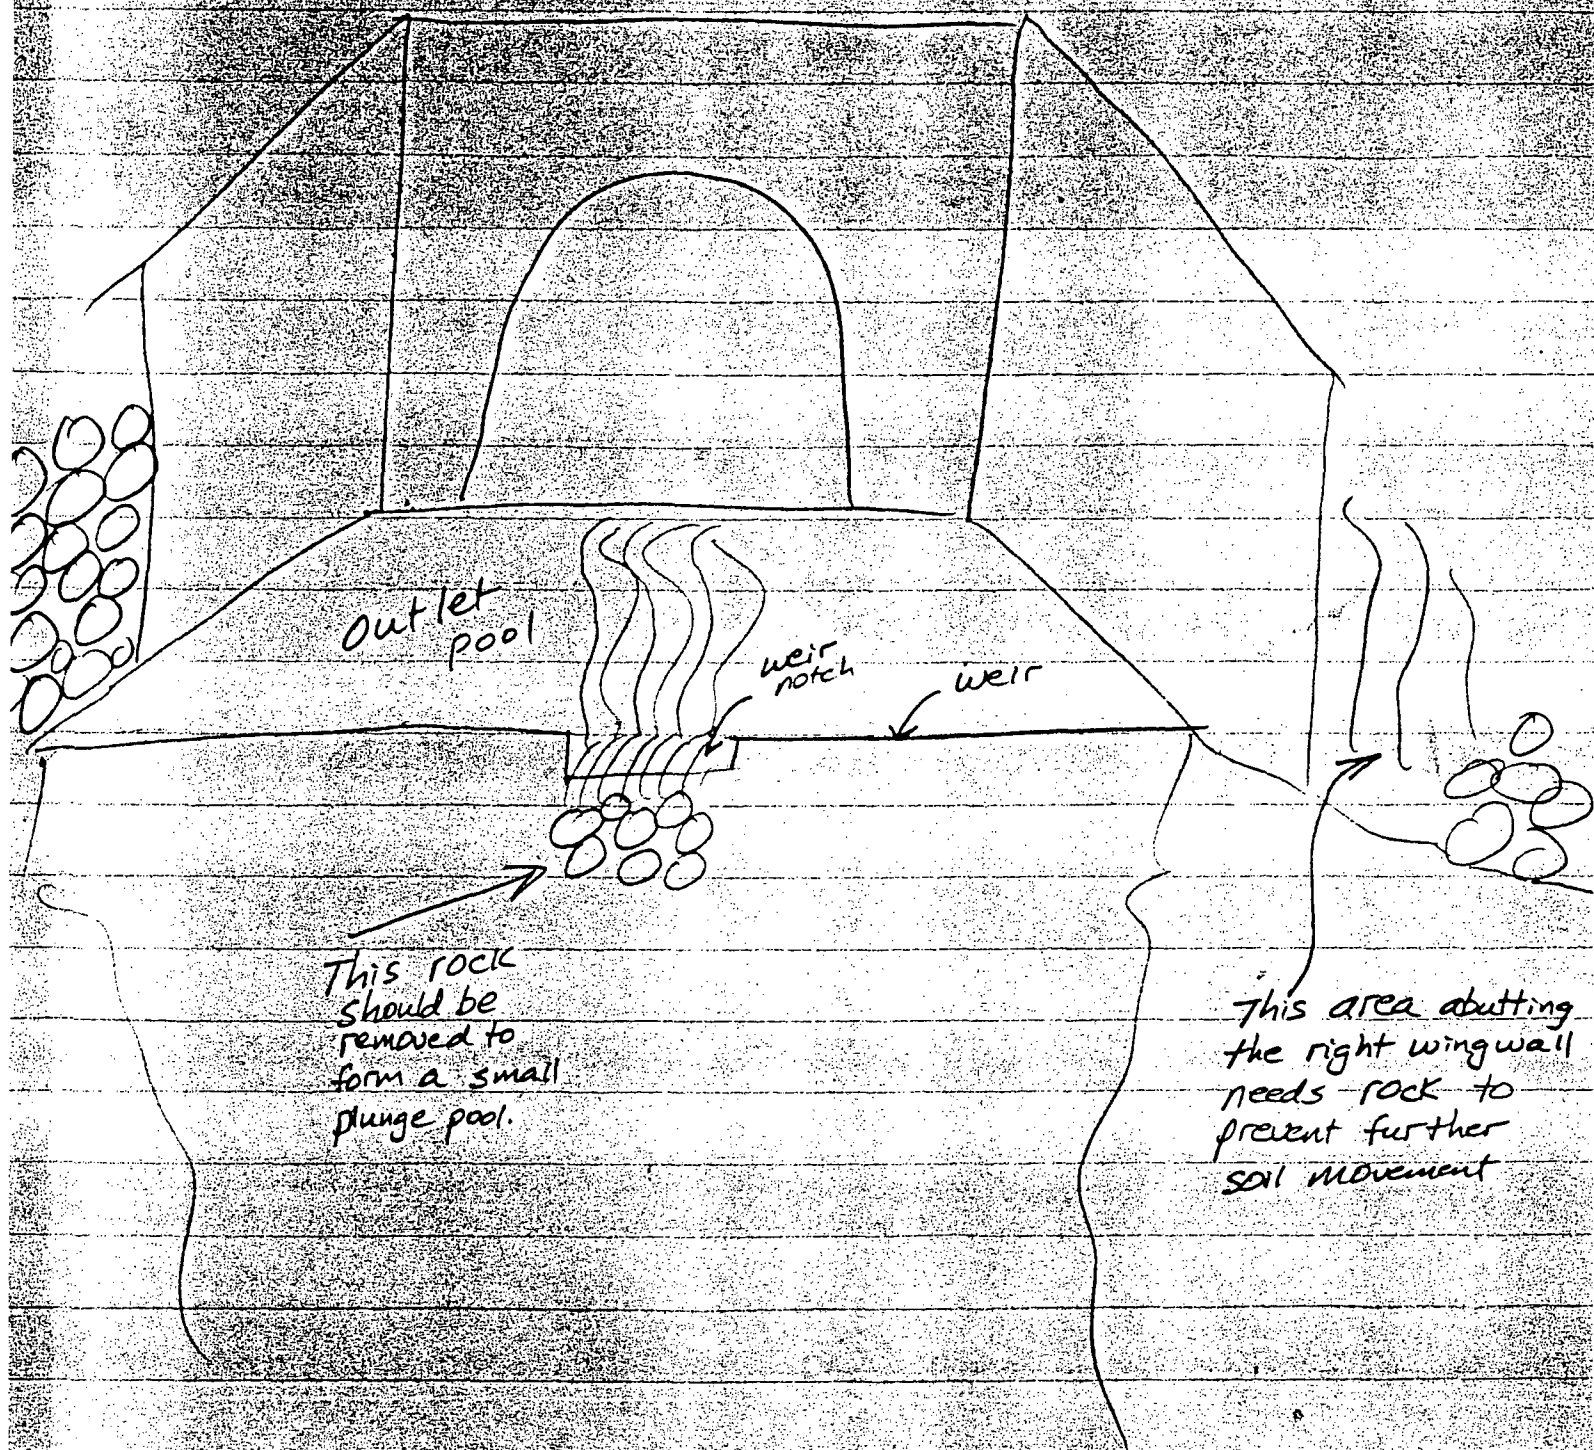
Looking up into May Creek culvert outlet

This rock should be removed to form a small plunge pool.

This area abutting the right wing wall needs rock to prevent further soil movement

The right wingwall at the outlet looks like it could use some light RSP replaced to prevent soil movement. Also, the RSP at the location immediately below the outlet weir should be moved to create a small pool instead of the current rocky splash apron. This will assist Coho in their upstream migration. Can we get this done before next fall?
