San Luis Obispo Creek Watershed Hydrologic Survey

California Regional Water Quality Control Board
Central Coast Region
Contract No. 4-106-253-0

The Land Conservancy of San Luis Obispo County

May 1996

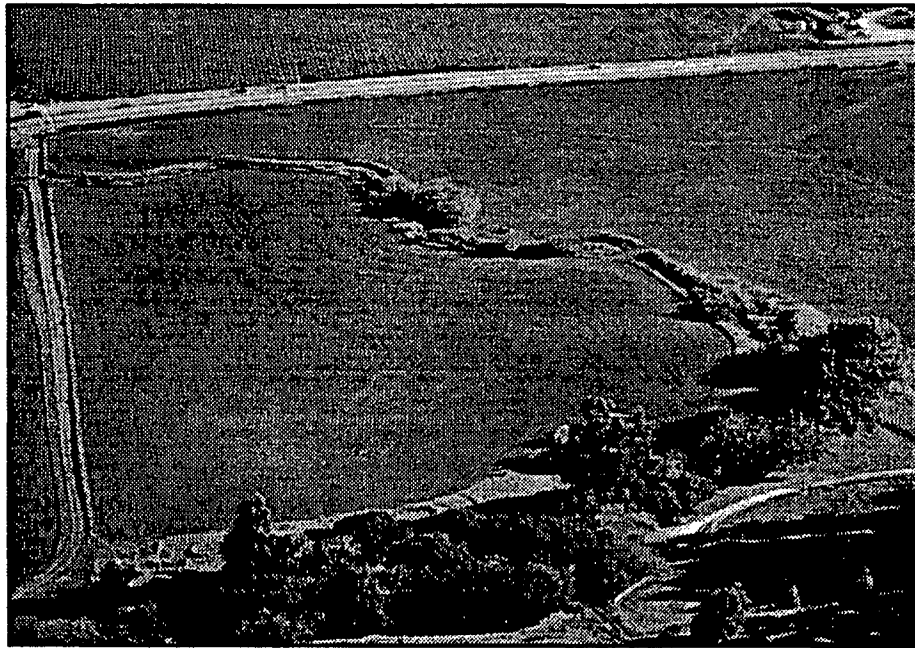
Riparian vegetation disappearing into agricultural field

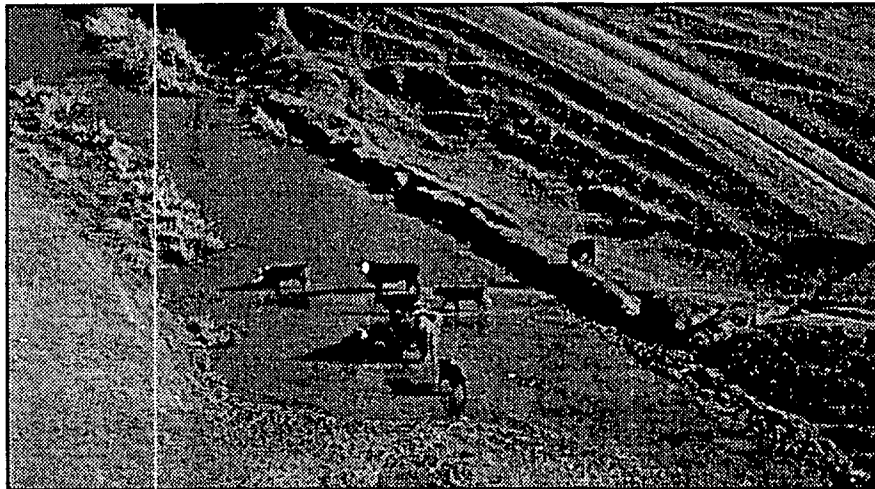
Cattle compact soil, cause erosion, and denude banks.

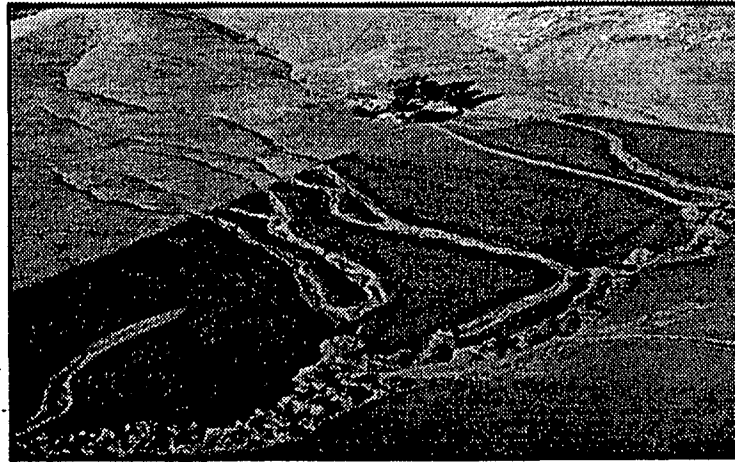
Small unvegetated rivulets contribute to sedimentation

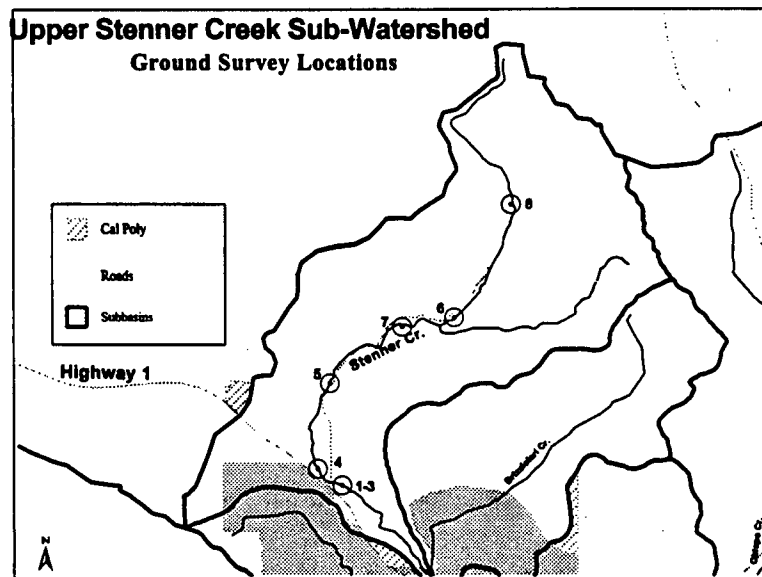
Figure 1.7 - Upper Stenner Creek Survey Locations

Loc.	Vegetation	Bank Condition	Substrata	Notes
1	Grasses along the banks with few established trees. <10% total cover	Severely eroded/ vertically cut banks.	Primarily coarse (sand and gravel). Some embedding, cobbles on bank.	Eroded banks are unvegetated. Further erosion is inevitable.
2	Some established trees. < 10% cover.	Eroded banks. 8' high.	Thalweg-sand and gravel. Active channel- cobbles. Exposed bedrock in channel.	Further bank erosion is inevitable.
3	Established willows and sycamores. >60% cover.	Some bank erosion. Concrete slabs on west bank. Better than downstream.	Geologic structure in thalweg.	
4	Established vegetation. >60% cover	Some erosion.	Geologic structure in channel.	
5	Some sycamores and grasses. <30% cover.	Flat, no banks. Active channel and road are the same elevation.	Embedded gravel and cobble.	Flow restricted by concrete bridge. High flood potential.
6	Established hardwoods. 70% cover on left bank. No vegetation along right bank.	Eroded and vertically cut. Exposed roots.	Coarse material in thalweg and active channel. Some exposed fines.	150' of exposed banks.

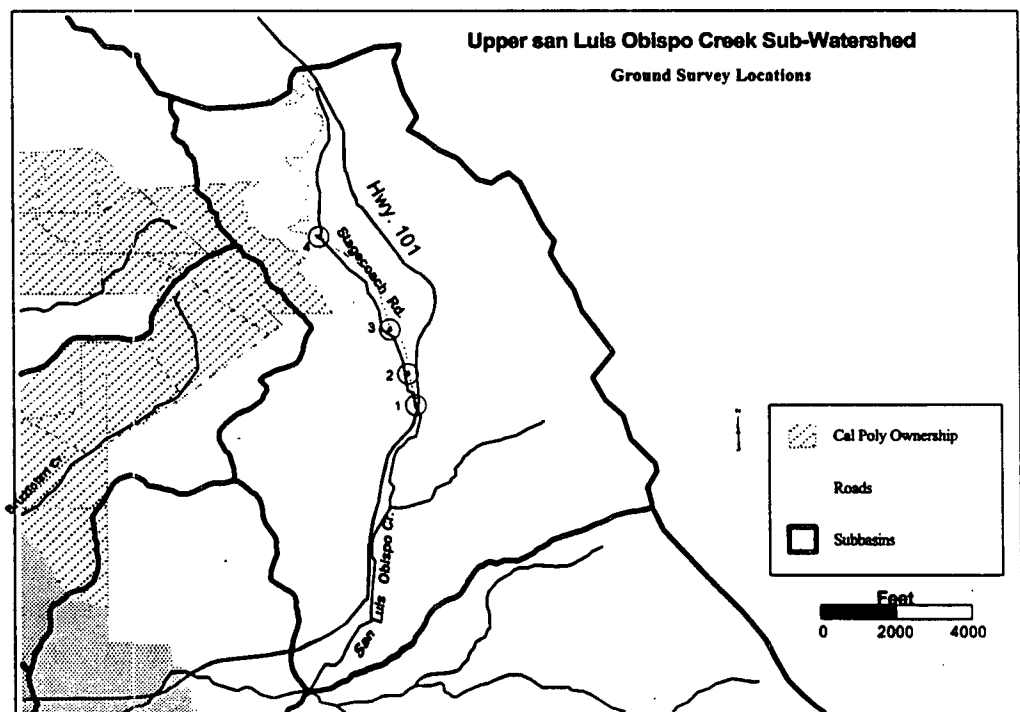
Figure 1.8 Upper San Luis Obispo Creek Survey Locations

Loc	Vegetation	Bank Condition	Substrata	Notes
1	>60% cover with mature canopy. Less developed understory.	Very little erosion with some terracing.	Cobbles.	Concrete in west bank, and road run-off is creating a gully. Culvert crosses under Hwy. 101.
2	Some woody vegetation and sparse, herbaceous understory	West bank has moderate erosion. Newly exposed roots. East bank is riprap.	Cobbles.	Riprap does not cover the eroded area. Backfill soil is extremely sandy and may continue to wash out.
3	Uniform vegetation cover. Woody canopy with herbaceous ground cover	Generally stable, some minor erosion.	Cobbles with some gravels.	Creek meanders more in this area.
4	Intermittent woody vegetation with non-native herbaceous cover.	Less stable area with erodible soils and slumping banks. Culverts cross under Stagecoach Rd.	Gravels 90% embedded in fines. Fines may be a product of fire damage.	Tributary confluence point. Higher gradient, and proliferation of algae. 2 of 3 culverts are clogged with fines and gravels.

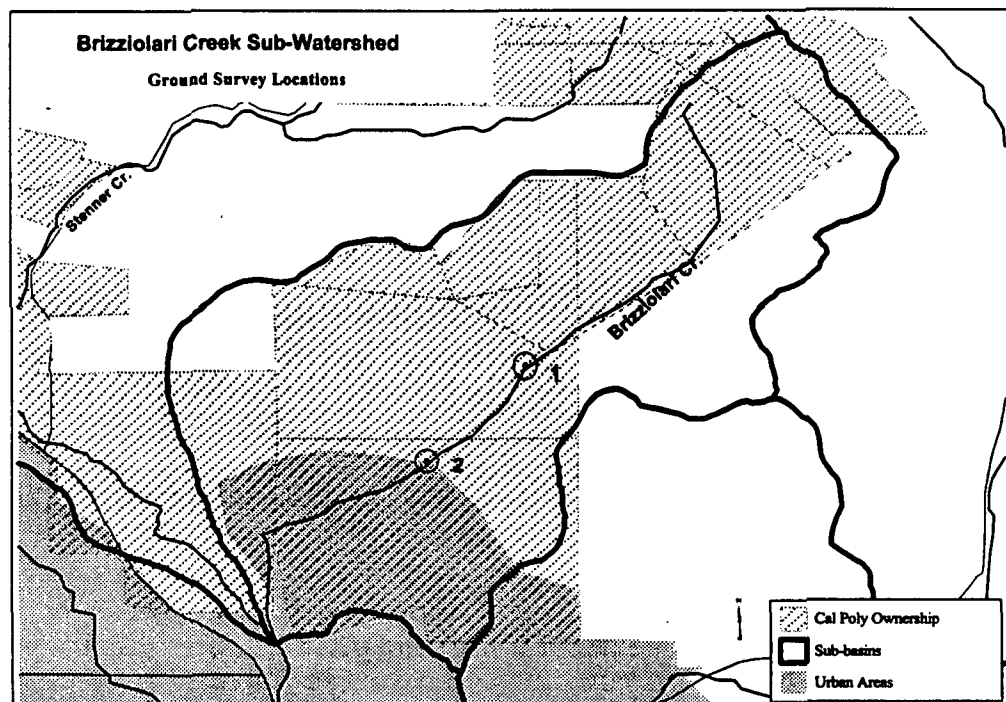
Figure 1.9 - Brizziolari Creek Survey Locations

Vegetation	Bank Condition	Substrata	Notes
Sparse vegetation where erosion is occurring.	Eroded. banks comprised of fine materials. Exposed bare soil.	Embedded gravels.	Cattle allowed in creek contributing to degradation.
Established hardwoods, but overall, little cover.	Intermittent bank undercutting. Exposed roots.	Coarse material. Area stabilized by exposed bedrock.	Flow constricted by culvert.

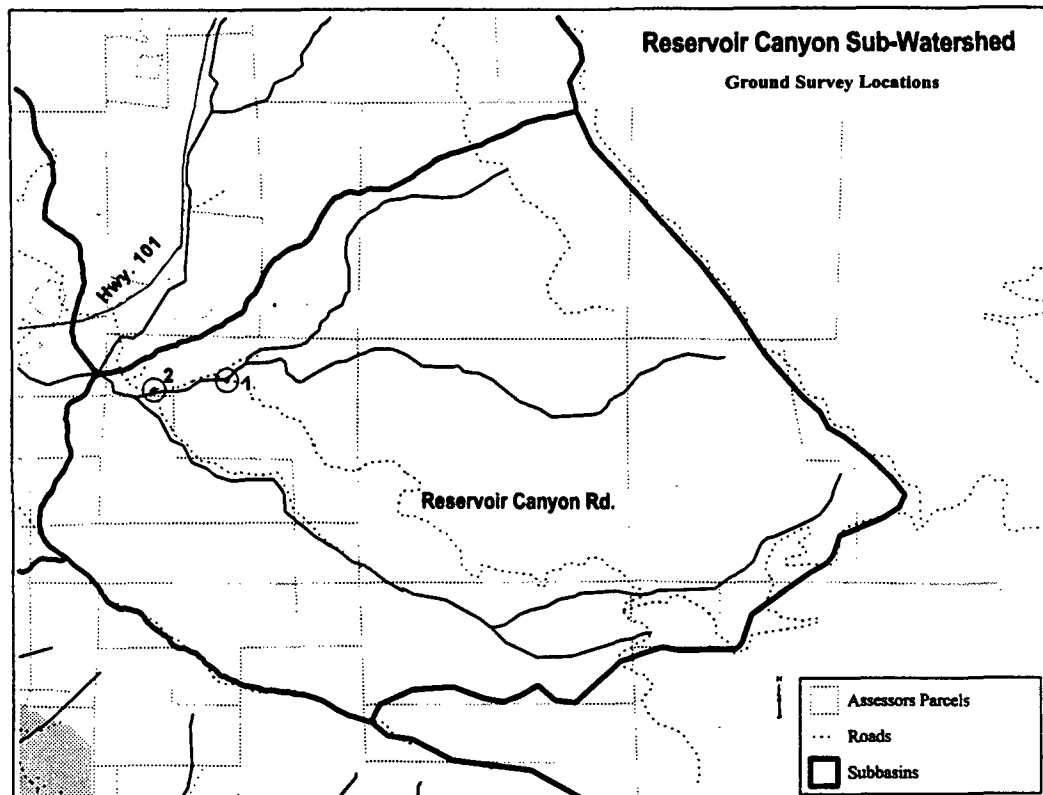
Fig. 1.10 - Reservoir canyon Survey Locations

Loc.	Vegetation	Bank Condition	Substrata	Notes
1	Mature riparian vegetation.	Erosion minimal. Some areas with exposed geology (serpentine).	Cobbles and gravels on sand banks.	
2	Grasses only.	Extreme vertical bank erosion.	(Access to survey was limited)

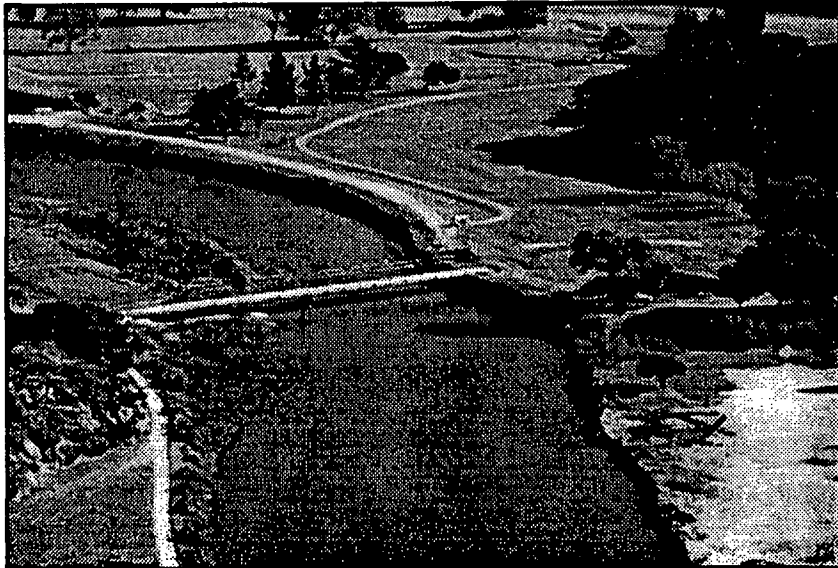
Erosion along the "Big Bend"

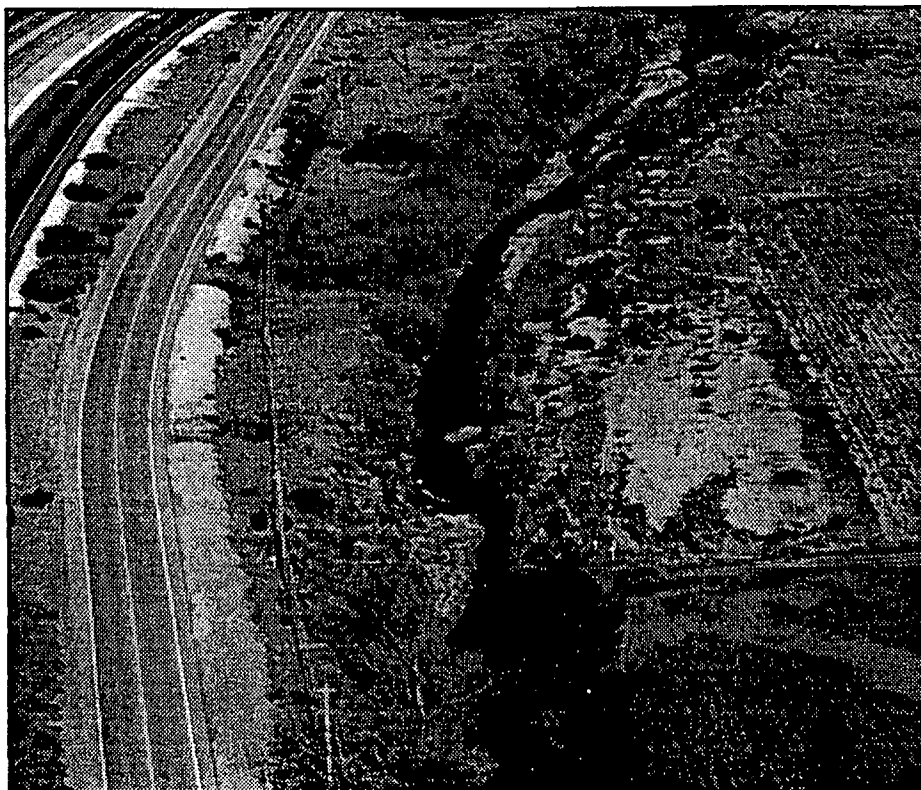
Severe erosion and scoured agricultural land.

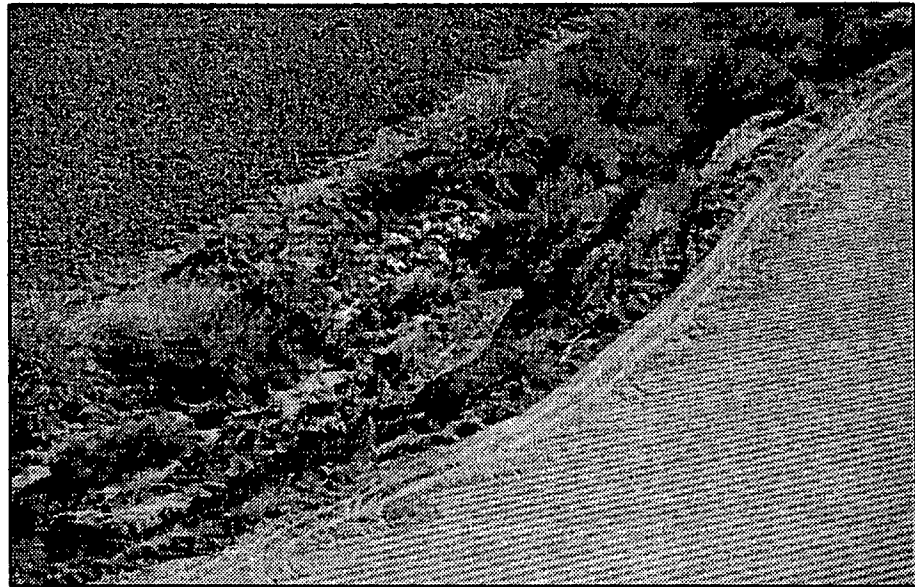
These banks have been damaged by fast moving water. Revegetation will reduce the risk of future damage

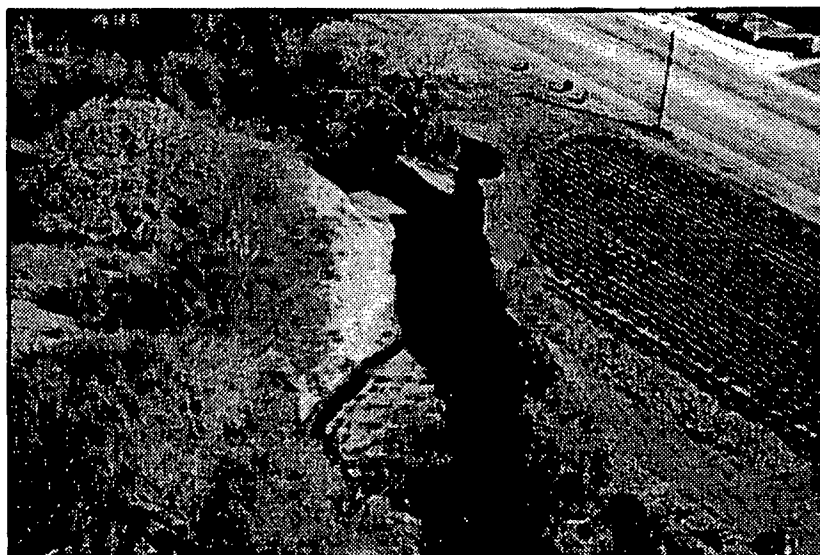
High vertical banks are common in this reach.

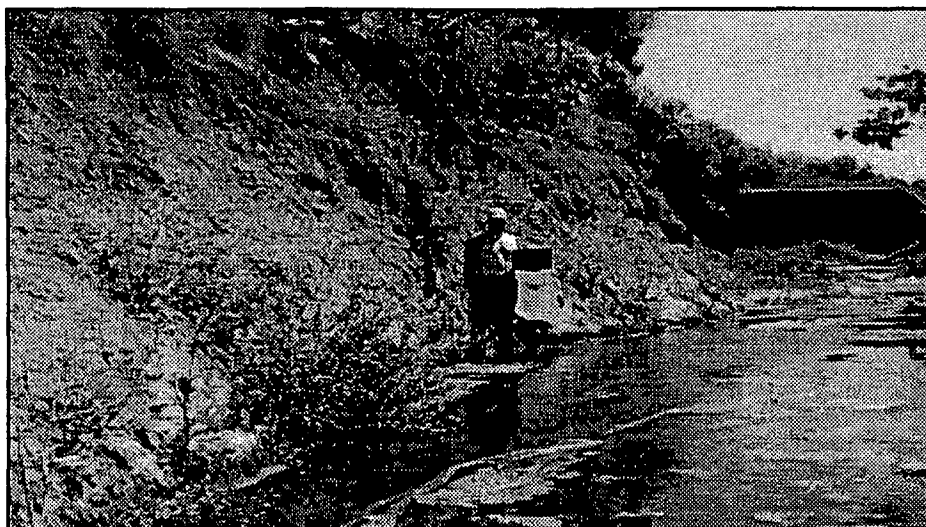
Some eroded banks are over 20 feet tall.
