TO: Jim Sung Senior Engineer, WR	DATE: 3/10/17
FROM: Dan Garcia, PE Engineer, WR	SUBJECT: Clifton Court Forebay Dam Intake Structure Concrete Apron Undermining Dive Inspections

**Underwater inspection
of the apron
at the Clifton Court
Intake Structure**

Project site: Clifton Court Forebay Intake Structure
 Date of work: 3/4/2017
 Objective: Determine the condition of the apron and wing walls

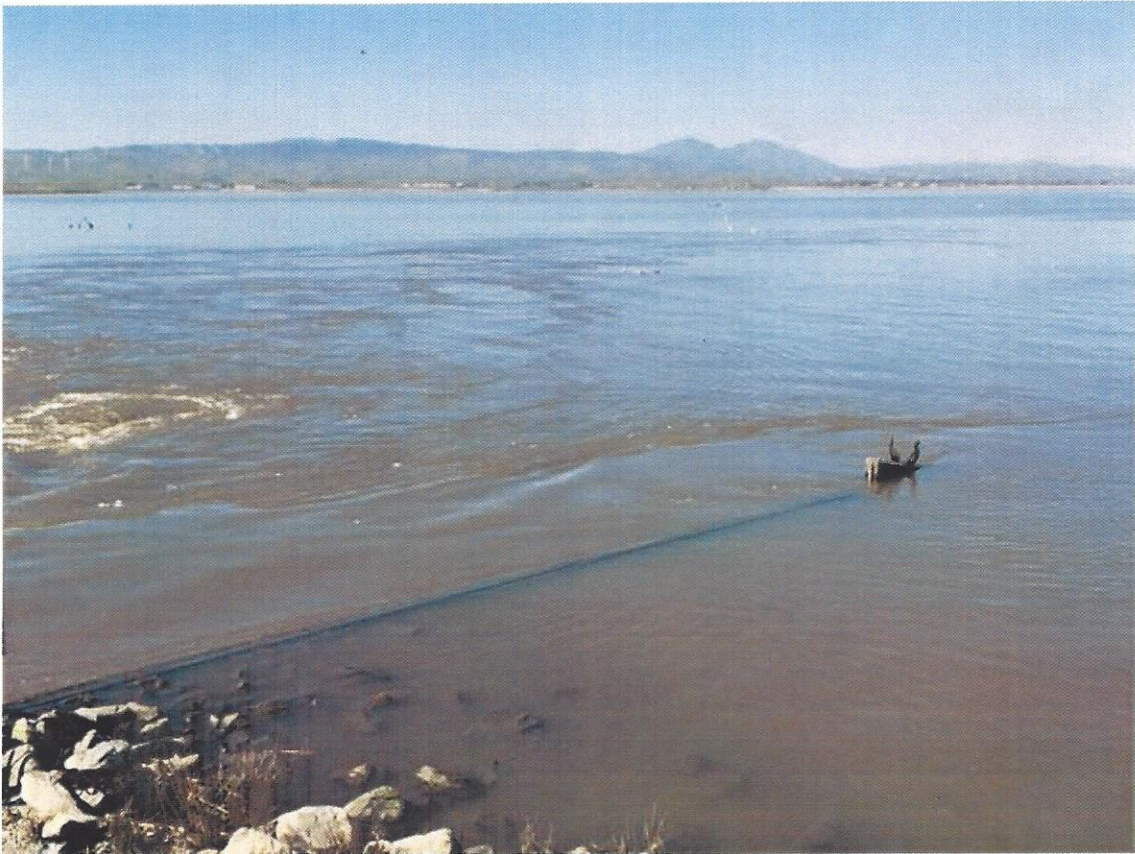
On March 1, 2017 the DFD informed the Dam Safety Branch of a possible failure of the Clifton Court Intake Structure right wing wall (**Photo 1**) and concrete apron on the reservoir side. At the request of DWR, DRS Marine Inc. performed a dive on March 4, 2017 to evaluate the extent of the undermining of the concrete apron and the condition of the apron itself.

- The left wing wall appears to have no damage.
- The scour and undermining appears to be less extensive on the left side compared to the right.
- Scour and undermining at the mid-section of the apron is minimal compared to both the left and right sides.
- The right side scouring and undermining is extensive and confirmed a segment of the concrete apron has failed and shifted down.

Photo 1: View of the exposed portion of the failed right wing wall.

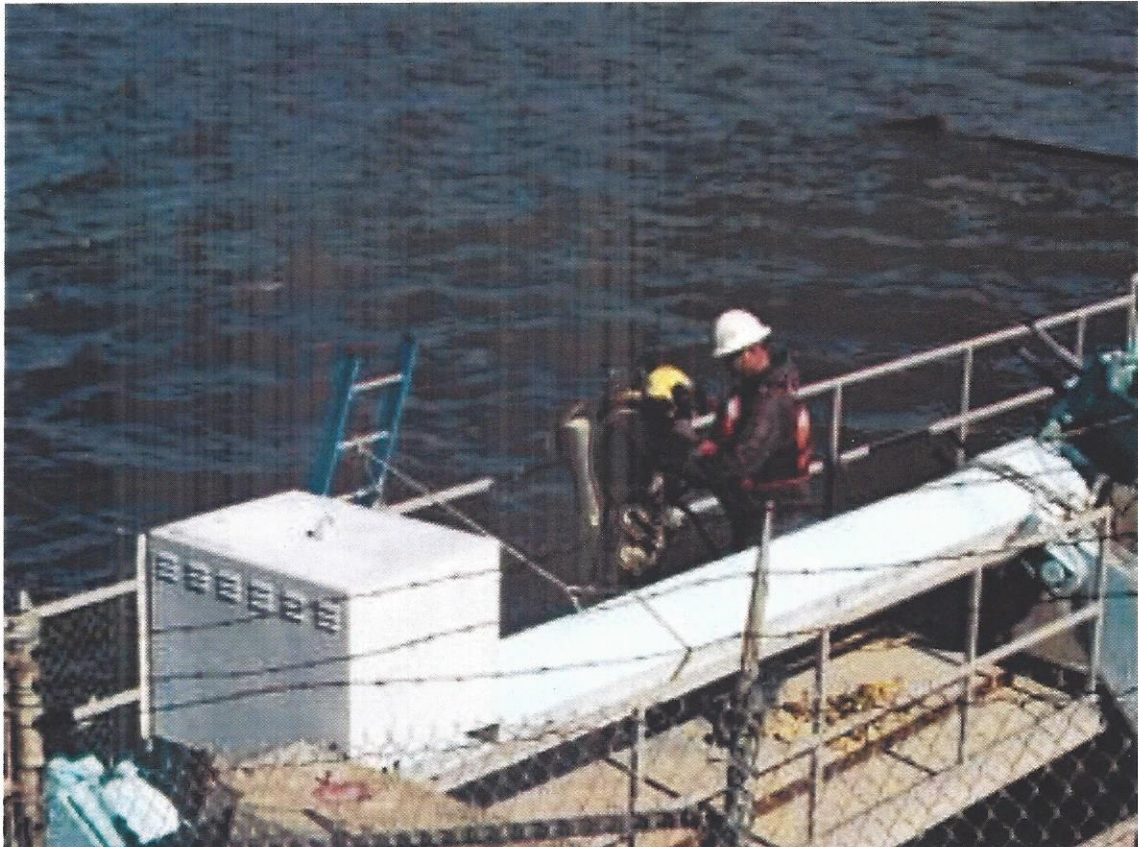
Photo 2: View of the diver getting ready to enter the water from the scaffolding at bay 1.

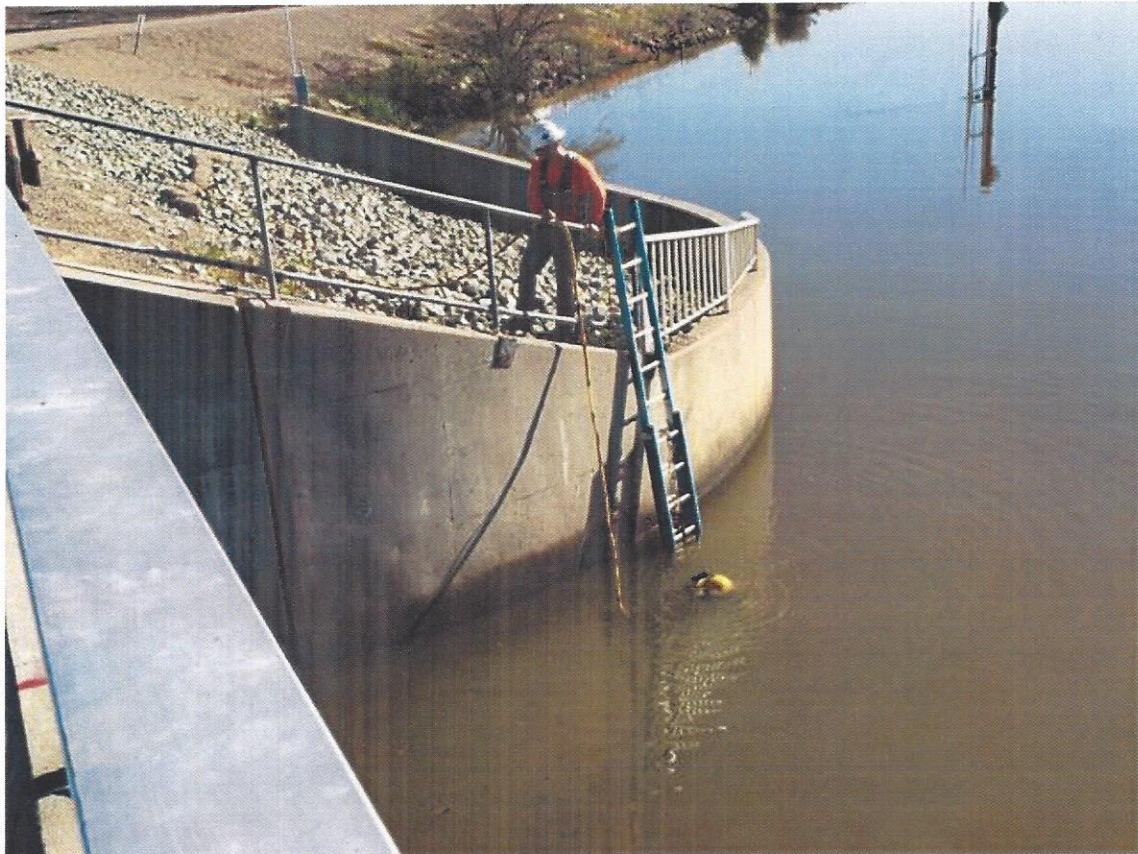
- No signs of damage or cracks were observed on the Intake Structure's approach side concrete apron or walls.
- The riprap is intact and in place adjacent to the concrete apron.

Photo 3: View of the diver entering the water on the approach side of the Intake Structure.

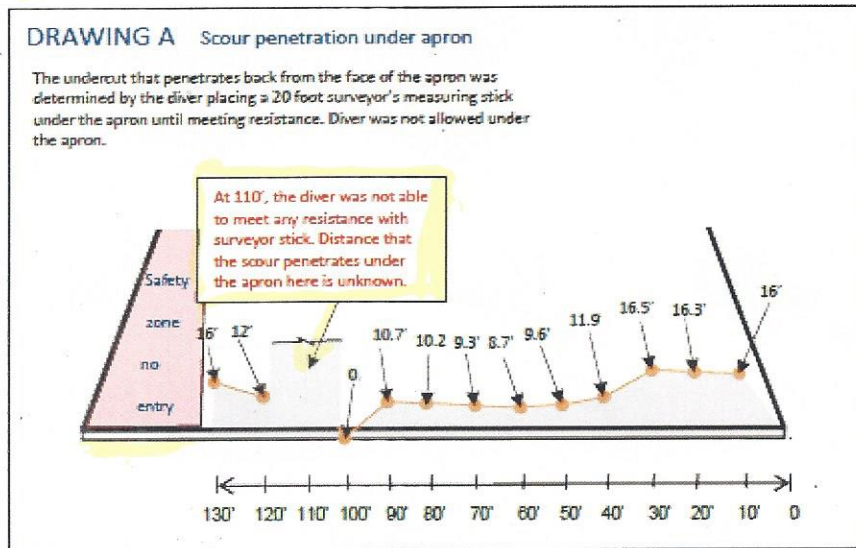
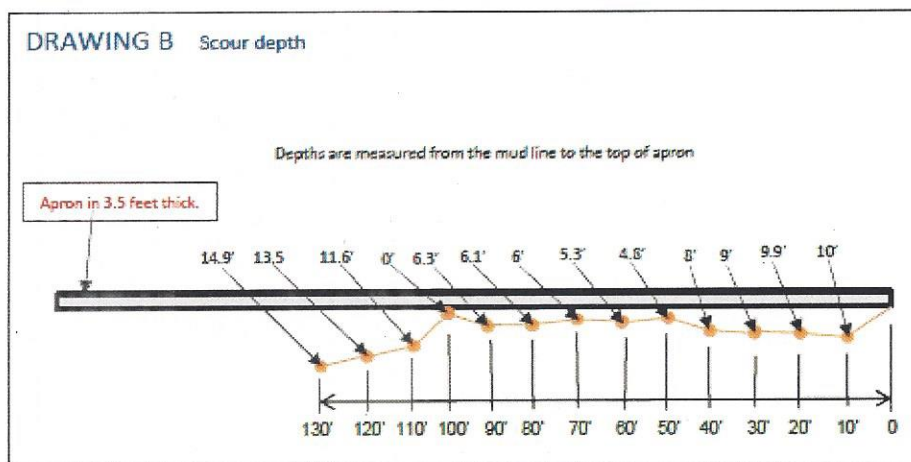
1. SCOURING UNDER THE APRON

The diver started the inspection from the North wing wall. The diver took measurements every 10 feet across the apron toward the South wing wall. Measuring from the end of the apron across from the North wing wall to the South wing wall, the apron measures 175 feet. At each 10 foot distance across the front of the apron, the diver took two measurements. The depth of the scour from the mud line to the top of the apron and the penetration distance under the apron that the scour is traveling from the face of the apron back. These every 10 foot measurements were taken up to 130 feet across the front of the apron. At this point it was determined unsafe to have the diver go any further across closer to the South wing wall due to it being unstable.

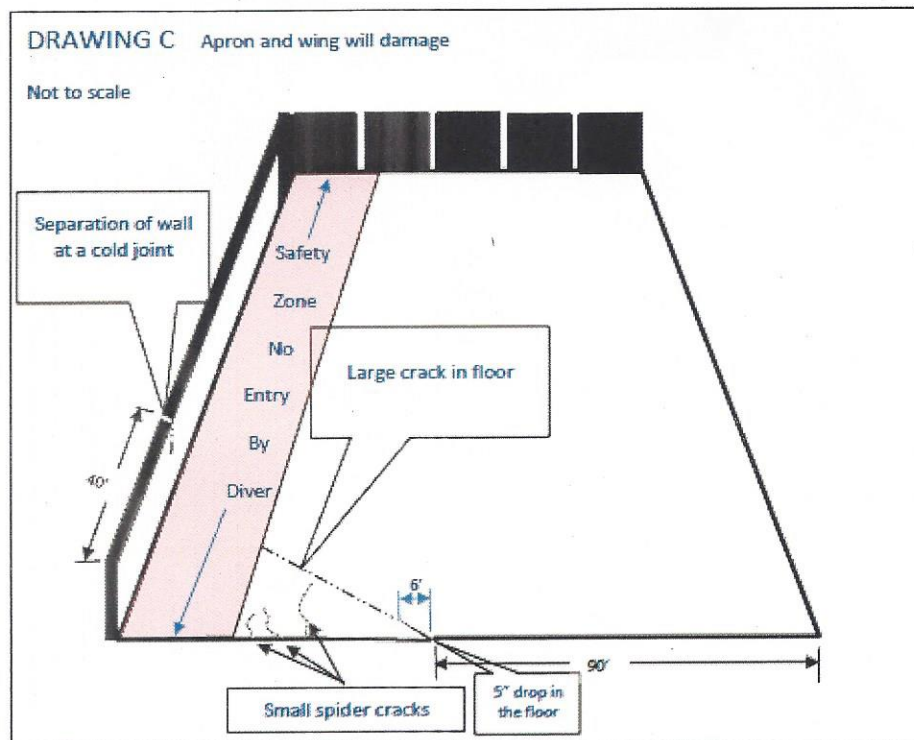
The apron has a large crack along the floor and up the right wing wall and has separated. DRAWING C below indicates the approximate location of crack.
