TO: Jim Sung Senior Engineer, WR	DATE: 3/10/17
FROM: Dan Garcia, PE Engineer, WR	SUBJECT: Clifton Court Forebay Dam Intake Structure Concrete Apron Undermining Dive Inspections

RE: Inspection of Apron

Project site: Clifton Court Forebay Intake Structure
Date of work: 3/4/2017
Objective: Determine the condition of the apron and wing walls

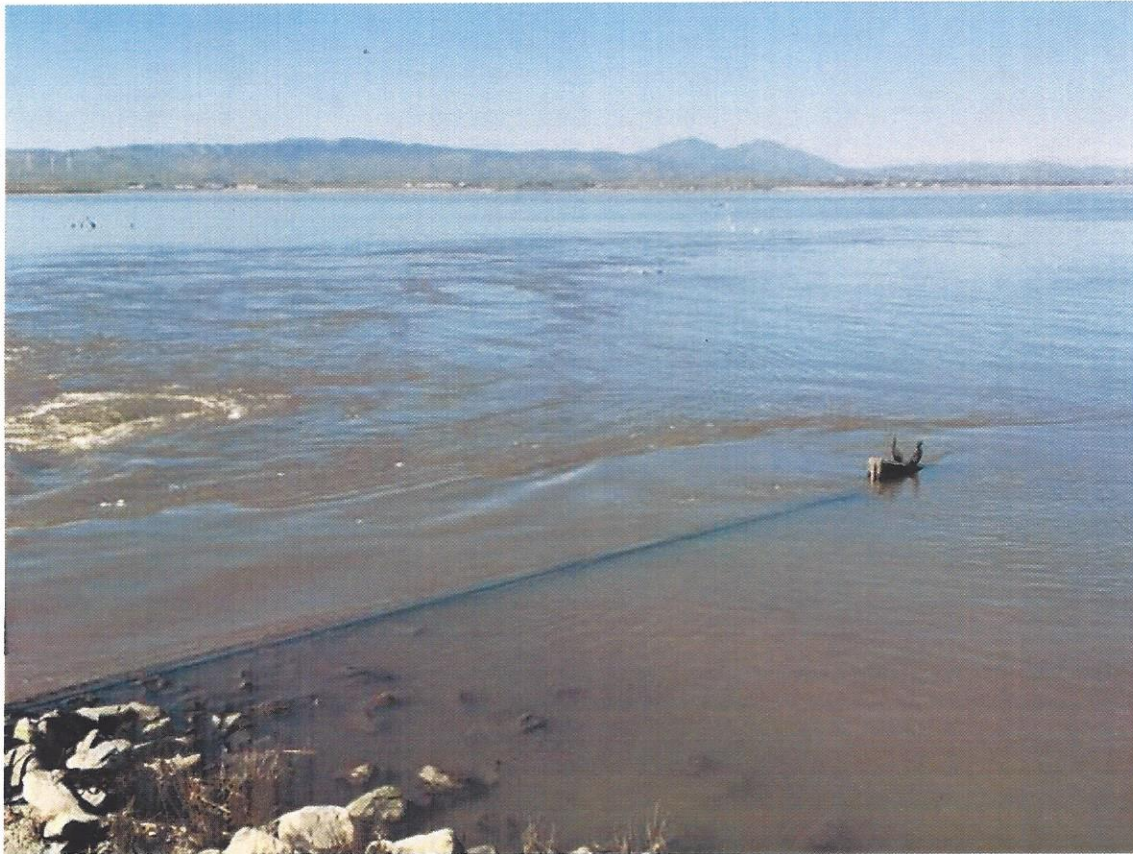
On March 1, 2017 the DFD informed the Dam Safety Branch of a possible failure of the Clifton Court Intake Structure right wing wall (**Photo 1**) and concrete apron on the reservoir side. At the request of DWR, DRS Marine Inc. performed a dive on March 4, 2017 to evaluate the extent of the undermining of the concrete apron and the condition of the apron itself.

- The left wing wall appears to have no damage.
- The scour and undermining appears to be less extensive on the left side compared to the right.
- Scour and undermining at the mid-section of the apron is minimal compared to both the left and right sides.
- The right side scouring and undermining is extensive and confirmed a segment of the concrete apron has failed and shifted down.

Photo 1: View of the exposed portion of the failed right wing wall.

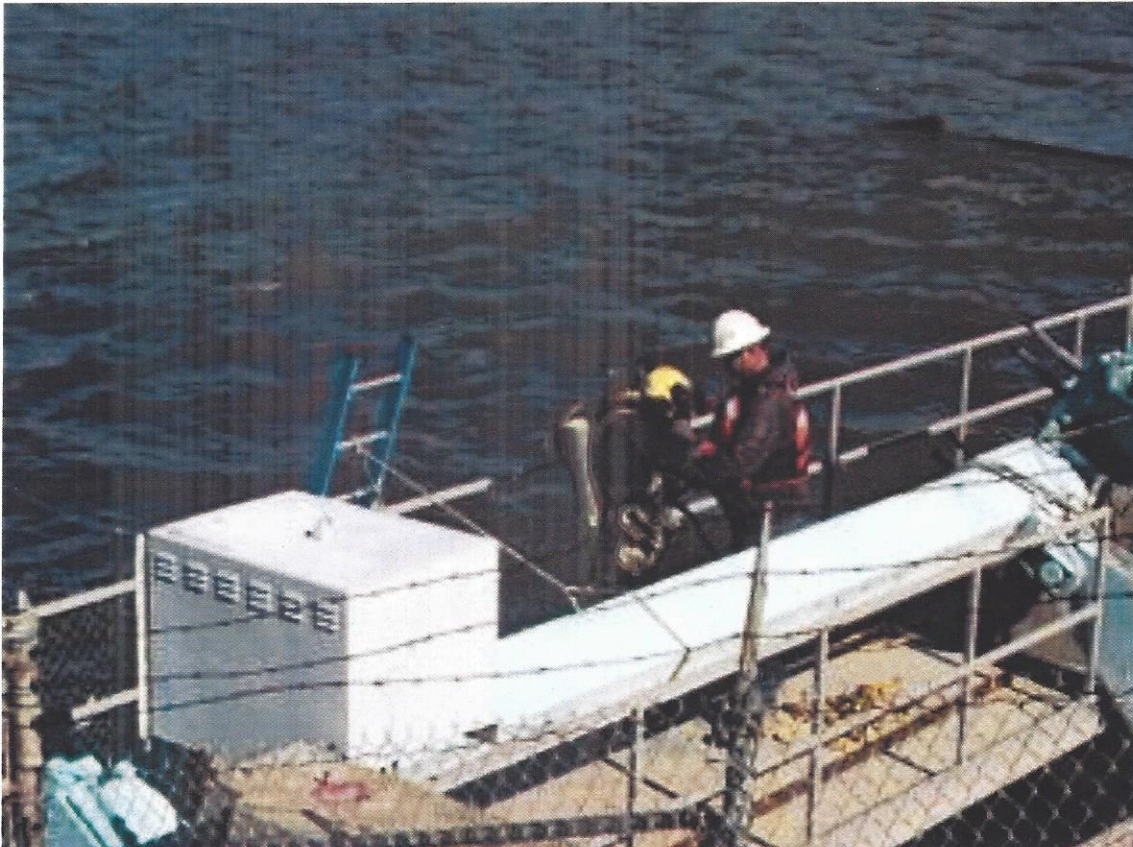
Photo 2: View of the diver getting ready to enter the water from the scaffolding at bay 1.

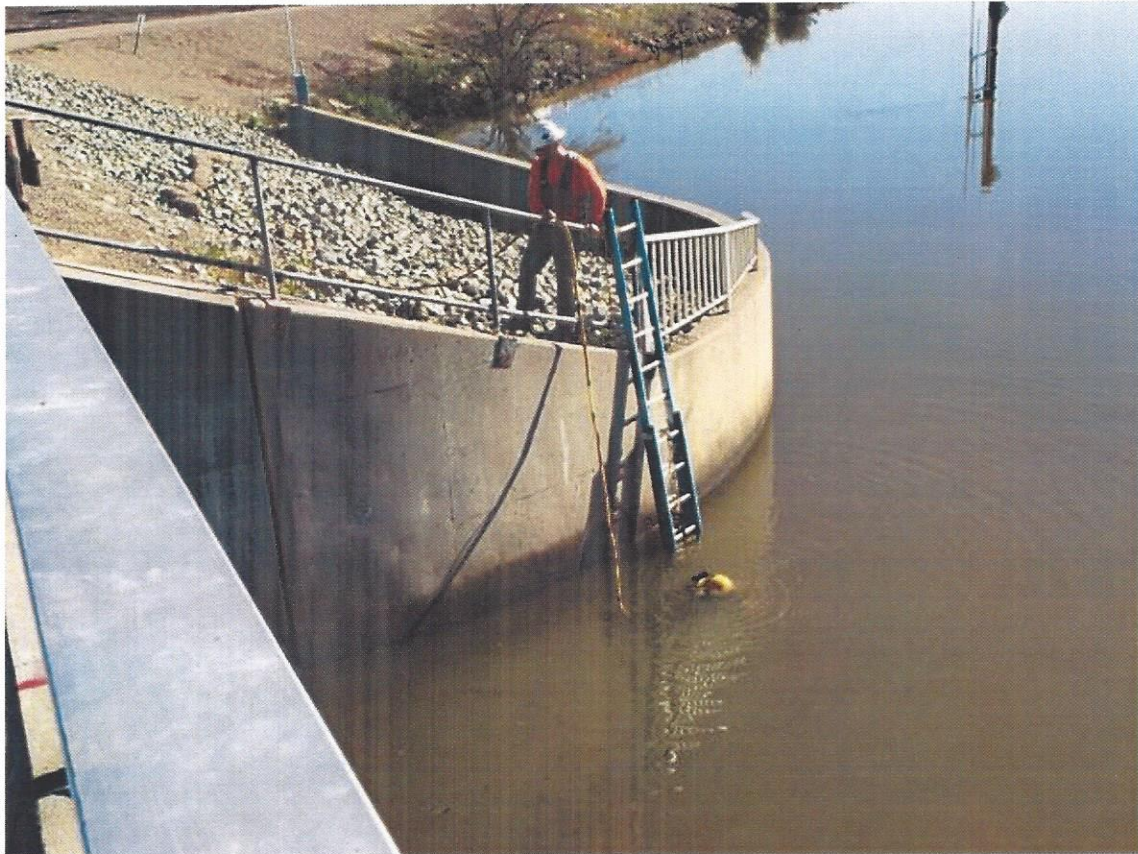
Photo 3: View of the diver entering the water on the approach side of the Intake Structure.

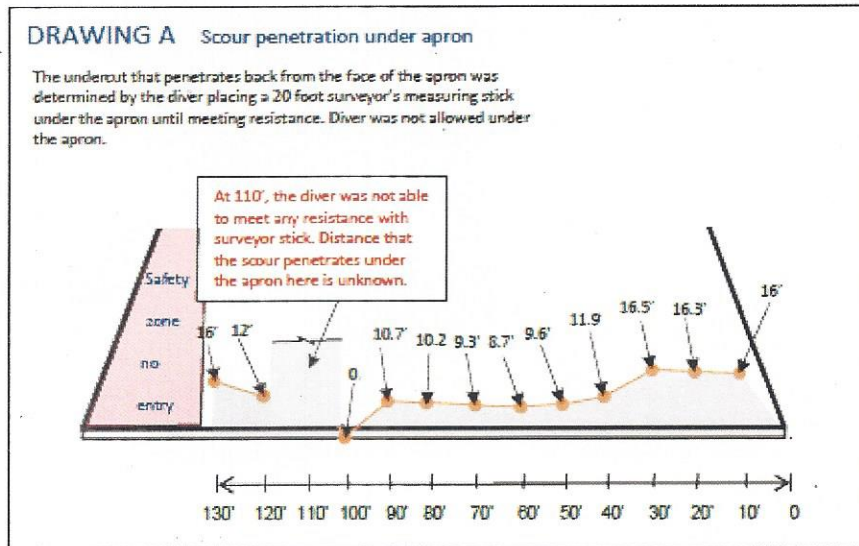
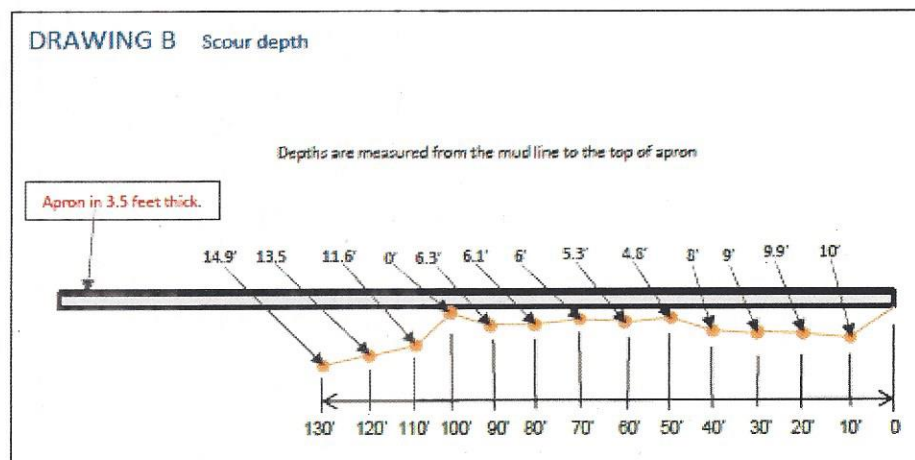
1. SCOURING UNDER THE APRON

The diver started the inspection from the North wing wall. The diver took measurements every 10 feet across the apron toward the South wing wall. Measuring from the end of the apron across from the North wing wall to the South wing wall, the apron measures 175 feet. At each 10 foot distance across the front of the apron, the diver took two measurements. The depth of the scour from the mud line to the top of the apron and the penetration distance under the apron that the scour is traveling from the face of the apron back. These every 10 foot measurements were taken up to 130 feet across the front of the apron. At this point it was determined unsafe to have the diver go any further across closer to the South wing wall due to it being unstable.

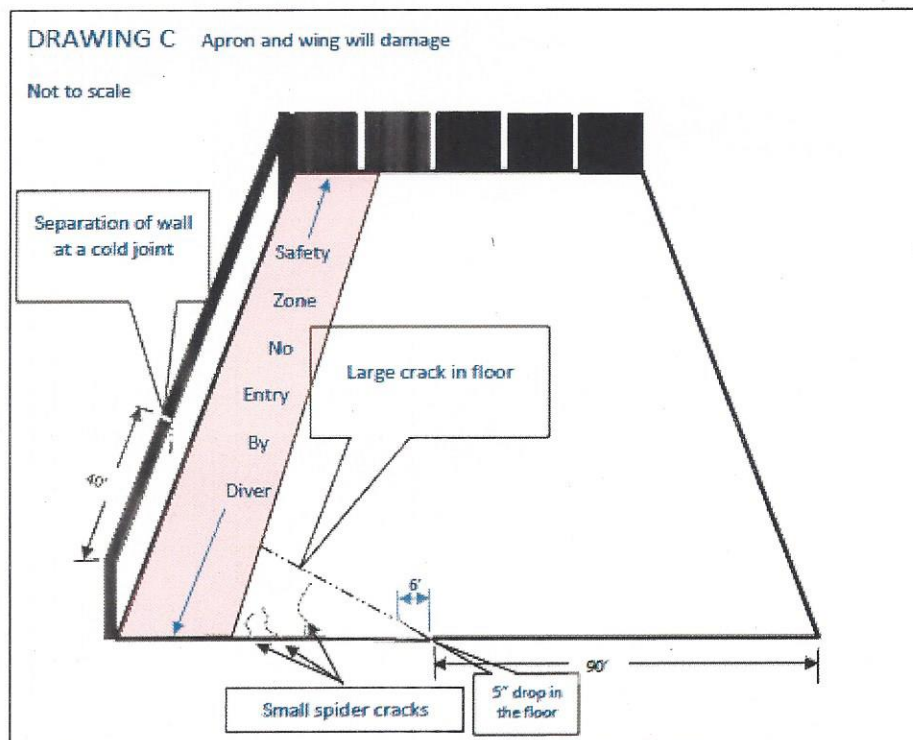
The apron has a large crack along the floor and up the right wing wall and has separated. DRAWING C below indicates the approximate location of crack.
