TO: Jim Sung Senior Engineer, WR	DATE: 4/18/17
FROM: Larry Lopez, PE Engineer, WR	SUBJECT: Clifton Court Forebay Dam Intake Structure Monitoring

INSPECTION REPORT

Facility: Delta Field Division – Clifton Court Forebay Dam
Intake Control Structure: Lat: 37.83 Long: -121.557

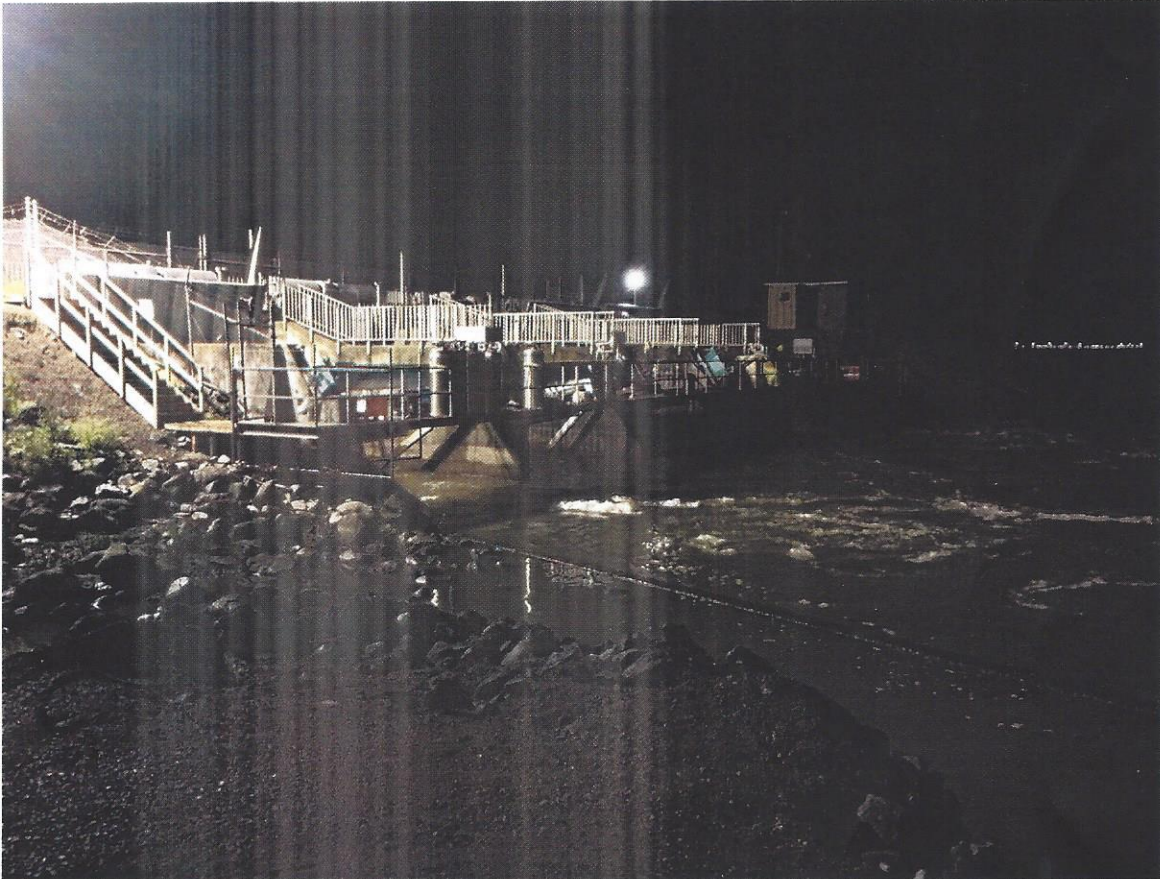
Photo 1- View D/S of Intake control structure from right side during inflows.

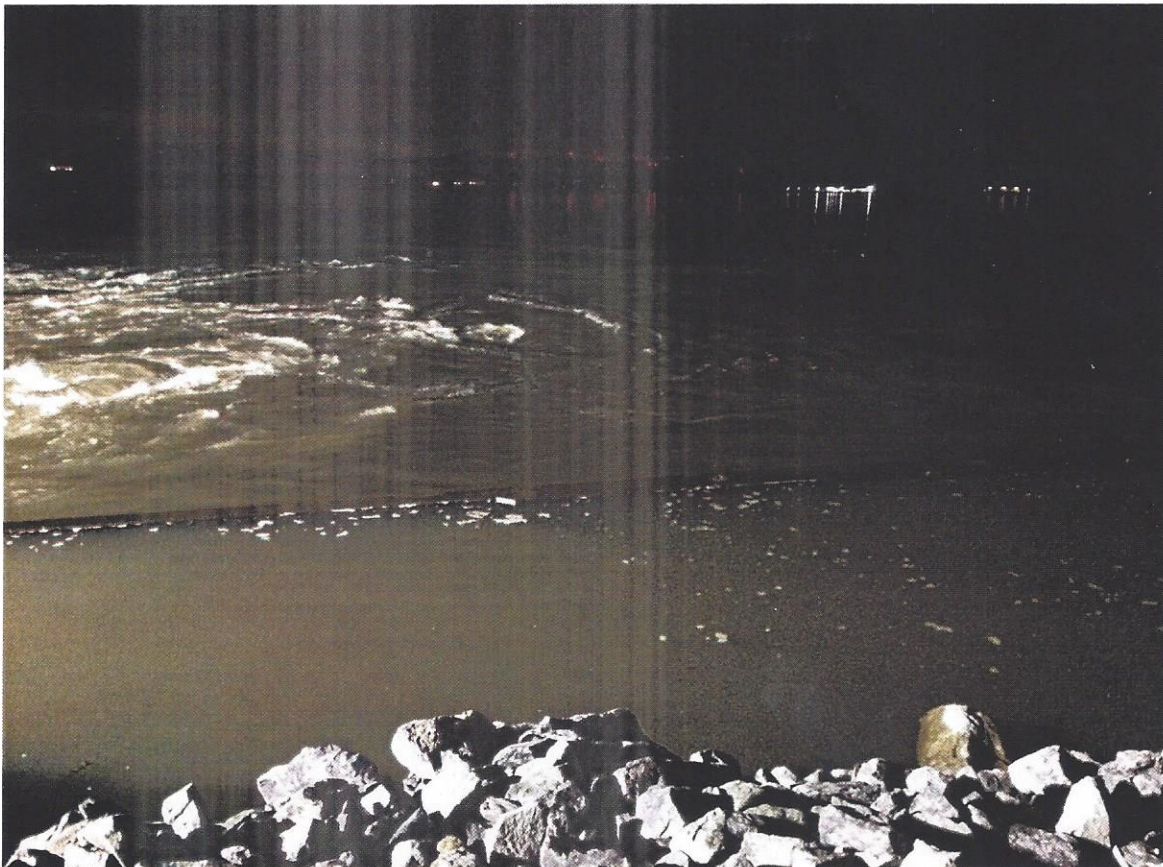
The new repaired wing walls were thicker and were enclosed in steel plates. They were joined to the existing wing walls and the steel plate appeared to overlap a small section of the existing walls.

Photo 2 – View of D/S right wing wall repair and surface turbulence.

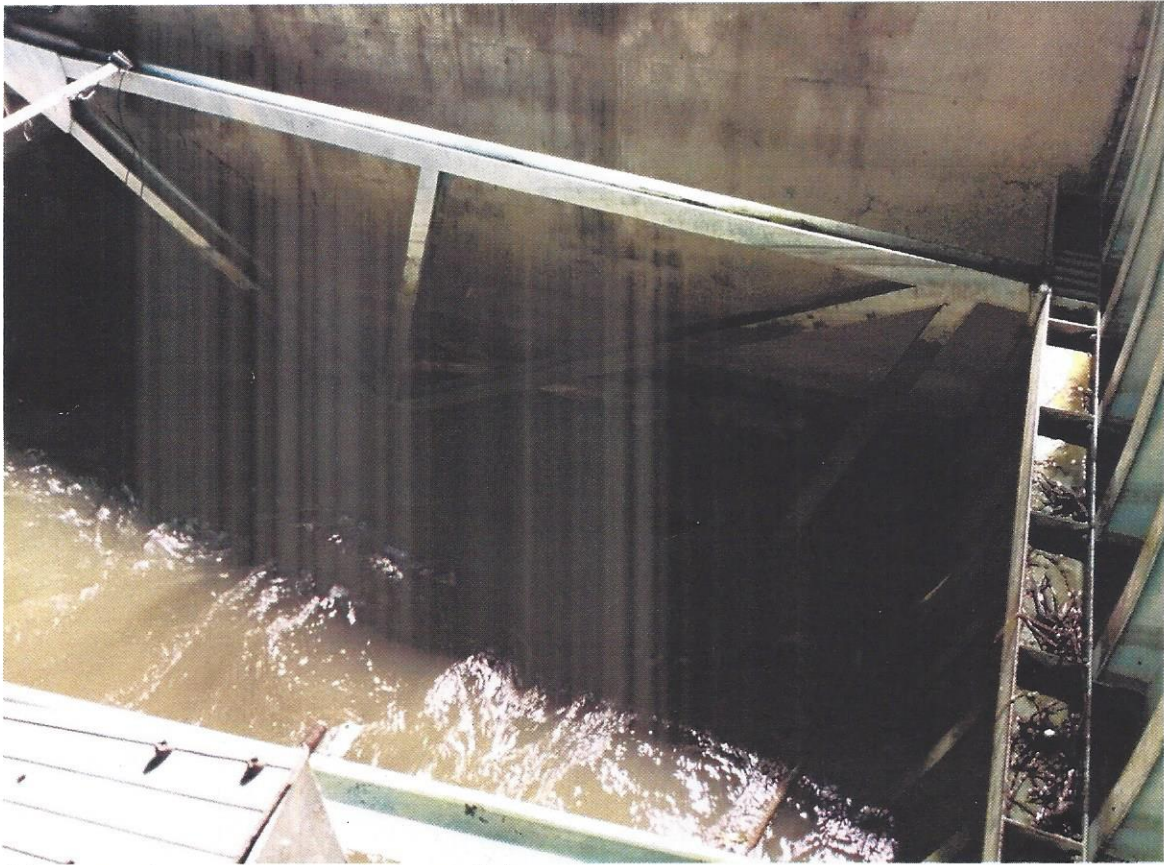
- **21:00 – 21:15 hrs:** Radial Gate No. 1 was raised to 5.0 ft., No. 2 was raised 5.2 ft., & No. 5 was raised 4.0 ft. Gate No. 4 remained closed. We observed small woody debris and several large logs caught in the radial gate arms of Gate 1, 2, & 5. Heavy turbidity was observed D/S of gate No. 5 initially after it opened. After several minutes, the turbidity returned to normal.

Photo 3 – Large log caught in radial gate arm.

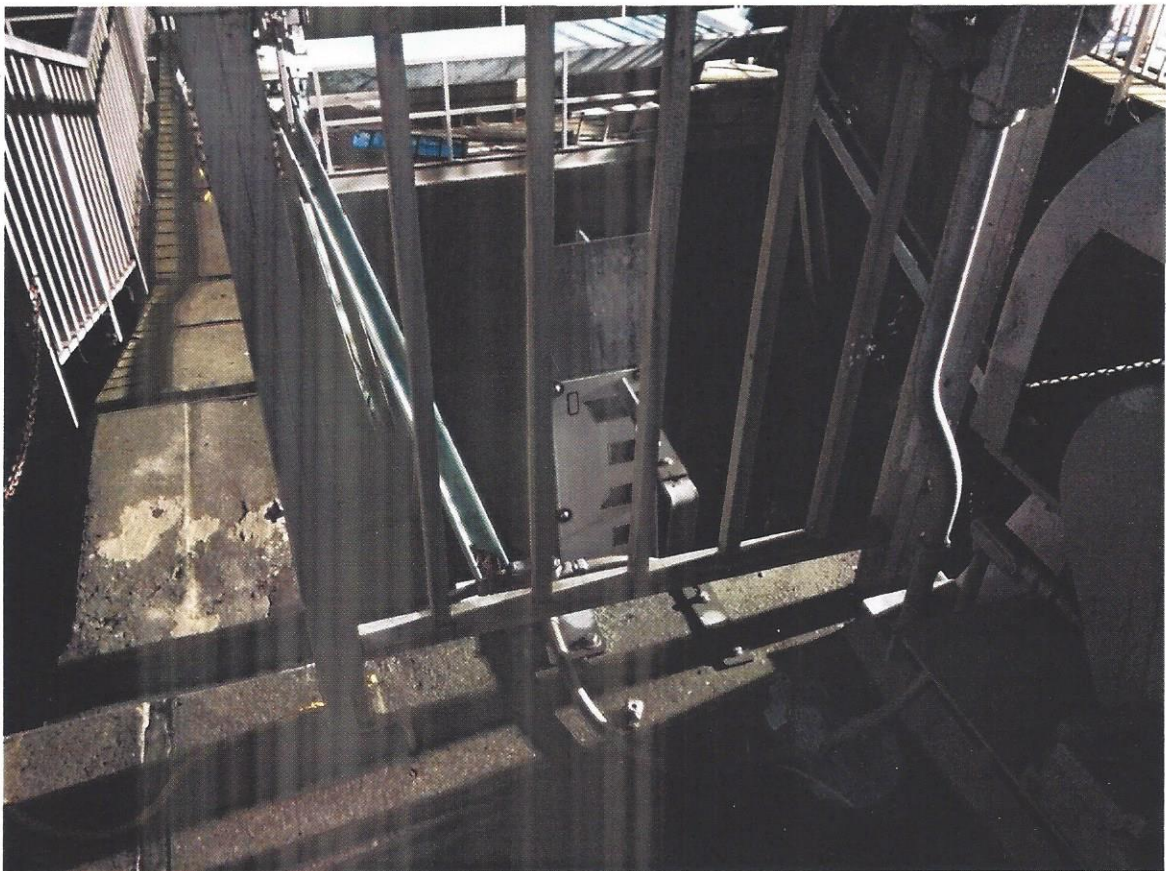
Photo 4 – Staff gauge on end of radial gate (typical).
