State Water Resources Control Board

DIVISION OF WATER RIGHTS SITE OBSERVATION REPORT

Date of Site Visit: 11/08/2023 8:45 AM
Report Author: Connor Bovée
Observation Performed By: Roberto Cervantes, Kathryn Bare, Kenneth Petruzzelli, Tomas Eggers, Connor Bovée
Type: Site Visit
Other Agencies Present: United States Forest Service, Non-Governmental Organizations

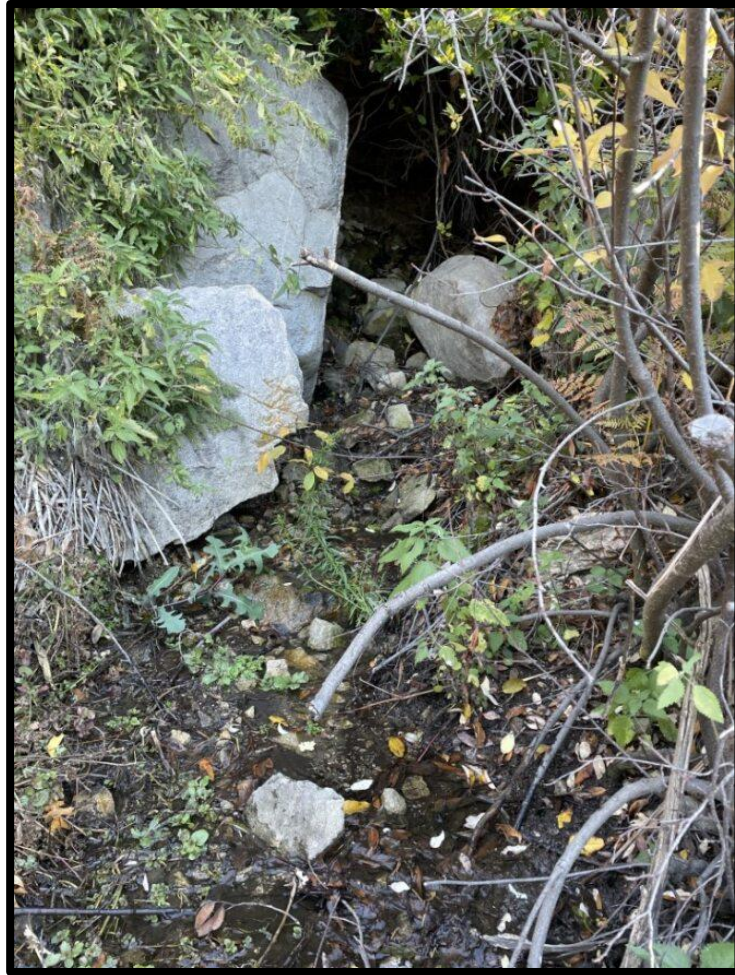
1. Headwaters: Looking at source of water

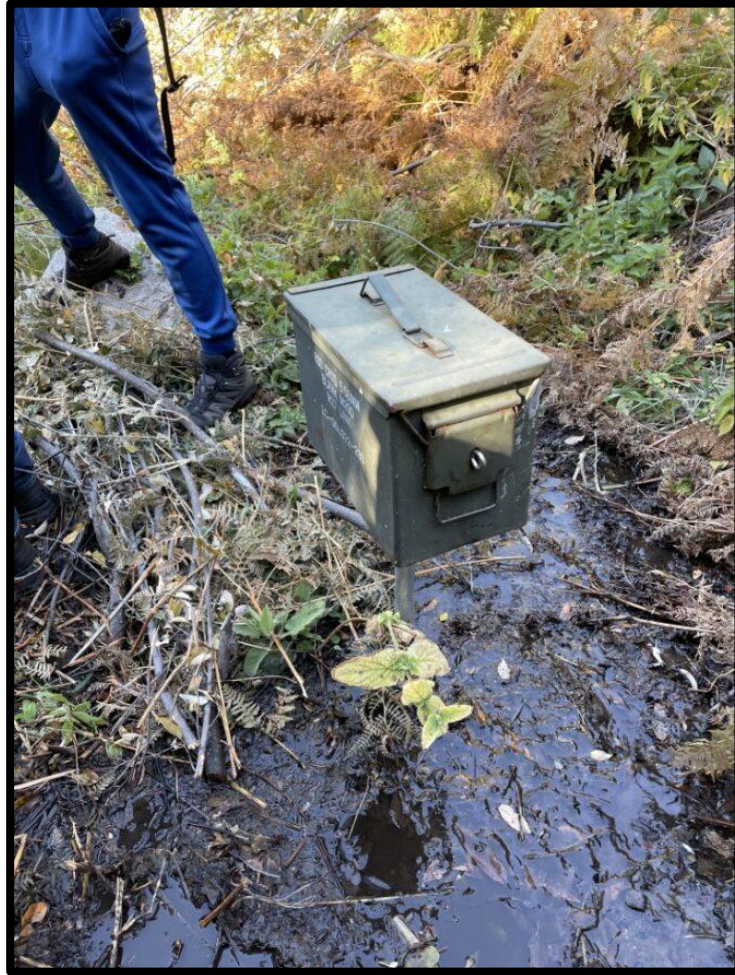
2. Headwaters: Looking at equipment installed downstream of source

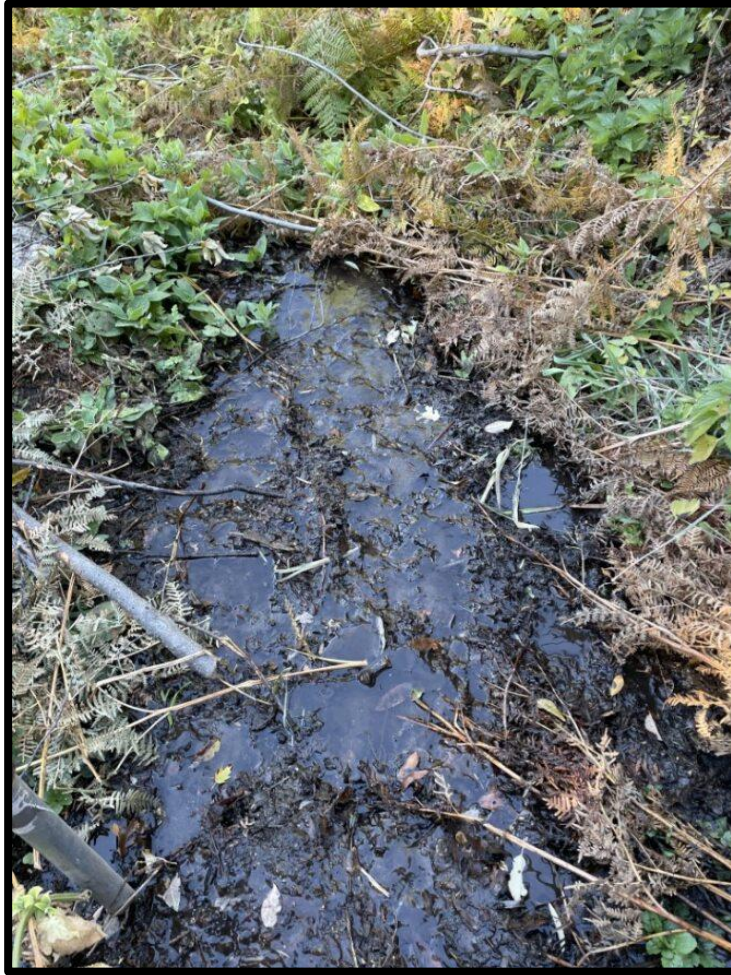
3. Headwaters: Looking at flow downstream from source

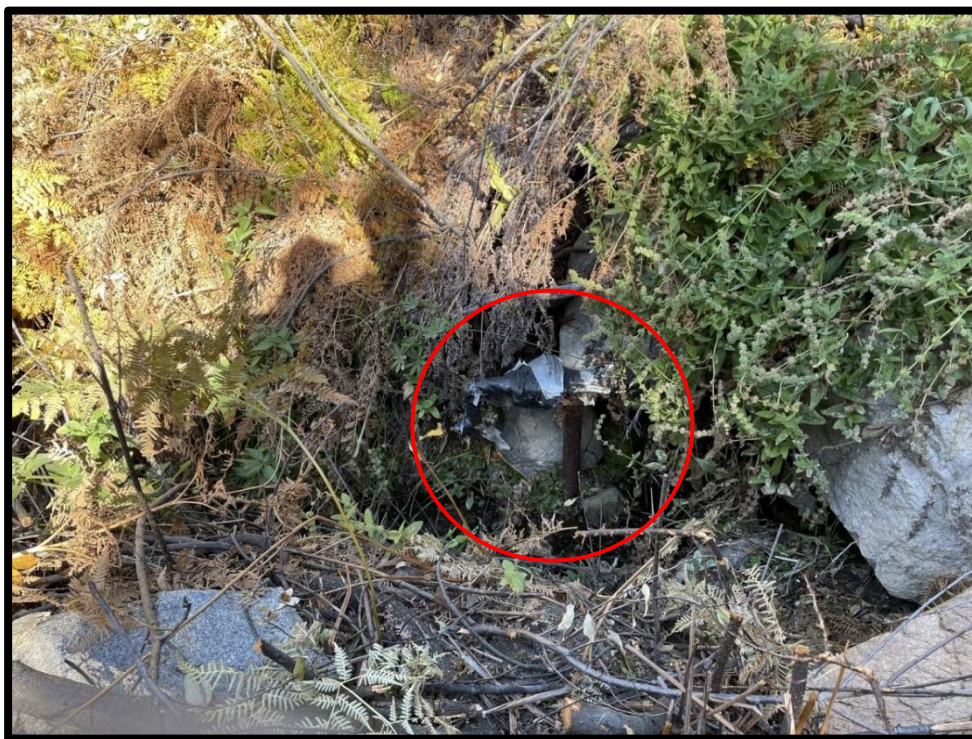
4. Headwaters: Looking at abandoned infrastructure at source

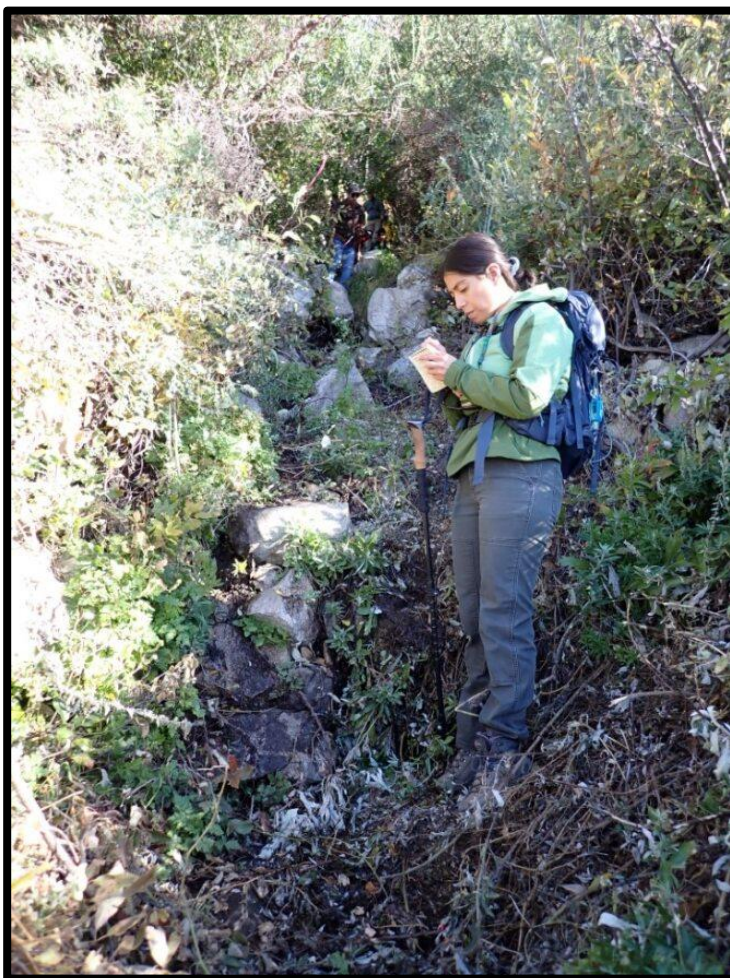
Spring ID:	Strawberry Creek Headwaters Spring (A006108)
Lat/Long:	34.229°, -117.234°
Description:	<p>During the site visit, flow was observed coming out of Headwaters Spring. This visible surface flow was observed to dry up approximately 300 feet downstream of the headwaters. This measurement was taken by SWRCB staff using a laser range finder. The site is located approximately 540 feet southwest of the meeting location. See photos 1-5 in the photo log for additional information.</p>
Spring ID:	Spring 1A
Lat/Long:	34.228°, -117.234°
Description:	<p>Infrastructure at this spring consisted of a small, enclosed vault made of cinderblocks with a metal pipe protruding from the bottom of the vault. No visible surface flow and no diversions were observed at this site during the site visit.</p> <p>The site is located approximately 250 feet south of the headwaters. See photo 6 in the photo log for additional information.</p>

5. Headwaters: Looking at location where water from source is no longer visible on the ground surface

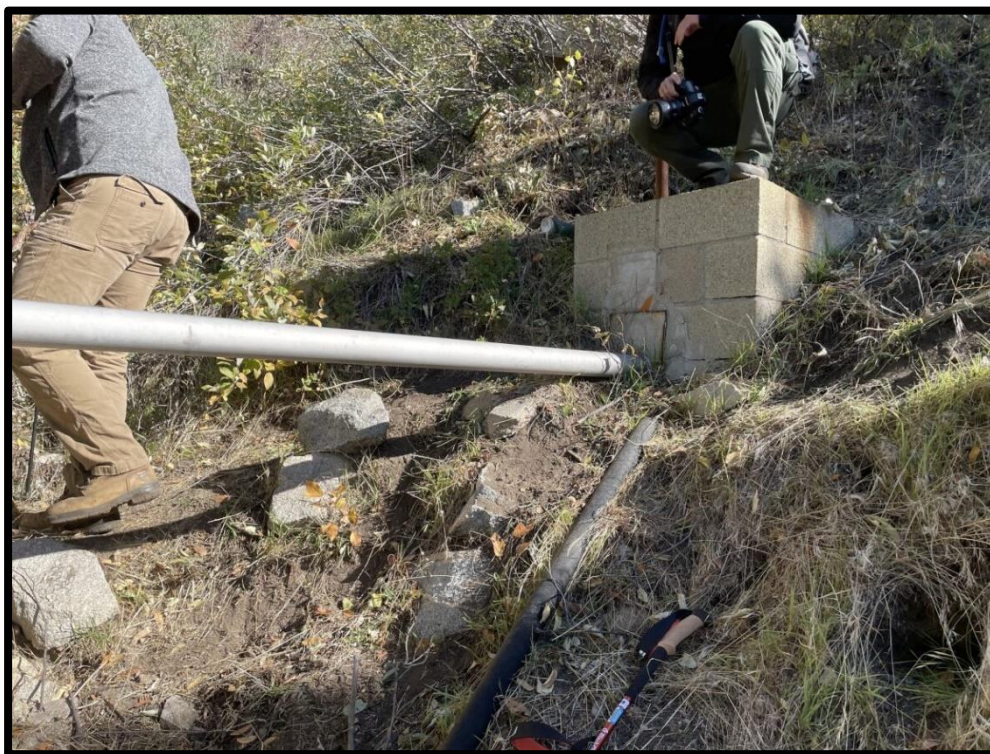
6. Spring 1A: Looking at infrastructure at site

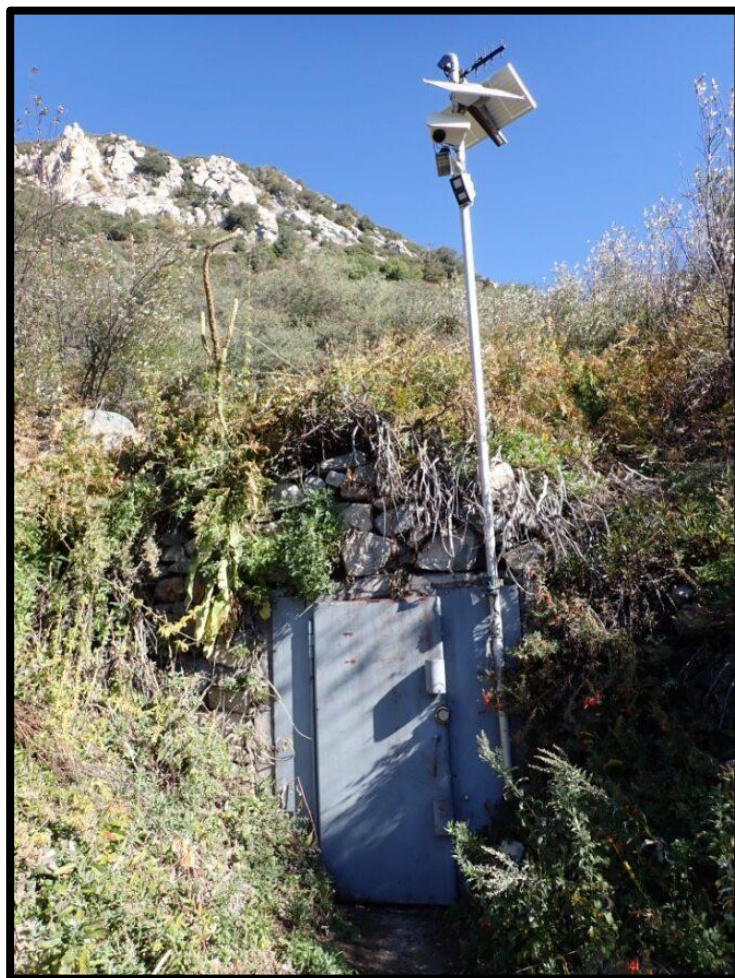
Description: The infrastructure at this spring consisted of a large, enclosed vault made of concrete encased in stone with pipes coming out of multiple locations. Two pipes protruded from the bottom of the vault going in a southeasterly direction.

7. Spring 2: Looking at infrastructure at site

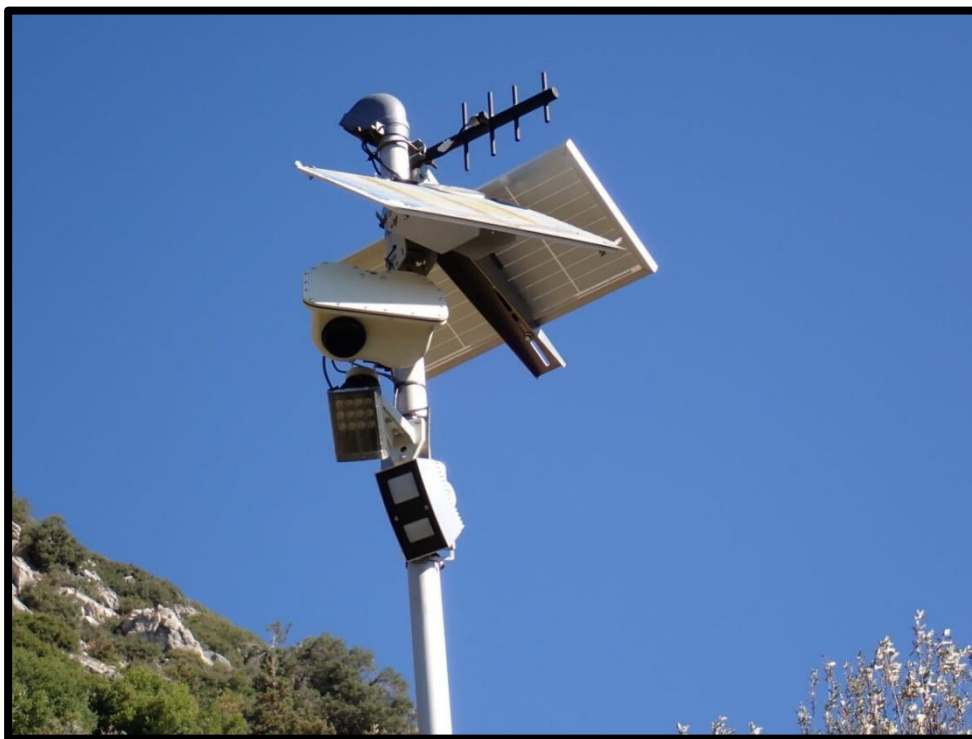
A metal pole was mounted to the front of the vault and extended upwards beyond the top of the enclosure. The base of the metal pole clearly goes inside the metal enclosure. Partway up the pole there was a trail camera. At the top of the pole were various cables connecting two solar panels, an antenna, what appeared to be another camera and some lights that were not on during the site visit.

8. Spring 2: Looking at equipment installed at top of pole

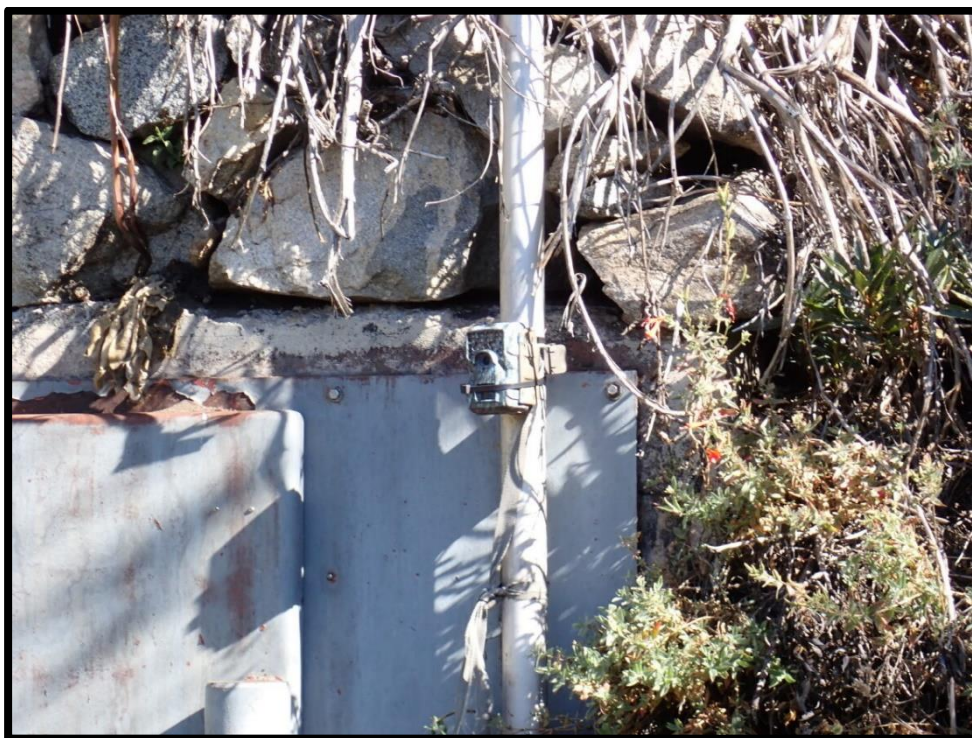
9. Spring 2: Looking at trail camera installed partway up pole

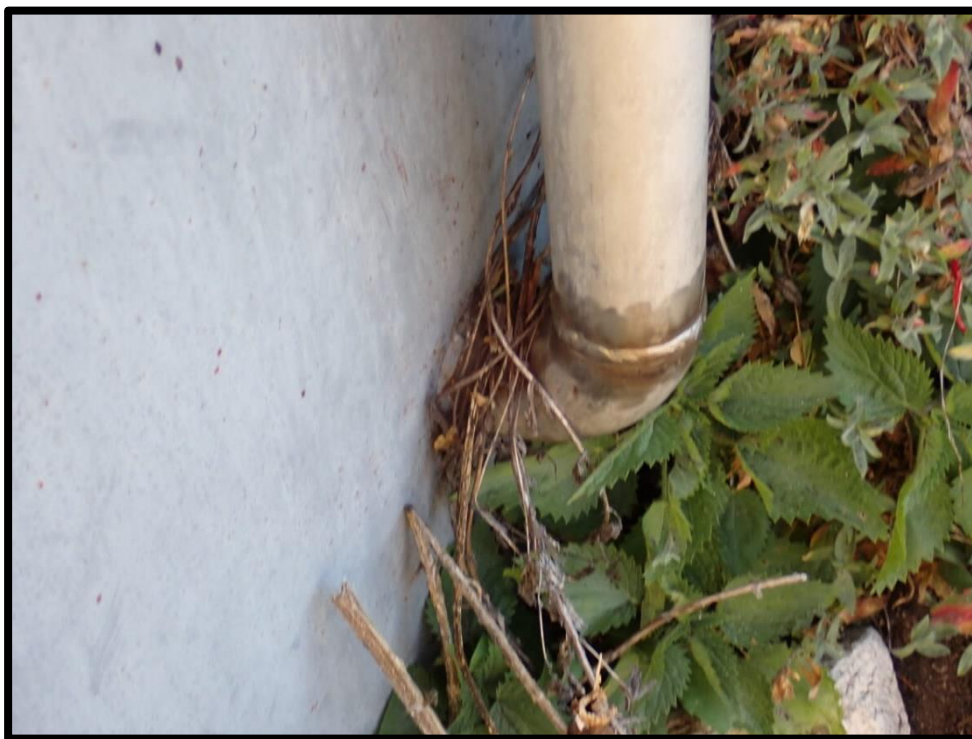
10. Spring 2: Looking at base of pole going into vault

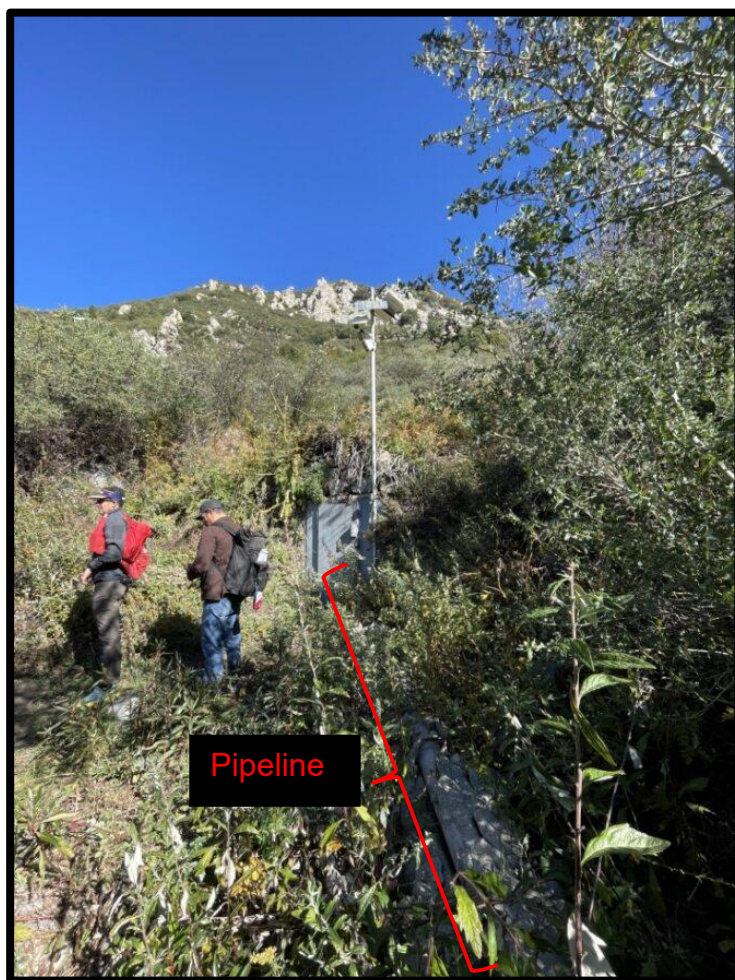
11. Spring 2: Looking upslope towards infrastructure from discharge pipeline

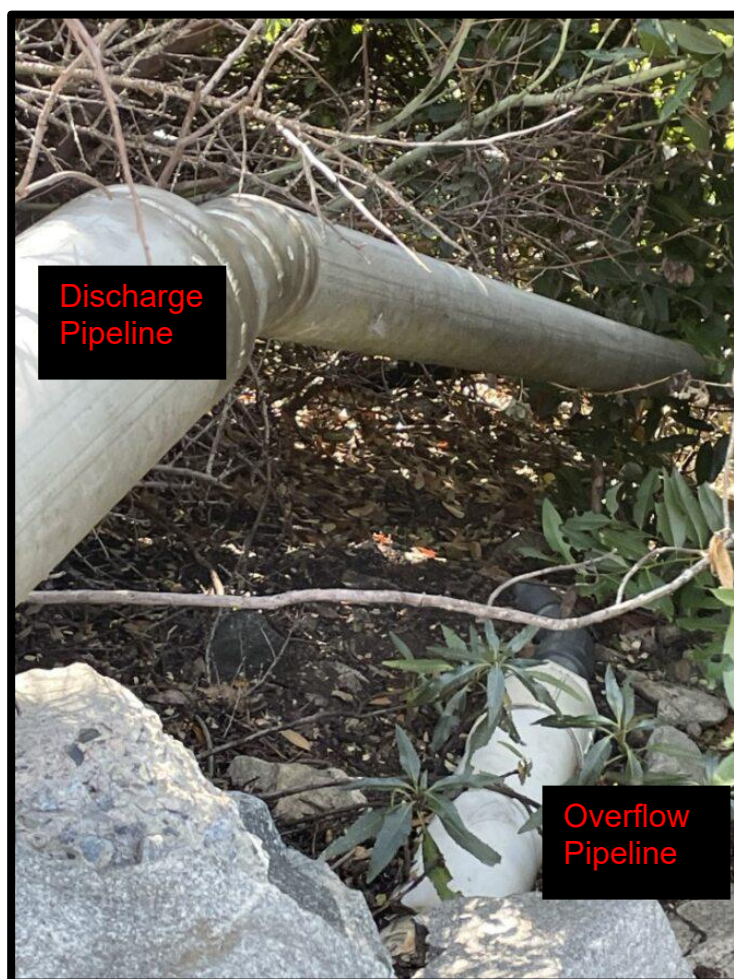
The topmost pipe was made of metal and was approximately 4-6 inches in diameter. Water could be heard and felt flowing through this pipe going toward an unseen location.

The bottommost pipe was made of a plastic material and appeared to act as an overflow system for the top pipe.

12. Spring 2: Looking at discharge pipeline and plastic overflow pipe

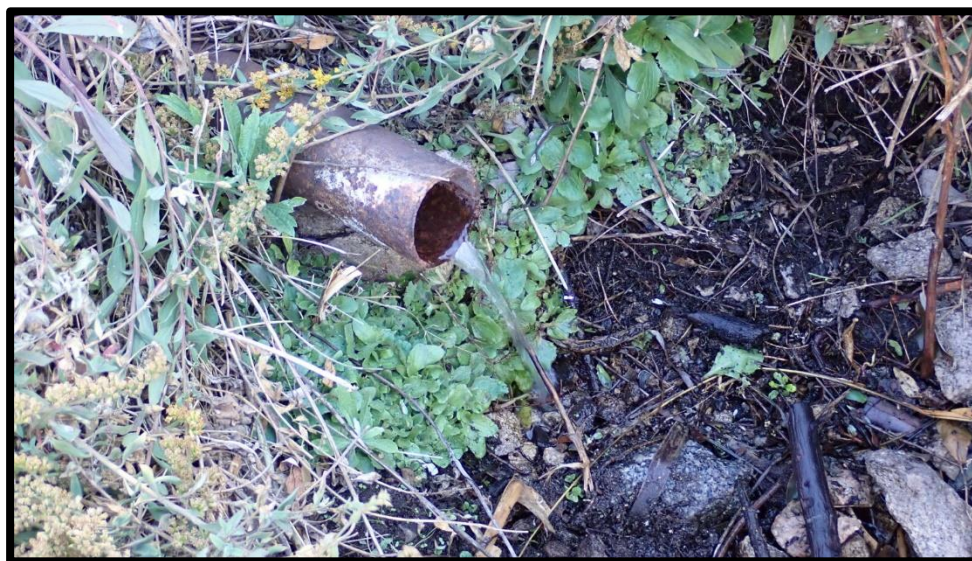
Another metal pipe came out of the bottom of the vault going south. This pipe appears to act as the overflow for the entire vault. During the site visit, flow was observed coming out of the end of the pipe. SWRCB staff took a flow measurement using a bottle and stopwatch of approximately 0.88 gallons per minute.

13. Spring 2: Looking at flow out of vault overflow pipe

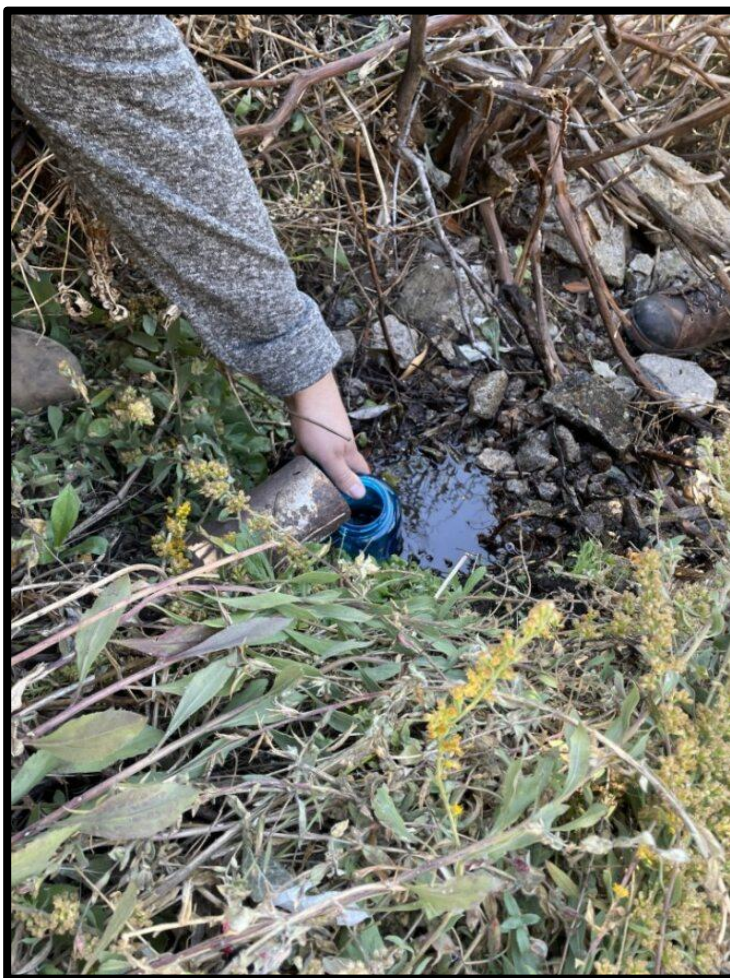
14. Spring 2: Looking at SWRCB staff taking flow measurement at vault overflow pipe

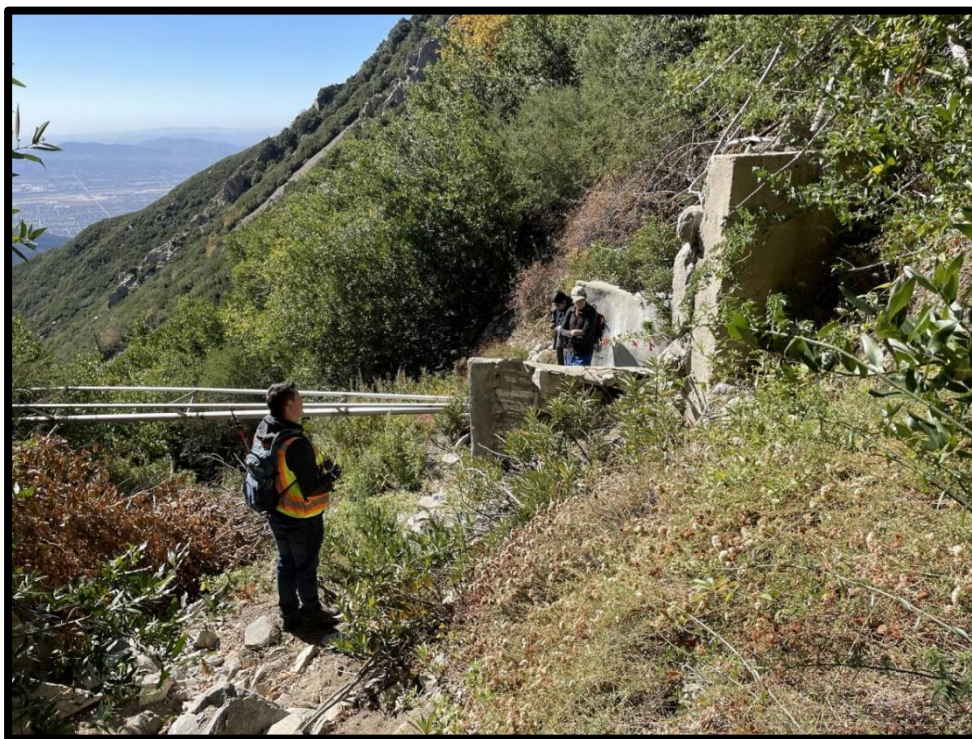
Spring ID: **Spring 3**
Lat/Long: 34.228°, -117.236°
Description: The infrastructure at this spring consisted of a large, enclosed vault made of concrete and encased in stone with pipes coming out of multiple locations.

15.Spring 3: Looking at infrastructure at site

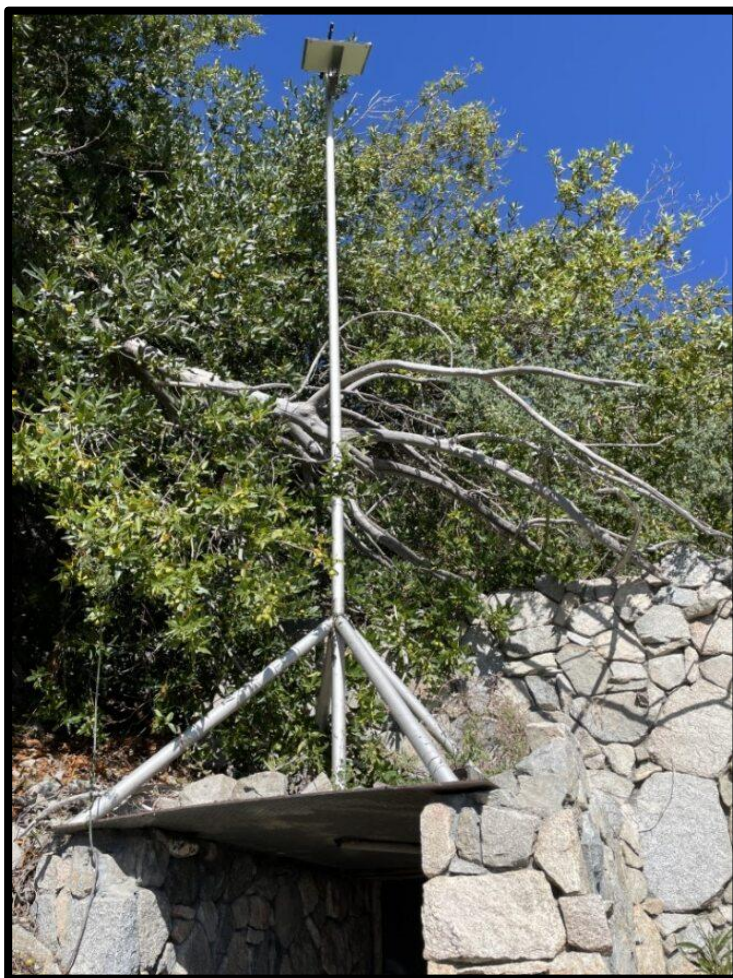
Coming out of the top of the vault was a metal pole at the top of which were some cables connected to a solar panel and an antenna. The base of this metal pole could be seen going into a conduit that ran into the bottom of the vault.

16. Spring 3: Looking at equipment installed at top of pole

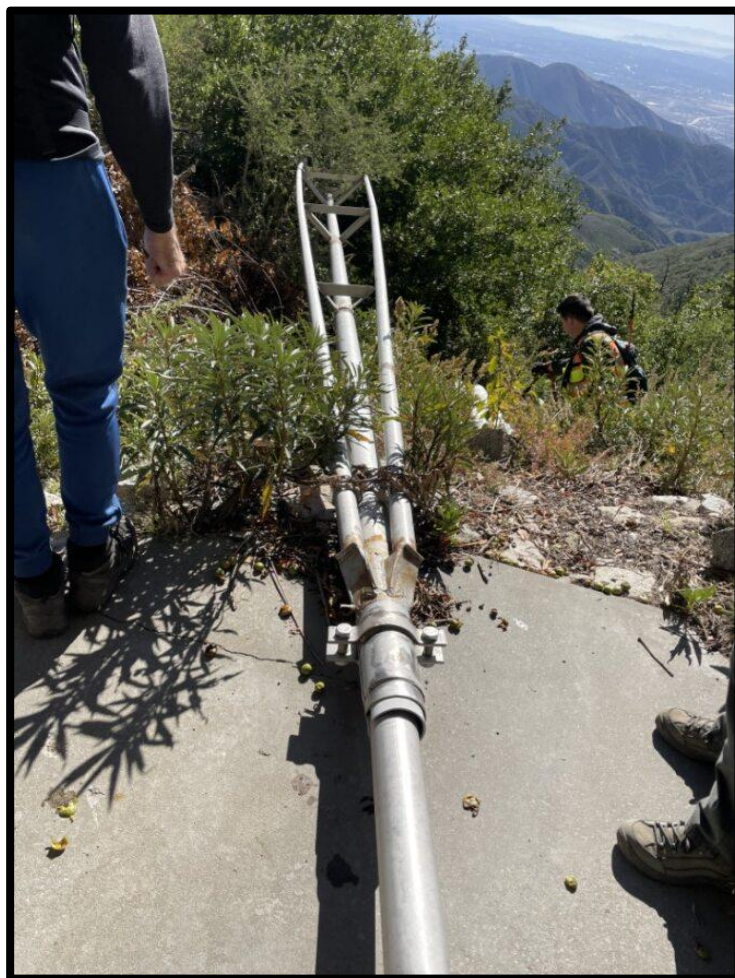
The main diversion pipe leaves from the bottom of the vault and heads southeast to an unseen location. This pipe is supported by a metal frame welded onto its exterior.

17. Spring 3: Looking at discharge pipeline from vault

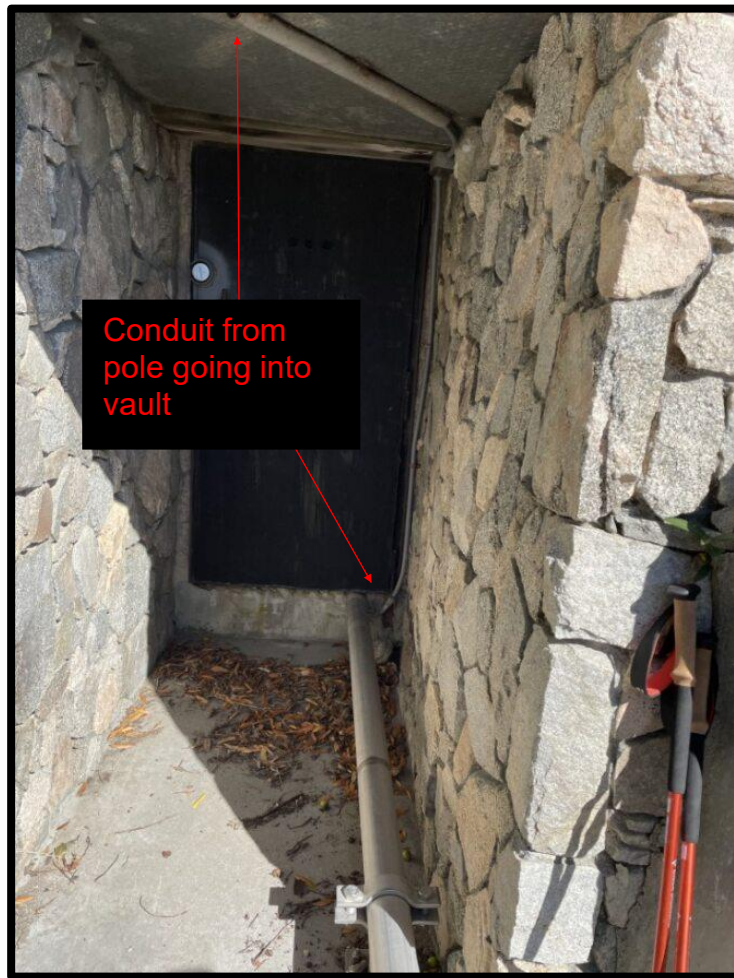
18. Spring 3: Looking at vault from discharge pipeline

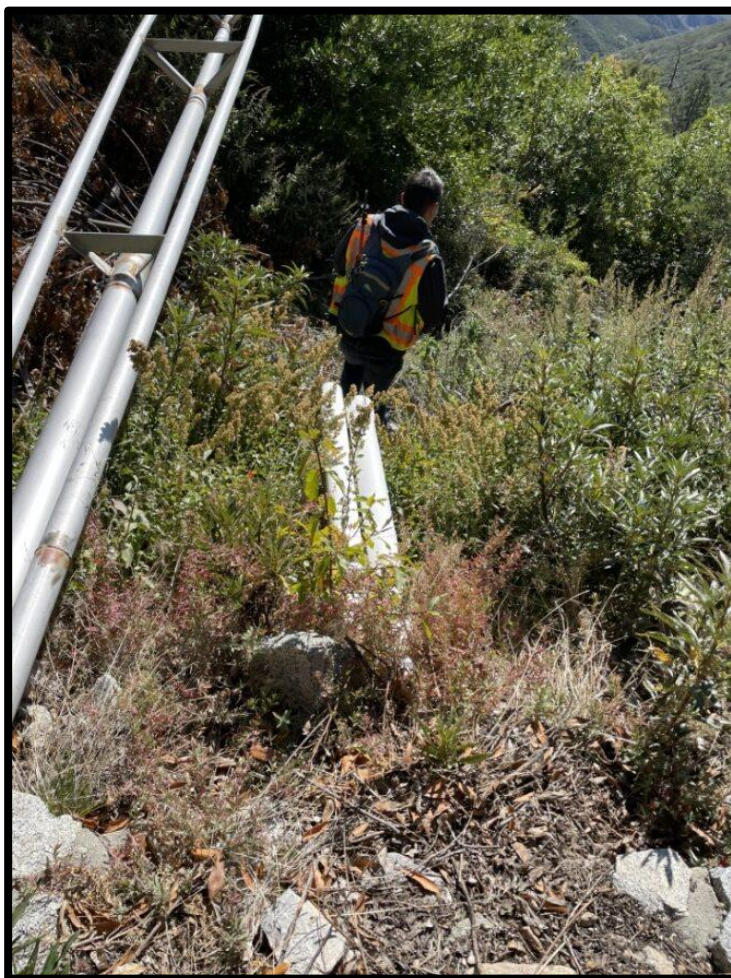
19. Spring 3: Looking at overflow pipes from vault

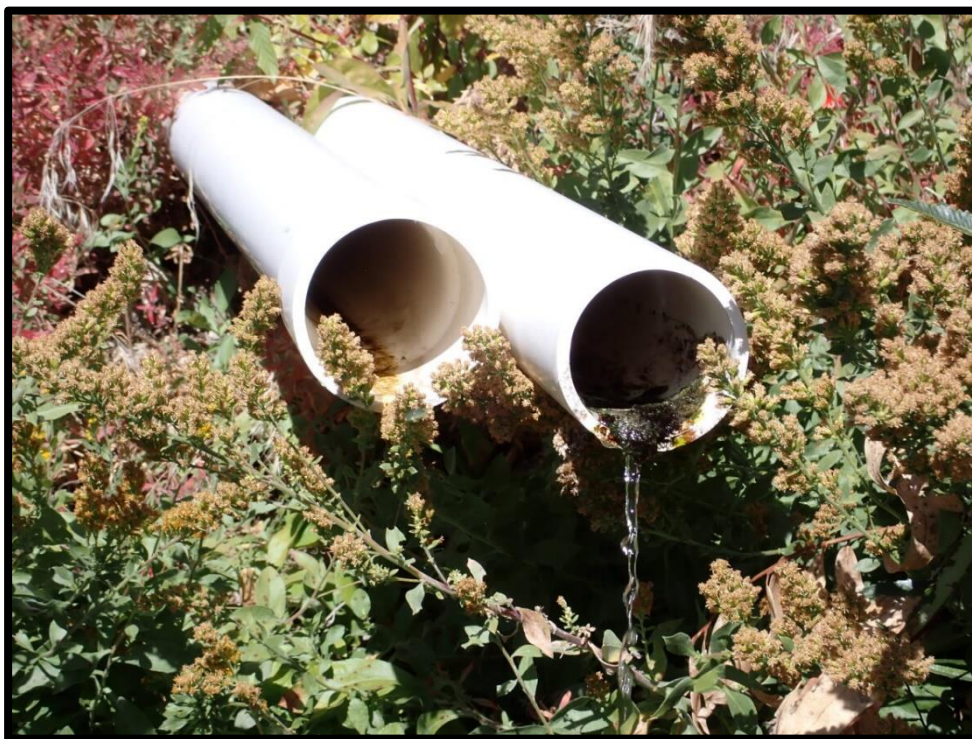
Below that pipe are two pipes made of a plastic material that appear to act as the overflow for the vault. Flow could be seen discharging from the end of one of the two pipes. SWRCB staff took a flow measurement using a bottle and stopwatch; the flow was approximately 0.21 gallons per minute.

20. Spring 3: Looking at flow coming out of one overflow pipeline

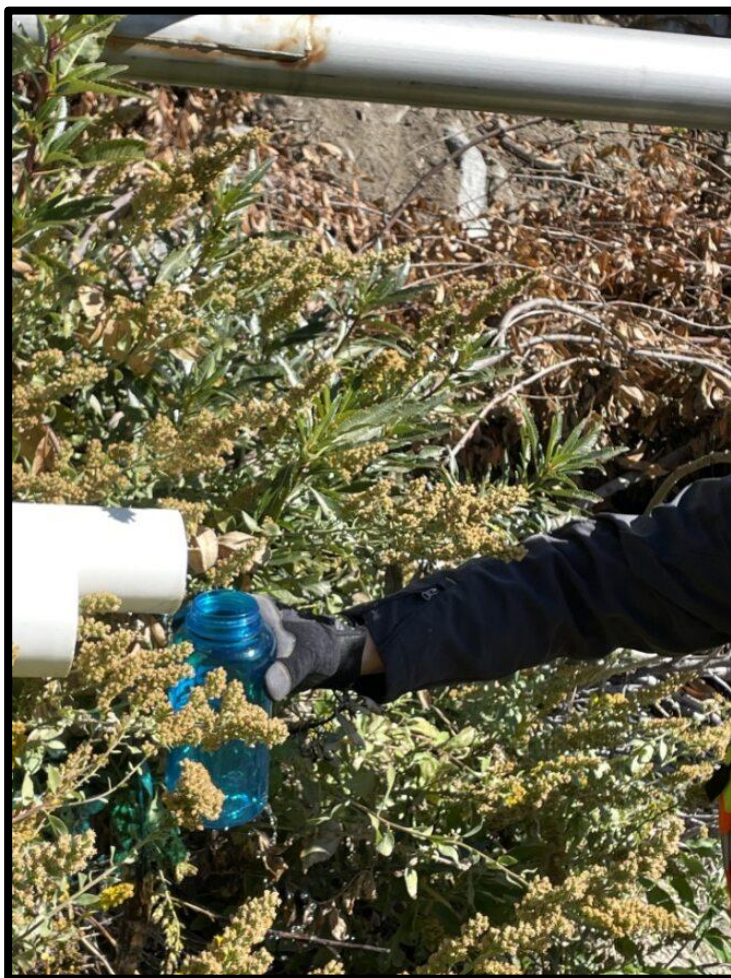
21. Spring 3: Looking at SWRCB staff taking flow measurement at vault overflow pipe

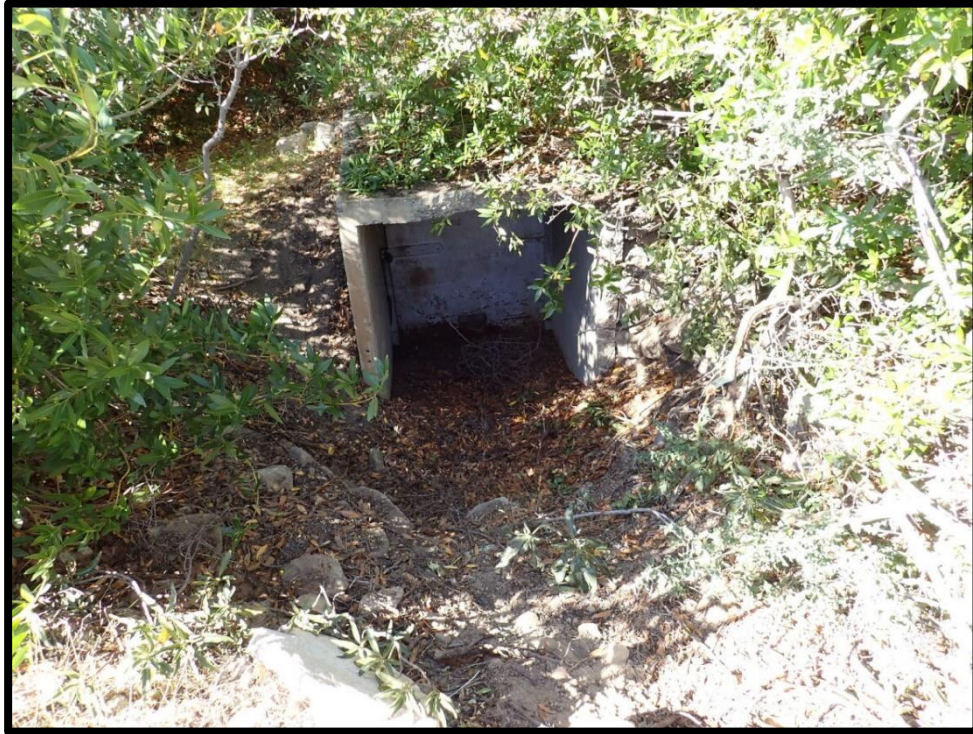
Spring ID: **Spring Tunnel 7**
Lat/Long: 34.226°, -117.229°
Description: The infrastructure at this spring consisted of a large, enclosed vault made of concrete. The vault sits at the bottom of a depression in the landscape created by a stone embankment. Staff did not observe any pipes at this site.

22. Spring Tunnel 7: Looking at infrastructure at site

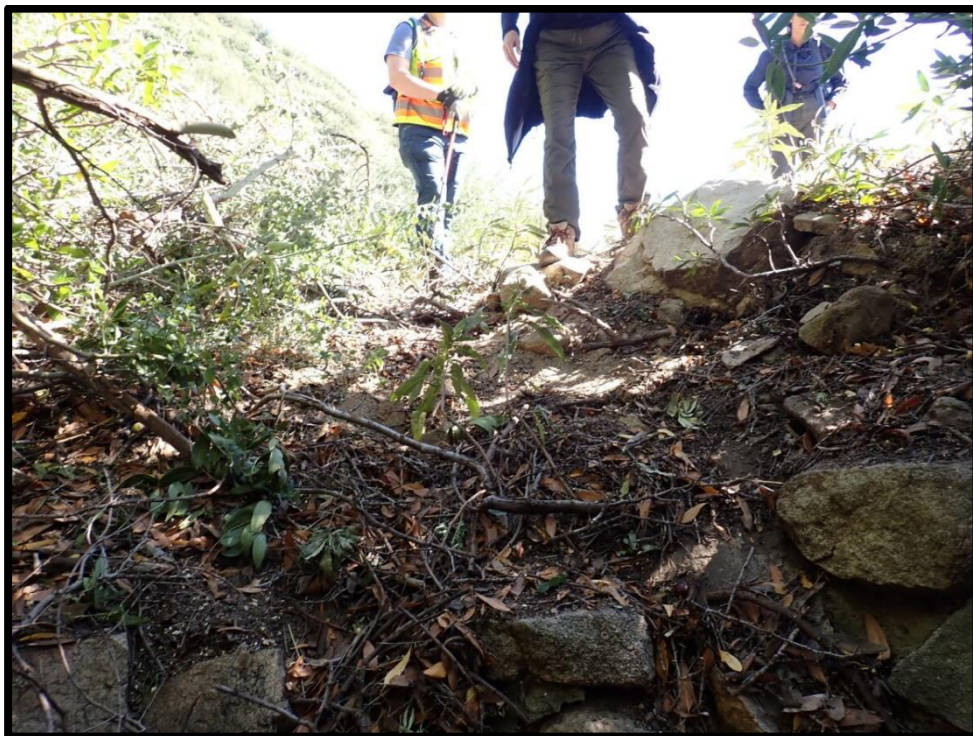
23. Spring Tunnel 7: Looking towards stone embankment

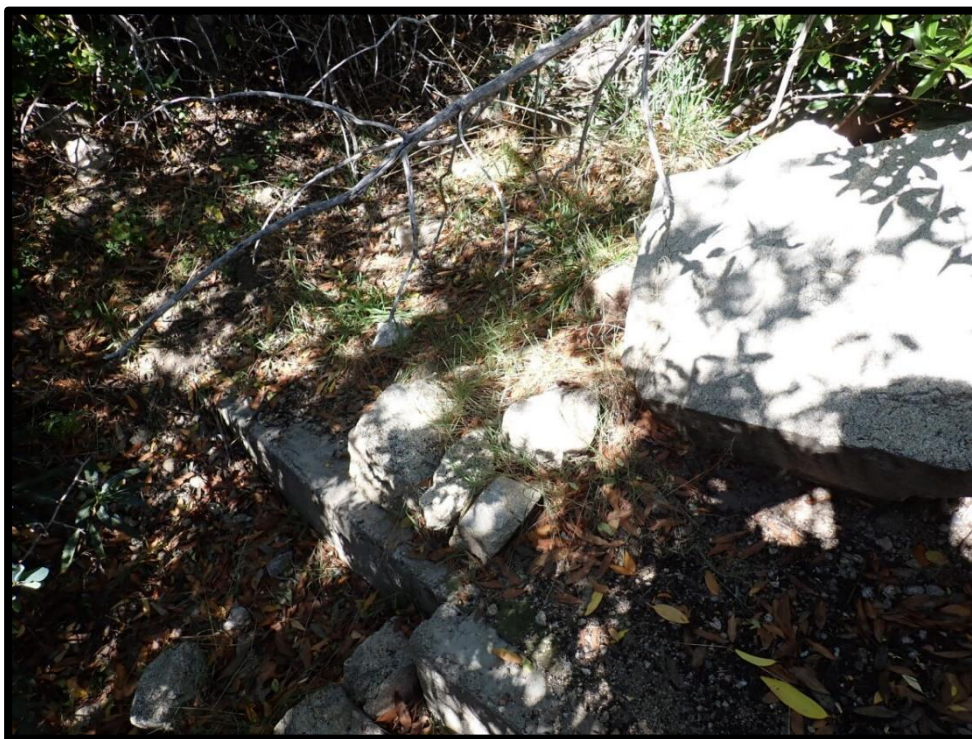
24. Spring Tunnel 7: Looking behind infrastructure at site

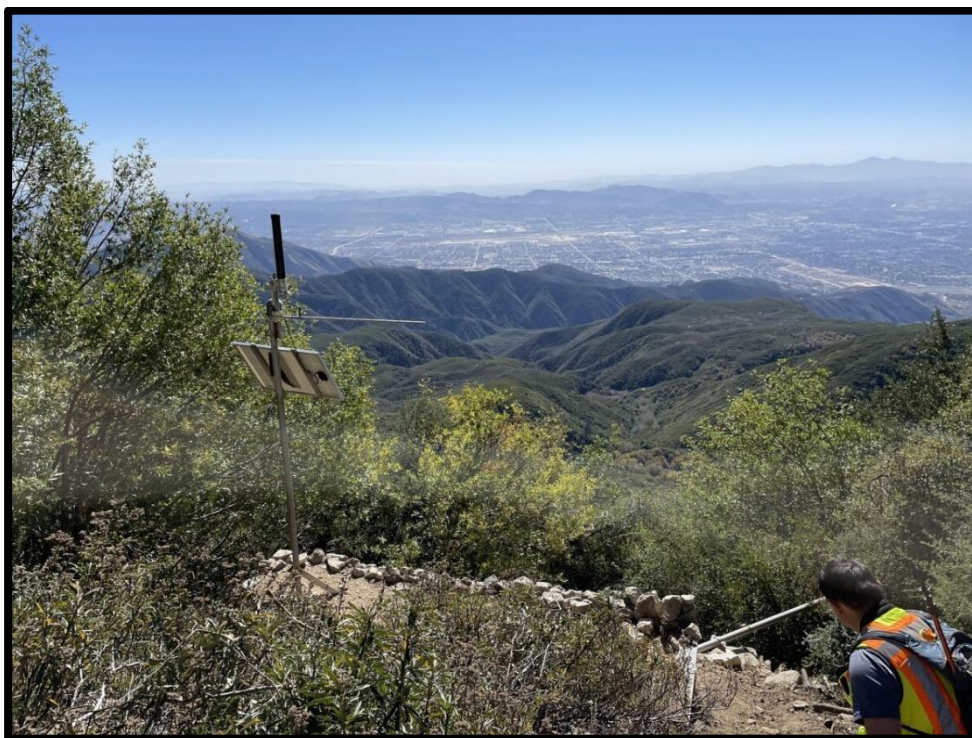
Spring ID: **Spring 7 ABC**
Lat/Long: 34.226°, -117.230°
Description: Infrastructure at this spring consisted of a large, enclosed vault made of concrete and encased in stone with pipes coming out of the vault at multiple locations. This site contains a total of four boreholes (7, 7A, 7B, and 7C).

25. Spring 7ABC: Looking at top of site containing boreholes 7, 7A, 7B, and 7C

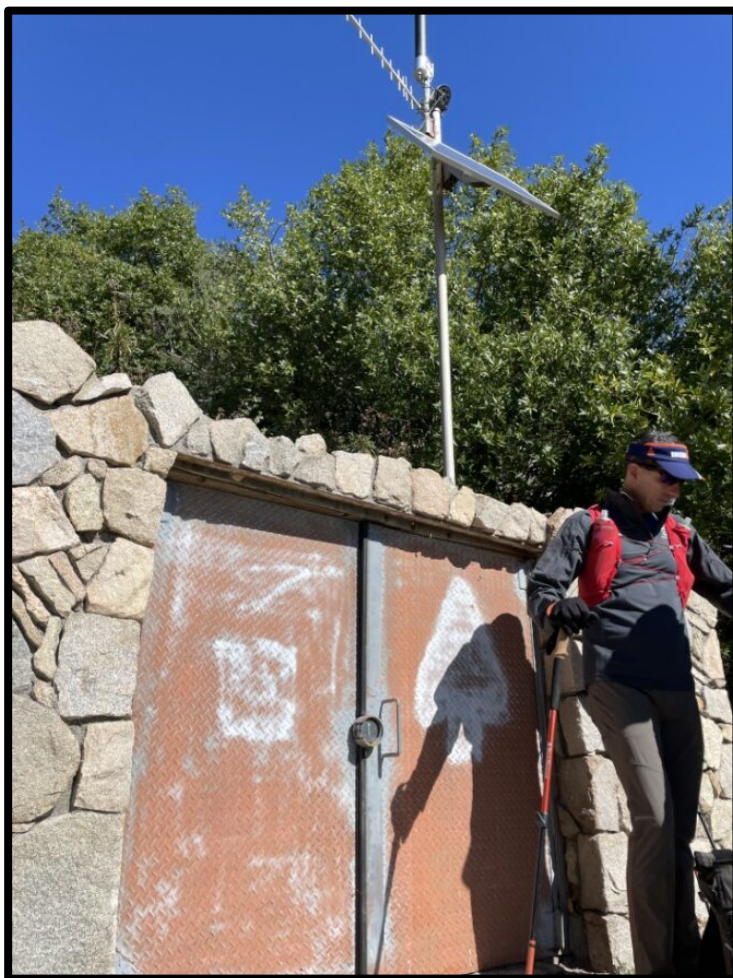
26. Spring 7ABC: Looking at infrastructure at site

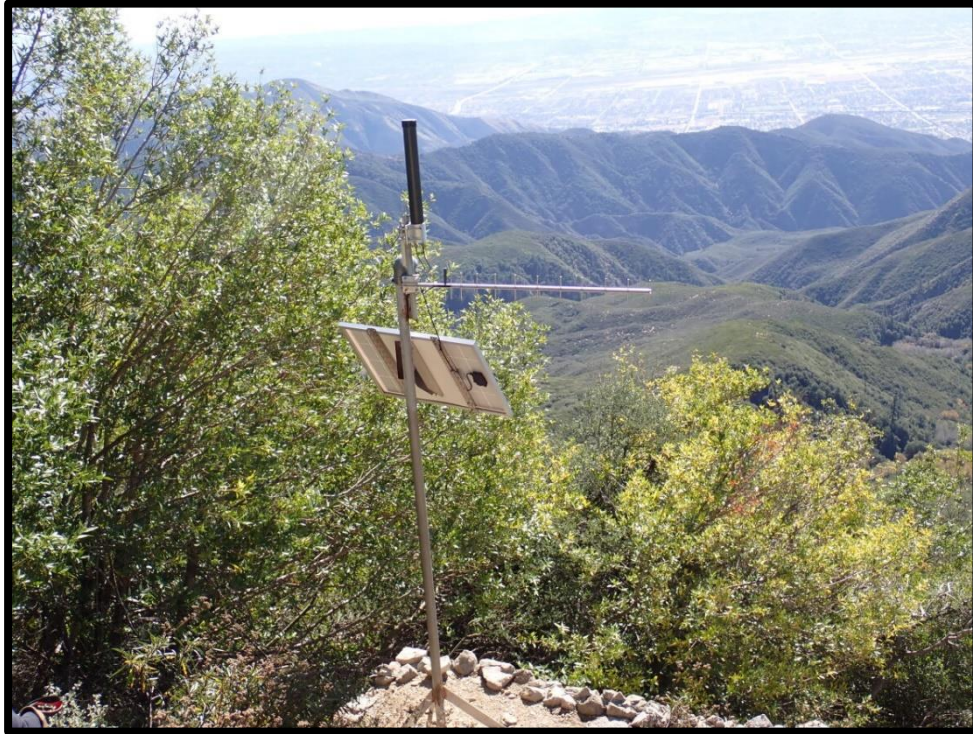
A metal pole protruded from the top of the vault where cables connected to a solar panel, an antenna, a camera, and another device that the group was unable to discern the purpose of. SWRCB staff commented that the device bears a strong resemblance to antennas used for telemetry devices in remote areas. USFS staff added that this area had the weakest cell signal out of all the sites so a stronger antenna might be necessary to transmit data collected at this site.

27. Spring 7ABC: Looking at equipment installed at top of pole

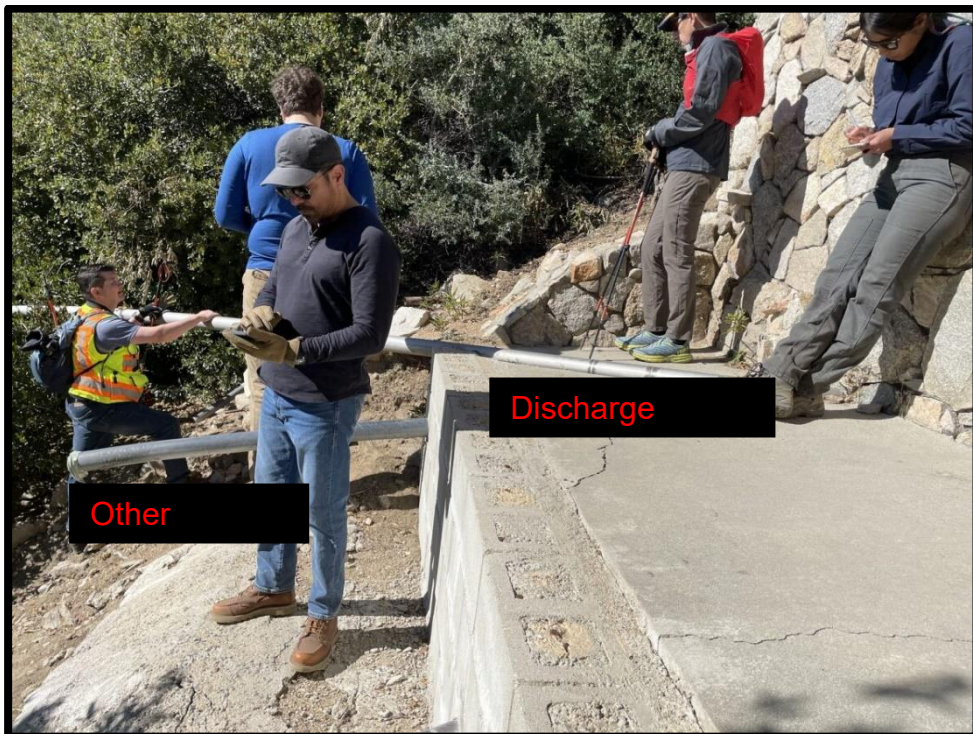
The main diversion pipeline leaves from the bottom of the vault and goes southwest. The end of this pipeline could not be observed from the site.

28. Spring 7ABC: Looking at discharge pipeline and other pipeline

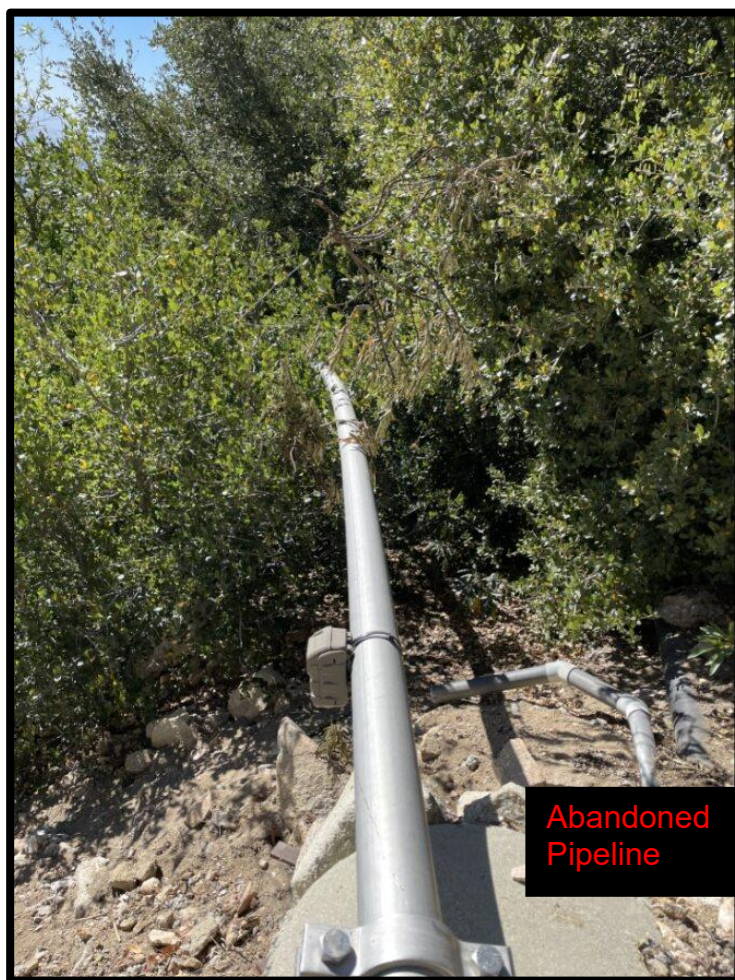
29. Spring 7ABC: Looking at discharge pipe and other abandoned pipes

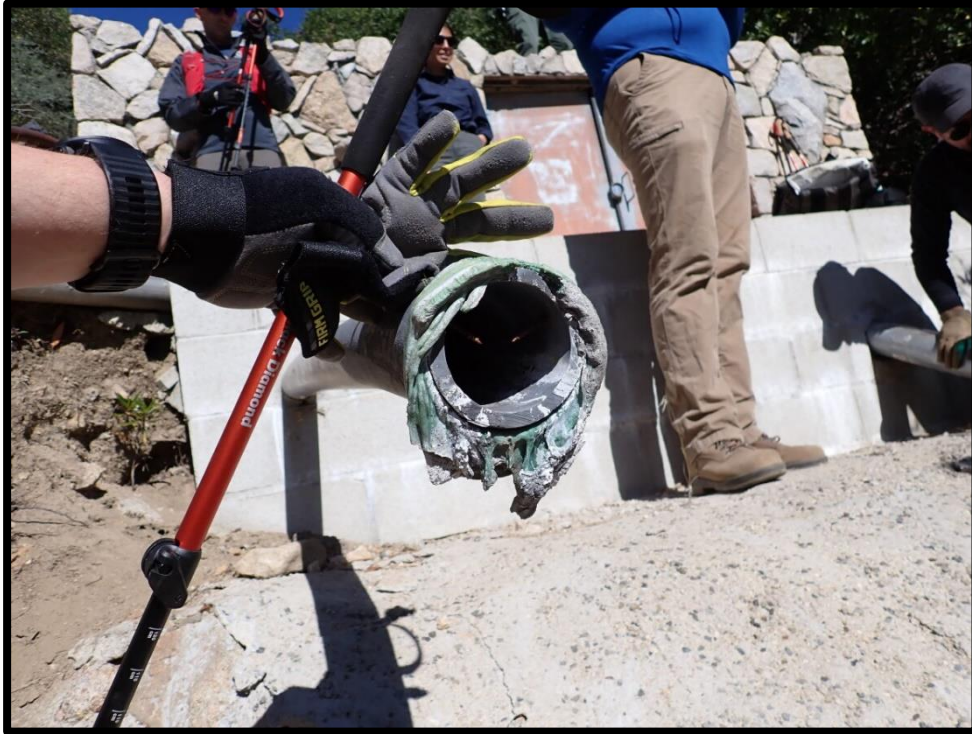
The pipe not discharging water was approximately 4 inches in diameter and also had an animal guard installed at the end of the pipe that reduced the effective inner diameter of the pipe.

30. Spring 7ABC: Looking at insert at the end of the other pipe
