State Water Resources Control Board

DIVISION OF WATER RIGHTS SITE OBSERVATION REPORT

Date of Site Visit: 11/08/2023 8:45 AM
Report Author: Connor Bovée
Observation Performed By: Roberto Cervantes, Kathryn Bare, Kenneth Petruzzelli, Tomas Eggers, Connor Bovée
Type: Site Visit
Other Agencies Present: United States Forest Service, Non-Governmental Organizations

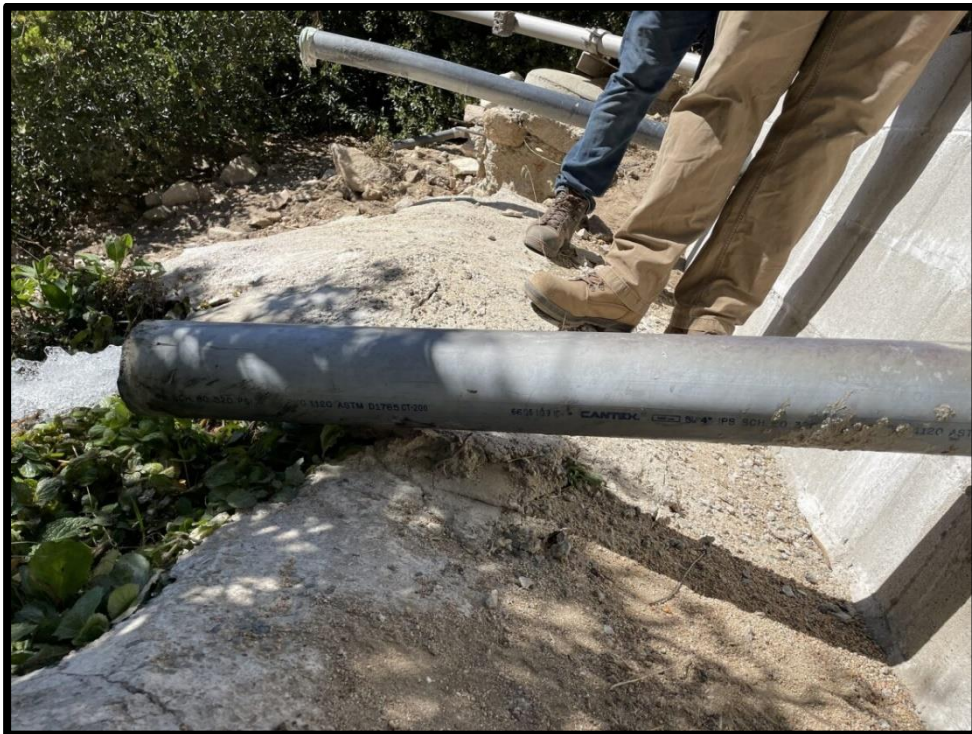
Staff observed two additional 4-inch pipes protruding from the bottom of the vault heading south for a short distance before terminating. A large amount of flow was observed discharging from one of these two pipes and had an animal guard installed at the outlet. SWRCB staff determined this flow rate was too high to measure using the bottle and stopwatch, or other equipment staff had available at that time.

31. Spring 7ABC: Looking at vault overflow pipeline (note flow coming out of pipe)

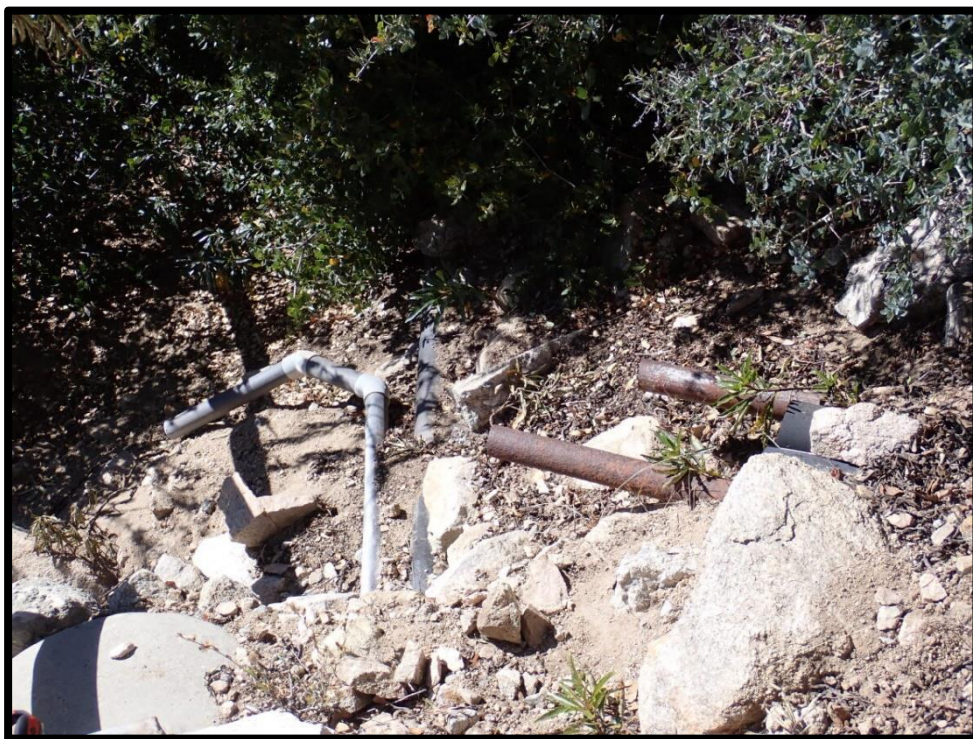
Metal and plastic pipes were found embedded in the terrain that did not connect to any of the facilities at this site. SWRCB staff presume these pipes were part of the original conveyance infrastructure of Spring 7 that have since been abandoned.

32. Spring 7ABC: Looking at abandoned pipelines to the north of the discharge pipeline

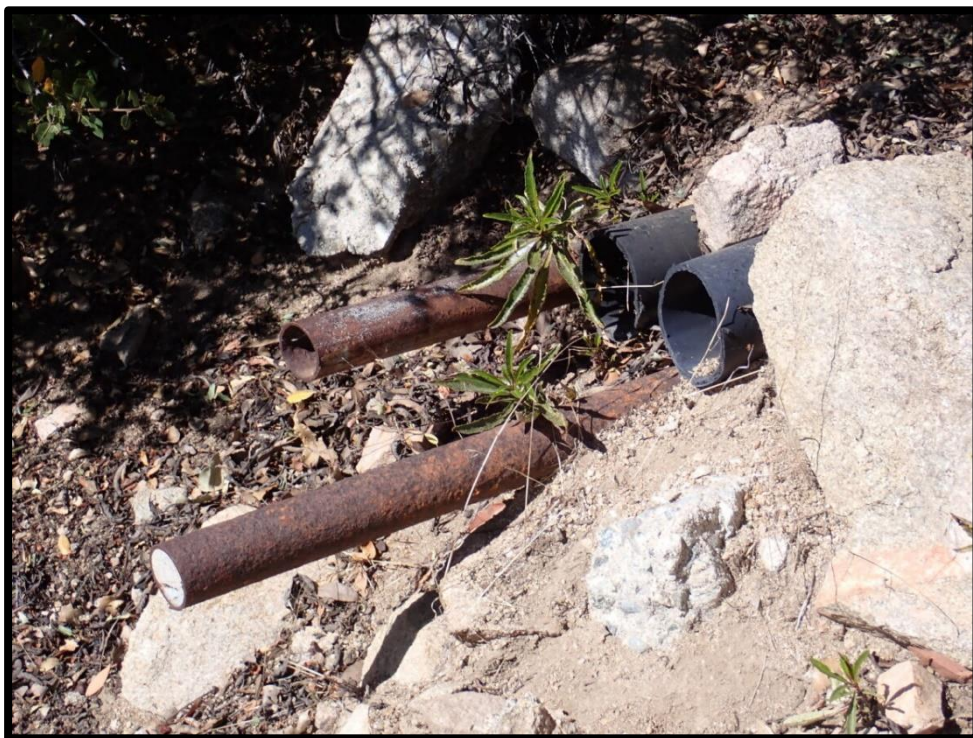
33. Spring 7ABC: Looking at ends of abandoned pipelines

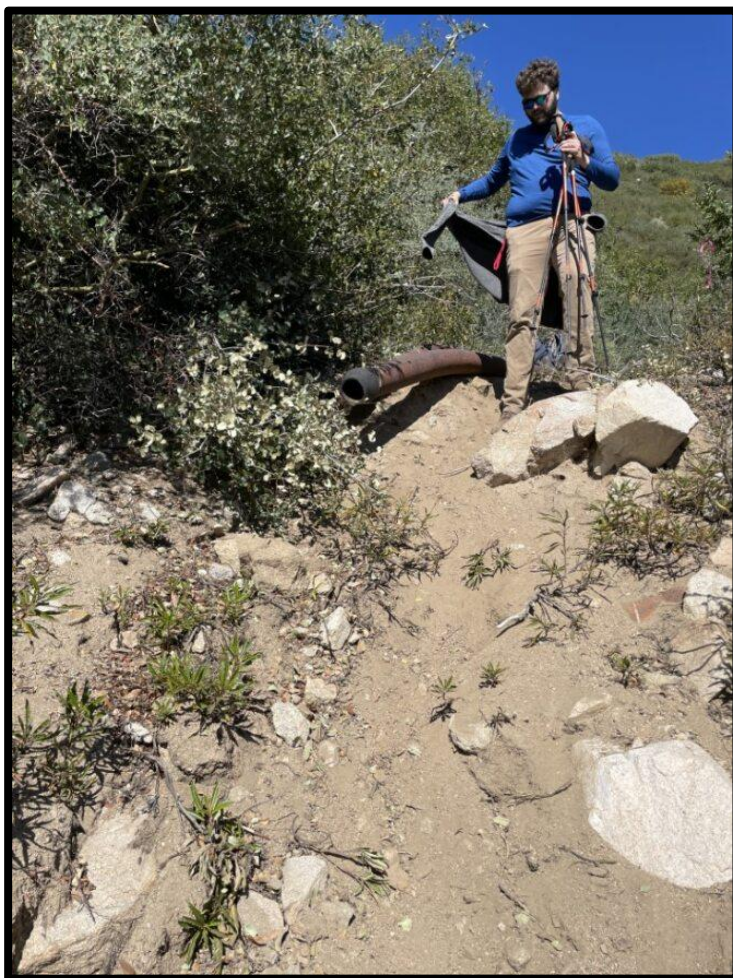
34. Spring 7ABC: Looking north of prior photo to upstream sections of abandoned pipelines

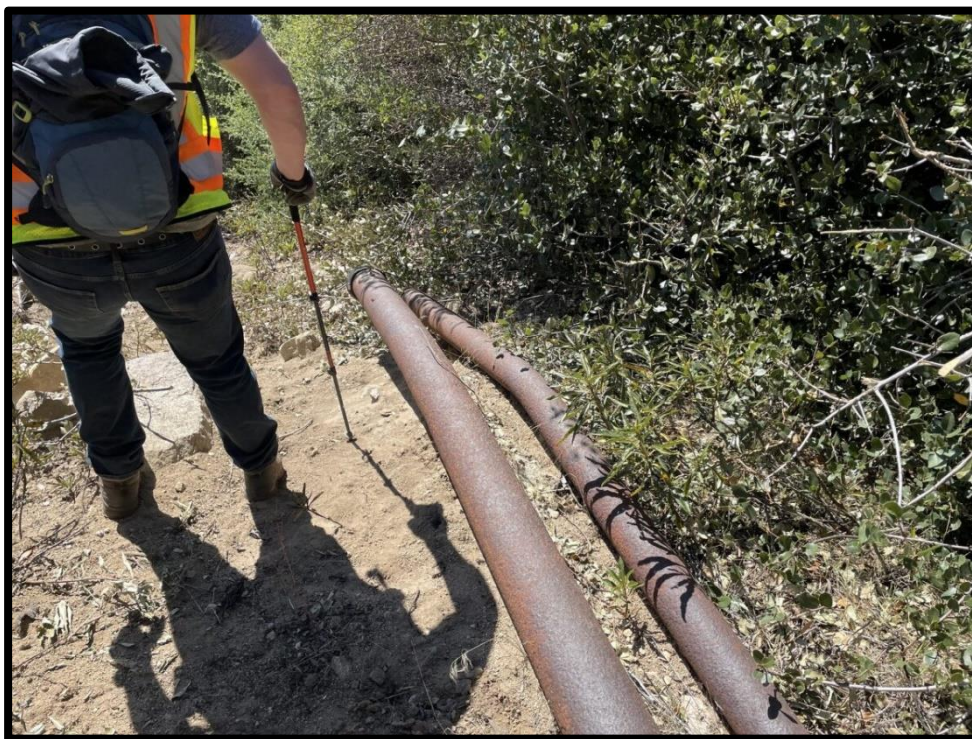
35. Spring 7ABC: Looking at upstream sections of abandoned pipelines

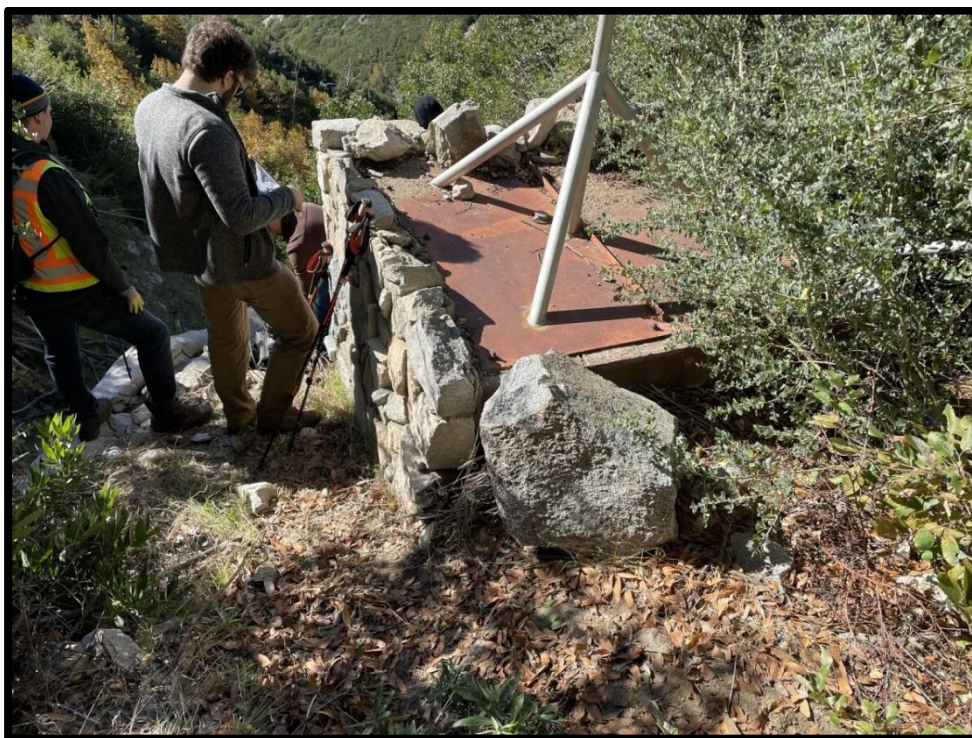
Spring ID:	Spring 8
Lat/Long:	34.228°, -117.234°
Description:	<p>Infrastructure at this spring consisted of a large, enclosed vault made of concrete and encased in stone with pipes coming out of the vault at multiple locations. There are two metal pipes that come from the bottom of the vault and head south. These pipes had no water in them and ended shortly after the concrete pad of the vault.</p> <p>Another metal pipe came out of the western side of the vault and had flow running through it to an unseen location. Water could be heard and felt flowing through this pipe.</p> <p>Out of the top of the vault there was a metal pole that had an antenna, a solar panel, and another device that appeared to be a camera.</p> <p>The site is located approximately 70 feet south of Spring 1A. See photos 36-40 in the photo log for additional information.</p>

36. Spring 8: Looking at top of site

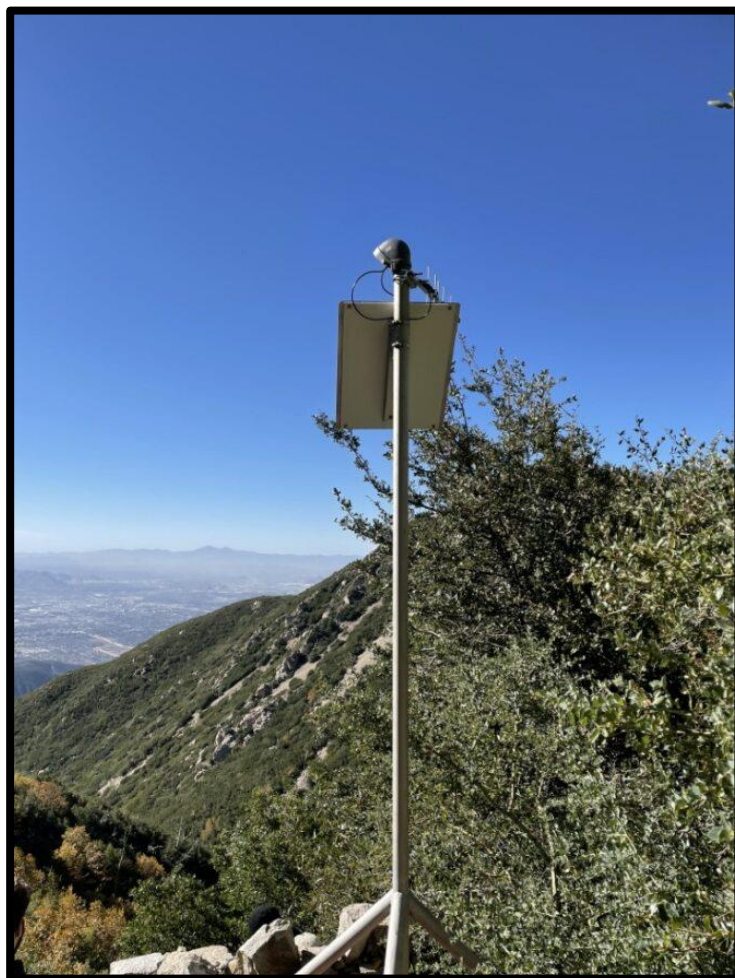
37. Spring 8: Looking at equipment at top of pole

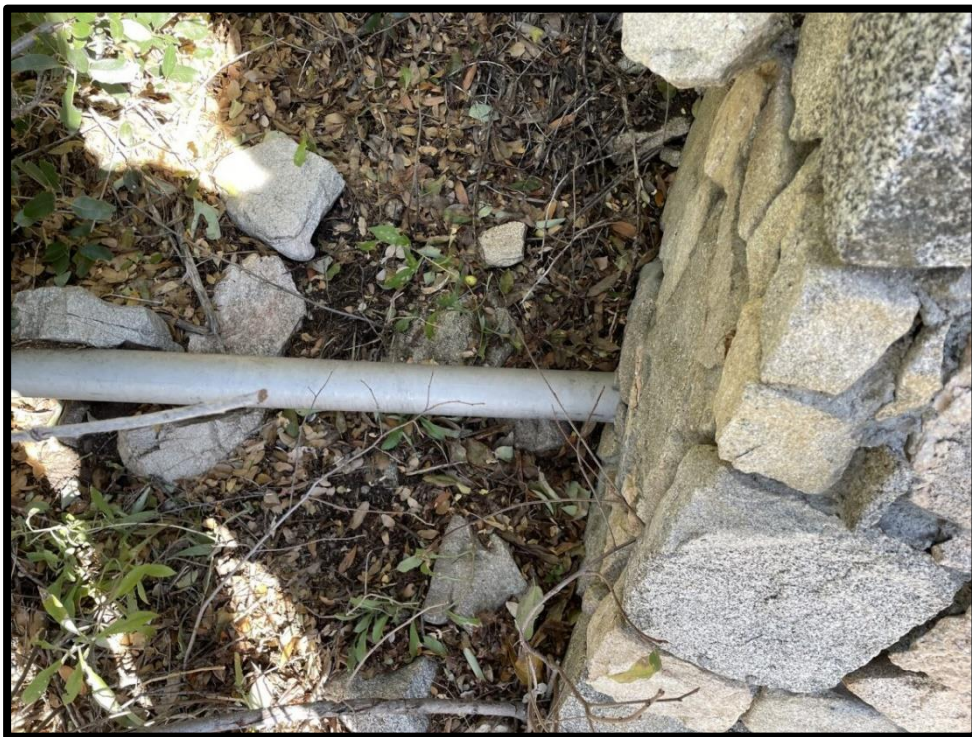
38. Spring 8: Looking at discharge pipeline coming out of west side of vault

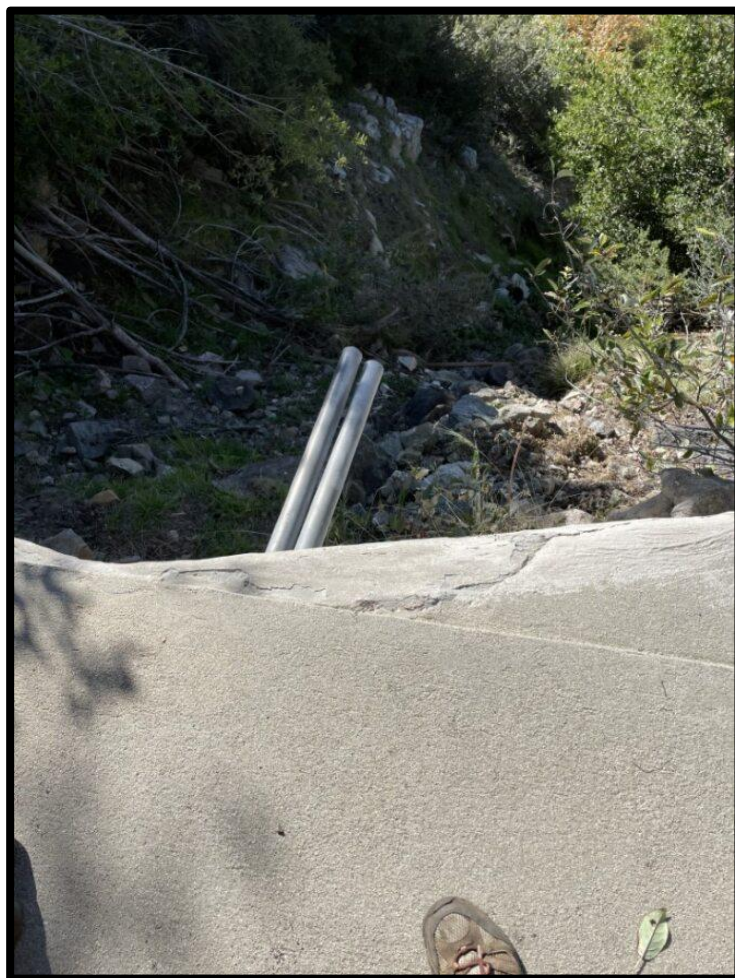
39. Spring 8: Looking at vault overflow pipelines

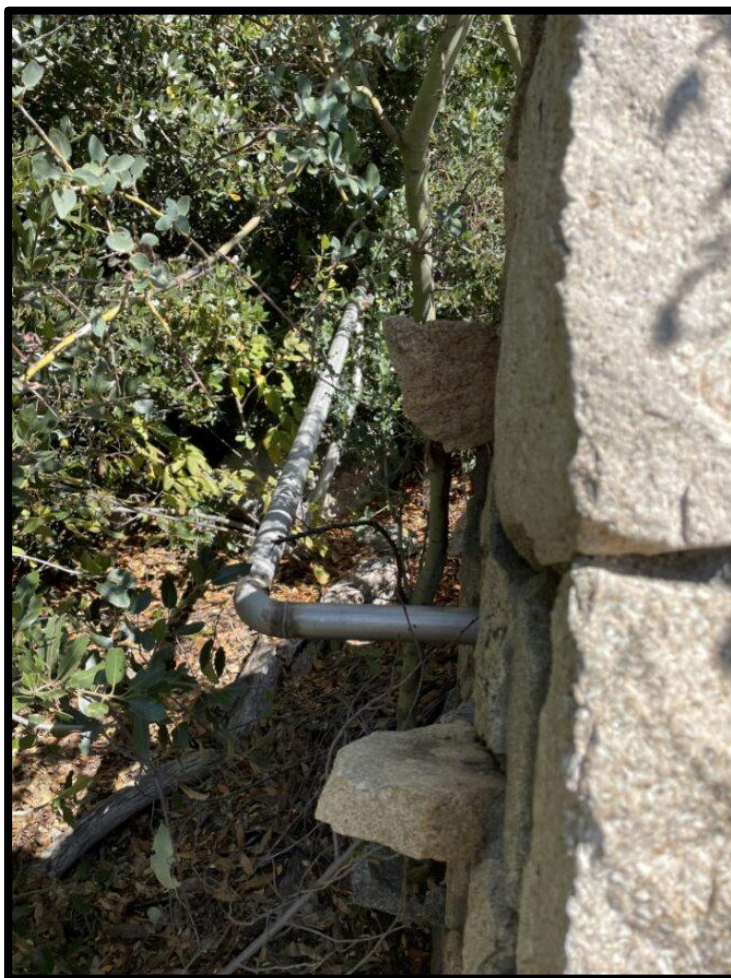
40.Spring 8: Looking at pipe coming from upstream of site going into vault
