**DIVISION OF WATER RIGHTS
REPORT OF INSPECTION**

Date of Inspection: 7-12-2015 deployment

Ownership: G. Scott Fahey
c/o Sugar Pine Spring Water, LP
2787 Stony Fork Way
Boise, ID 83706

Water Right(s): A029977 (Permit 20784) and A031491 (Permit 21289)

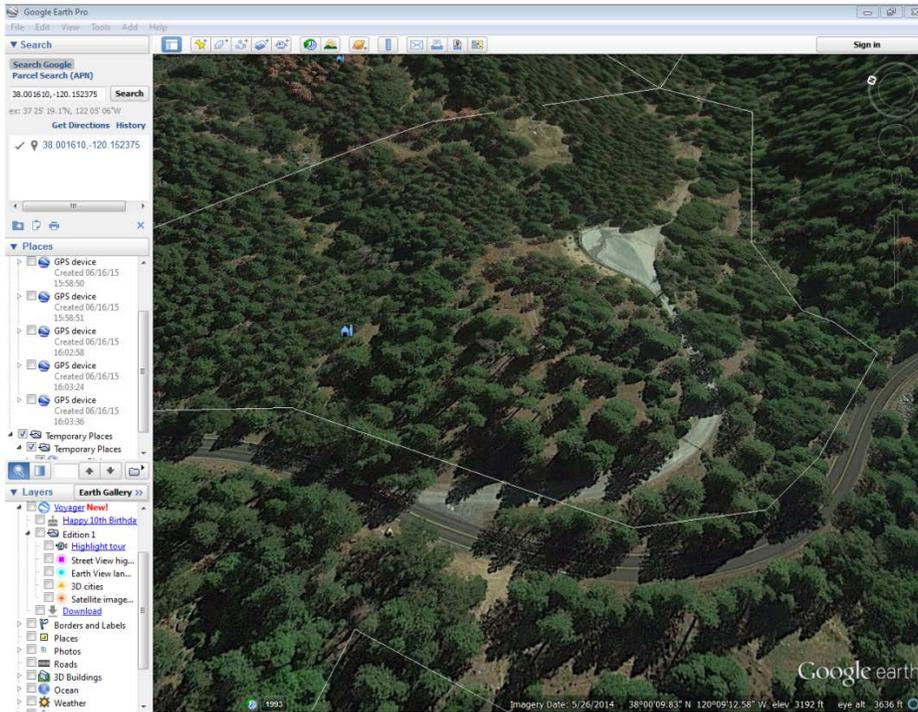
While the sources of water include 4 springs located throughout sections 16 and 22 of Township 2N, Range 17E MDBM, the waters are piped together and transported over 1 mile southwest to a transfer station located in section 30 where an overhead water truck loading station exists. This location consists of the overhead fill pipe and gravel turnabout that can accommodate the 40,000 gallon tractor trailers. The location does not appear to have an address; however the GPS coordinates are 38.002739, -120.152459 within Tuolumne County APN 052-060-48-00. The water is then bulk hauled to various bottling locations as described above to be put to beneficial use off of the parcel.

Photo 1 – Aerial image of the gravel round about and overhead filling station courtesy of Google Earth.

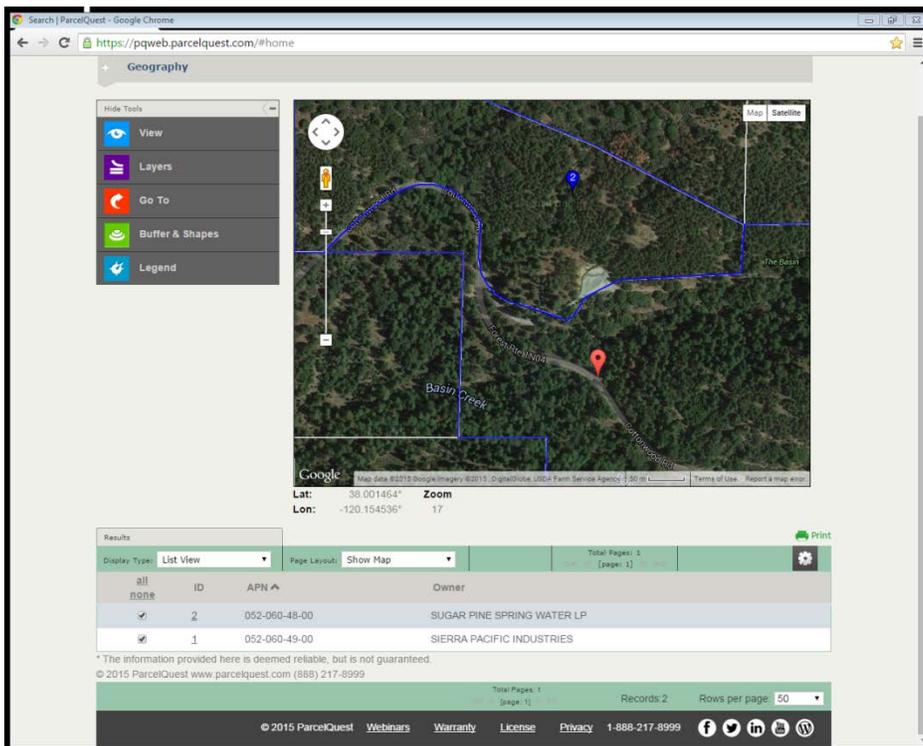
Photo 2 – Aerial image of Sugar Pine Spring Water LP parcel and surrounding parcels.

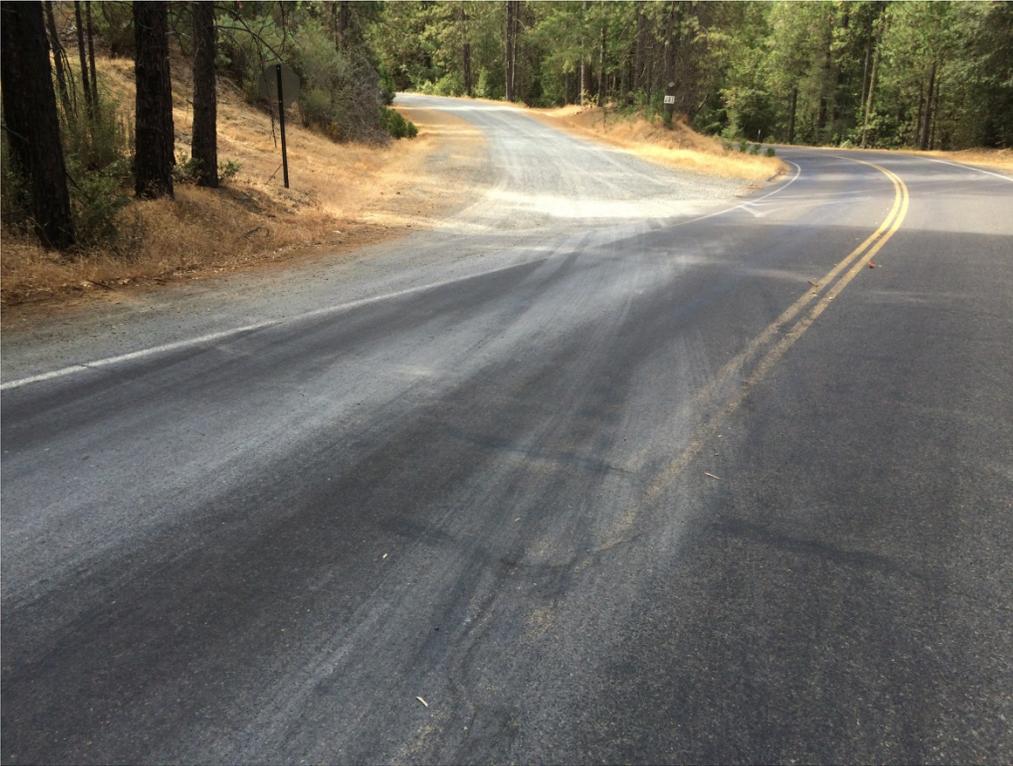
On July 12, 2015 Division Staff performed a covert inspection of the facility as could best be accessed via public right of way. Due to surrounding properties all being privately owned, Division Staff were restricted to areas along the public right of way; Cottonwood Road. Upon initial arrival, staff noted visible tire dust tracks exiting the facility onto Cottonwood road, indicating the existence of recent, heavy activity.

Photo 3 – Photo from Cottonwood Road, showing tire marks leaving Facility access road.

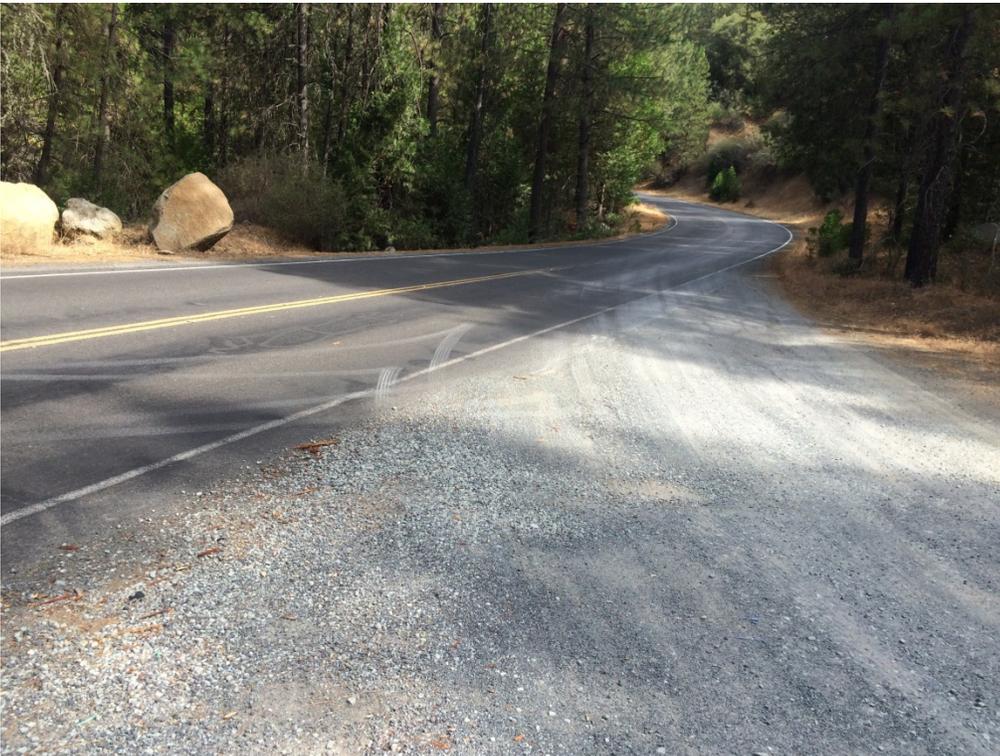
Photo 4 – Photo from Facility Access road showing view north of Cottonwood Road.

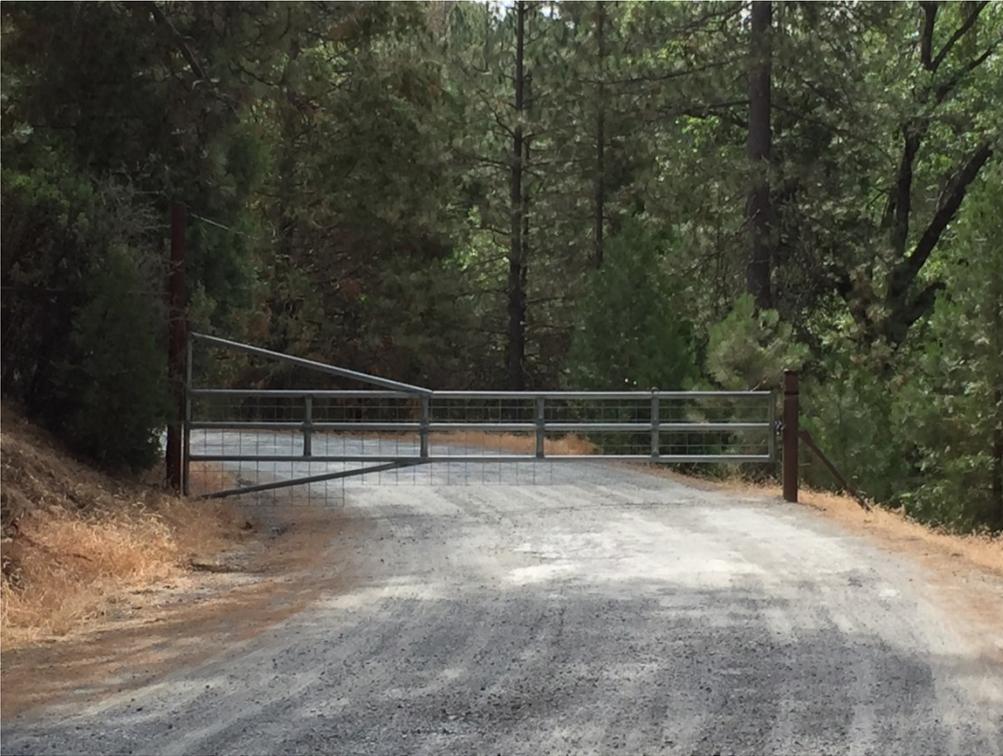
Photo 5 – Gate on Facility access road blocking access to Facility.

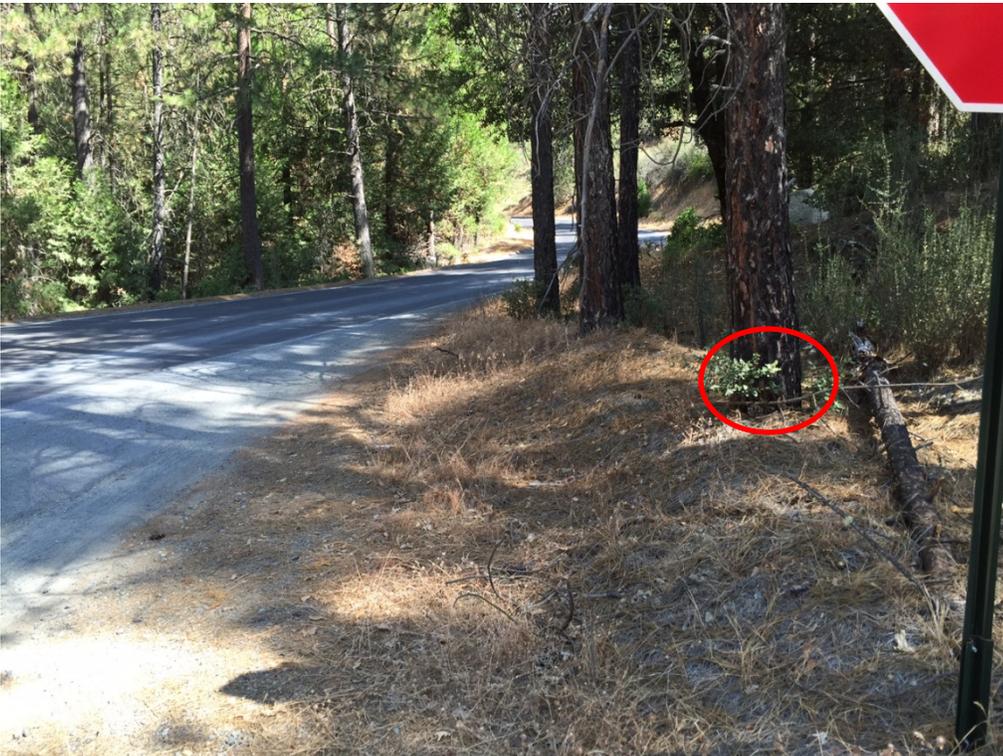
All three cameras have different setting combinations for time lapse interval and quality/resolution so as to determine what will be the ideal settings for future deployments at this facility. Camera 1 is the camera located nearest the trucks and as such was given a time lapse interval of 5 seconds with "Image Quality" set to highest resolution. Other pertinent settings that remained constant with all three cameras included "Scene" set to Daylight, "HDR Range" set to High, "Time Stamp" On, "Low Light Recording" Off, and "LED Indicator" Off.

Photo 6 – Camera 1 location at base of tree on right.

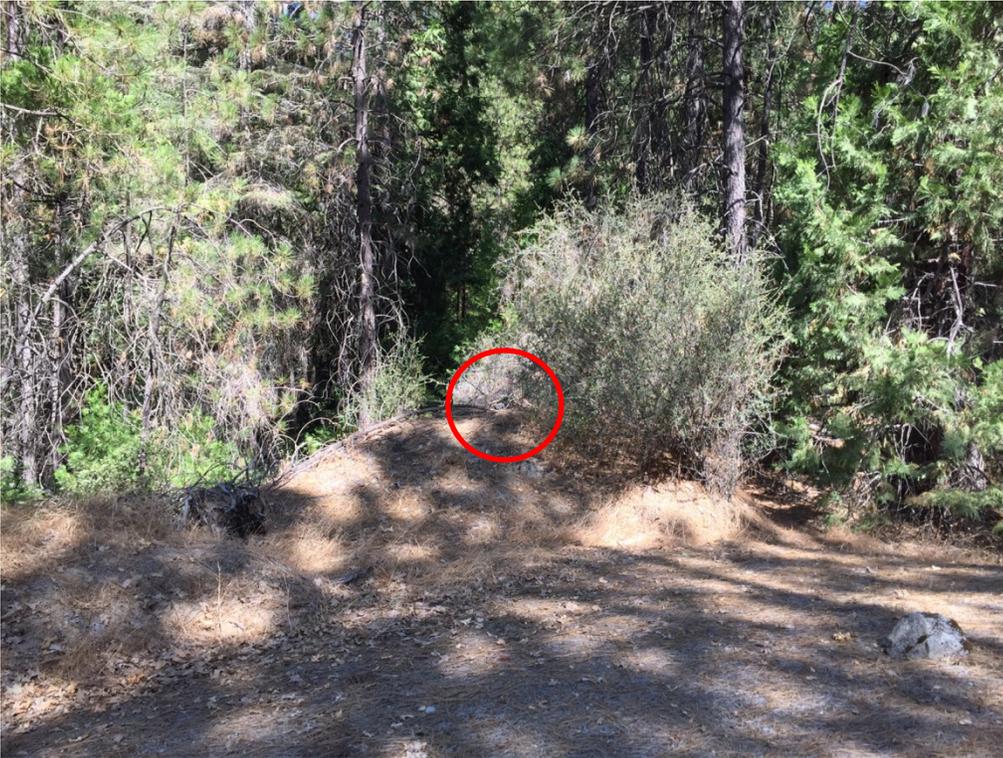
Camera 2, being situated across Cottonwood Road from Camera 1, is placed in an ideal location to see down the access road to the gate. Due to being set back some distance from the access road and being of the wide-angle lens type, details such as Logos and plates will likely be unable to be seen regardless of setting, so "Image Quality" was set to lowest resolution setting of "Good" to conserve storage capacity on the SD cards. Time lapse interval was set to 5 seconds to maximize the activity captured.

Photo 7 – Camera 2 located on rock next to bush across Cottonwood Road from facility.

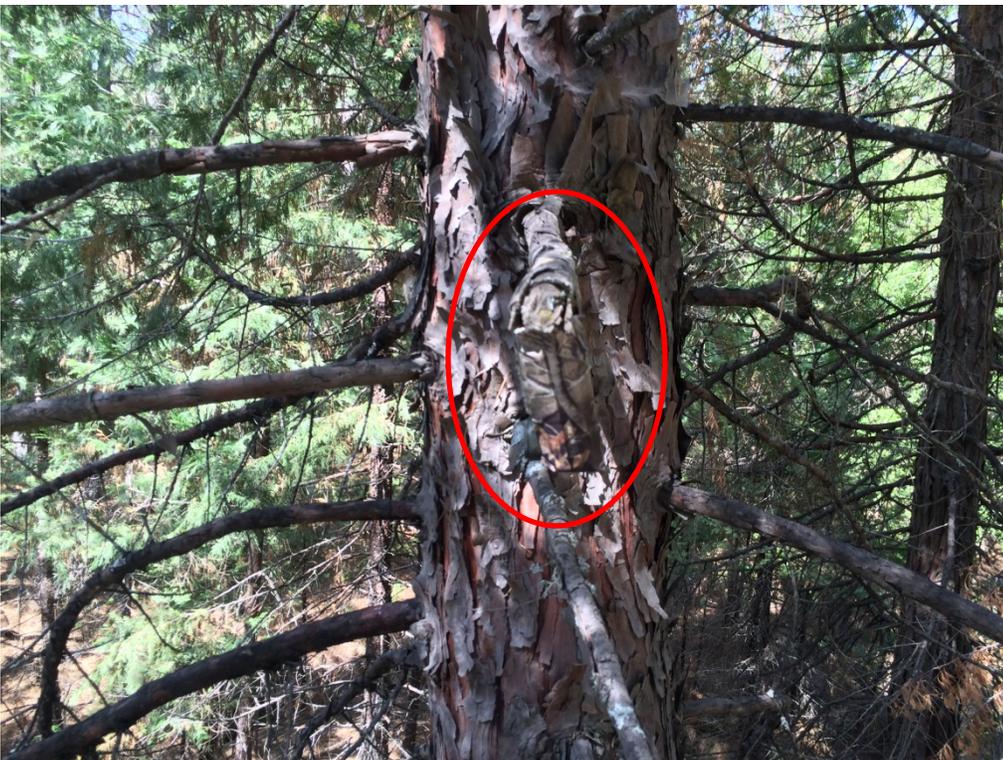
Camera 3 was primarily placed as a backup camera to watch the other cameras in the case of theft, to have a general overview of the facility and road in the case that activity was other than suspected, and as a means to mitigate potential interruptions in surveillance in the case that the other two cameras reached the data and/or battery limit. Camera 3 was set to conservative settings to maximize battery life and memory capacity at a time lapse duration of 10 seconds and "Image Quality" of Good.

Photo 8 – Camera 3 located off Cottonwood Road North of the facility access road.
