## TECHNICAL MEMORANDUM

### Sediment Delivery Potential from Failures on the Stanshaw Creek Diversion Ditch

# Stanshaw Creek Diversion Ditch Sediment Source Assessment

April 4, 2017

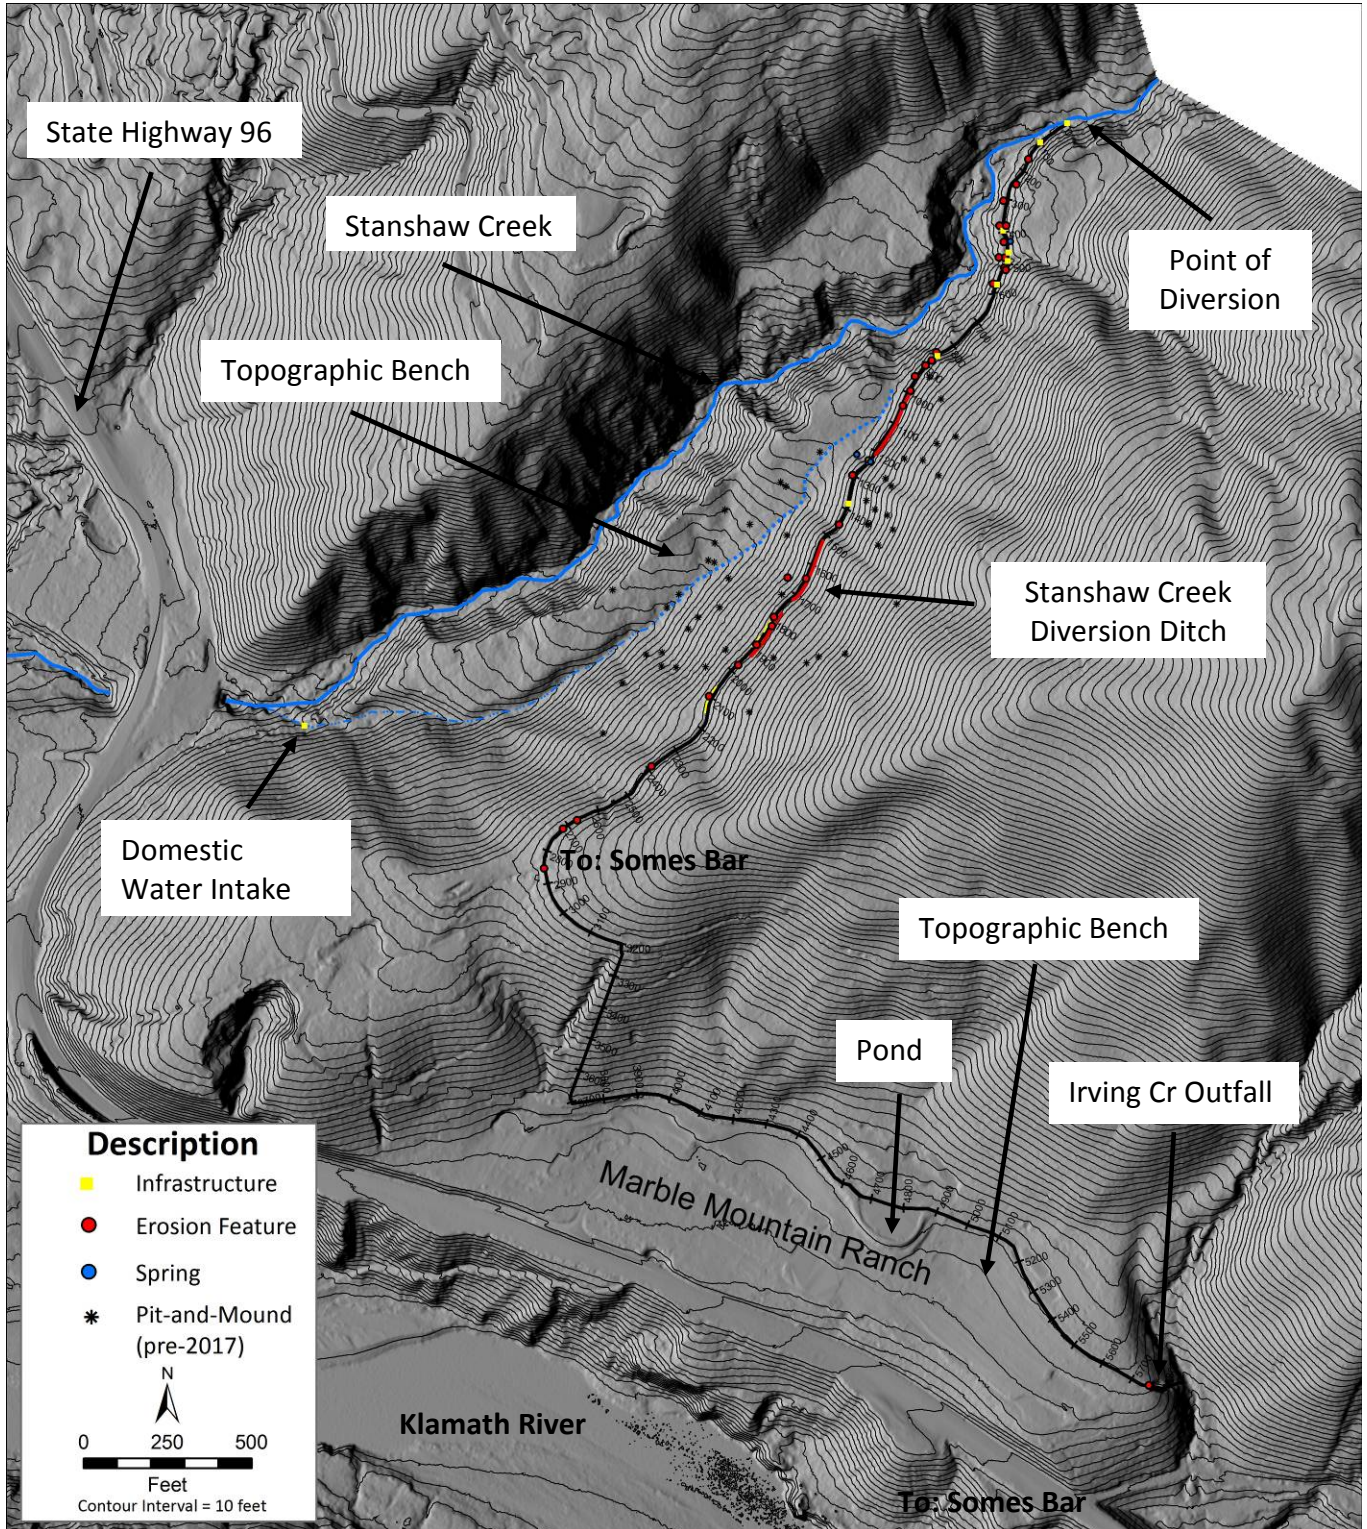
Data in Table 3 show that compared to other feature types cutslope failures had the greatest frequency of occurrence (14/22), produced approximately 96 yds<sup>3</sup> of sediment, and did not deliver sediment to the waters of California during the study period. Volume estimates for pre-WY2017 cutslope failures were not prepared for this study, but could be extrapolated from existing data. Ditch segments with pre-2017 fillslope and cutslope erosion are delineated by solid yellow and red lines, respectively on Figure 2.

Figure 2. Study Area Map. Marble Mountain Ranch and the Stanshaw Creek Diversion Ditch. Base image is a portion of the 2014/15 1-meter LiDAR DEM Hillshade, provided by the Mid-Klamath Watershed Council.

Ditch segments with pre-2017 fillslope and cutslope erosion are delineated with solid yellow and red lines, respectively. Map prepared by FGS.

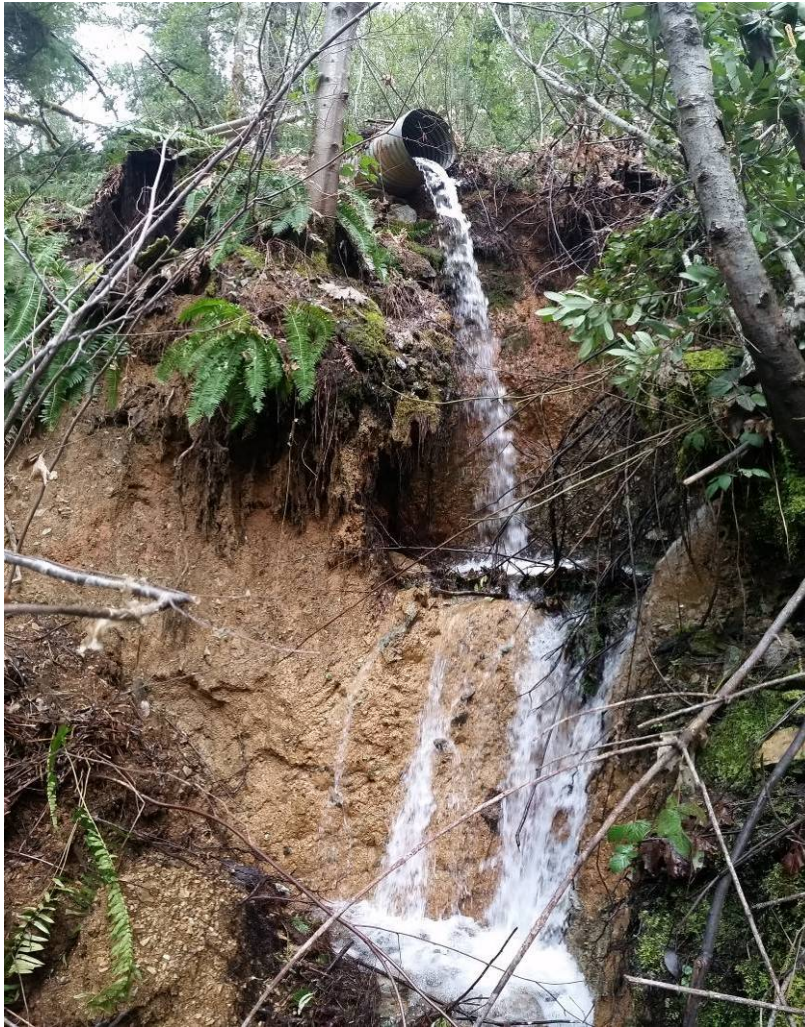
Sediment production and delivery volumes were estimated for the shotgun culvert located at Station 474. During WY2017 study period, erosion related to the outfall from the shotgun culvert was estimated to produce and deliver 1 yds<sup>3</sup> and 0.7 yds<sup>3</sup> of sediment, respectively. The long-term sediment production and delivery volumes were estimated to be 6.3 yds<sup>3</sup> (Table 3). According to Douglas Cole, the culvert was installed in 1996. By assuming the plunge pool volume represents erosion over a 21-year period an erosion rate of ~0.3 yds<sup>3</sup>/yr and incision rate of ~ 4"/yr was estimated. Field inspection of the feature indicates the plunge pool has become quasi-stable in the consolidated paleo-landslide deposits that underlie the site. The difference in the short- and long-term of sediment delivery rates, 0.7 yds<sup>3</sup> versus

~0.3 yds<sup>3</sup>/yr, was likely due to the accounting of the sedimentation related to a scarp that formed along the contact between the unconsolidated colluvium and fill, and the underlying paleo-landslide deposits (Figure 3). The cylindrical shape and flat base of the plunge pool, and the stair-stepped topography suggests this feature has eroded into more resistant material and the current incision rate may be an order of magnitude lower than the rate calculated above.

Figure 3. Upstream view of the shotgun culvert located at an unnamed tributary to Stanshaw Creek, Station 474.

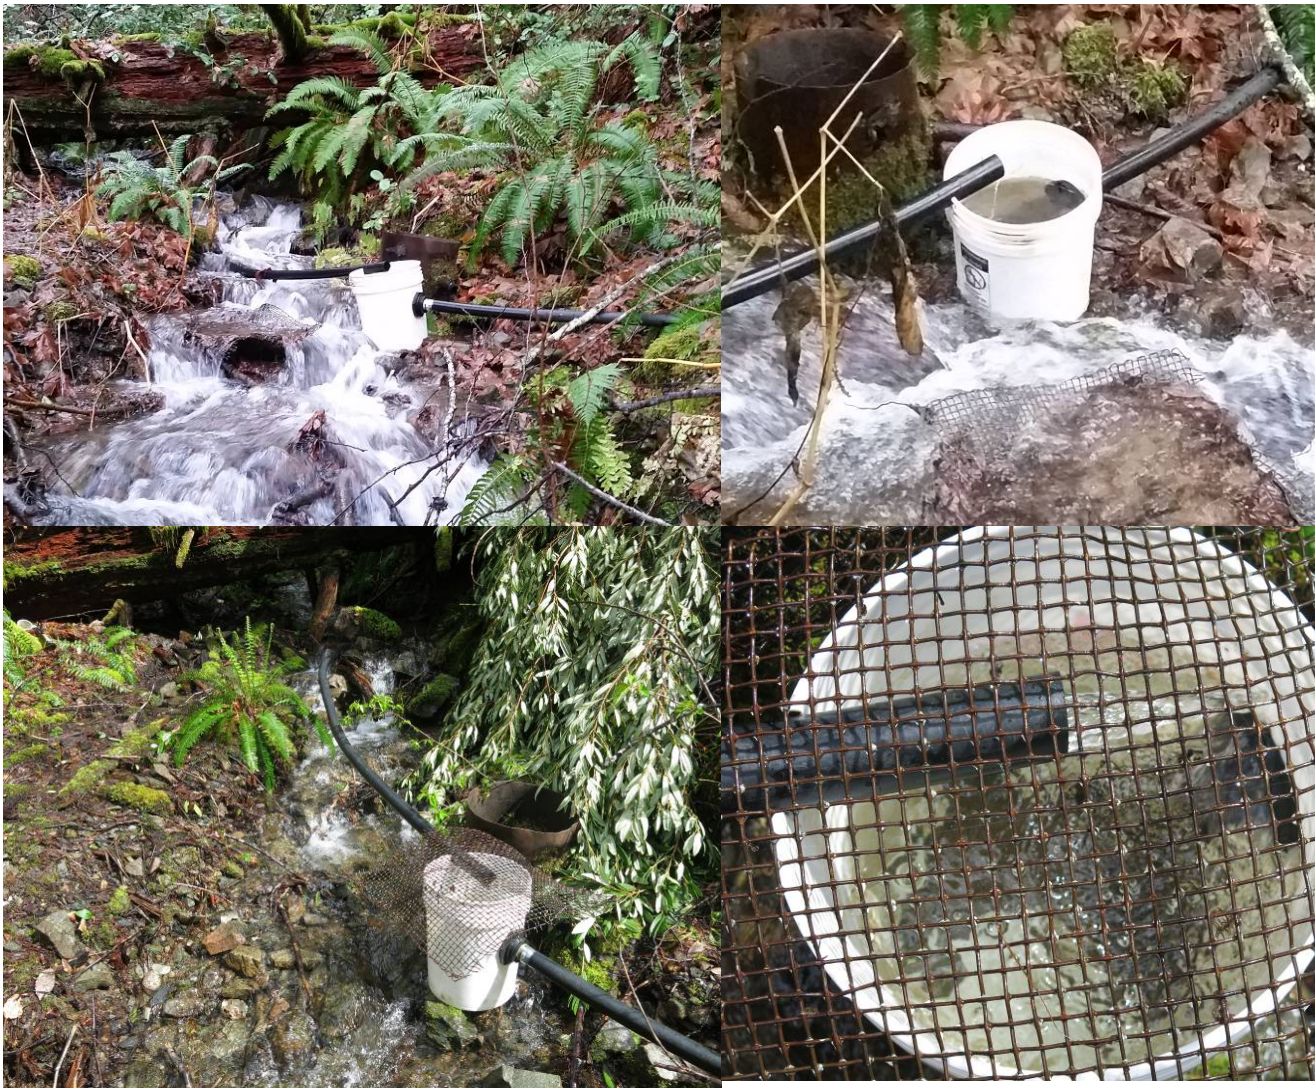
Field assessments including storm water quality monitoring conducted on the topographic bench located downslope of Stations 1000 to 2850 found no clear evidence that ditch related sedimentation or turbidity has affected or has the potential to affect the waters of California, barring natural and catastrophic events. Instead, FGS observed clear water consistently draining from the topographic bench during storm water runoff periods, a high degree of surface roughness from vegetation and irregular topography capable of trapping and storing fine sediments proximal to sediment producing features, and soils with a significant fraction of coarse angular particles that appear to resist surface erosion. Additionally, a sediment trap (in the form of a five-gallon bucket) connected to a domestic water intake system contained negligible amounts of fine sediment and organic materials during two field surveys (Figure 2 and 4).

The quantities and material types observed in the sediment trap were consistent with and supportive of the observations described herein. Moreover, it should be considered that the domestic water system and sediment trap would provide the water user an alert system and mechanism to document the occurrence of nuisance level water quality impacts associated with disturbances within the watercourse.

Figure 4. Photographs of downstream receiving waters of the Stanshaw Creek Ditch (Stations 1000 to 2880) and the domestic water supply intake system. Note the five-gallon bucket used as a sediment trap. Survey dates: Upper photographs - December 16, 2016, lower photographs - March 22, 2017.

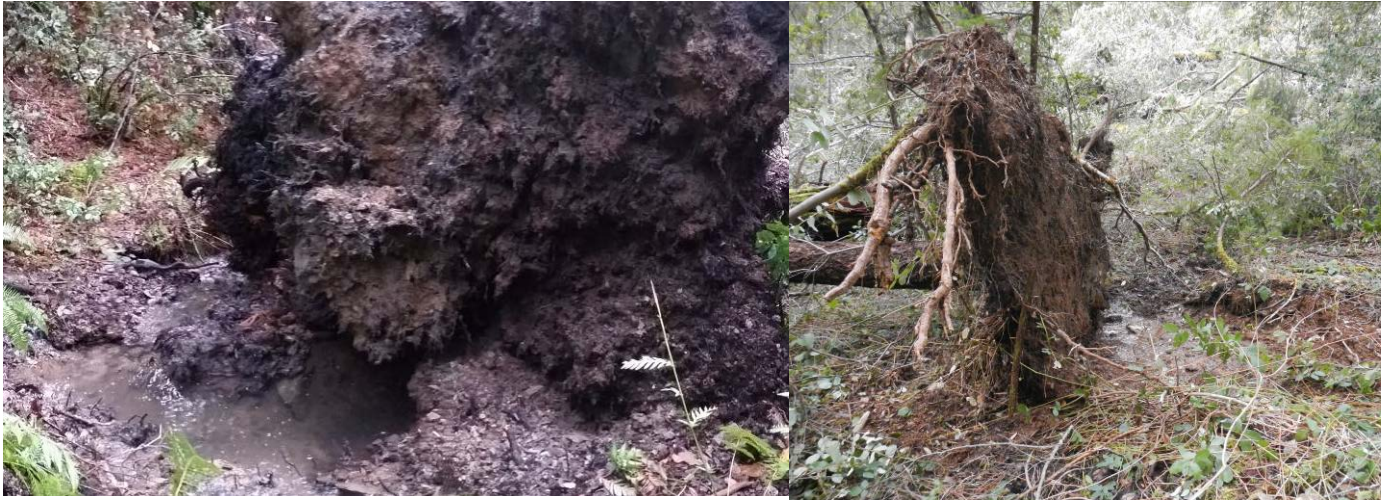
Several toppled trees were identified and mapped during fieldwork conducted on December 16, 2017. Some of these toppled trees were located within 1200 feet of the domestic water intake and overland flow was observed to connect these sediment sources to the ephemeral channel and domestic water supply intake (Figures 4 and 5a). However, field observations conducted during overland flow conditions indicate sediment transport and/or turbidity originating from these sources would likely occur only during the most extreme, short duration, high intensity rainfall events.

During the field assessment on February 24, 2017, FGS observed the initial aftermath of a significant snow-down event that occurred in relation to a winter storm that delivered several feet of wet snow to the Mid-Klamath region on January 2<sup>nd</sup> and 3<sup>rd</sup>, 2017. This snow-down event resulted in toppling a significant number of trees across the study area, including trees in close proximity to the domestic water system intake. Overland flow was observed to connect to the ephemeral watercourse upstream of the domestic water system, yet no sediment transport nor turbid waters were noted (Figure 5b).

Figure 5. Photographic examples of uprooted trees and overland flow in the study area. These natural sediment sources are located on the topographic bench upstream of the domestic water supply that is shown in Figures 2 and 4. Survey dates: Left photograph (5a) - December 16, 2016, Right photograph (5b) - February 24, 2017.
