Subject: Enrollment of THP 1-04-242 HUM (Unit 3) in the Freshwater Creek WWDR, "Tier II"

THP: Fresh 1 THP 04-242 Unit # 3 2-12-09

Erosion Control Plan (ECP) for
the “Fresh 1” THP

1-04-242HUM

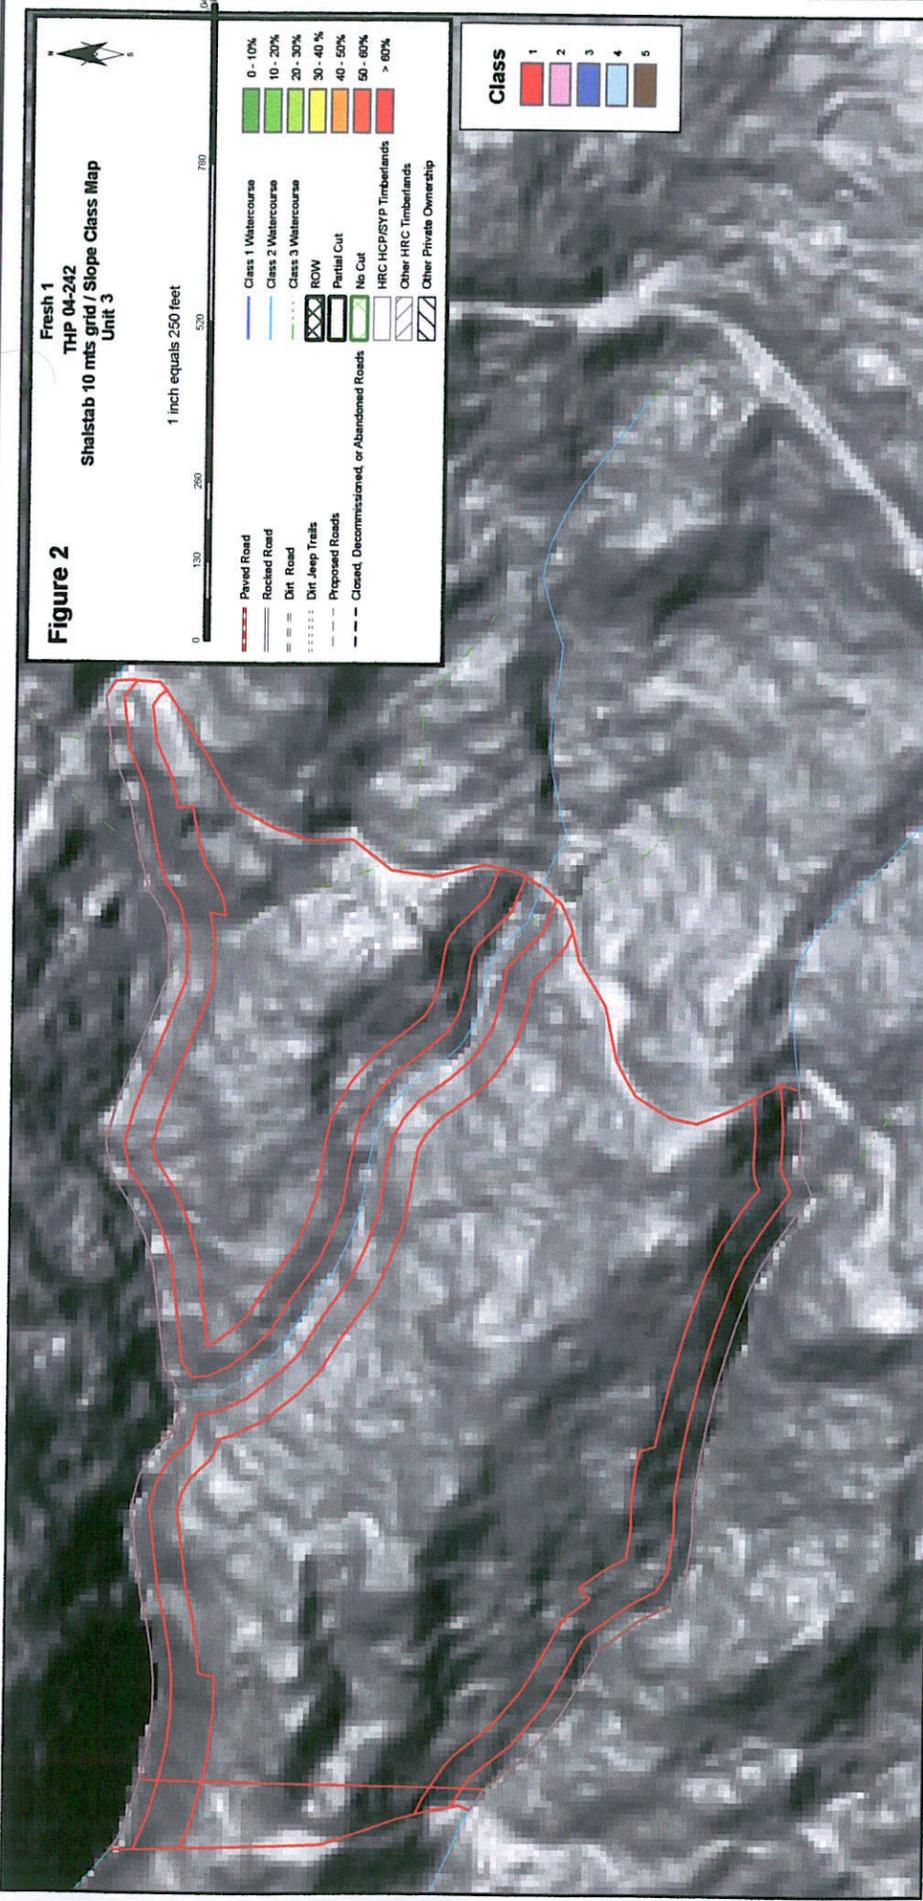
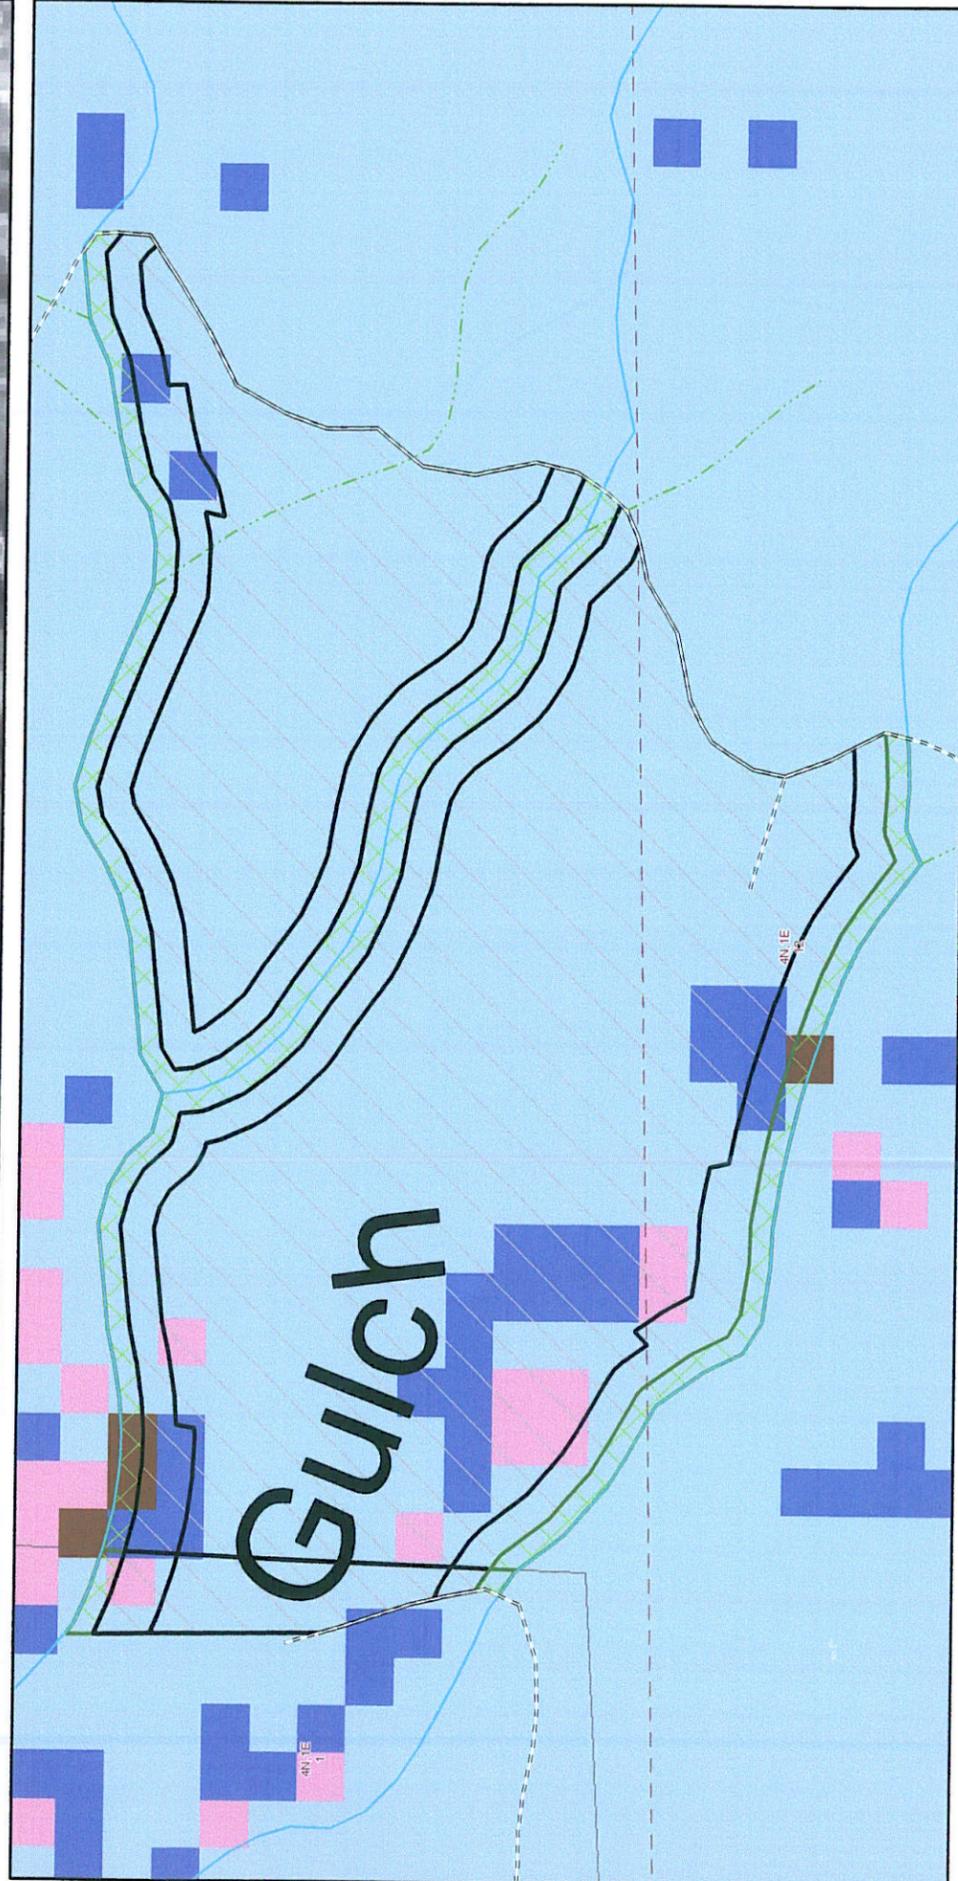
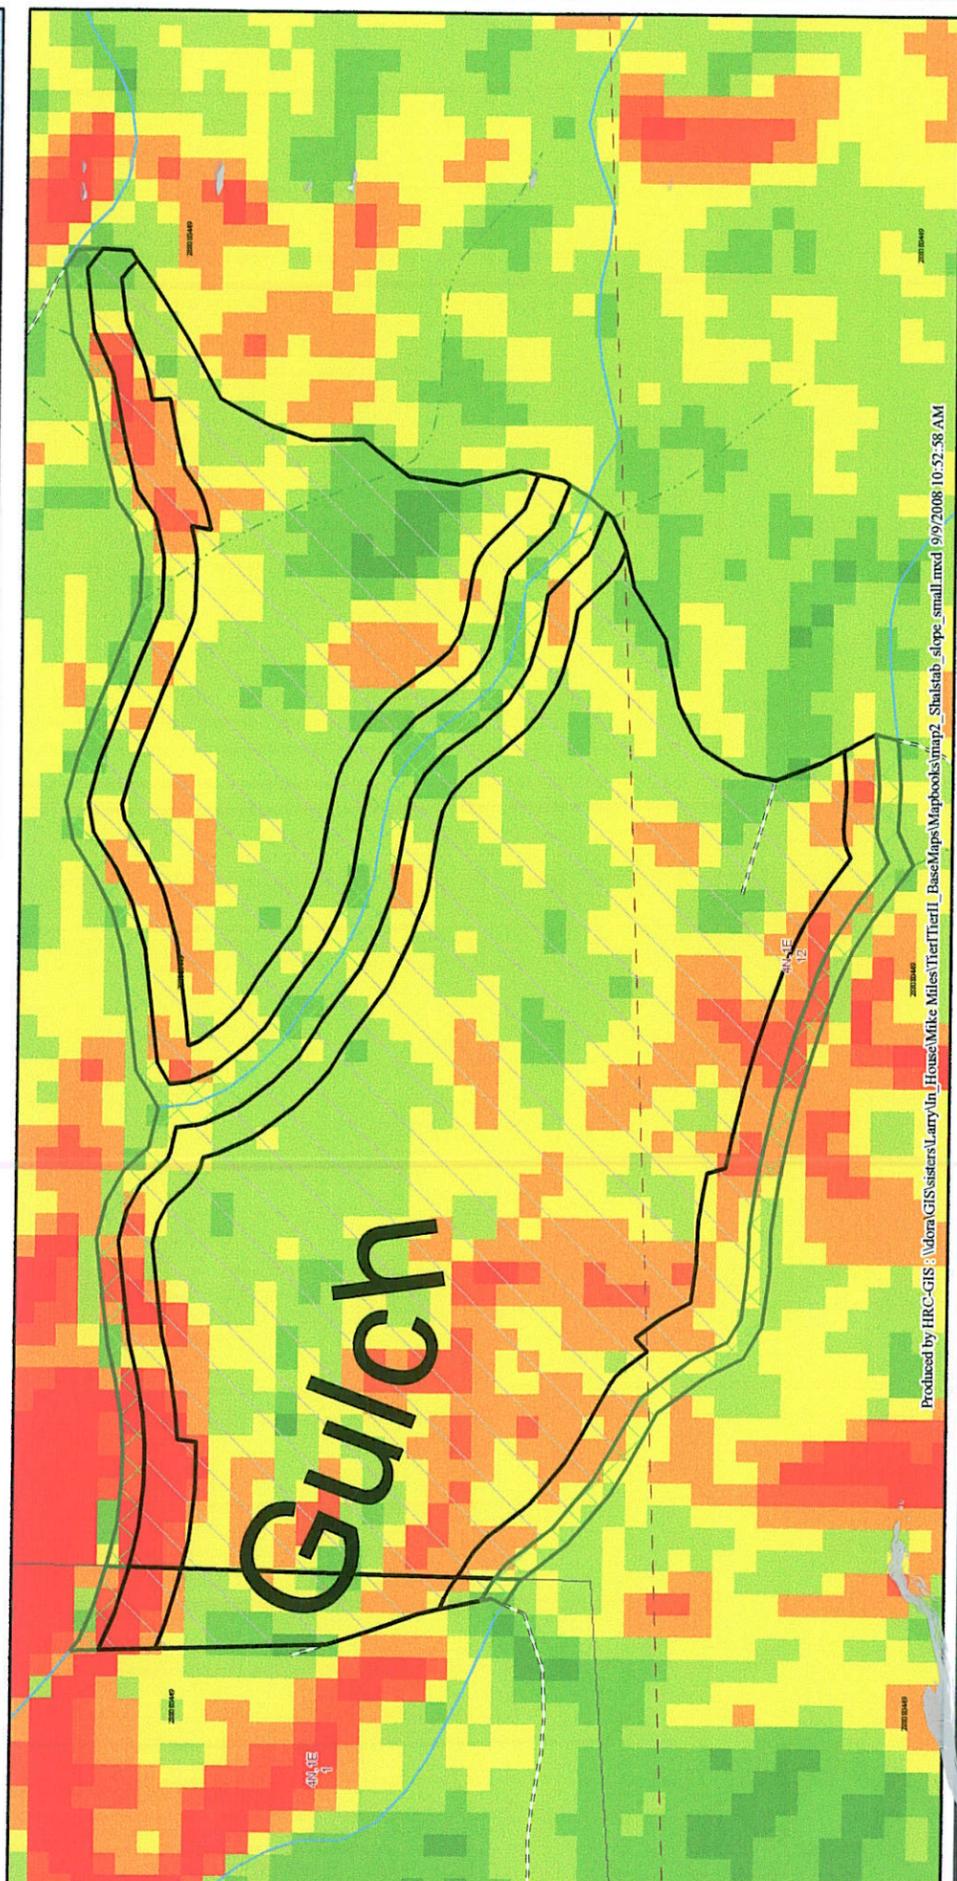
Figure 2

Hillslope shade (Figure 2) shows the slope forms to be uniform with slightly irregular surface topography. Convincing morphology documenting earthflow morphology is not observed and may be in response to small of a scale of viewing.

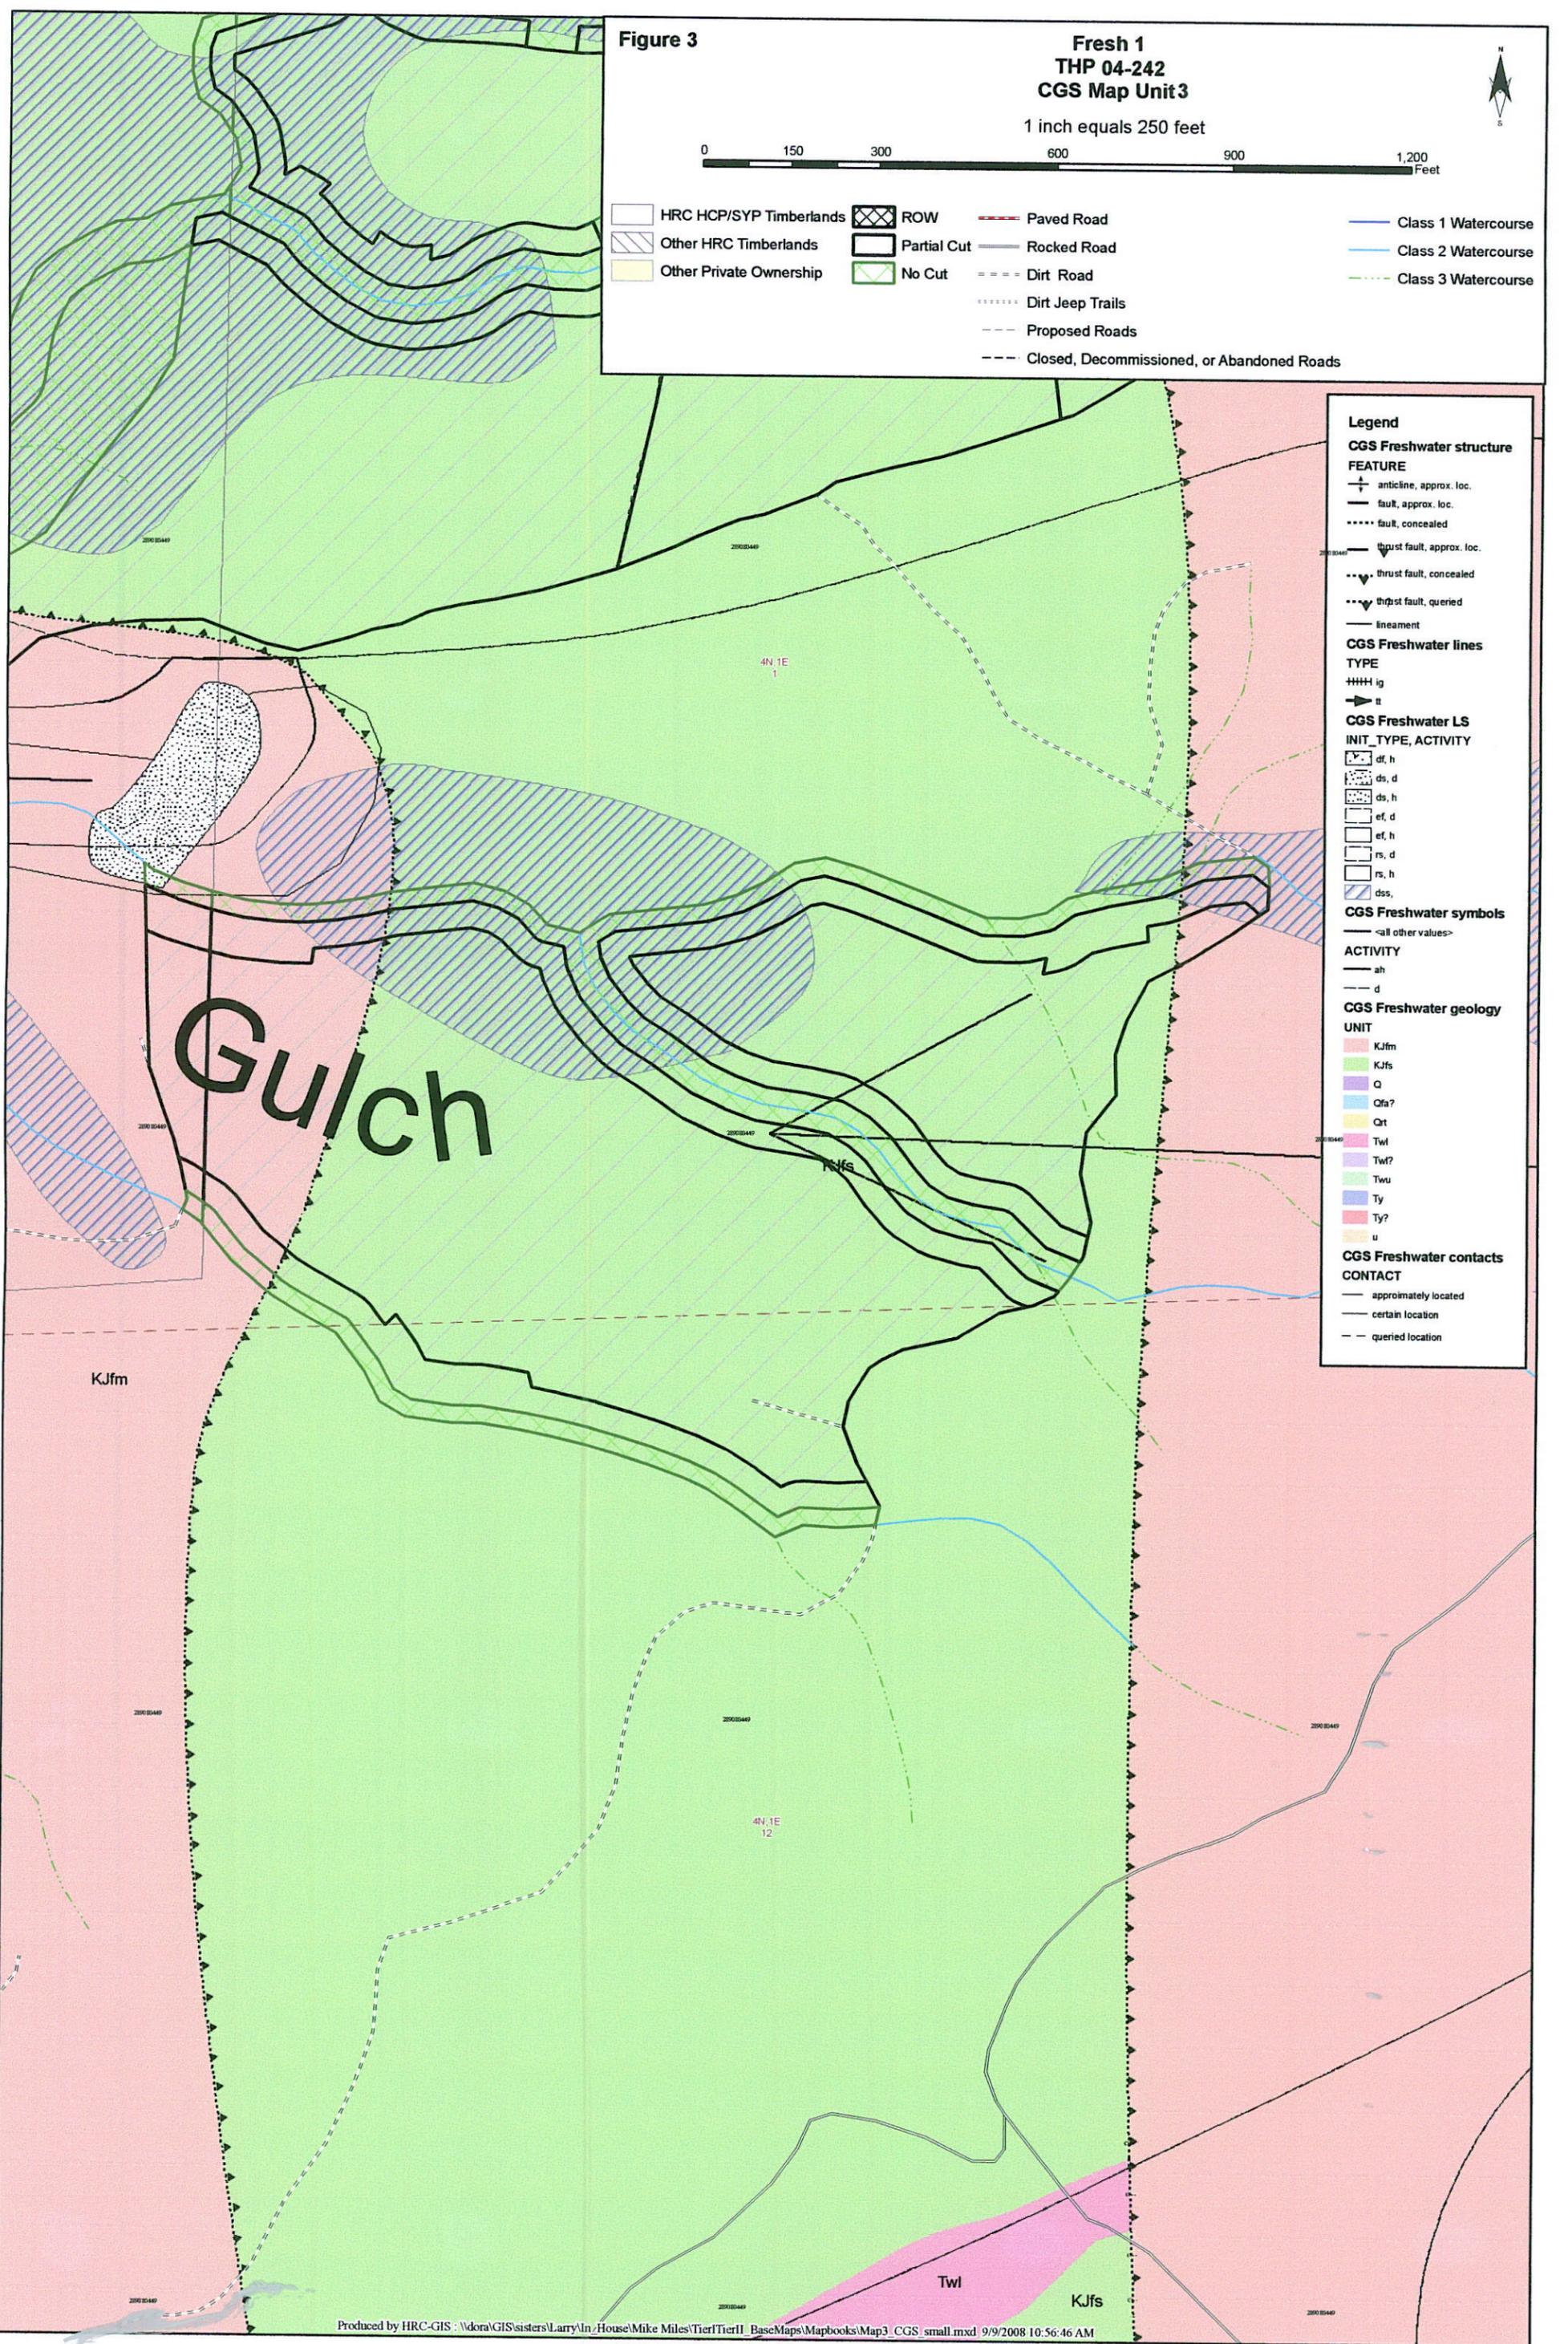
Figure 3 shows the unit predominantly underlain by sedimentary rocks of the central belt of the Franciscan Complex. The eastern and western tips of the unit are underlain by Franciscan Mélange material. The contacts are mapped as dormant faults.

Figure 3 also maps the unit to be within the margins of a dormant (over 1-mile wide) earthflow. The side slopes of the well entrenched Class II watercourse confluence within the northern portions of the unit are mapped as debris slide slopes.

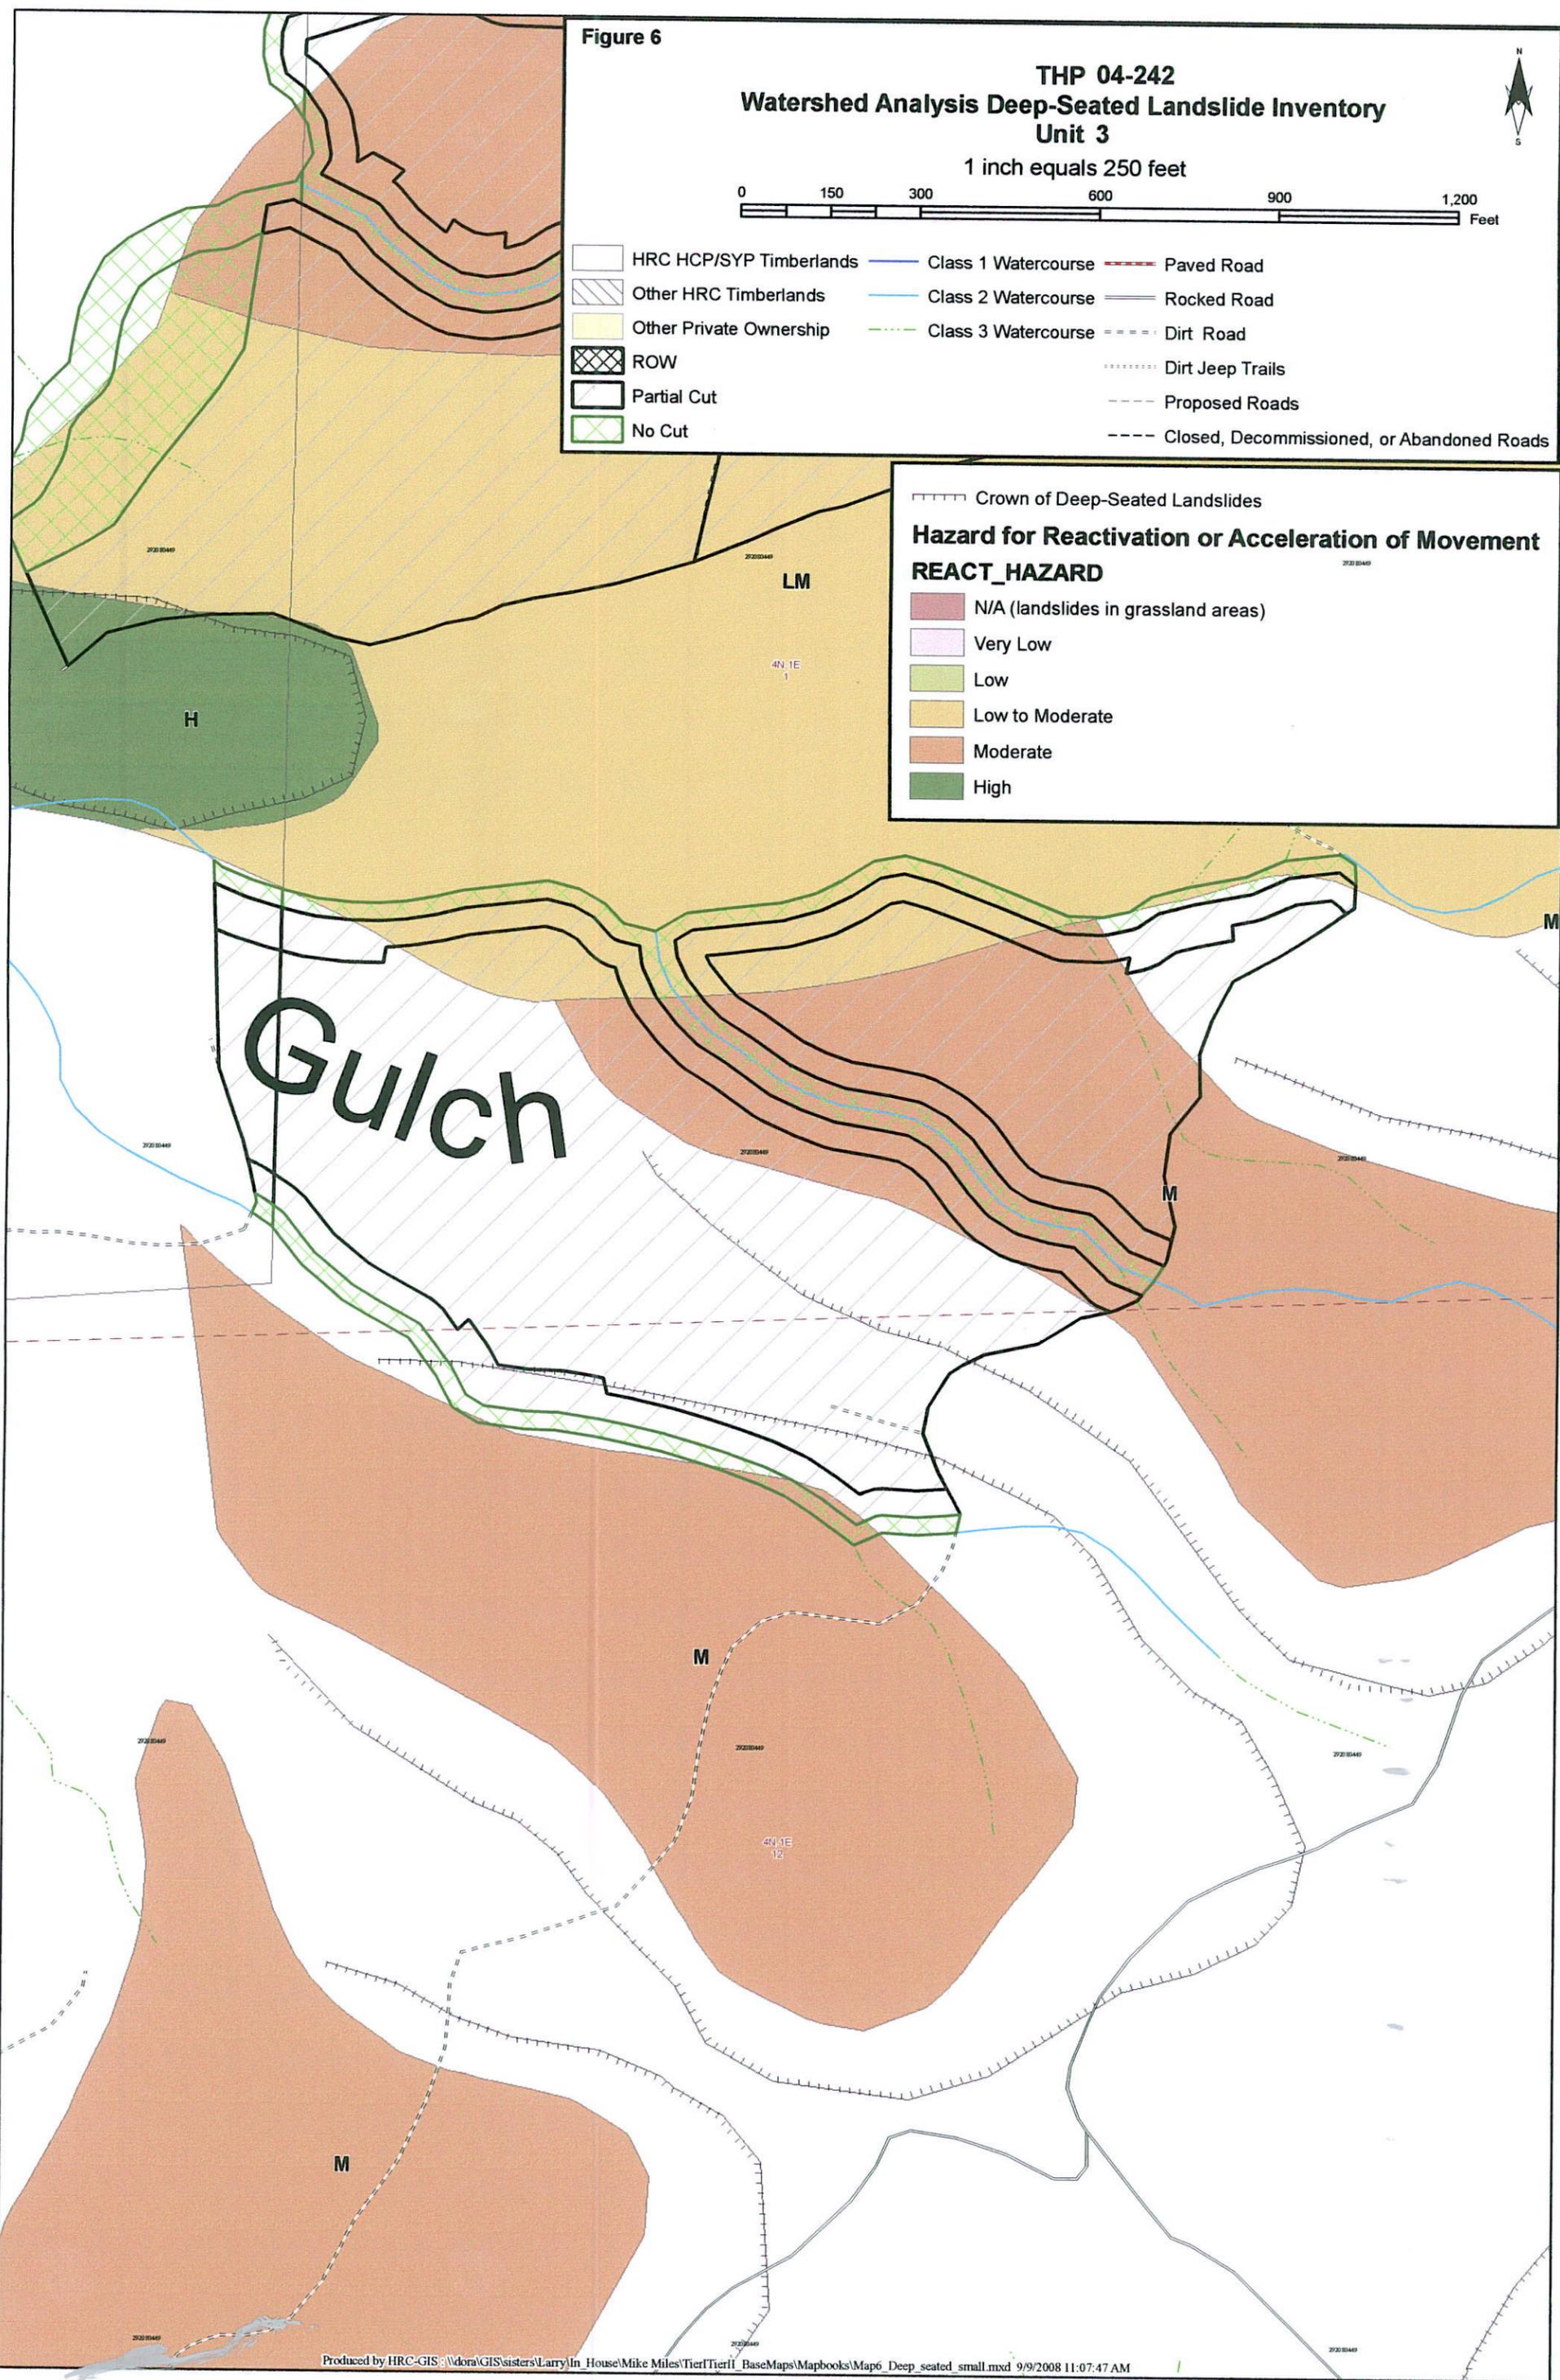
Figure 6 shows the northern half of the unit to be underlain by a northwest trending, moderate hazard landslide. A second

moderate hazard landslide is mapped south of the unit. The right lateral margin of the landslide has been identified as the northern channel side slope of the Class II watercourse that defines the southern boundary of the unit. The scarps of the moderate hazard landslides are mapped within the unit and essentially represent the flanking slopes to the watercourses.
