# Merkel & Associates, Inc.

May 25, 1995  
M&A# 95-037-01

**Re: Eelgrass Survey of the North Dike of the Chula Vista Wildlife Reserve**

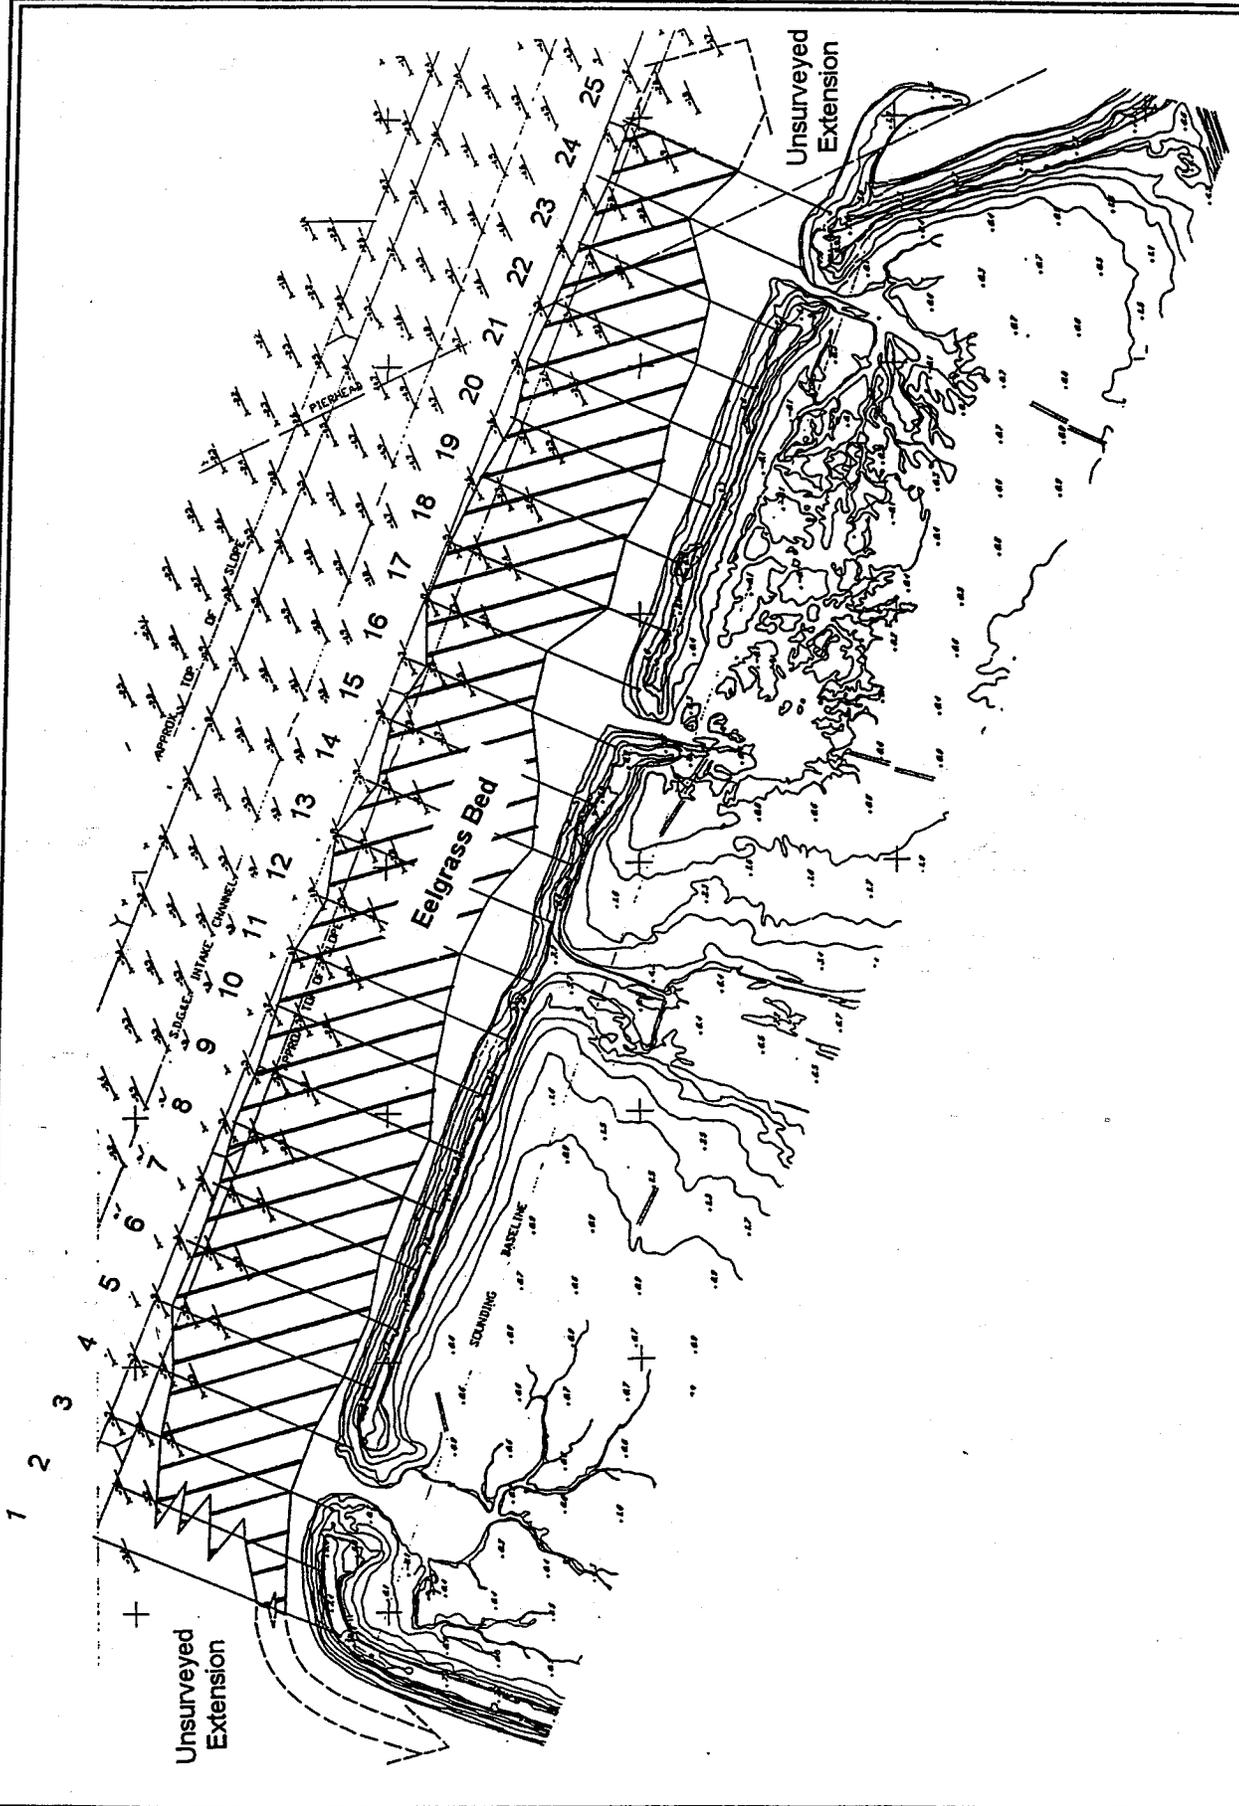
**Figure 2**

The survey revealed eelgrass extending from approximately -1.0 feet MLLW to as deep as -3.5 feet MLLW, the edge of the intake channel (Figure 2). The eelgrass found along the transects appeared to be in excellent health. Shoots observed during the survey were tall in stature and relatively free of epiphytic loading. With the exception of a few patches on the western boundary of the survey site, the eelgrass occurred in a relatively dense, contiguous bed along the north dike and stretched almost to, and in some cases to the edge of the intake channel. Some matting of eelgrass, possibly due to sedimentation, was observed along the eastern portions of the shore-ward third of the main bed, an area subject to greater amounts of island erosion and in an area exhibiting high turbidity originating from the island as the tide ebbed.

The mean shoot density within the eelgrass was determined to be  $158.7 \pm 48.8$  turions/m<sup>2</sup> SD (n=25). The total area of eelgrass in the study area is approximately 13.0 acres (566,880 sq. ft.) more than double the coverage observed at the same time in 1994.

**Eelgrass Distribution Along the North Dike of the Chula Vista Wildlife Island**  
 May 1995
