CDFG, 1995

STREAM INVENTORY REPORT

Mill Creek

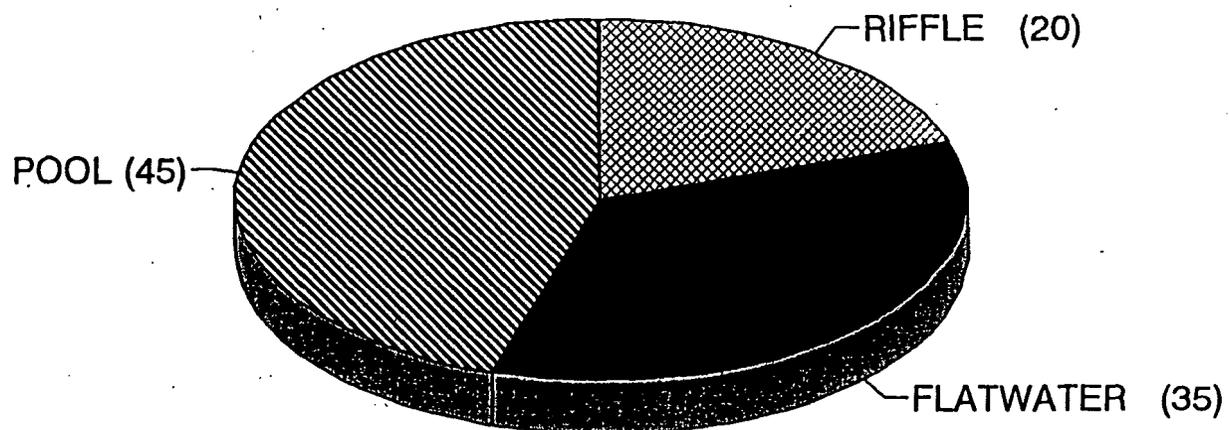
GRAPH 1

Table 1 summarizes the Level II riffle, flatwater, and pool habitat types. Based on frequency of **occurrence** there were 45% pool units, 35% flatwater units, and 20% riffle units (Graph 1). Based on total **length** of Level II habitat types there were 47% flatwater units, 38% pool units, and 15% riffle units (Graph 2).

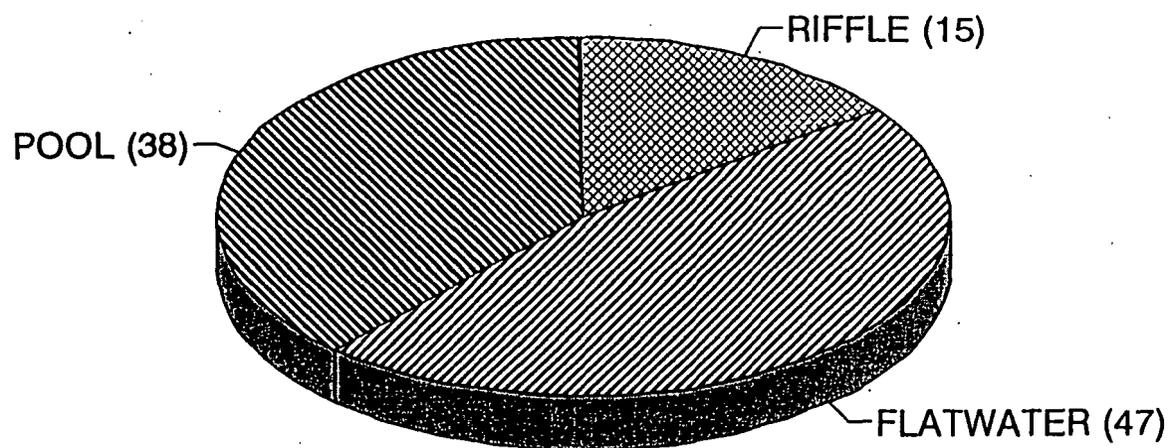
GRAPH 2

Flatwater habitat types comprised 47% of the total length of this survey, riffles 15%, and pools 38%. The pools are relatively shallow, with only 2 of the 47 (5%) pools having a maximum depth greater than 2 feet. In general, pool enhancement projects are considered when primary pools comprise less than 40% of the length of total stream habitat. In first and second order streams, a primary pool is defined to have a maximum depth of at least two feet, occupy at least half the width of the low flow channel, and be as long as the low flow channel width. Installing structures that will increase or deepen pool habitat is recommended for locations where their installation will not be threatened by high stream energy.

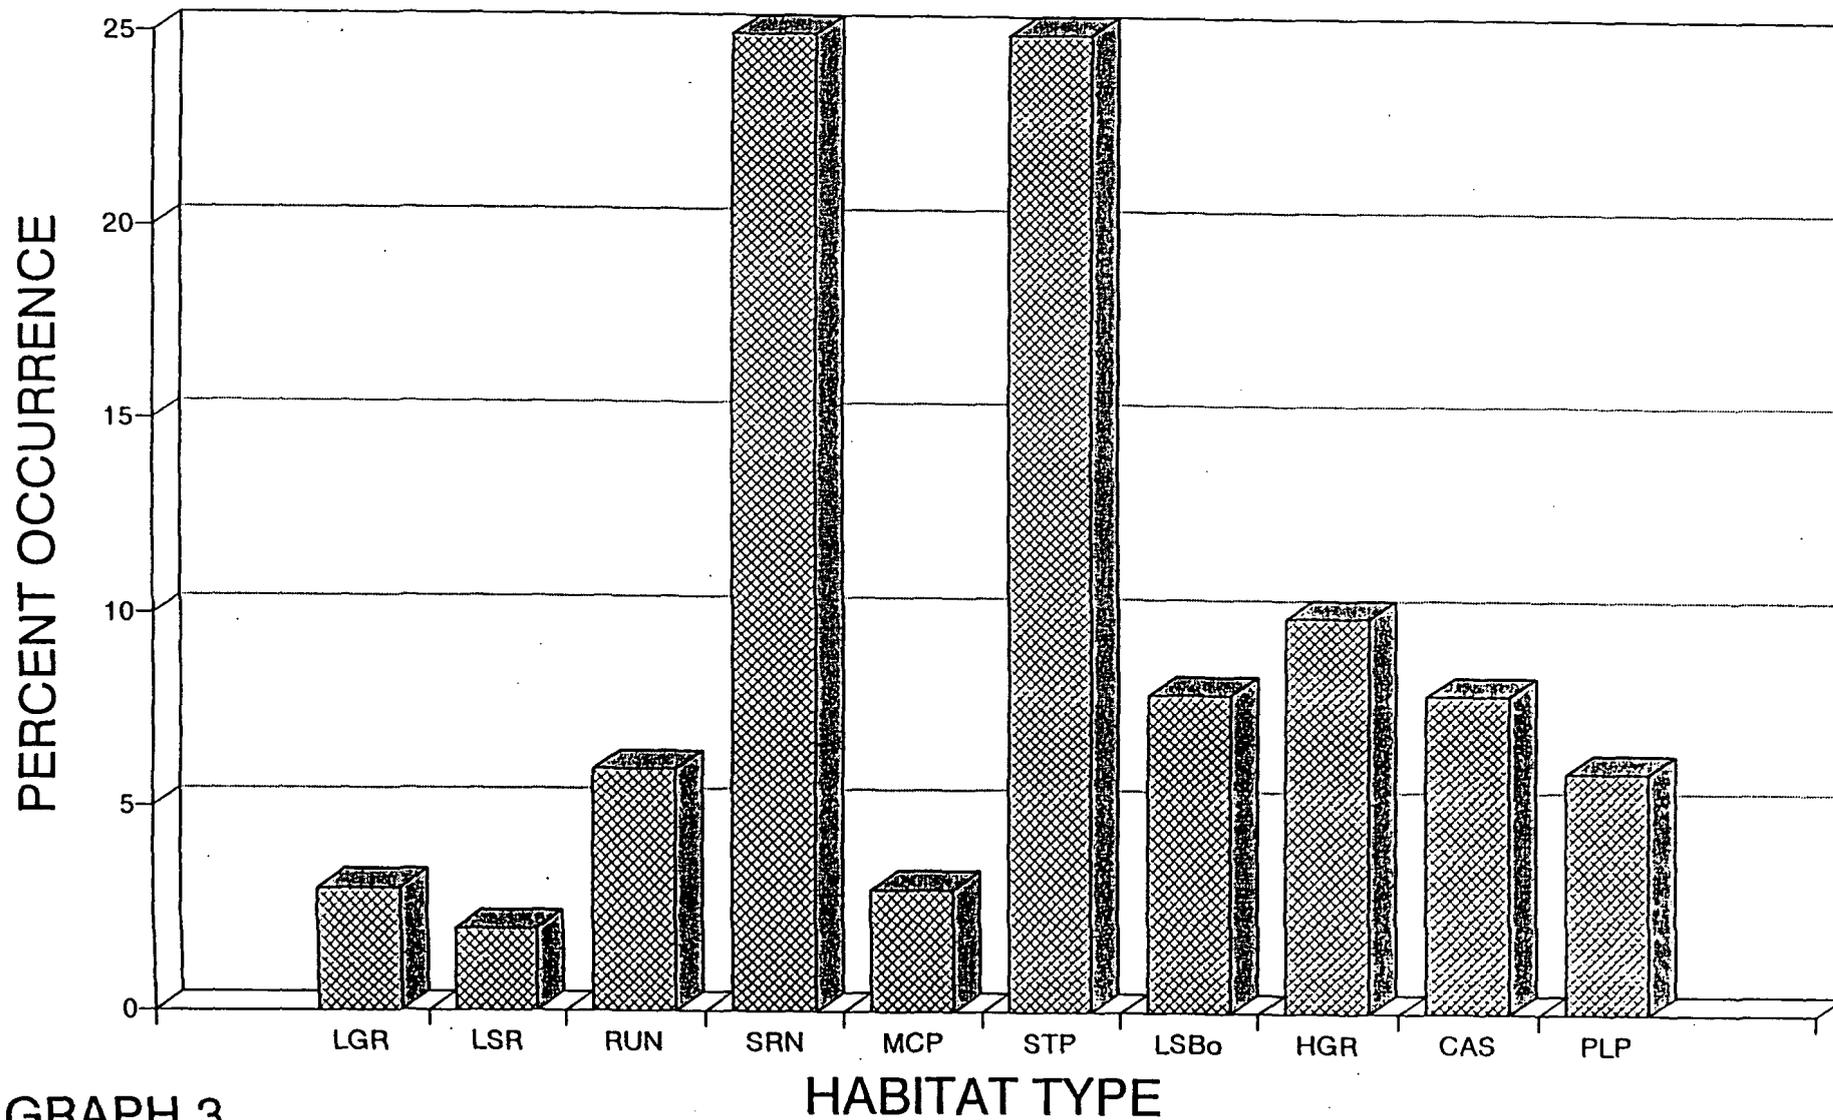
GRAPH 3

Twelve Level IV habitat types were identified (Table 2). The most frequent habitat types by percent **occurrence** were step runs and step pools, 25% each; high gradient riffles, 10%; and cascades and lateral scour pools - boulder formed, 8% (Graph 3). Based on percent total **length**, step runs made up 38%, step pools 29%, and high gradient riffles 9%.

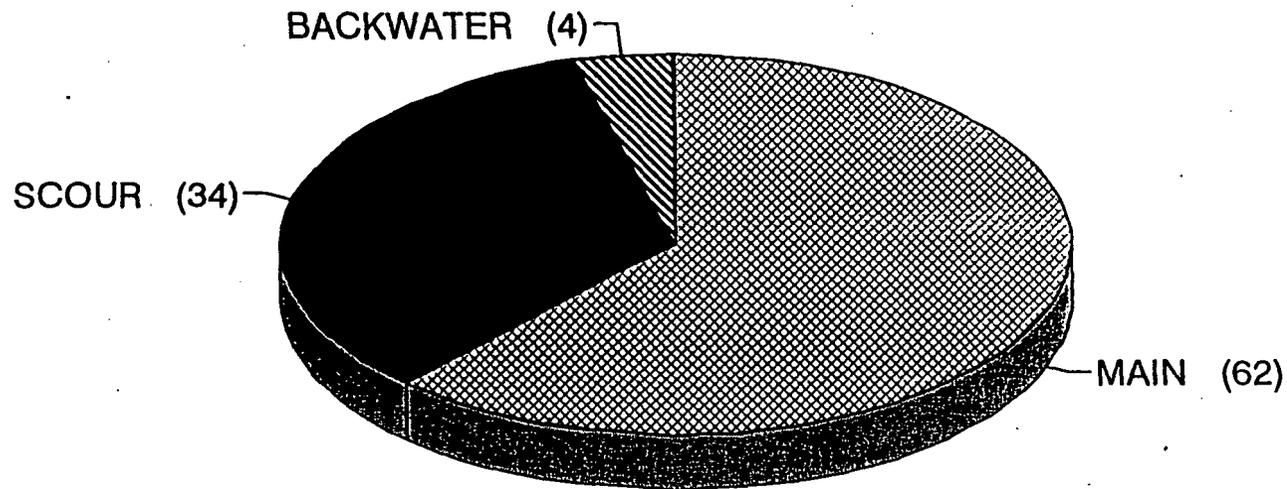
GRAPH 4

A total of forty-seven pools were identified (Table 3). Main channel pools were most frequently encountered at 62% and comprised 80% of the total length of all pools (Graph 4).

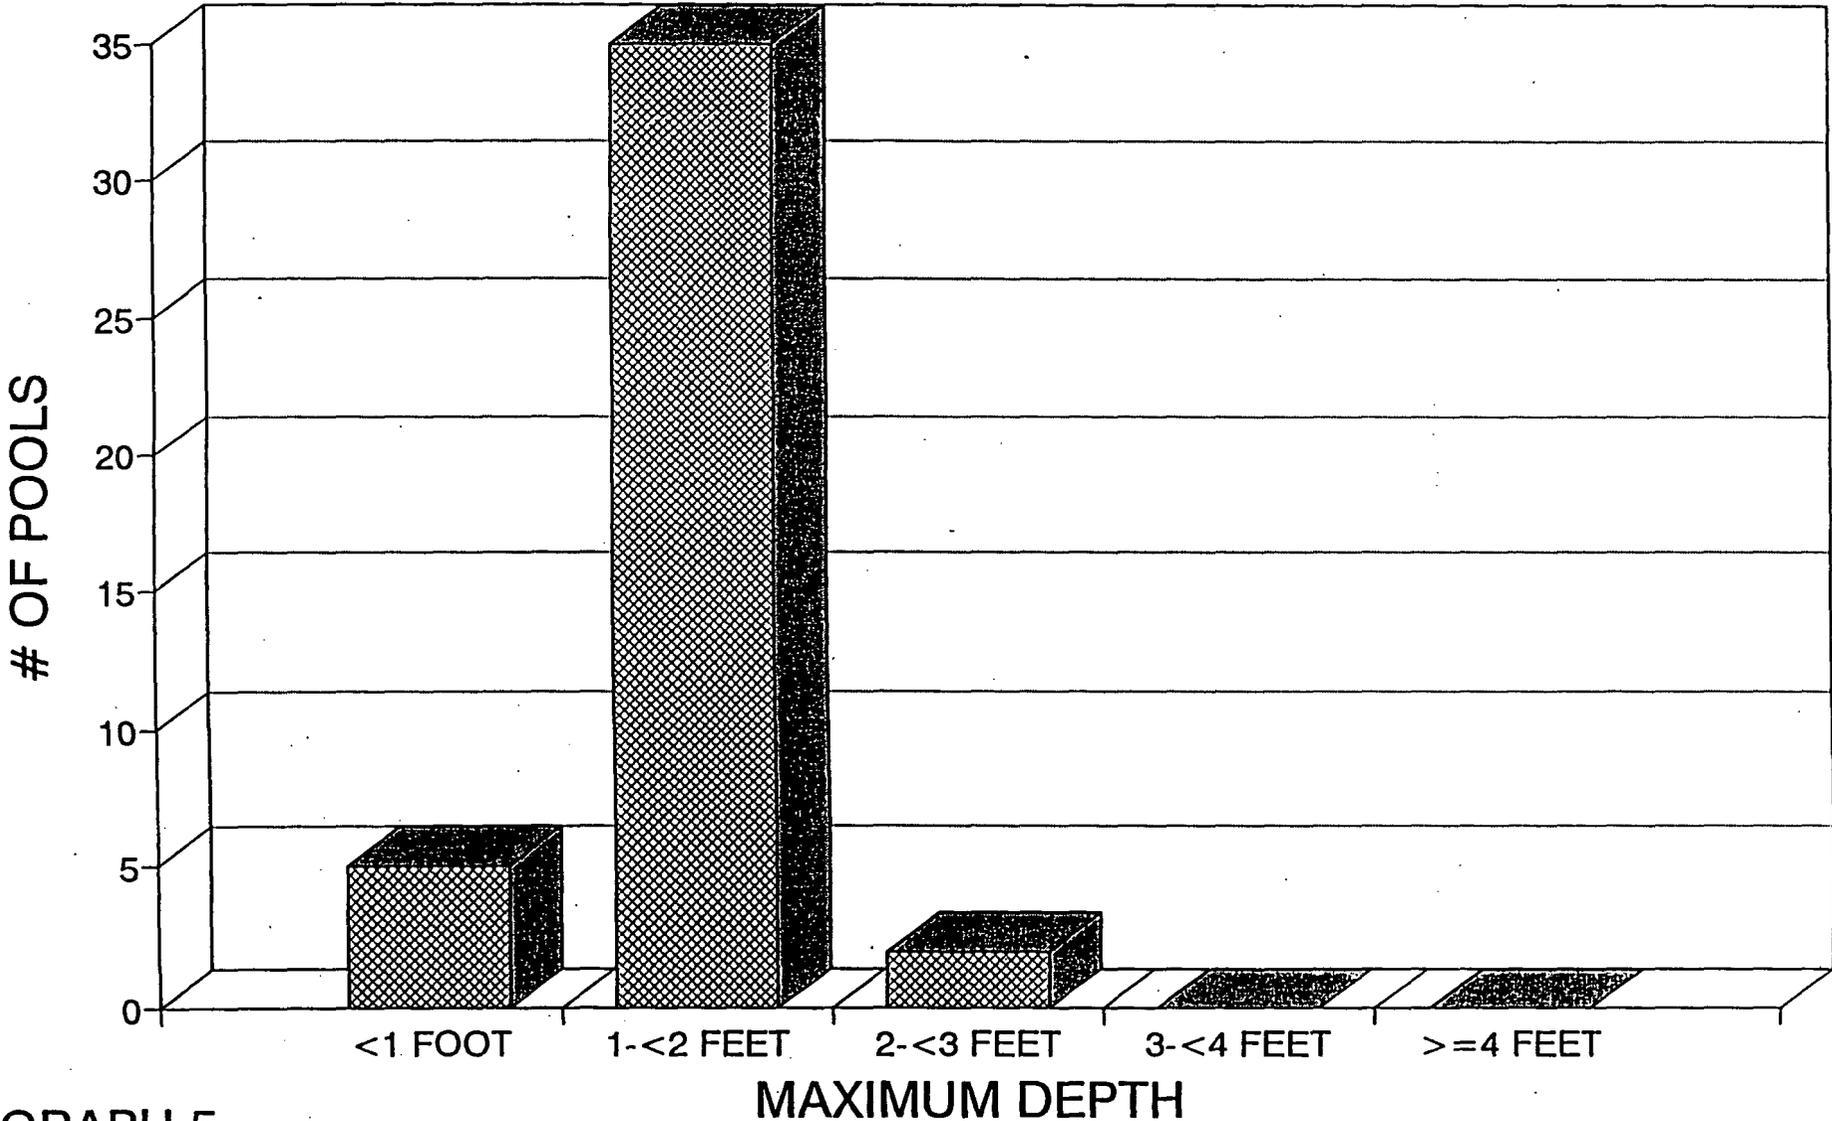
GRAPH 5

Table 4 is a summary of maximum pool depths by pool habitat types. Pool quality for salmonids increases with depth. Two of the forty-seven pools (4%) had a depth of two feet or greater (Graph 5).

- 5) In the B4 channel type, design and engineer pool enhancement structures to increase the number of pools or deepen existing pools. This must be done where the banks are stable or in conjunction with stream bank armor to prevent erosion.

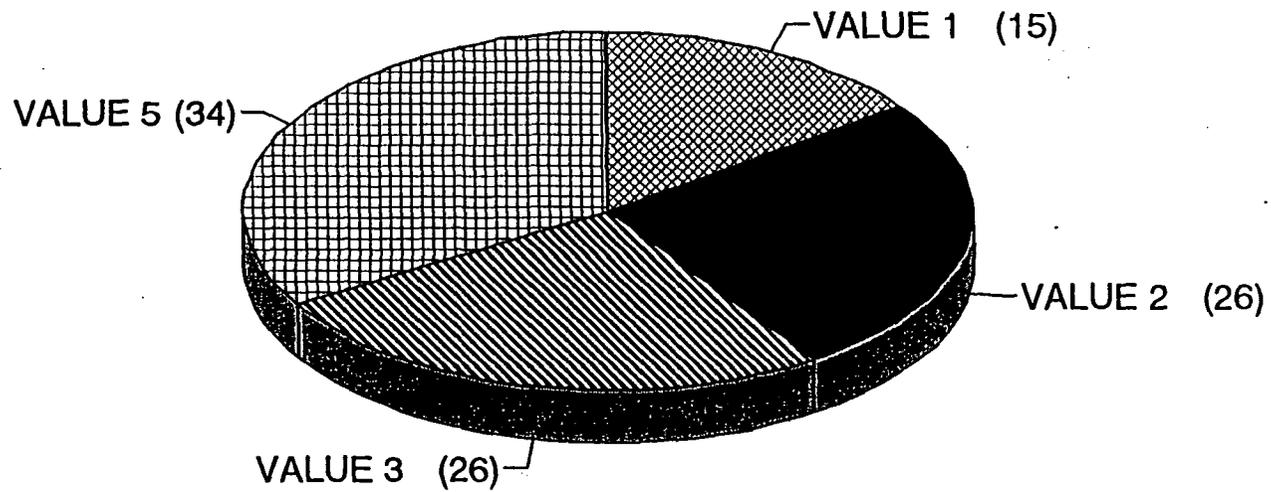
GRAPH 6

The depth of cobble embeddedness was estimated at pool tail-outs. Of the 47 pool tail-outs measured, 7 had a value of 1 (15%); 12 had a value of 2 (26%); 12 had a value of 3 (26%); and 16 had a value of 5 (34%) (Graph 6). On this scale, a value of 1 indicates the highest quality of spawning substrate.

Twenty-eight of the forty-seven (60%) pool tail-outs measured had embeddedness ratings of 3, 4 or 5. Only seven (15%) had a 1 rating. Cobble embeddedness measured to be 25% or less, a rating of 1, is considered to indicate good quality spawning substrate for salmon and steelhead. In Mill Creek, sediment sources should be mapped and rated according to their potential sediment yields, and control measures should be taken.

- 3) Active and potential sediment sources related to the road system need to be identified, mapped, and treated according to their potential for sediment yield to the stream and its tributaries.

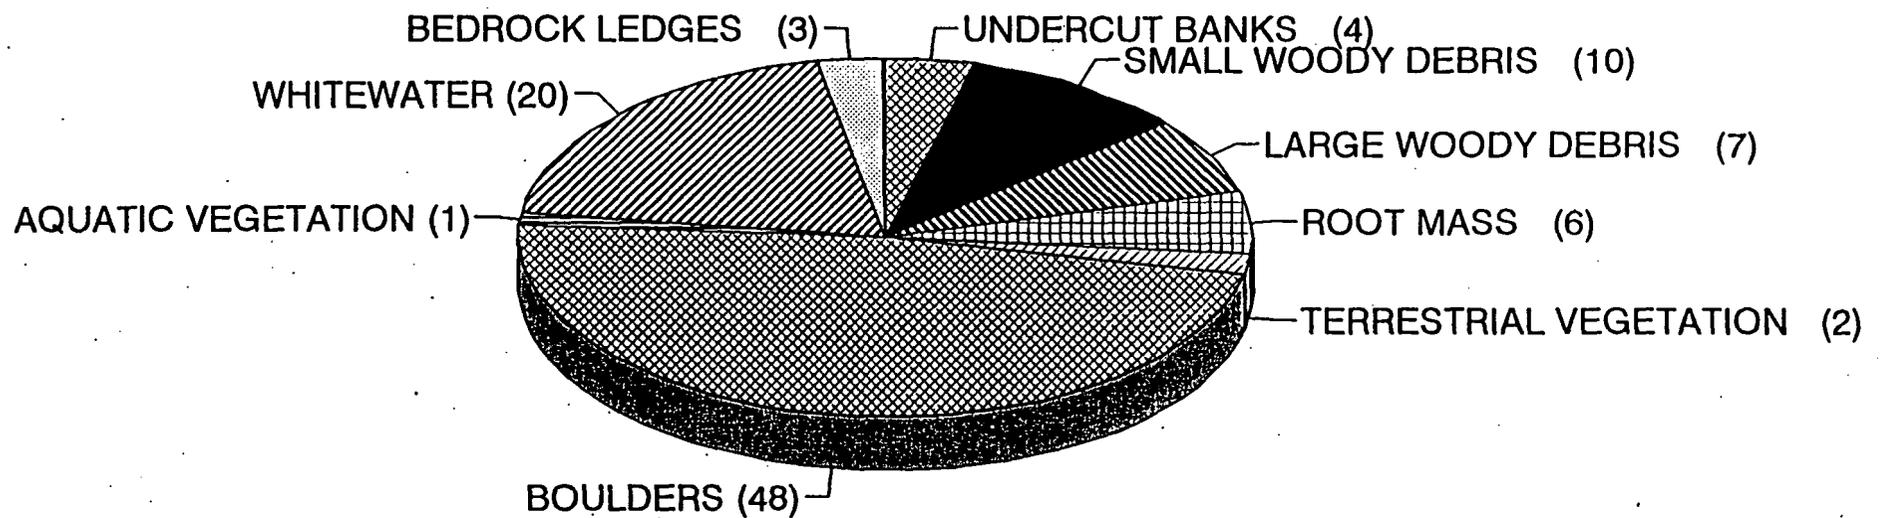
GRAPH 7

Table 5 summarizes mean percent cover by habitat type. Boulders are the dominant cover type in Mill Creek. Graph 7 describes the pool cover in Mill Creek.

The mean shelter rating for pools was low with a rating of 41. The shelter rating in the flatwater habitats was slightly lower at 23. A pool shelter rating of approximately 100 is desirable. The relatively small amount of cover that now exists is being provided primarily by boulders in all habitat types. Additionally, white water contributes a small amount. Log

and root wad cover structures in the pool and flatwater habitats are needed to improve both summer and winter salmonid habitat. Log cover structure provides rearing fry with protection from predation, rest from water velocity, and also divides territorial units to reduce density related competition.

- 1) Mill Creek should be managed as an anadromous, natural production stream.
- 2) Increase woody cover in the pools and flatwater habitat units. Most of the existing cover is from white water. Adding high quality complexity with woody cover is desirable.

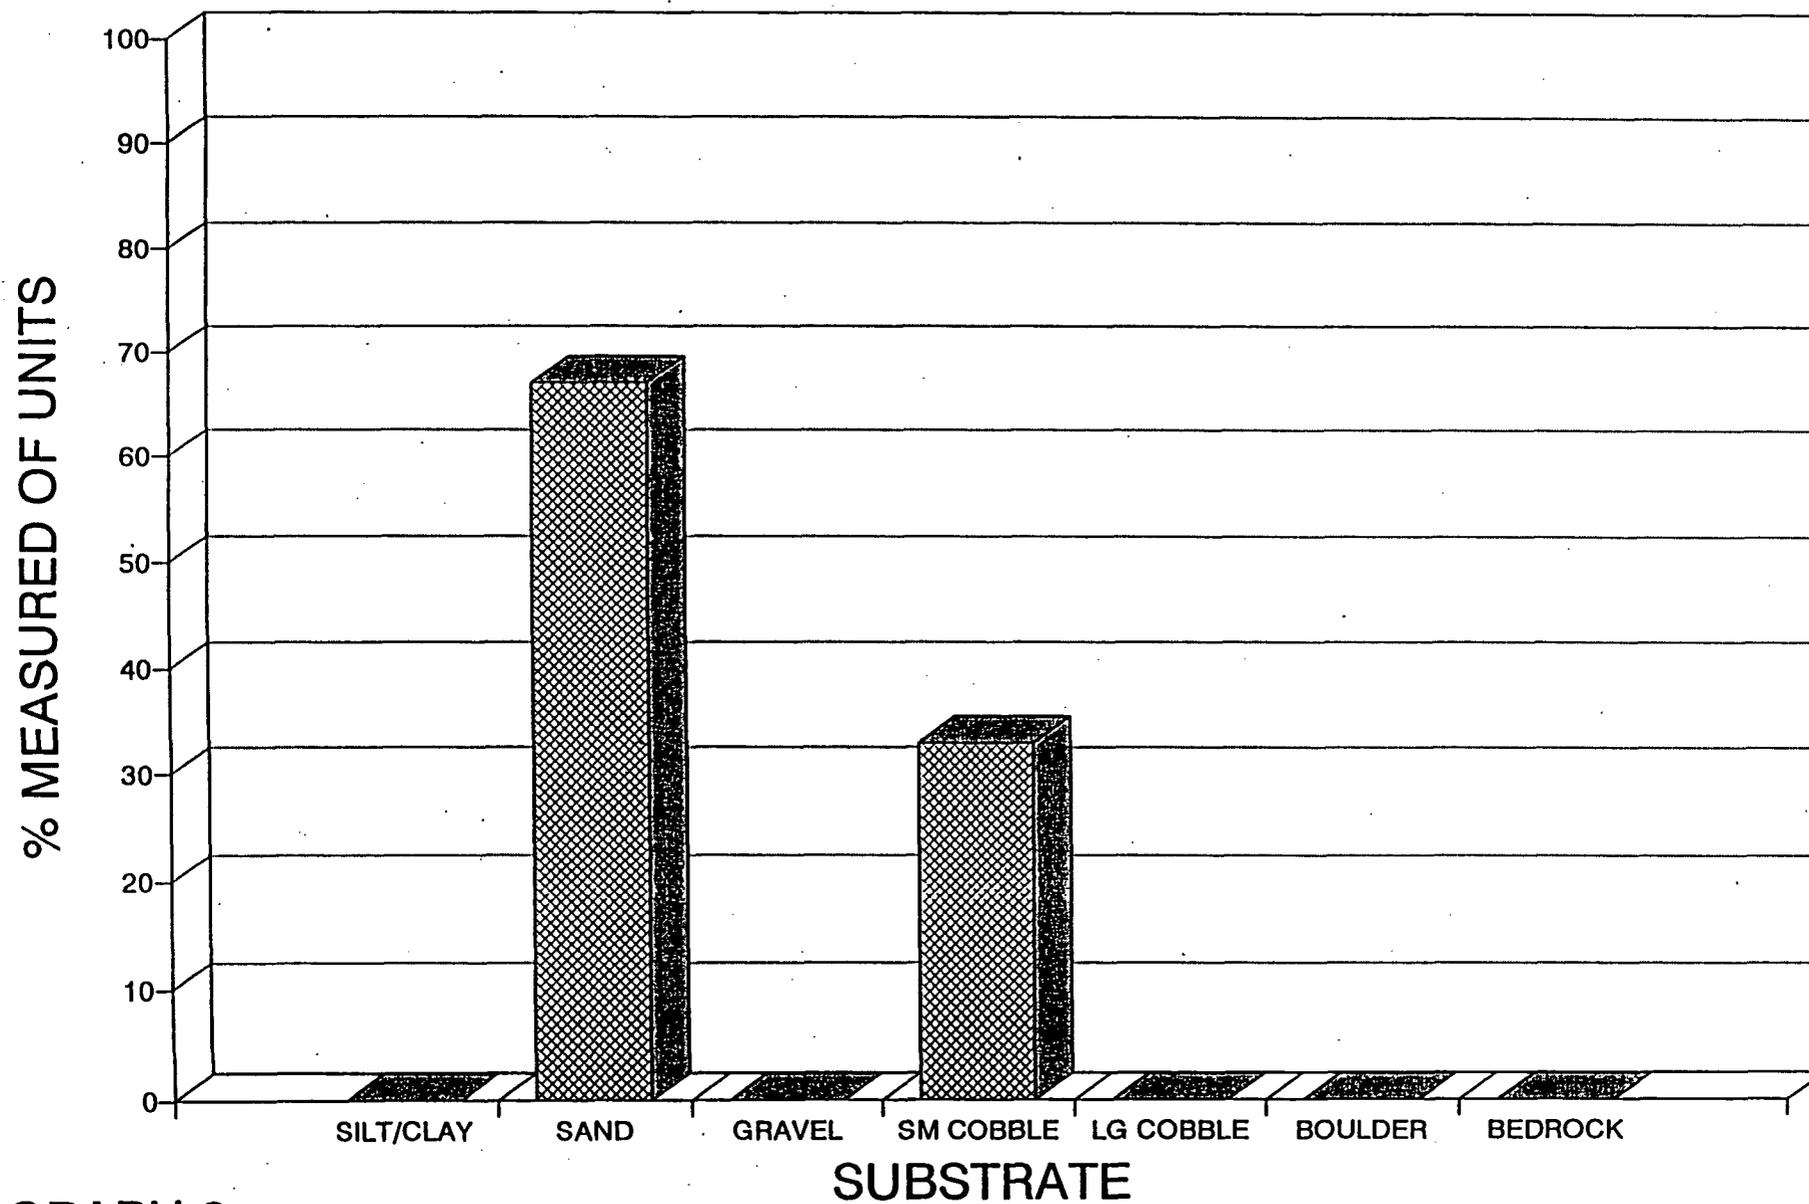
GRAPH 8

Table 6 summarizes the dominant substrate by habitat type. Sand was the dominant substrate observed in 67% of the low gradient riffles measured. Small cobble was the next most frequently observed dominant substrate type and occurred in 33% of the low gradient riffles (Graph 8).

Two of the three low gradient riffles had sand as the dominant substrate. This is generally considered unsuitable for spawning salmonids.

- 6) Spawning gravel on Mill Creek are limited to relatively few reaches. Projects should

be designed at suitable sites to trap and sort spawning gravel.

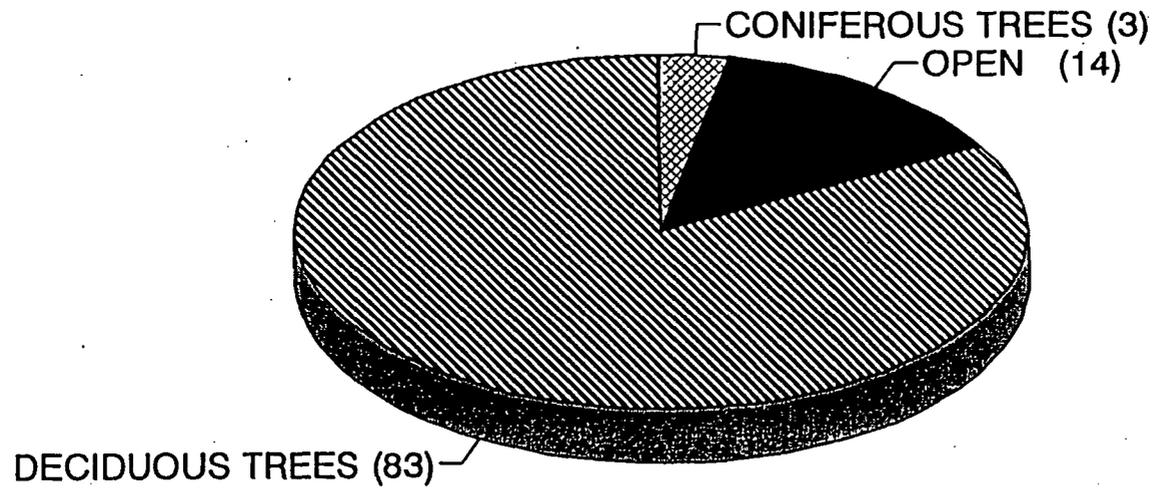
GRAPH 9

The mean percent canopy density for the stream reach surveyed was 86%. The mean percentages of deciduous and coniferous trees were 97% and 3%, respectively. Graph 9 describes the canopy in Mill Creek.

The mean percent canopy density for the stream was 86%. This is a relatively high percentage of canopy, although conifers are lacking in the riparian zone. In general, re-vegetation projects are considered when canopy density is less than 80%.

- 7) Plant conifers to improve the canopy in the riparian zone.

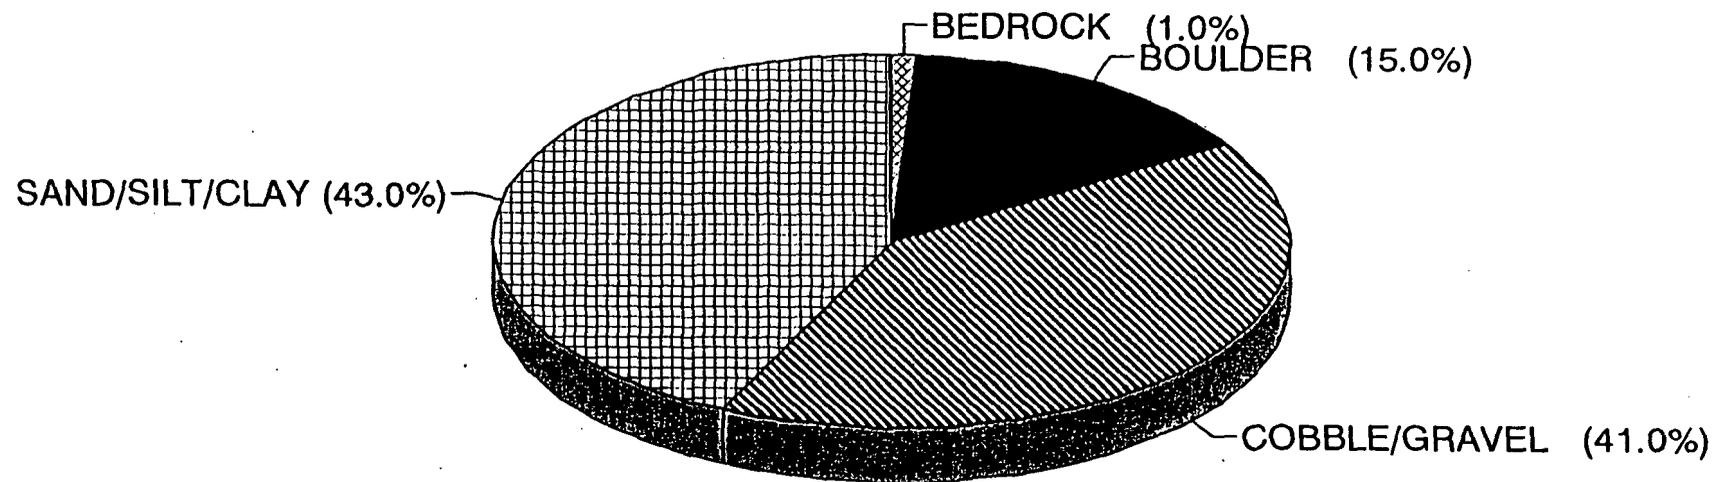
GRAPH 10

For the stream reach surveyed, the mean percent right bank vegetated was 56.2%. The mean percent left bank vegetated was 62.9%. The dominant elements composing the structure of the stream banks consisted of 1% bedrock, 15% boulder, 41% cobble/gravel, and 43% sand/silt/clay (Graph 10). Deciduous trees were the dominant vegetation type observed in 48.5% of the units surveyed. Additionally, 36.4% of the units surveyed had brush as the dominant vegetation type, and 14.1% had grass as the dominant vegetation (Graph 11).

The percentage of right and left bank covered with vegetation was low at 56.2% and 62.9%, respectively. In areas of stream bank erosion or where bank vegetation is not at acceptable levels, planting endemic species of coniferous and deciduous trees, in conjunction with bank stabilization, is recommended.
