**HABITAT INVENTORY AND INITIAL ASSESSMENT OF  
ANTHROPOGENIC SEDIMENTATION OF  
UPPER MARK WEST CREEK,  
SONOMA COUNTY, CALIFORNIA**

**PREPARED FOR:  
New-Old Ways Wholistically Emerging  
7768 St. Helena Road  
Santa Rosa, California 95404**

**PREPARED BY:  
STACY K. LI, PH.D.  
AQUATIC SYSTEMS RESEARCH  
1210 SPENCER AVENUE  
SANTA ROSA, CALIFORNIA 95404  
AND  
DOUGLAS PARKINSON  
DOUGLAS PARKINSON AND ASSOCIATES  
960 L STREET  
ARCATA, CALIFORNIA**

**JUNE 27, 2009**

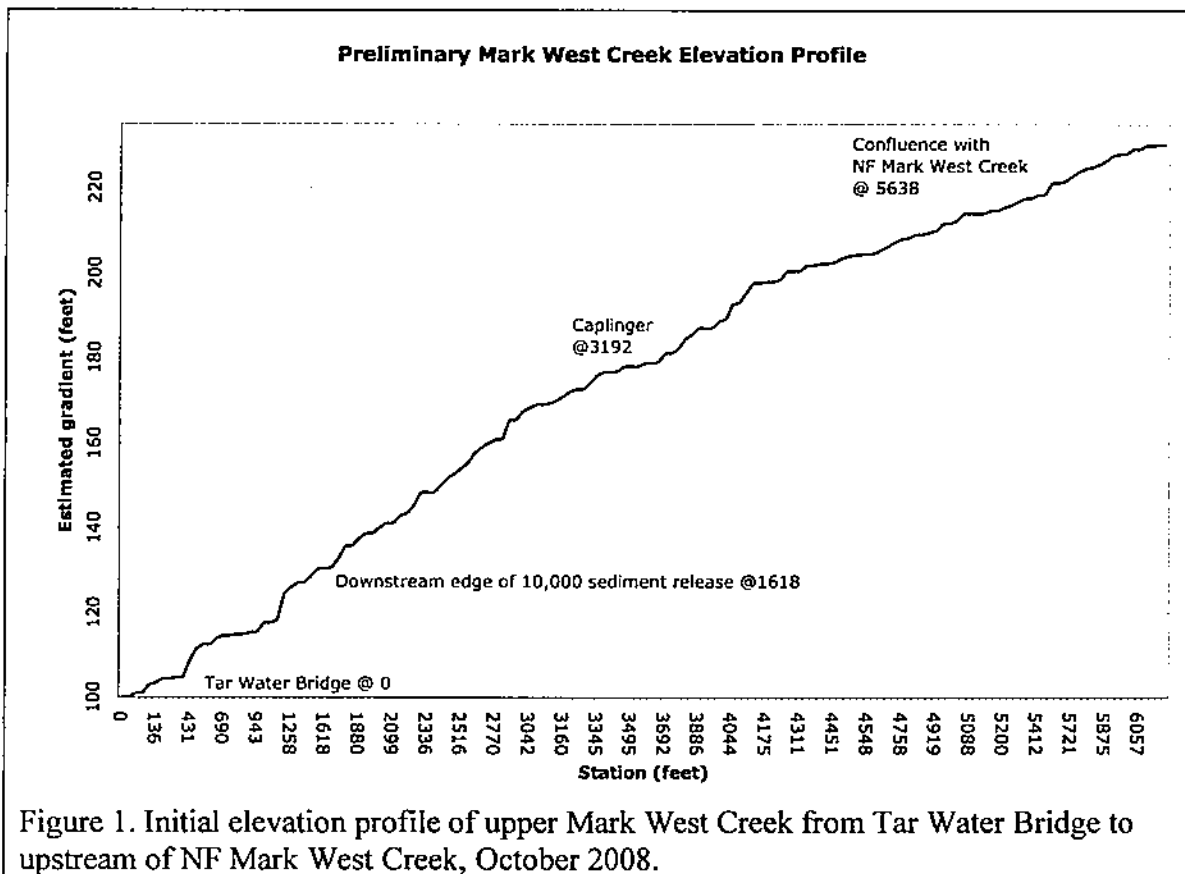
We developed a preliminary relative elevation profile based upon periodic gradient measurements and estimates of gradient (Figure 1). The stream has a consistent gradient between 3% and 4%.

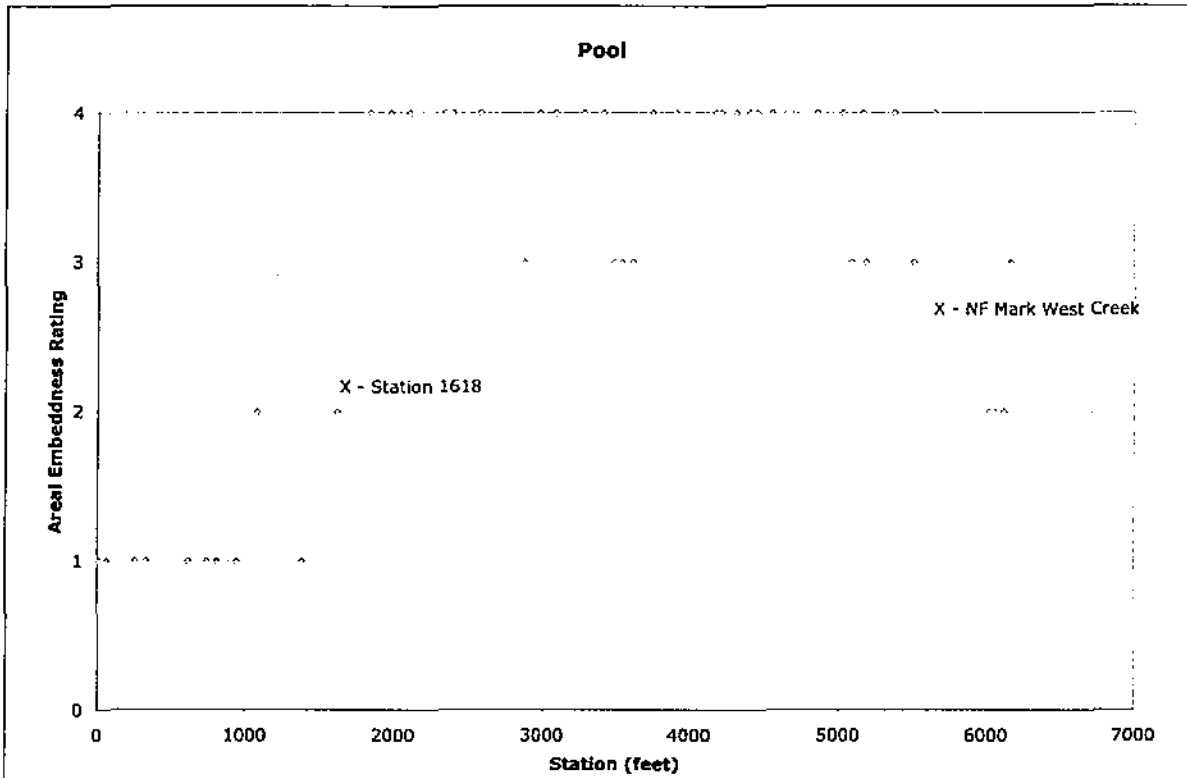
Figure 3. Longitudinal profile of area embeddedness in pools during low streamflow conditions in upper Mark West Creek, Sonoma County, California, October 2008.

Pool areas were relatively free of sediment downstream of Station 1618 and were more highly embedded thereafter in the upstream direction (Figure 3).

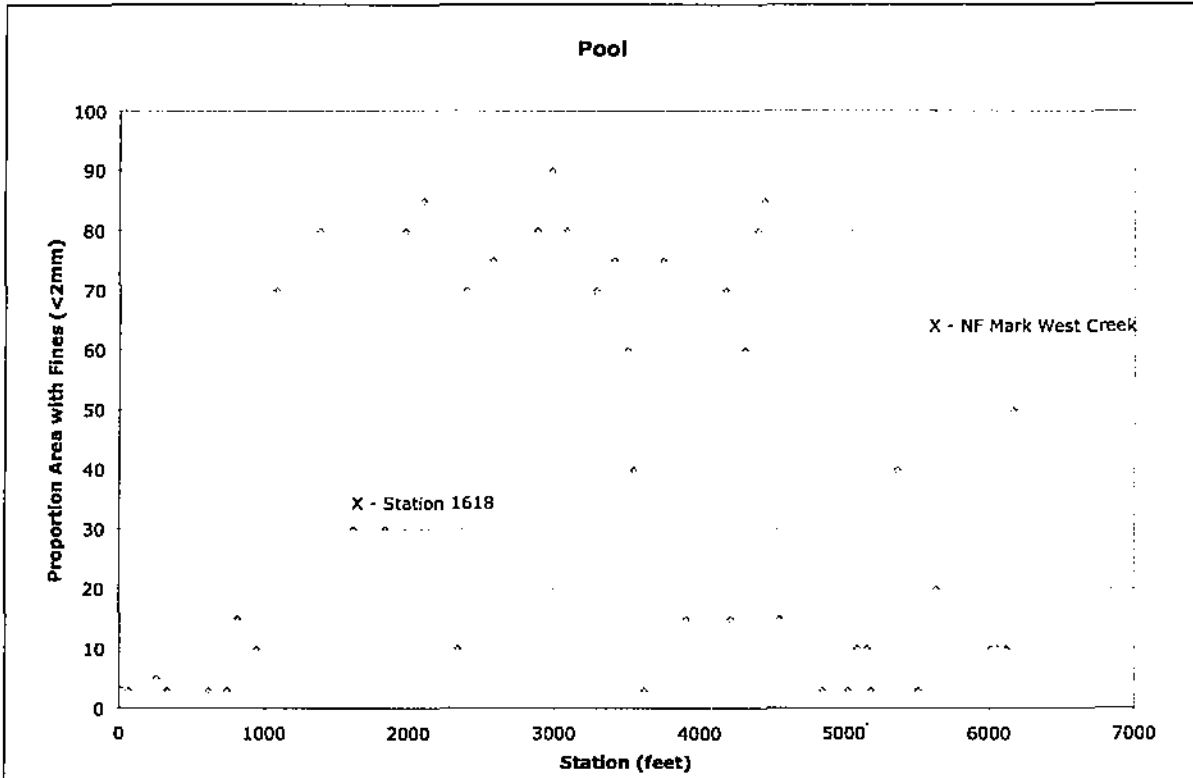
Figure 4. Longitudinal profile of percent surface fines in pools during low streamflow conditions in upper Mark West Creek, Sonoma County, California, October 2008

The percent of surface fines in pools was lower prior to Station 1618 and was higher thereafter in the upstream direction (Figure 4).

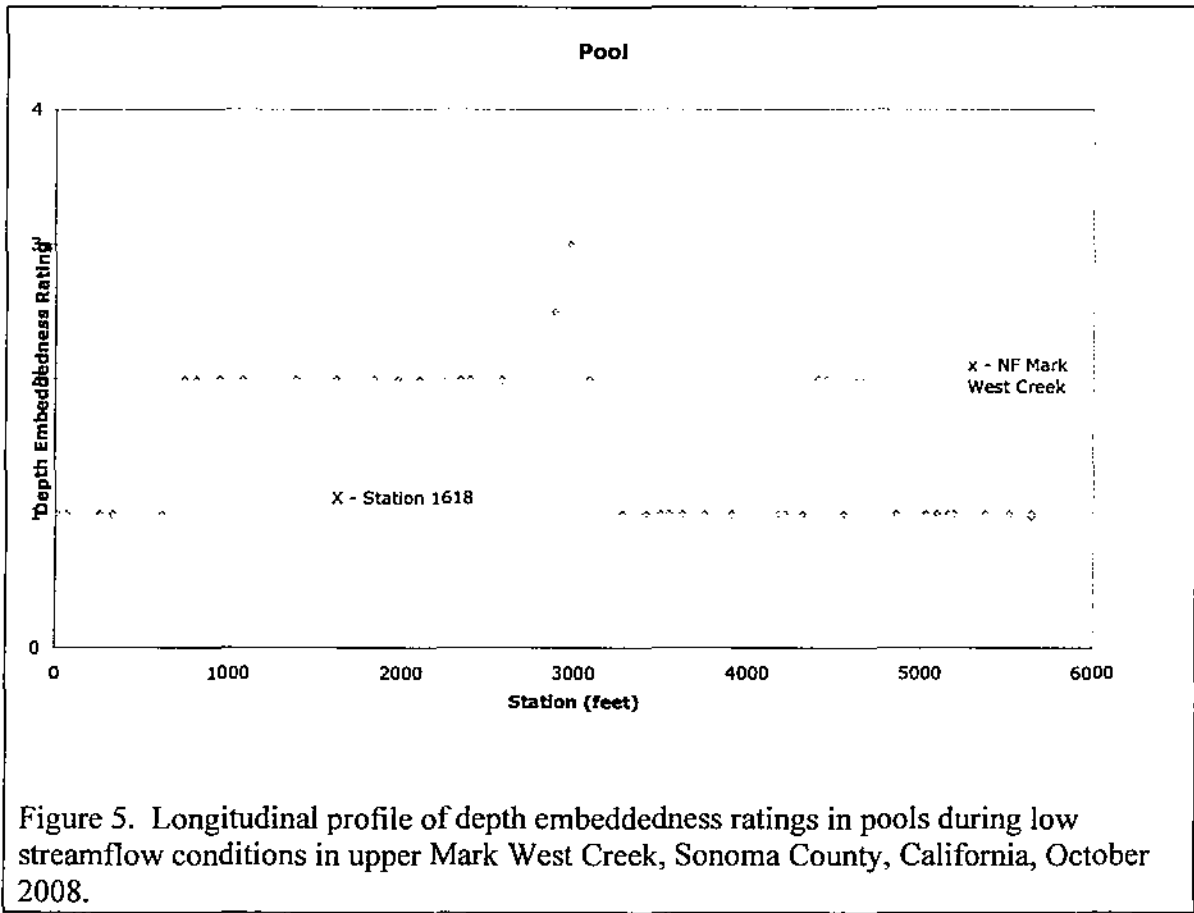
Figure 5. Longitudinal profile of depth embeddedness ratings in pools during low streamflow conditions in upper Mark West Creek, Sonoma County, California, October 2008.

There was an increase in embeddedness depth in pools from station 1000 to station 5000 (Figure 5).

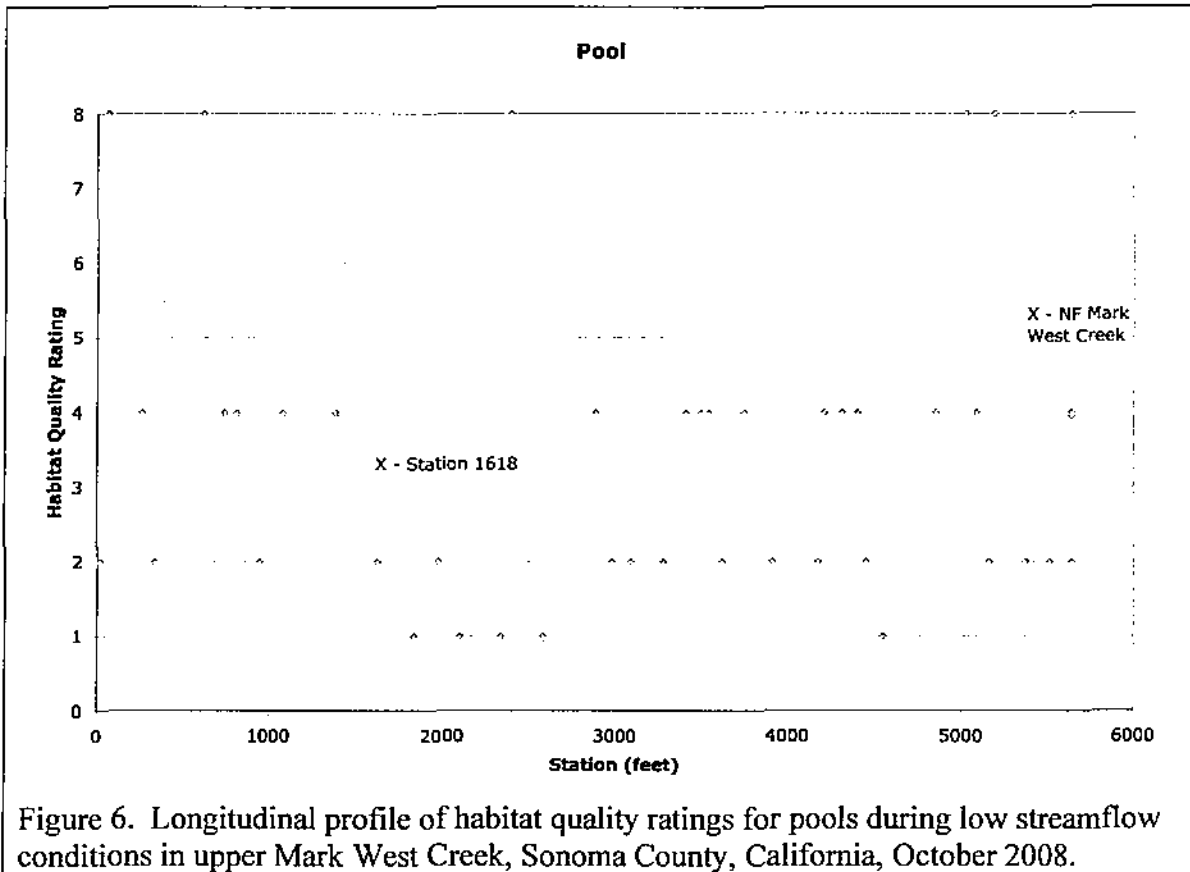
Figure 6. Longitudinal profile of habitat quality ratings for pools during low streamflow conditions in upper Mark West Creek, Sonoma County, California, October 2008.

Habitat quality for pools was fair to good (Figure 6). There were some excellent habitat ratings within the sediment slug (upstream of station 1618). The adverse effects of sediment in pools are delayed until the living space is filled up.

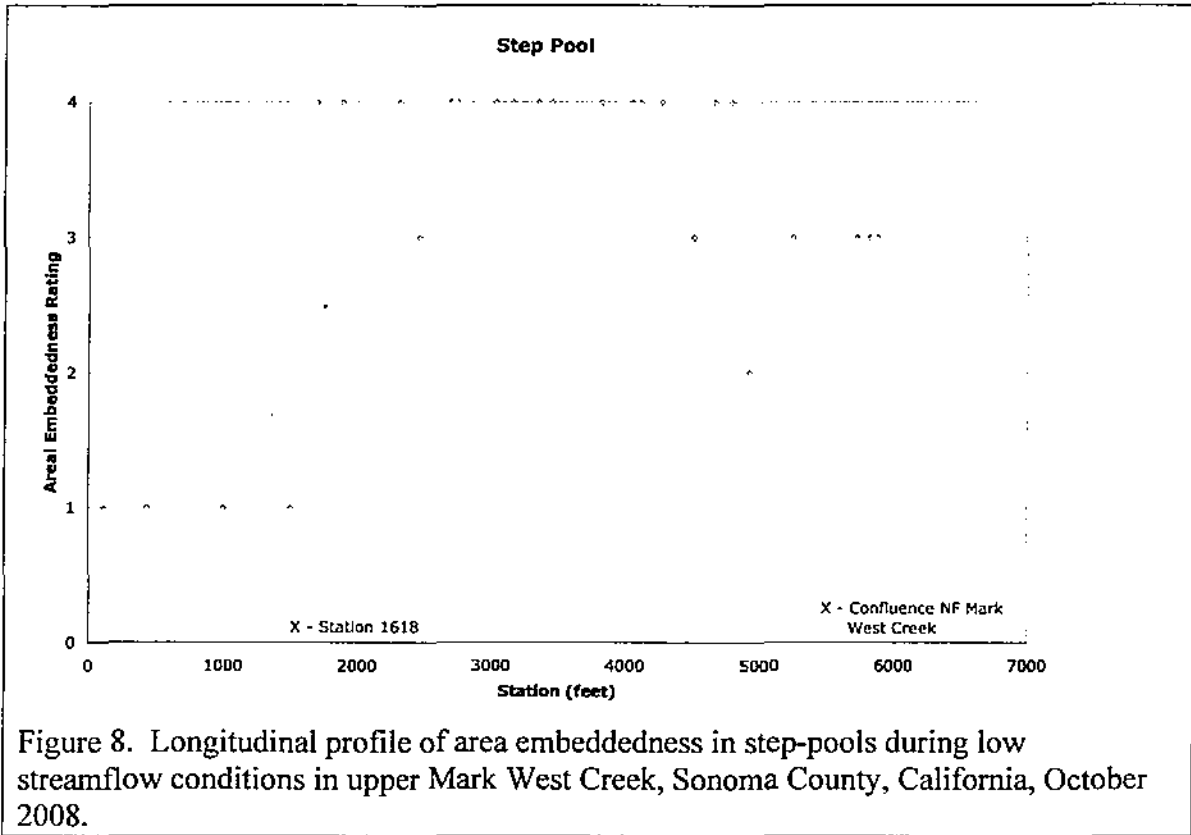
Figure 8. Longitudinal profile of area embeddedness in step-pools during low streamflow conditions in upper Mark West Creek, Sonoma County, California, October 2008.

Area embeddedness was low downstream of Station 1618, but increased upstream of that location (Figure 8).

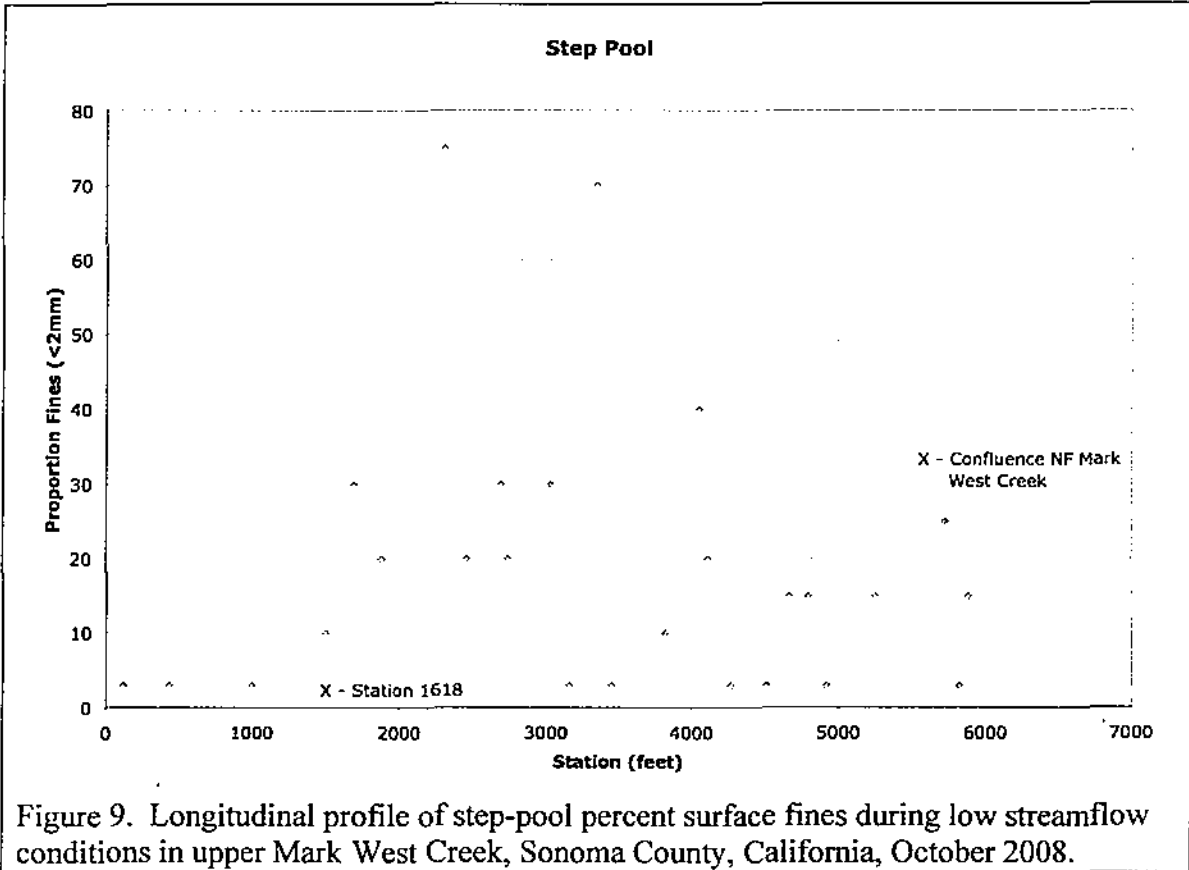
Figure 9. Longitudinal profile of step-pool percent surface fines during low streamflow conditions in upper Mark West Creek, Sonoma County, California, October 2008.

Percent surface fines in step-pools was initially low, but increased noticeably upstream of Station 1618 (Figure 9).

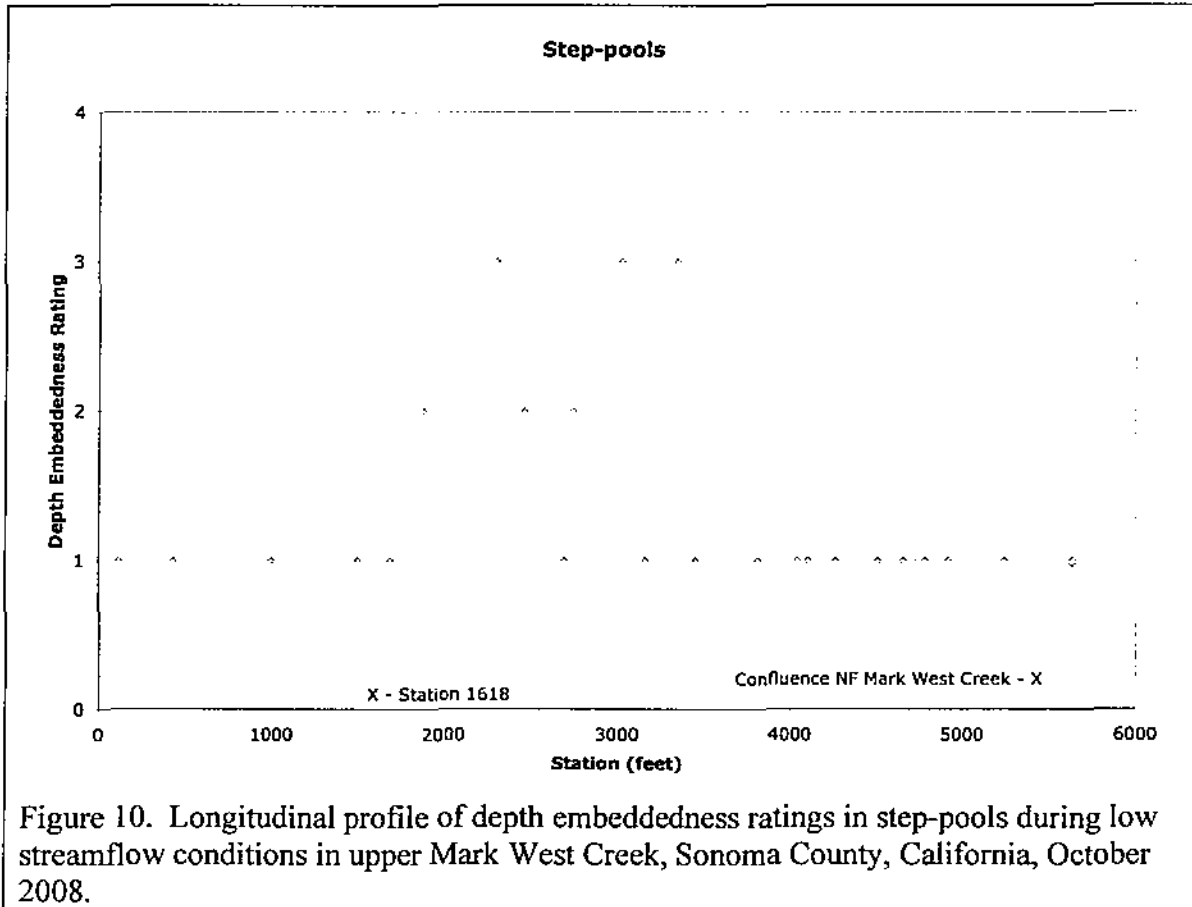
Figure 10. Longitudinal profile of depth embeddedness ratings in step-pools during low streamflow conditions in upper Mark West Creek, Sonoma County, California, October 2008.

There was an increase in depth embeddedness upstream of station 1618 (Figure 10).

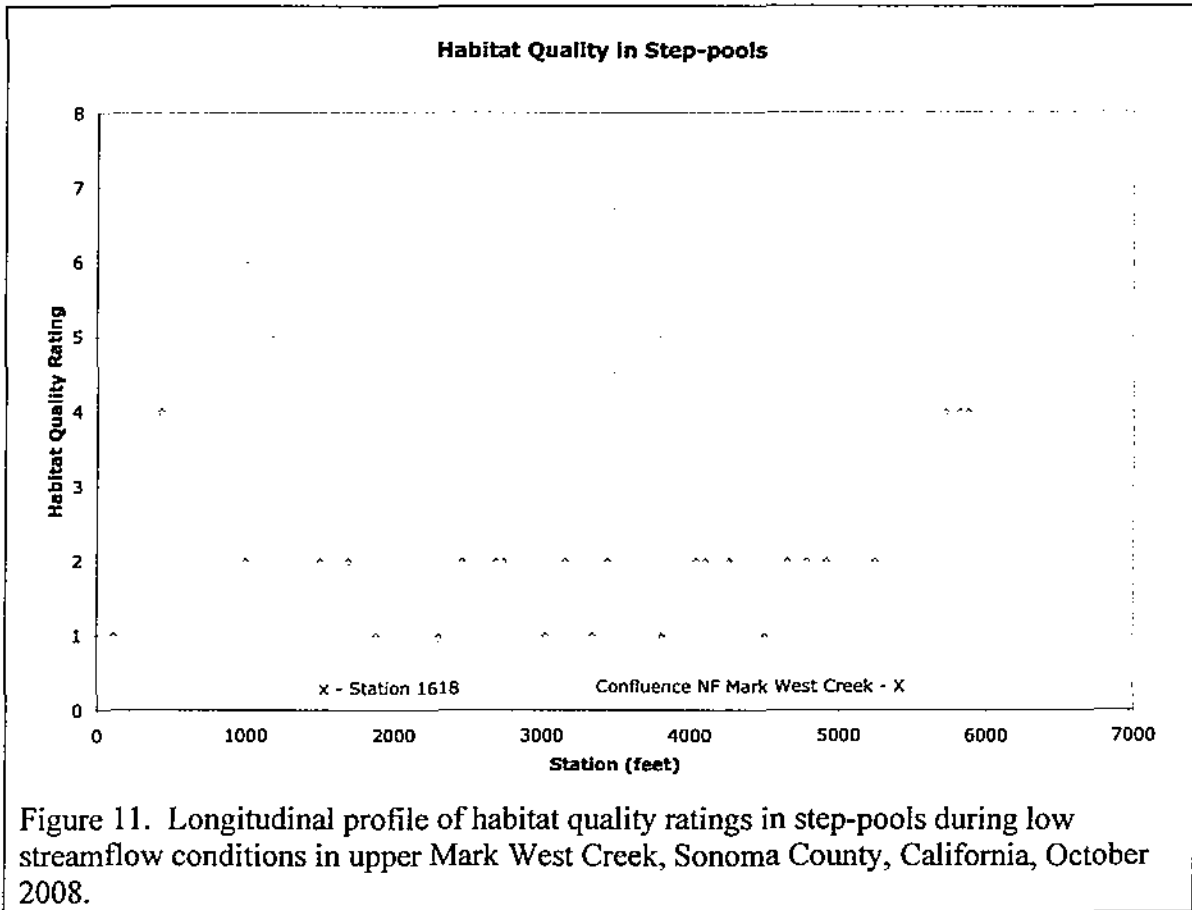
Figure 11. Longitudinal profile of habitat quality ratings in step-pools during low streamflow conditions in upper Mark West Creek, Sonoma County, California, October 2008.

Step-pool habitat quality was lower between Station 1000 and Station 5500 (Figure 11).

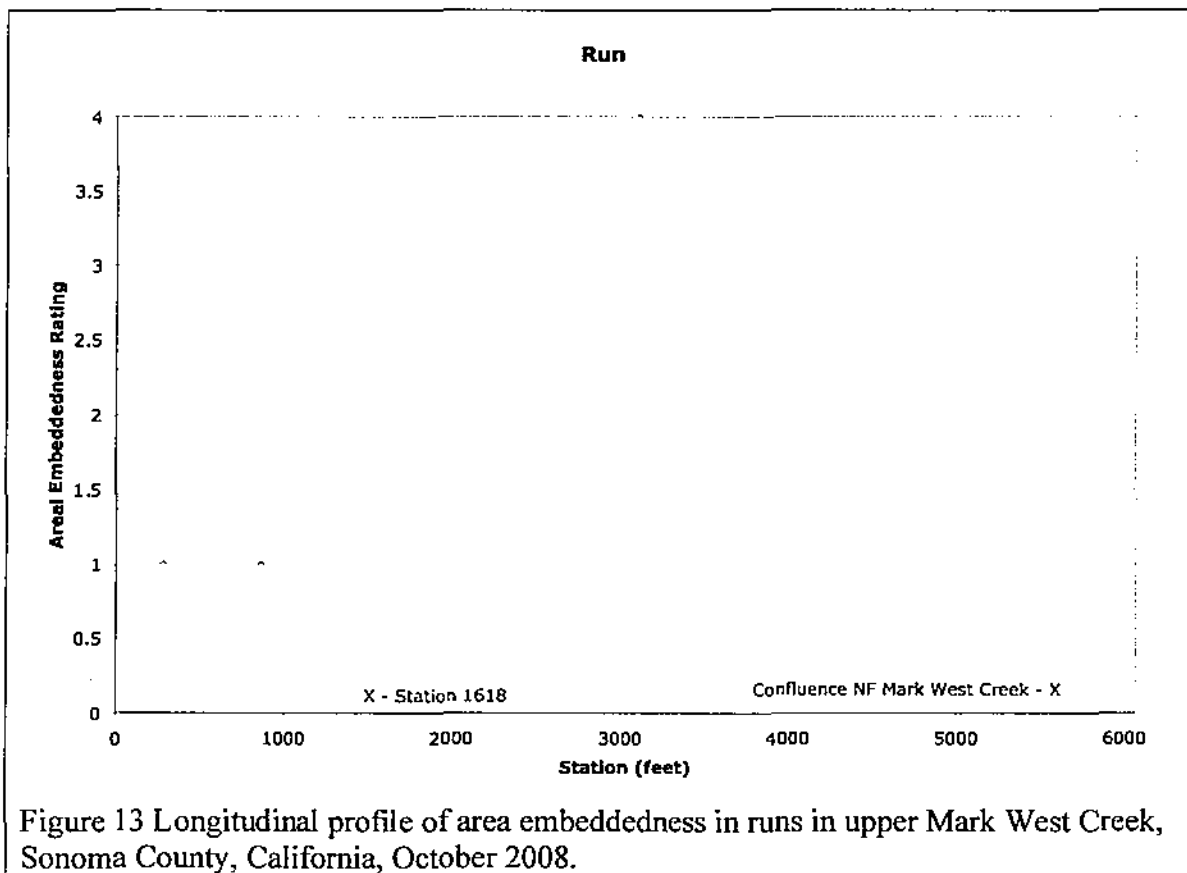
Figure 13 Longitudinal profile of area embeddedness in runs in upper Mark West Creek, Sonoma County, California, October 2008.

The two downstream runs are not under the influence of the 10,000 cubic yard sediment spill, consequently their area embeddedness is low (Figure 13).

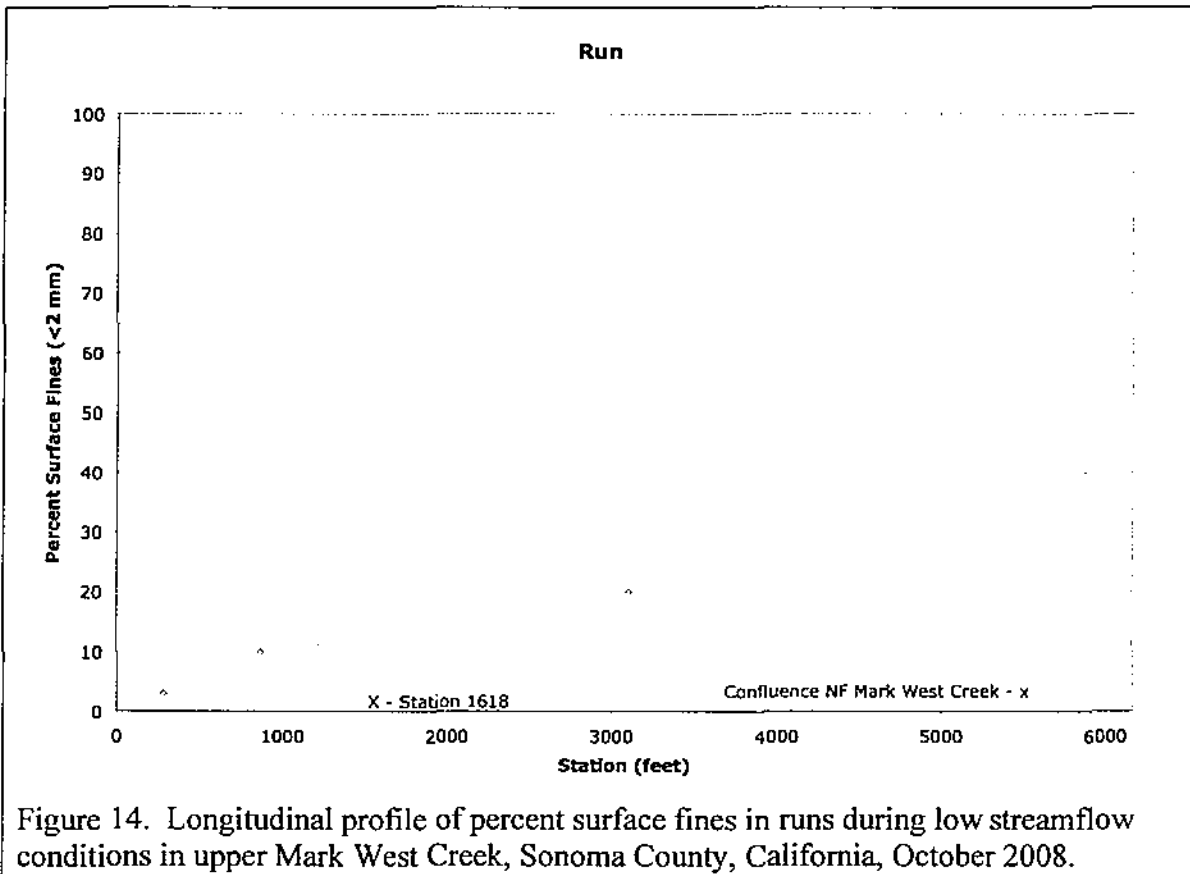
Figure 14. Longitudinal profile of percent surface fines in runs during low streamflow conditions in upper Mark West Creek, Sonoma County, California, October 2008.

The two downstream runs are not under the influence of the 10,000 cubic yard sediment spill; as a result, their percent surface fines are low (Figure 14).

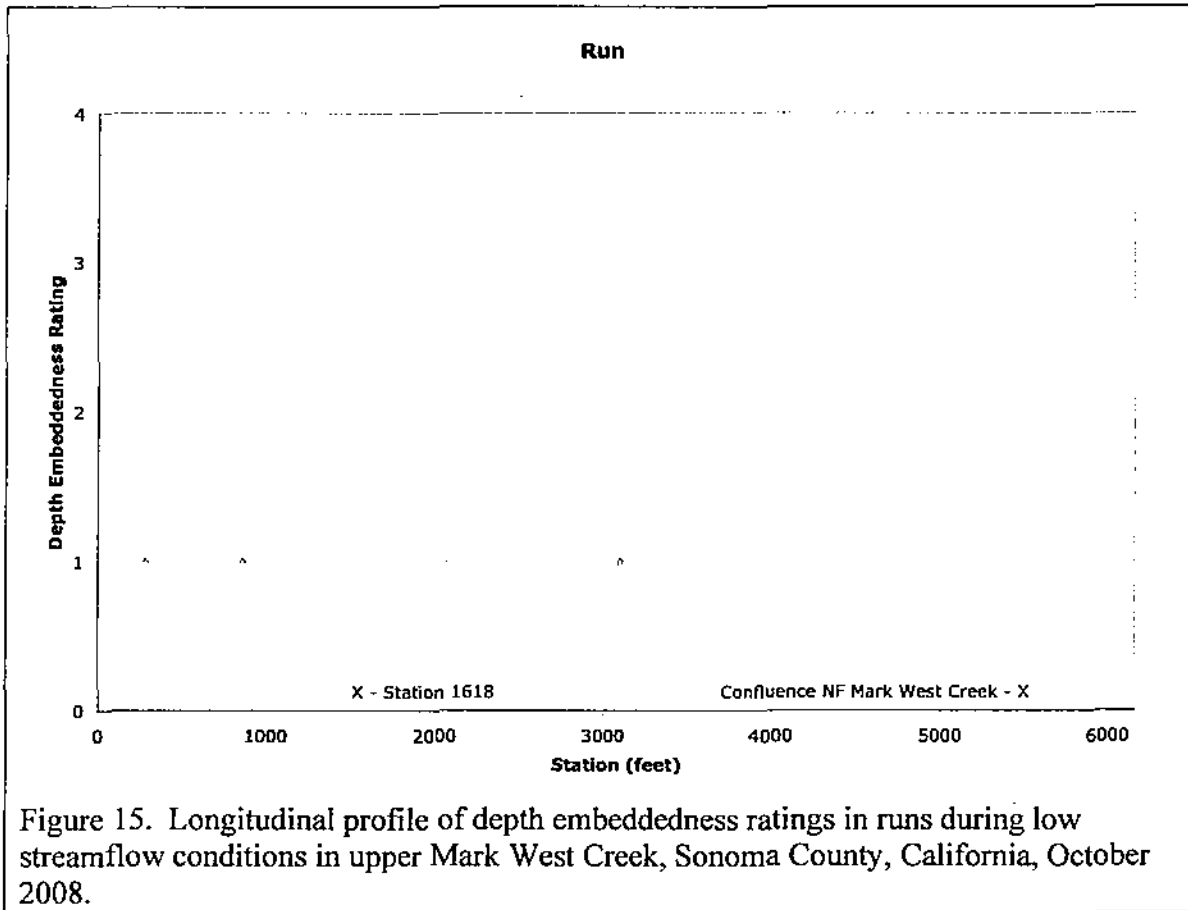
Figure 15. Longitudinal profile of depth embeddedness ratings in runs during low streamflow conditions in upper Mark West Creek, Sonoma County, California, October 2008.

Depth embeddedness was low in runs (Figure 15).

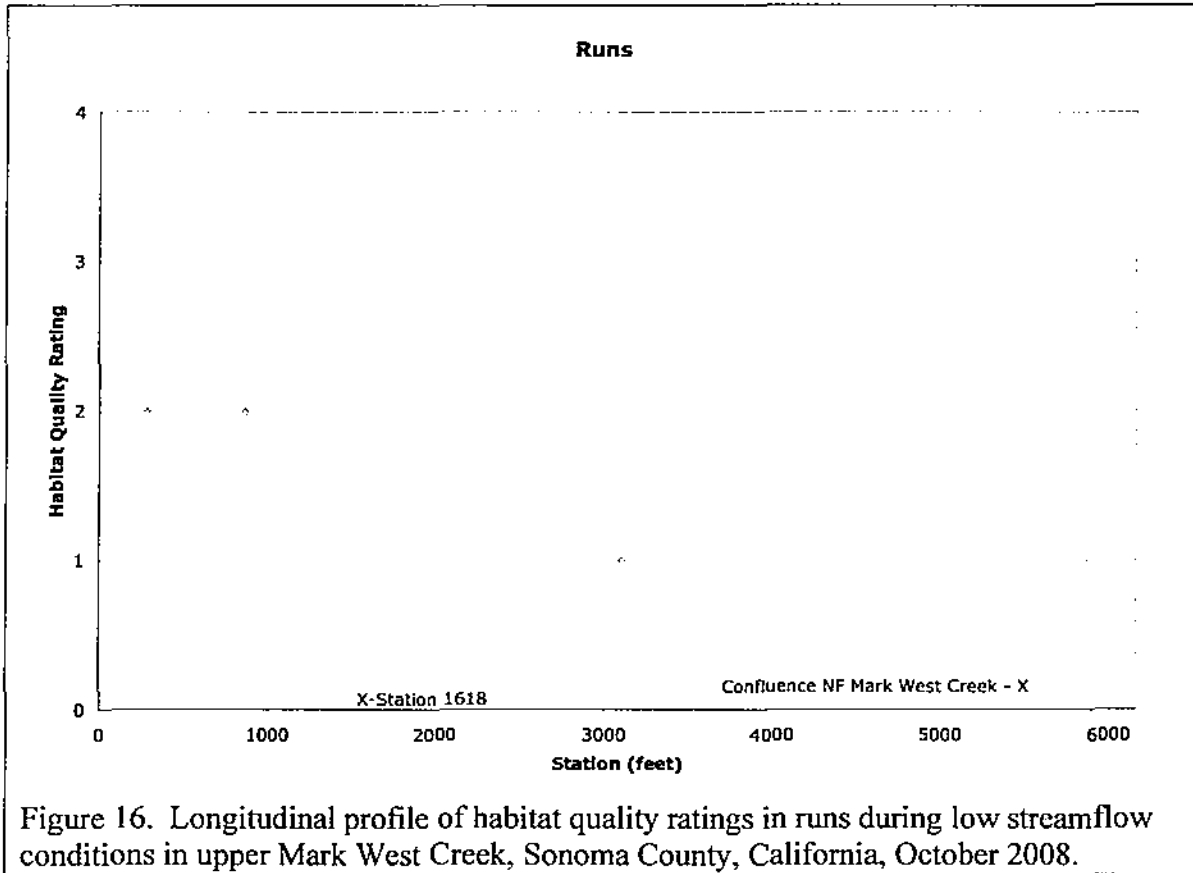
Figure 16. Longitudinal profile of habitat quality ratings in runs during low streamflow conditions in upper Mark West Creek, Sonoma County, California, October 2008.

Runs had poor to fair habitat quality (Figure 16).

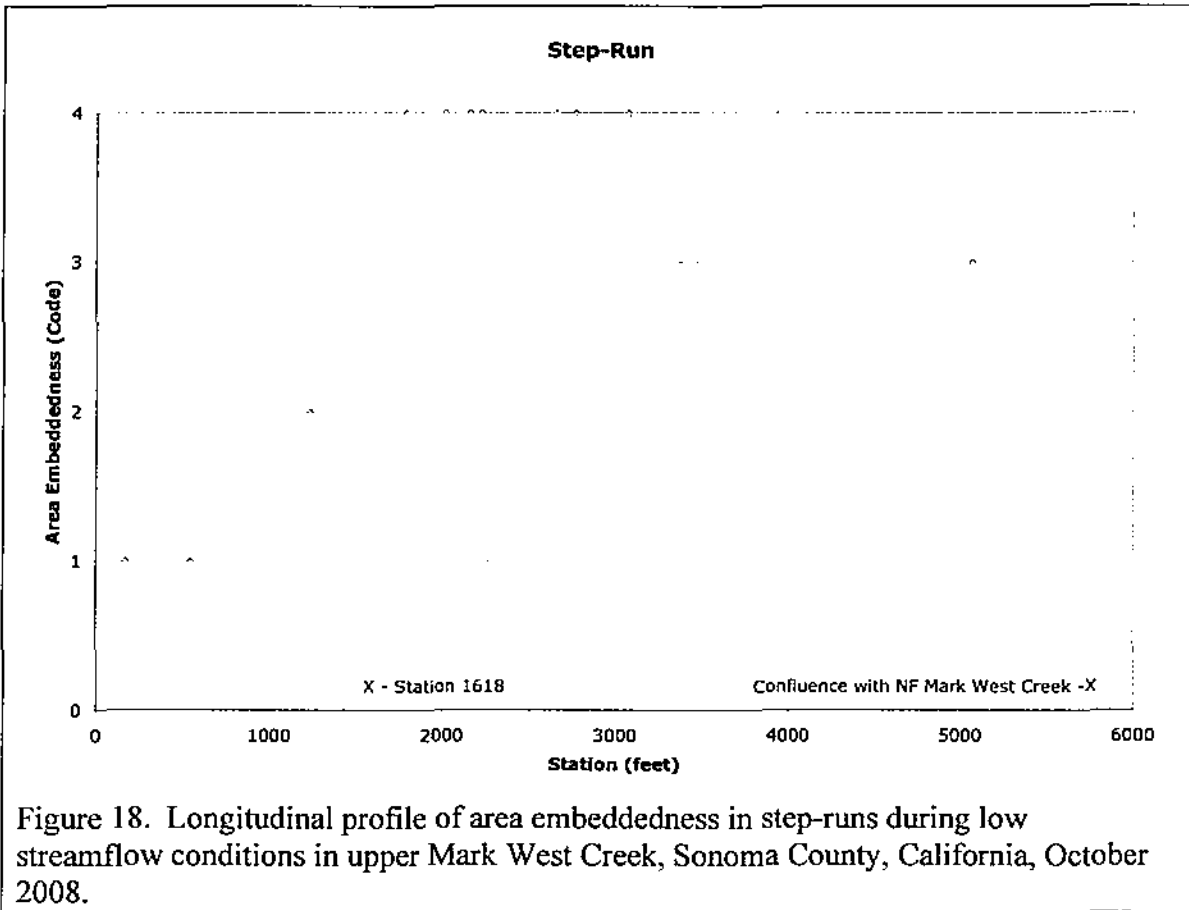
Figure 18. Longitudinal profile of area embeddedness in step-runs during low streamflow conditions in upper Mark West Creek, Sonoma County, California, October 2008.

Step-runs areas were typically filled with sediment upstream of Station 1618 and only lightly sedimented downstream (Figure 18).

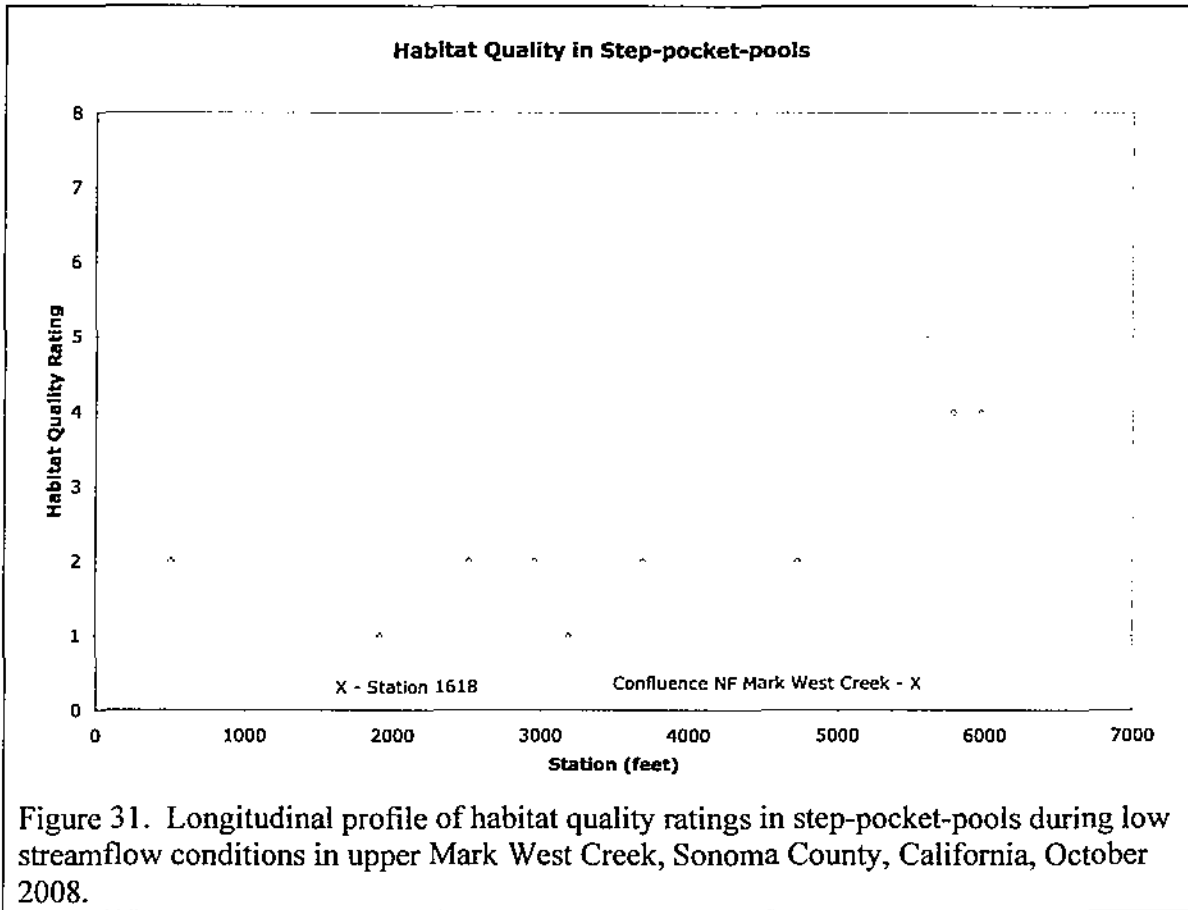
Figure 31. Longitudinal profile of habitat quality ratings in step-pocket-pools during low streamflow conditions in upper Mark West Creek, Sonoma County, California, October 2008.

Step-pocket-pool habitat quality ratings were generally fair, but increased around station 5500 (Figure 31).

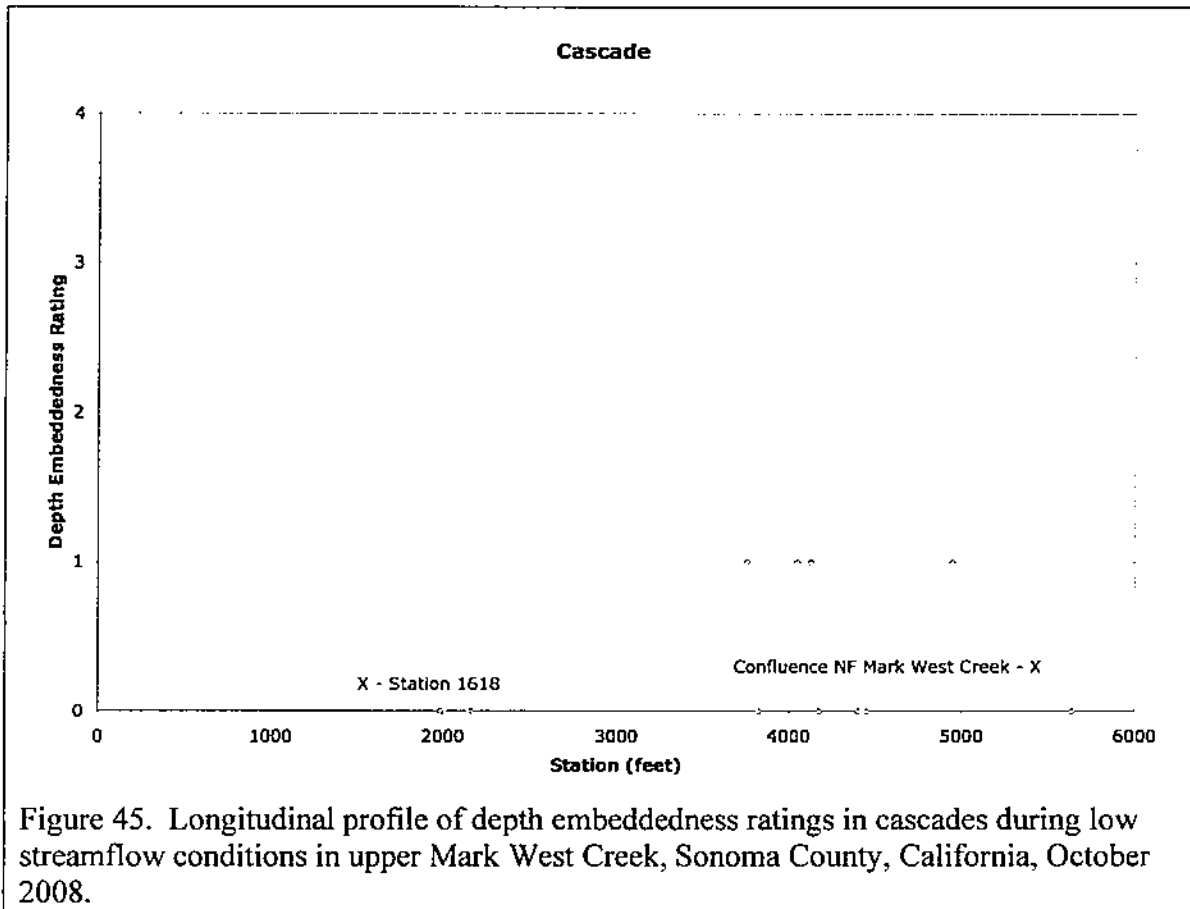
Figure 45. Longitudinal profile of depth embeddedness ratings in cascades during low streamflow conditions in upper Mark West Creek, Sonoma County, California, October 2008.

Depth embeddedness ratings were between none and light in cascades (Figure 45).

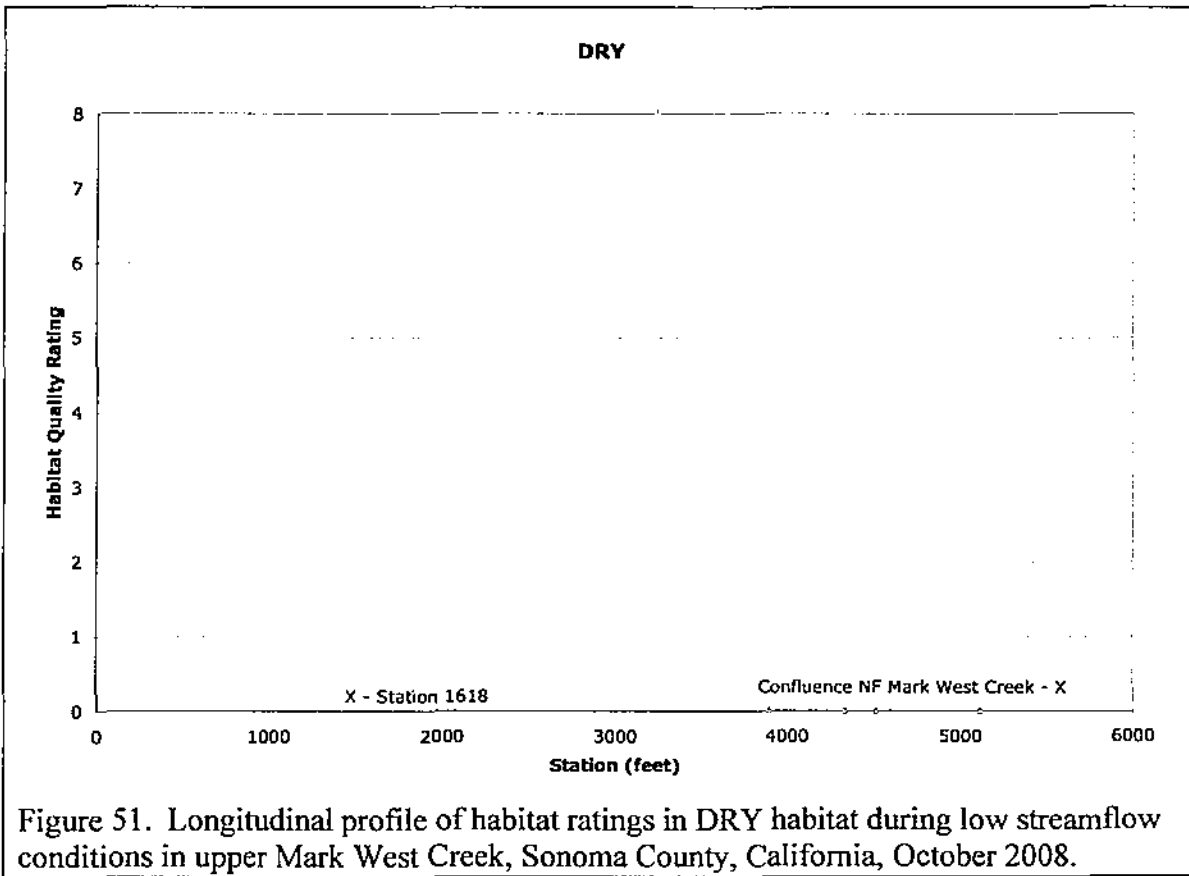
There is no fish habitat in DRY habitat (Figure 51).
