Timeline of Oroville Dam crisis, February 2017

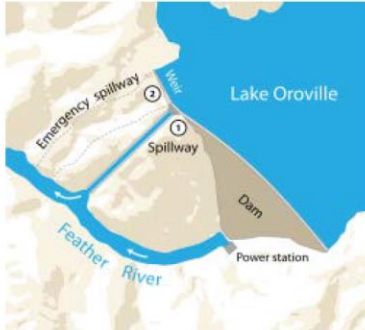
Oroville Dam normal operations

1. The lake level is controlled using the main spillway gate, which releases water down the concrete spillway to get to the river below.
2. The emergency spillway, which has a 30 ft (9 m) high concrete wall at the top of a hill, is unused.

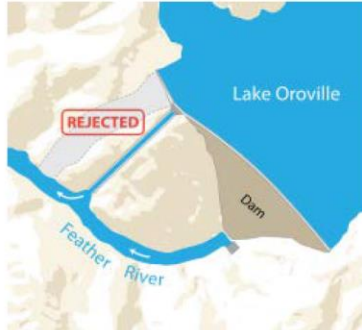
2005: Upgrade proposal rejected

Despite concerns that the emergency spillway is vulnerable to erosion, a \$100 million request by community groups to upgrade it to a concrete-lined auxiliary spillway is rejected by the federal regulators.

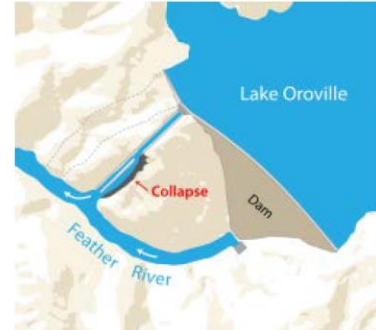
7 Feb 2017: Main spillway fails

Craters appear in the main spillway. To avoid increasing the damage to the spillway, water releases are slowed allowing the lake to rise.

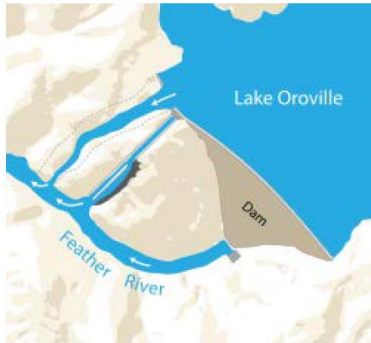
11 Feb 2017: Emergency spillway used

Water flows over the emergency spillway causing erosion and damage. This is by design and prevents water going over the top of the main dam. However the ground erodes faster than expected.

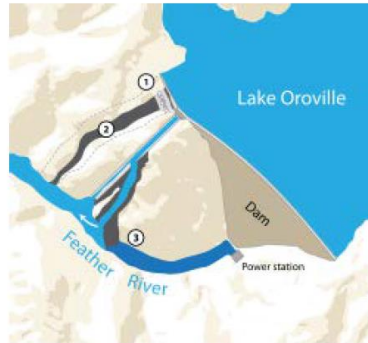
13 Feb 2017: Repairs made

Rocks and concrete (1) are placed under the emergency spillway weir to repair erosion damage (2). The release of water into the main spillway is increased, to lower the lake in preparation for more rain. This erodes the adjacent hillside considerably, generating a debris dam (3) that blocks the river and forces the closure of the hydroelectric plant.

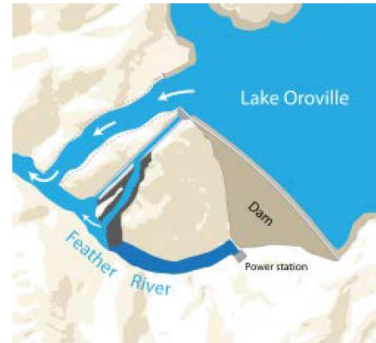
Potential risks

While the main 770 ft (230 m) dam is not threatened, if the erosion on *either* spillway reaches the top, it would cause the weir or gate (respectively) to collapse, causing a large uncontrolled water release and life-threatening floods.
