SANTA YNEZ RIVER WATERSHED REPORT

Final Report: May, 2013

Prepared by:
Heidi Block and Aaron Francis
Fisheries Biologists
Pacific States Marine Fisheries Commission, and
California Department of Fish and Wildlife
4665 Lampson Ave, Suite C
Los Alamitos, CA 90720

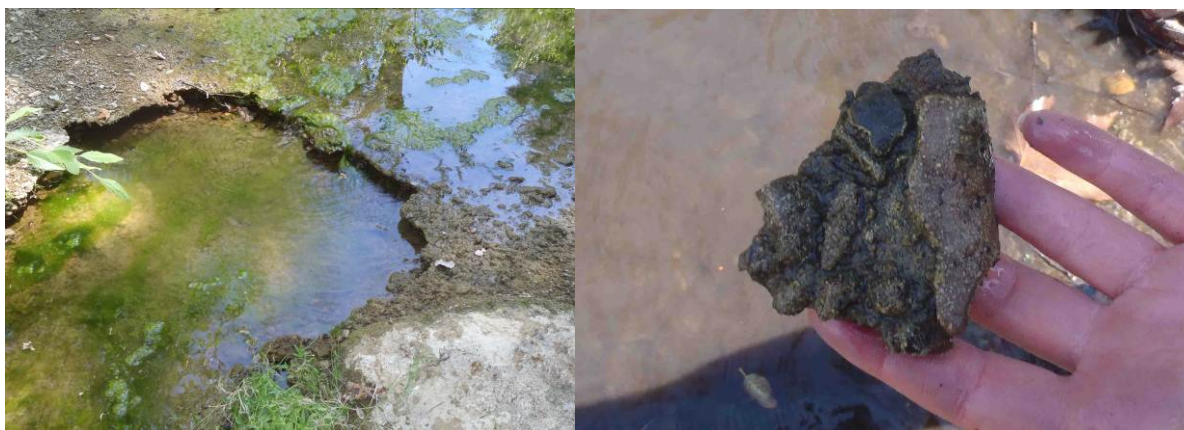
One factor which could have negatively impacted populations in the upper watershed is sedimentation from increased erosion after the Zaca fire. Although there is still suitable habitat for adults and juveniles in many of these streams, there is a definite lack of suitable spawning gravel. In areas where gravel and cobble of appropriate size were found, these often coincided with other negative factors such as the presence of fine sand or silt around gravel, or an apparent cementation of the gravel at the tail crest (see picture below). These conditions could partly be due to increased sedimentation in the streams from the Zaca fire.

Gravel cemented together in East Fork Santa Cruz Creek (left) and Cachuma Creek (Right)

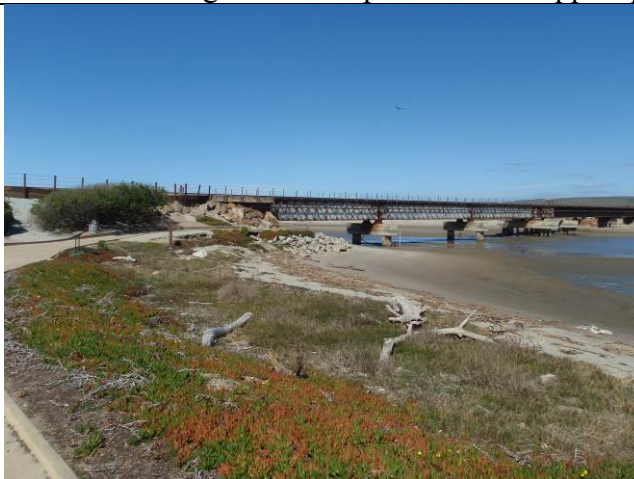
NAME: Santa Ynez River Estuary Rail Road Crossing Bridge	
GPS: SYRRBRG	Stoecker ID: No Stoecker ID
Barrier Type: Natural bottom bridge	Location: 34.69142, -120.60025
Description: This natural bottom bridge had multiple concrete support pillars in stream bed.

Santa Ynez River, Railroad Crossing

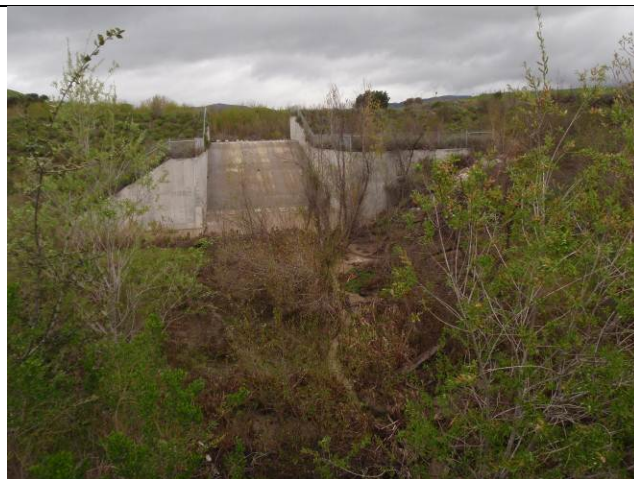
NAME: Santa Ynez Estuary Flood Dam	
GPS: SYFLDDAM	Stoecker ID: No Stoecker ID
Barrier Type: Dam	Location: 34.68697, -120.58728
Description: Overflow dam

Santa Ynez Estuary Flood Dam

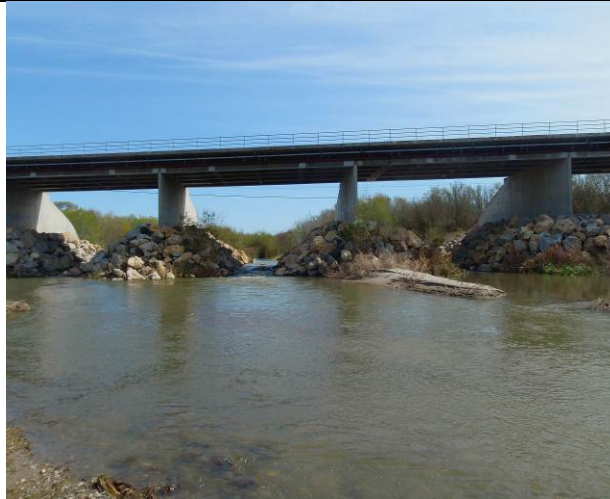
NAME: 13th Street Bridge	
GPS: SYVBBDG1	Stoecker ID: No Stoecker ID
Barrier Type: Natural bottom bridge with riprap around concrete pillars	Location: 34.67766, -120.55414
Description: This natural bottom bridge measured a length of 500ft and had eight concrete support pillars. There was a distance of 55ft between each pillar and each pillar was one foot wide and surrounded by riprap. Four of the pillars were in the wetted stream bed.

Santa Ynez River, 13th Street Bridge

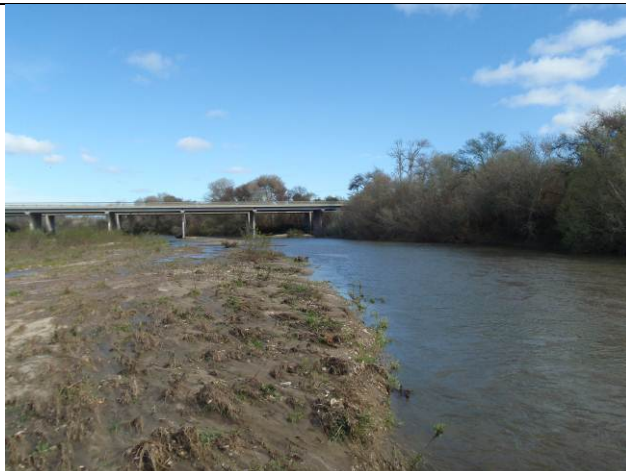
NAME: HWY 1 Bridge	
GPS: SYHWY1BRG1	Stoecker ID: No Stoecker ID
Barrier Type: Natural bottom bridge	Location: 34.66835, -120.45813
Description: This natural bottom bridge had multiple concrete support pillars in the stream bed. Three of the pillars were in the wetted channel.

Santa Ynez River, Highway 1 Bridge Upstream

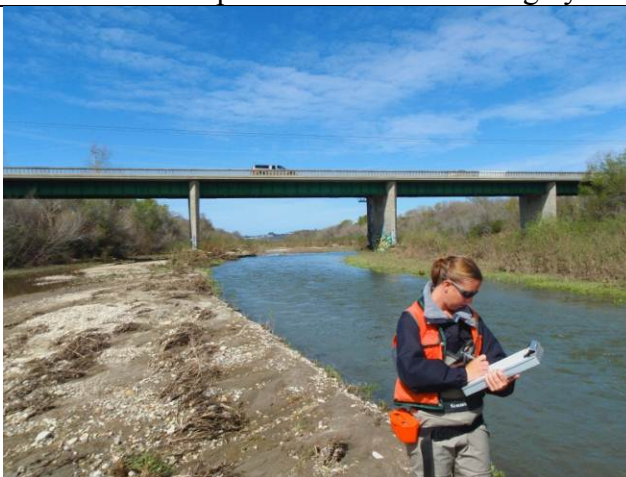
NAME: HWY 246 Bridge	
GPS: SYRPBRDG	Stoecker ID: No Stoecker ID
Barrier Type: Natural bottom bridge	Location: 34.64383, -120.43175
Description: This natural bottom bridge measured 260ft long and 60ft wide. It had four concrete support pillars in the stream bed. Each pillar measured 32ft long by 2 ft wide.

Santa Ynez River, Highway 246 Bridge Downstream

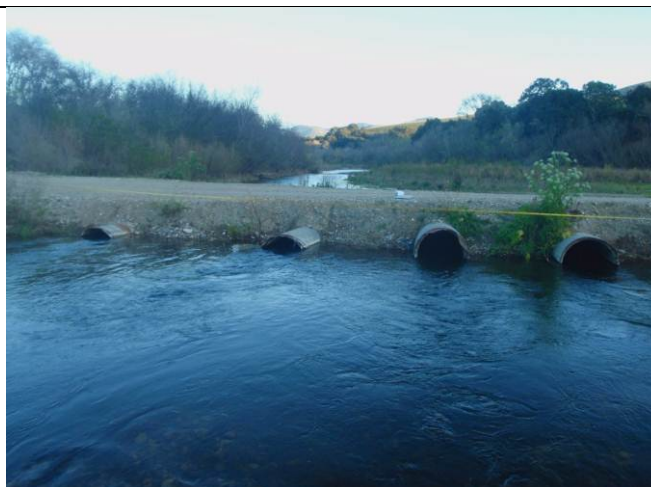
NAME: SY06 Arizona Crossing 02	
GPS: SY06AZ02	Stoecker ID: No Stoecker Id
Barrier Type: Corrugated pipe culvert	Location: 34.61501, -120.37347
Description: This corrugated metal culvert pipe Arizona crossing measured 45ft wide. It had four pipes that measured a 2.5ft diameter.

Santa Ynez River, Arizona Crossing 2 Upstream

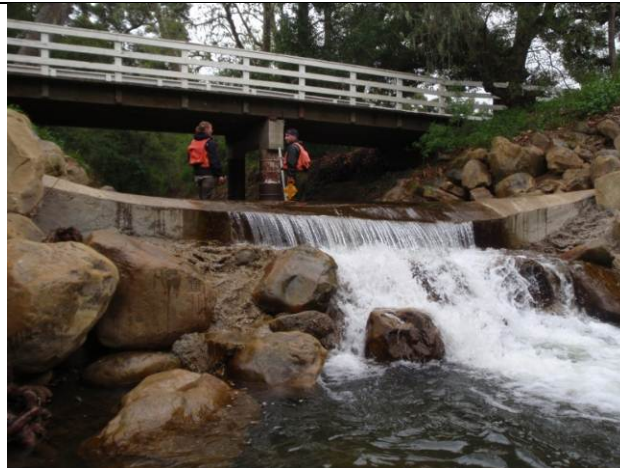
NAME: SYNJA Bridge 01	
GPS: SYNJABRDG01	Stoecker ID: No Stoecker ID
Barrier Type: Bridge with concrete apron	Location: 34.53543, -120.17883
Description: This natural bottom bridge measured 40ft long by 15 ft wide. It had two metal pillars supports in wetted channel. Additionally, there was a concrete bottom plunge downstream from bridge.

Nojoqui Creek, Nojoqui Bridge 1, Downstream

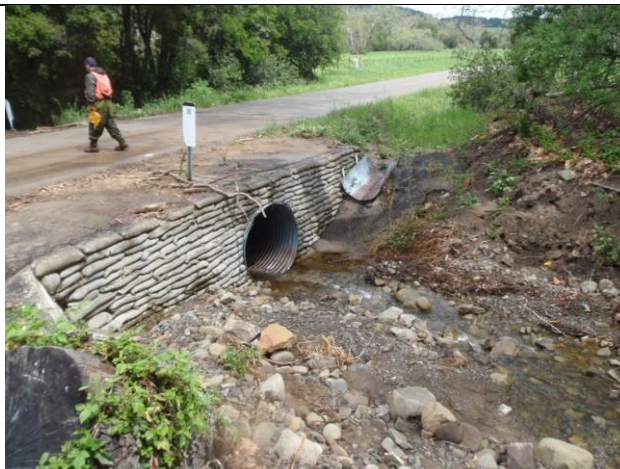
NAME: Alisal Road Bridge	
GPS: SYNJBBDG01	Stoecker ID: SY NI 7
Barrier Type: Corrugated metal culvert bridge	Location: 34.53517, -120.17595
Description: This bridge measured 17ft long by 39 ft wide and had a 4ft diameter culvert pipe for water to flow through. The culvert pipe was encased in sacrete walls. There was also broken up concrete debris on both banks.

Nojoqui Creek, Nojoqui B Bridge 1, Upstream

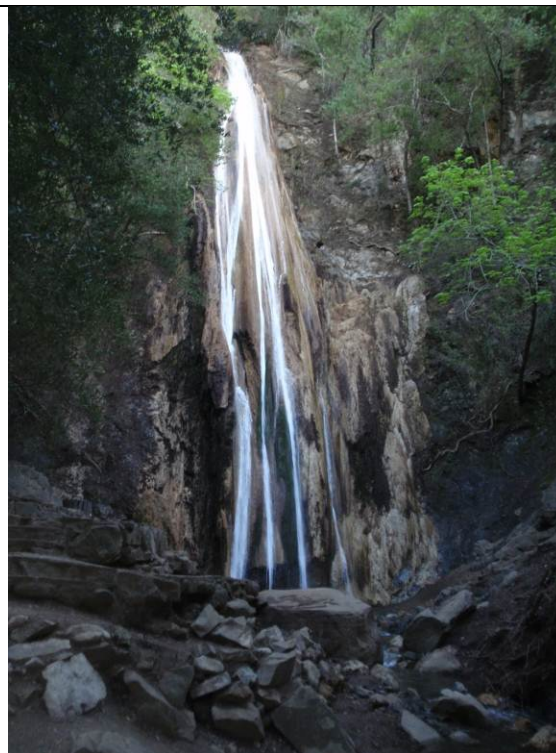
NAME: Nojoqui Creek Waterfall	
GPS: SYNJB029	Stoecker ID: SY NI 8
Barrier Type: Waterfall	Location: 34.52845, -120.17228
Description: This waterfall is over 75ft high and was composed of calcium and magnesium carbonate (travertine). It was determined to be the natural limit of anadromous migration for Nojoqui Creek.

Nojoqui Creek Waterfall

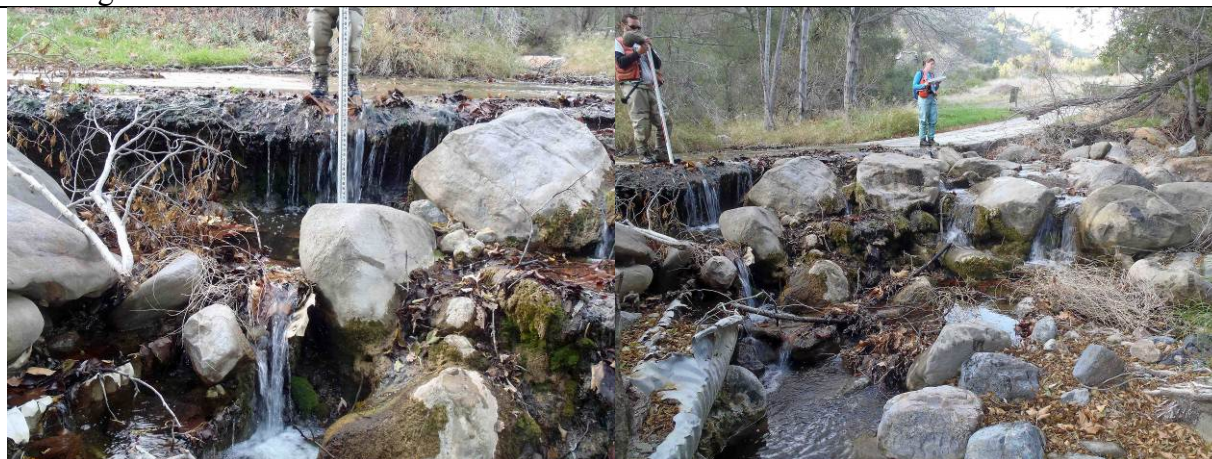
Happy canyon road crossing, upstream plunge

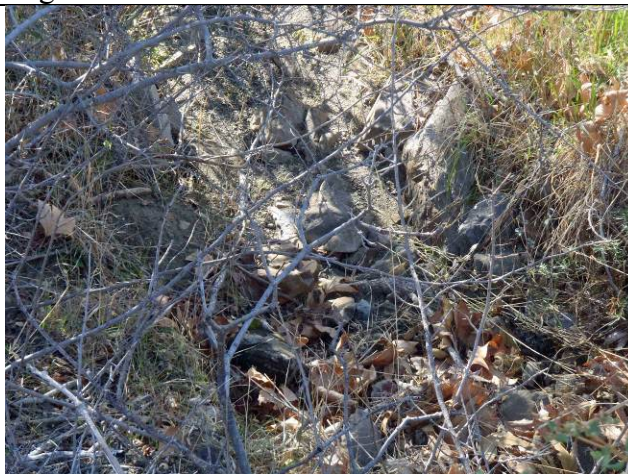
Cachuma creek completely dry

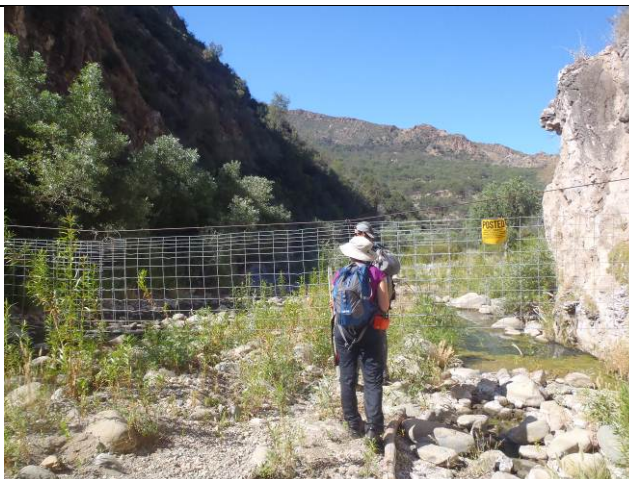
Private property gate across stream channel

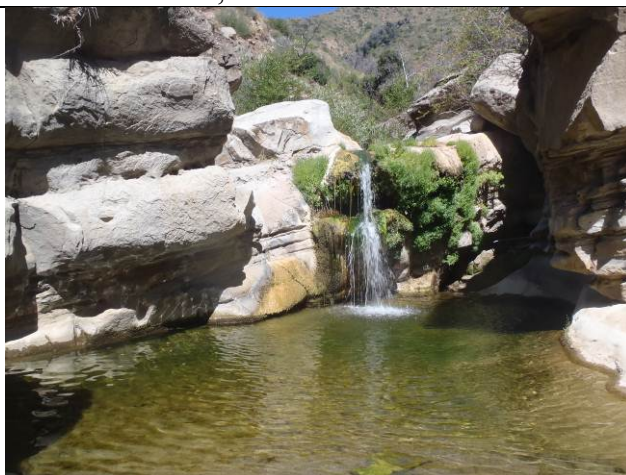
East Fork Santa Cruz Creek waterfall barrier 1

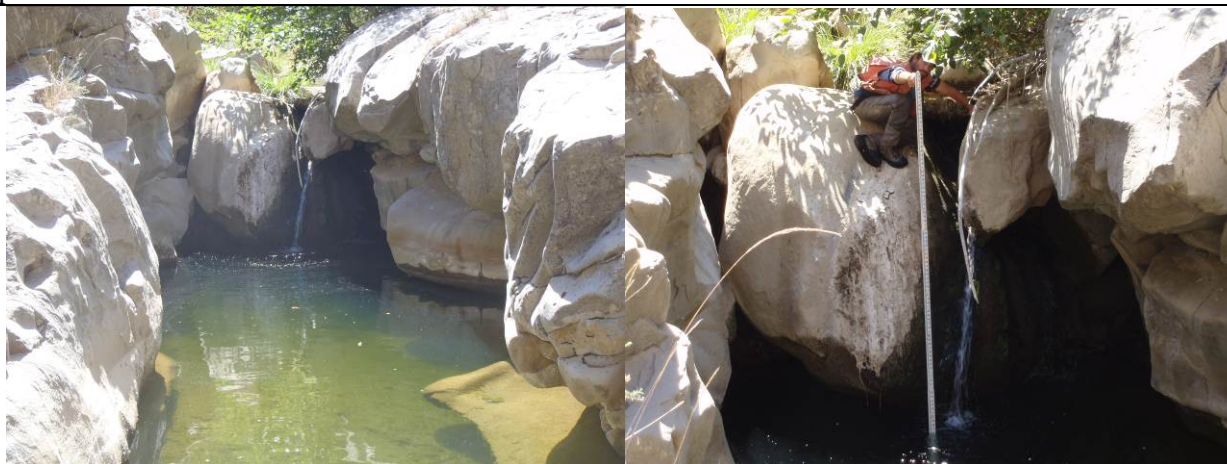
East Fork Santa Cruz waterfall barrier 2

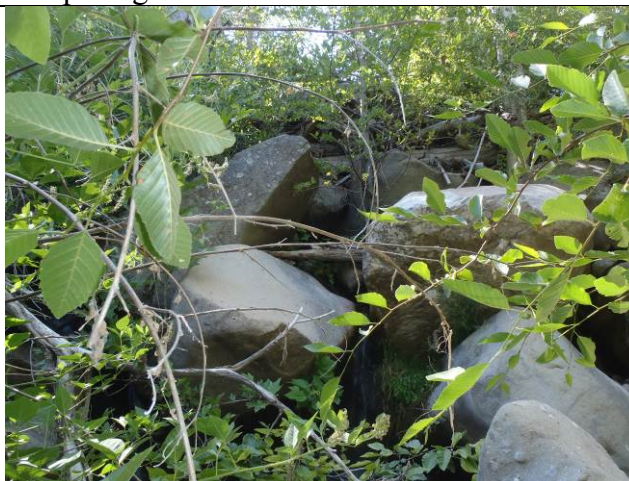
Upstream view of log and boulder jam

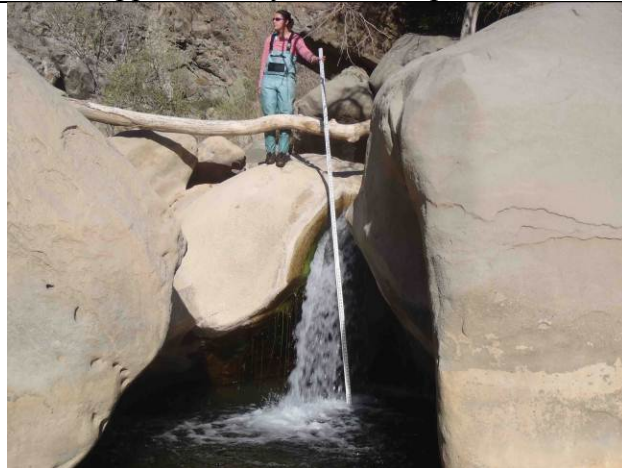
Mono partial barrier, upstream

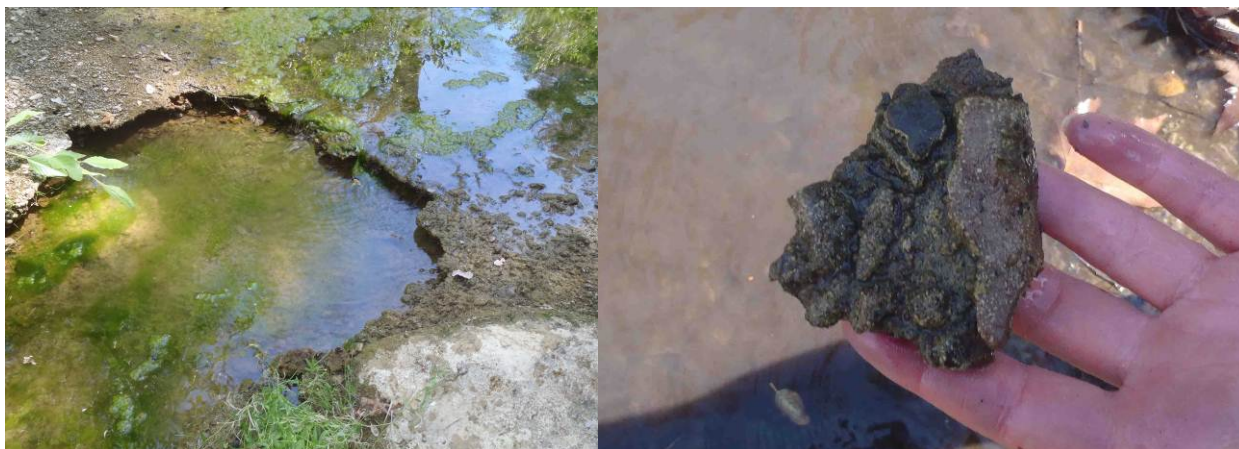
Gravel cemented together in East Fork Santa Cruz Creek (left) and Cachuma Creek (Right)
