Stanshaw Creek Coho Habitat Enhancement Project

FRGP Grant Number: P1110319

Mid Klamath Watershed Council

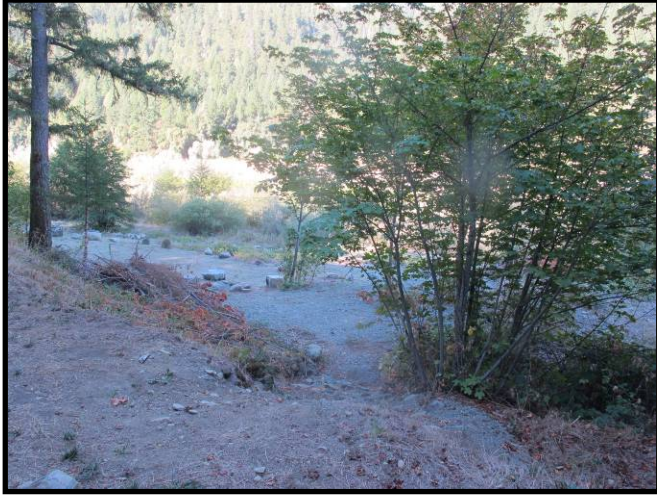
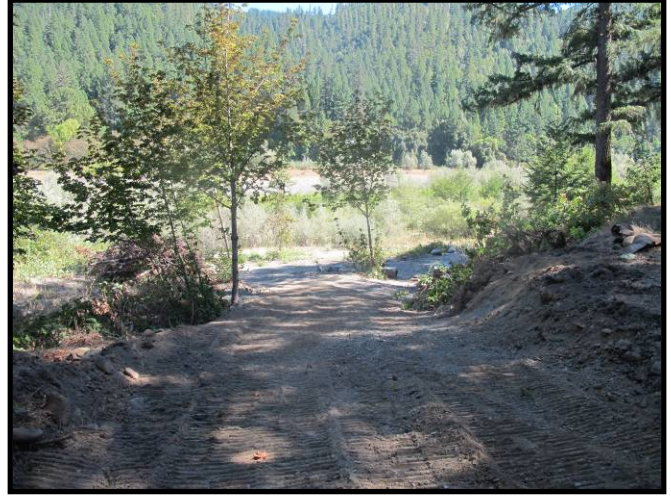
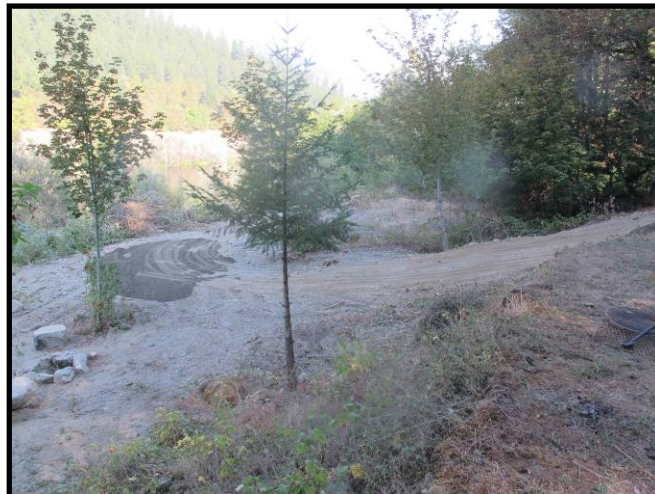
A 200 foot access road was constructed between an existing roadway and the project site, across the Klamath River floodplain. This access road was seeded and mulched after project construction was completed. Images above left and right show the access road from the top, before and after construction. Below, the perspective show's a more complete view of the access road from the top and across the river floodplain.

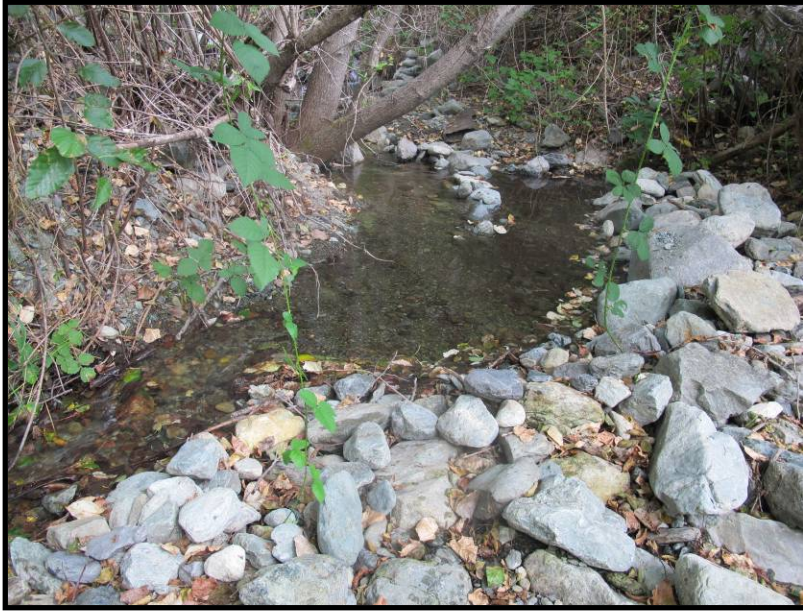
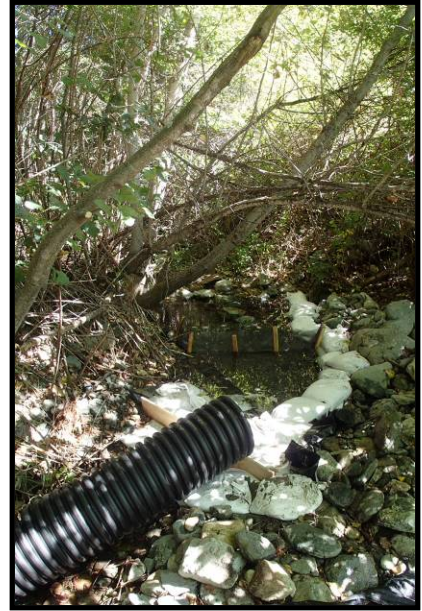
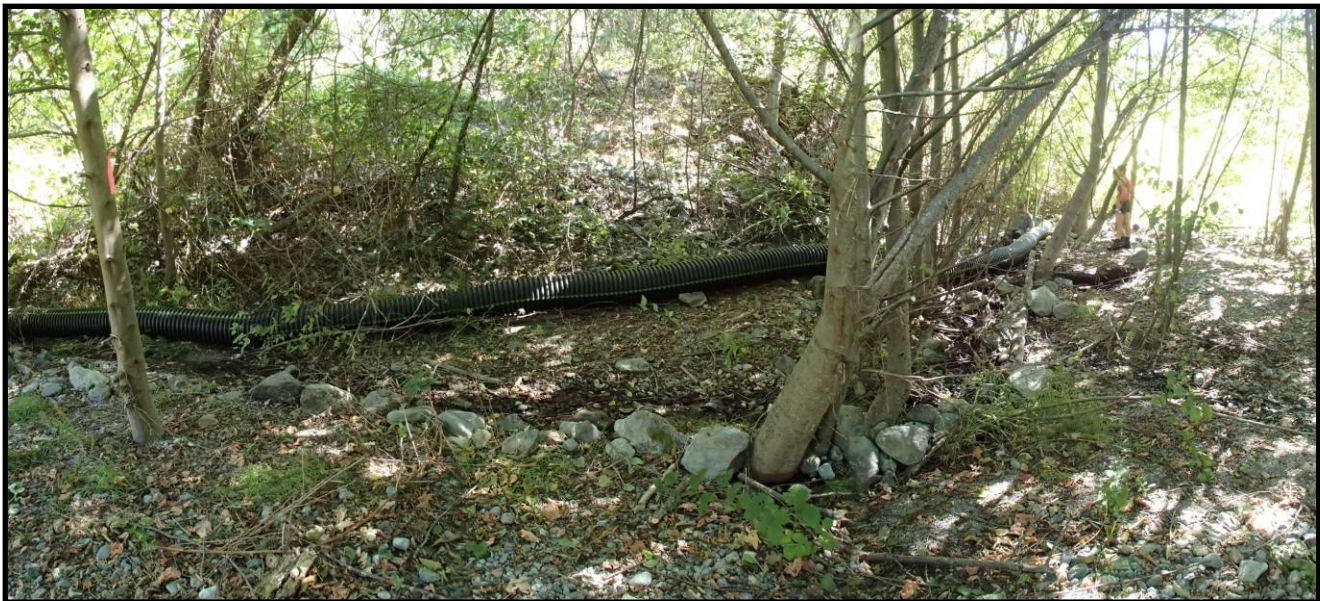
Prior to construction activities, it was necessary to divert a small amount of Stanshaw Creek’s flow around the project area. The point of diversion was located at the top of Stanshaw Creek’s active delta (above left and right), and 120’ of 16” flexible tile was used to reroute approximately .24 cfs of water around the site and into the existing pool habitat, assuring a cold water connection to this habitat (below). The “head gate” was constructed using a plywood splash board, sand bags, and 1/8’ screening both on the end of the tile and across the stream bed, approximately 6’ above the diversion.

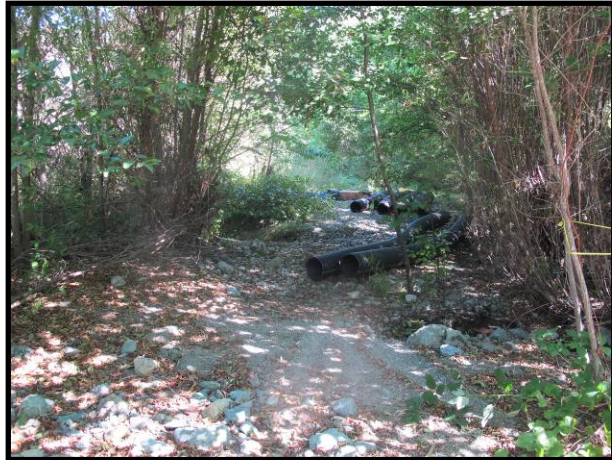
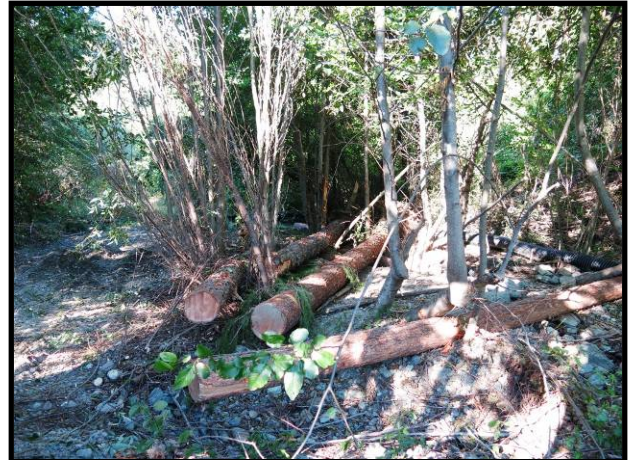
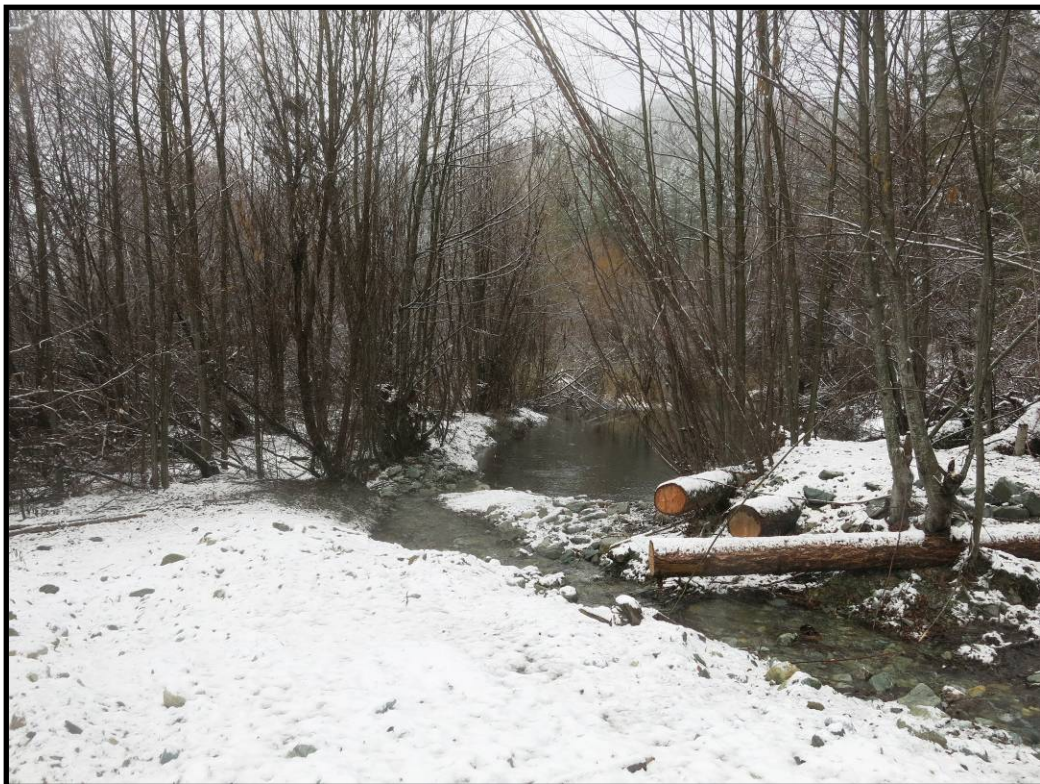
Five 30' logs with rootwads attached were locked into existing vegetation at the head of the off-channel pool, designed to redirect sediment around the project area in high flow events. The upper left and right photos show a close up, before and after, of the log placement, while the photo below shows the structure in relation to Stanshaw Creek and the off-channel habitat during winter flows.

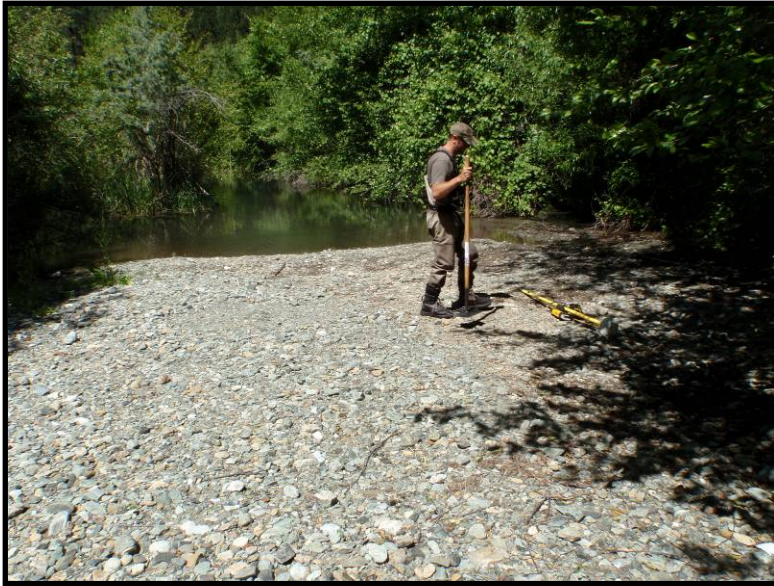
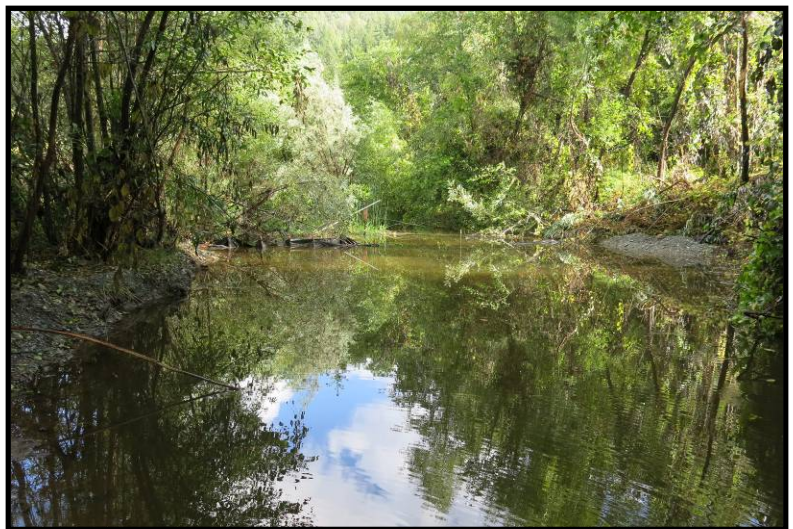
Approximately 560 cubic yards of gravel, rock and sand was removed from the site, more than doubling the volume of off-channel habitat. Photos taken before and after (above and below) illustrate the quality and quantity of habitat restored through this project.
