## North Coast Regional Water Quality Control Board

June 15, 2021

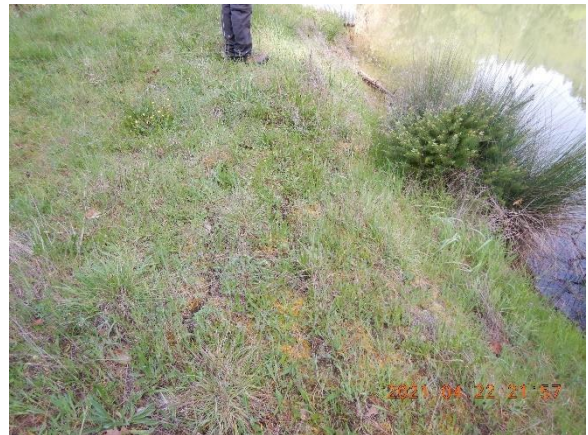
*Figure 48. Cracks in berm near outlet pipe.*

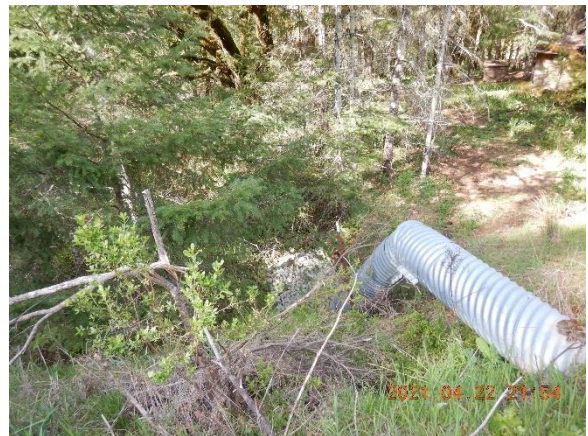
*Figure 49. Pond outlet pipe downspout to channel with rock recently placed.*
