North Coast Regional Water Quality Control Board

February 4, 2021

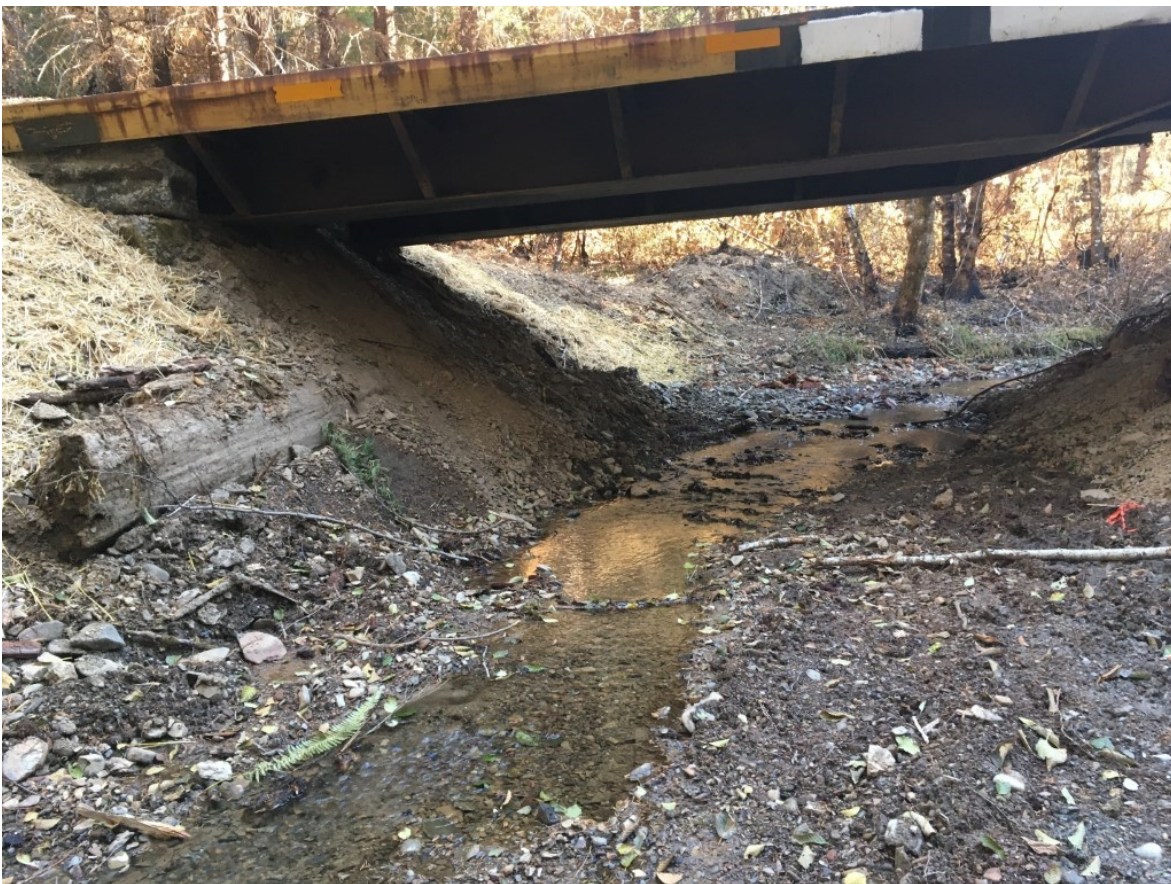
Figure 1: Looking upstream at the abutment on the north side of RP 1. Photo taken during the Regional Water Board staff inspection conducted on October 28, 2020.

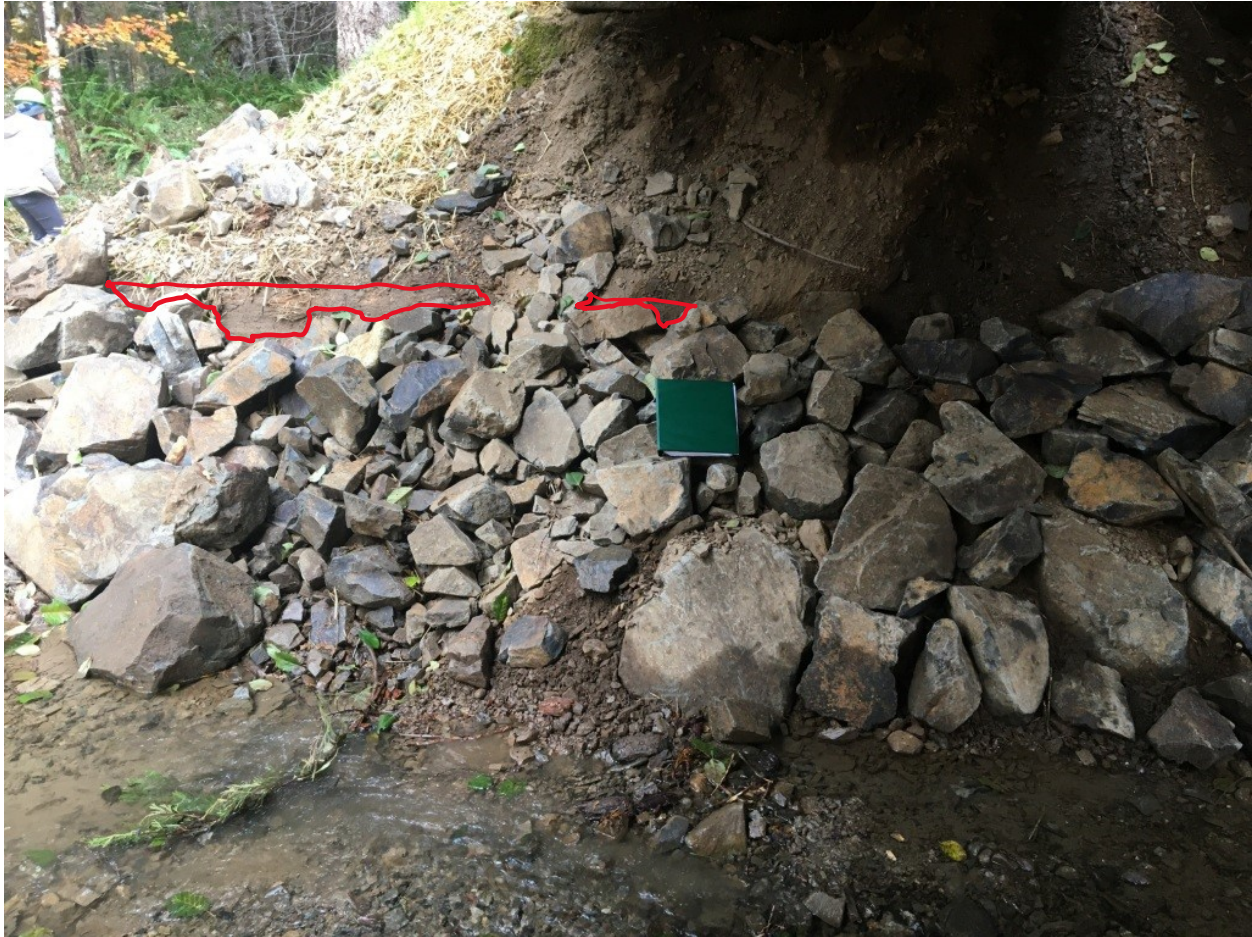
Figure 2: Abutment on the north side of RP1. Photo taken during the CDFW inspection conducted on November 10, 2020. Note log buried in the fill, outlined in red.

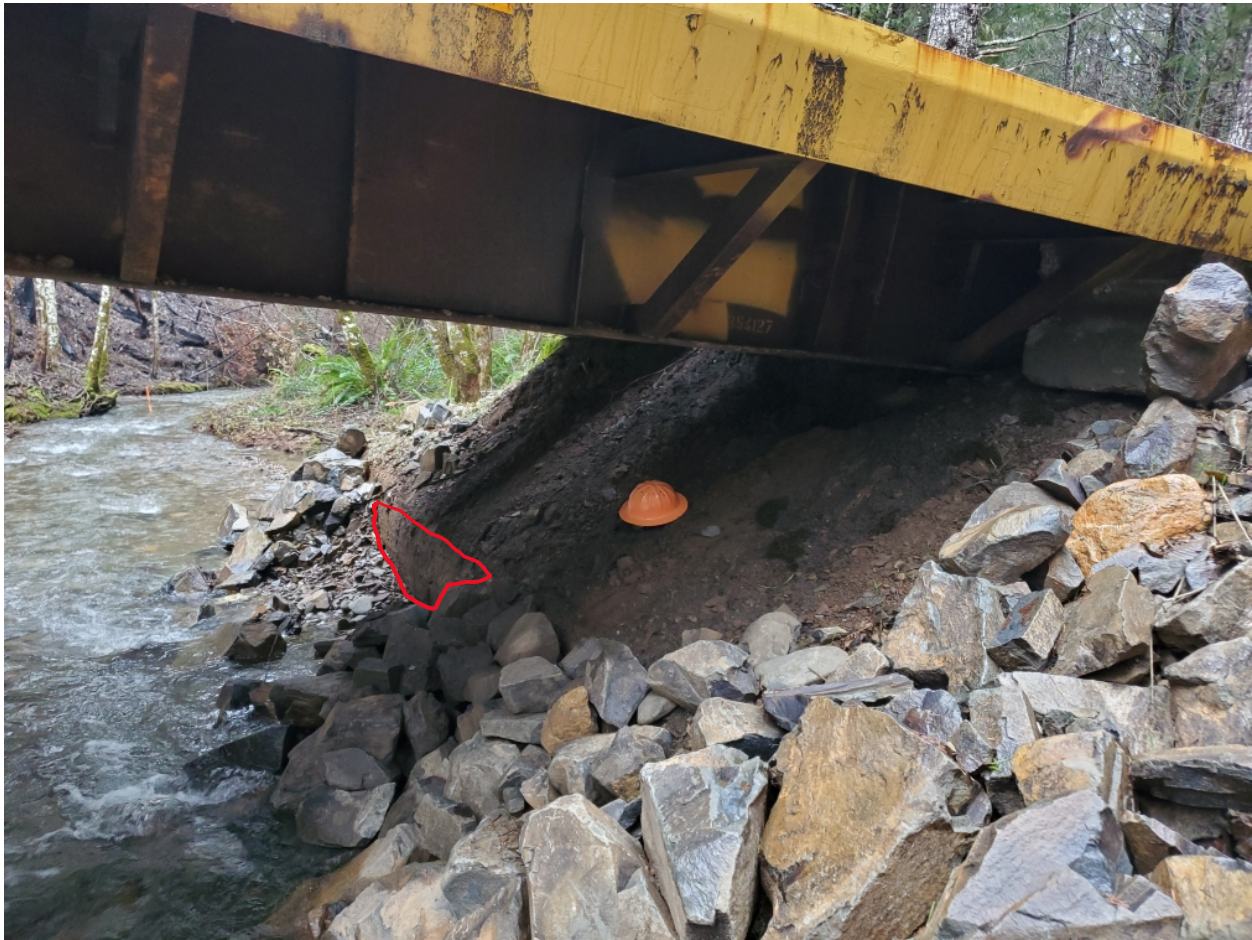
Figure 3: Abutment on the north side of RP1, showing erosion after storm damage (note exposed log outlined in red, also outlined prior to erosion on Figure 2). Photo taken by GDRC on January 21, 2021.
