Subject: Enrollment of THP 1-09-108 HUM (Unit 4) in the Elk River WWDR, "Tier II"

THP: South Elk Ridge THP 09-108 Unit # 4 June 9, 2010

THP No. 1-09-108 HUM (South Elk Ridge) Unit # 4

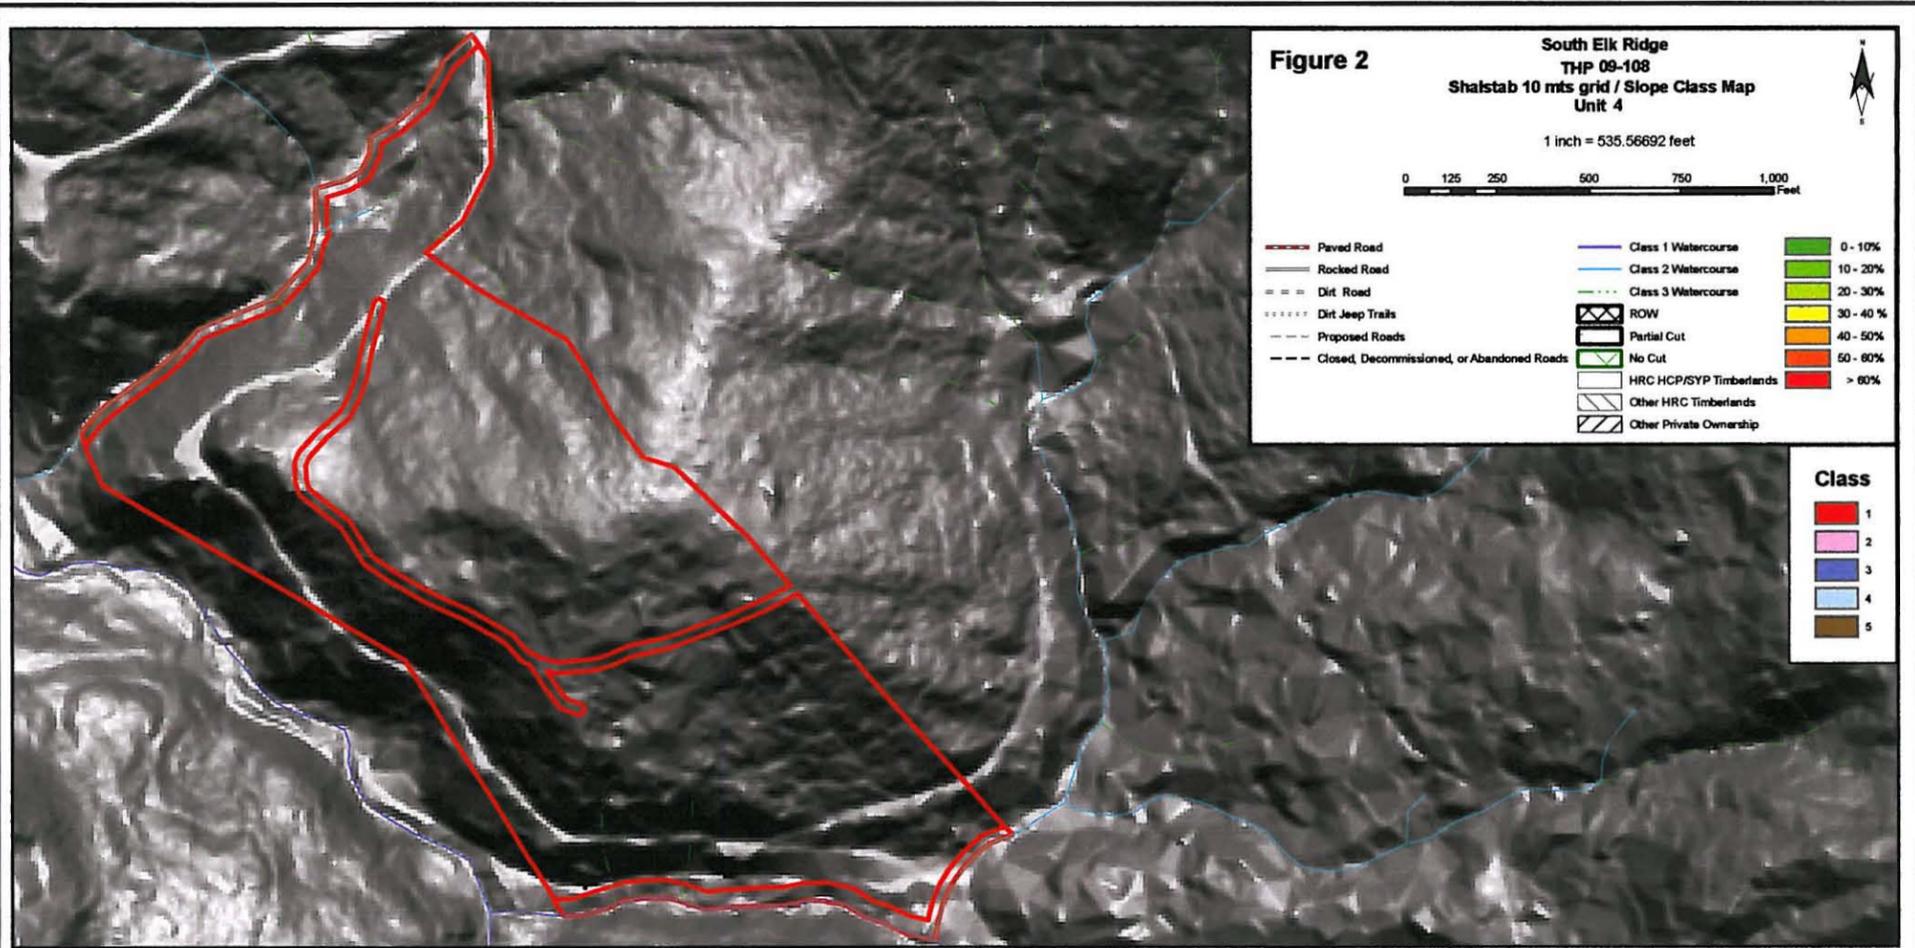
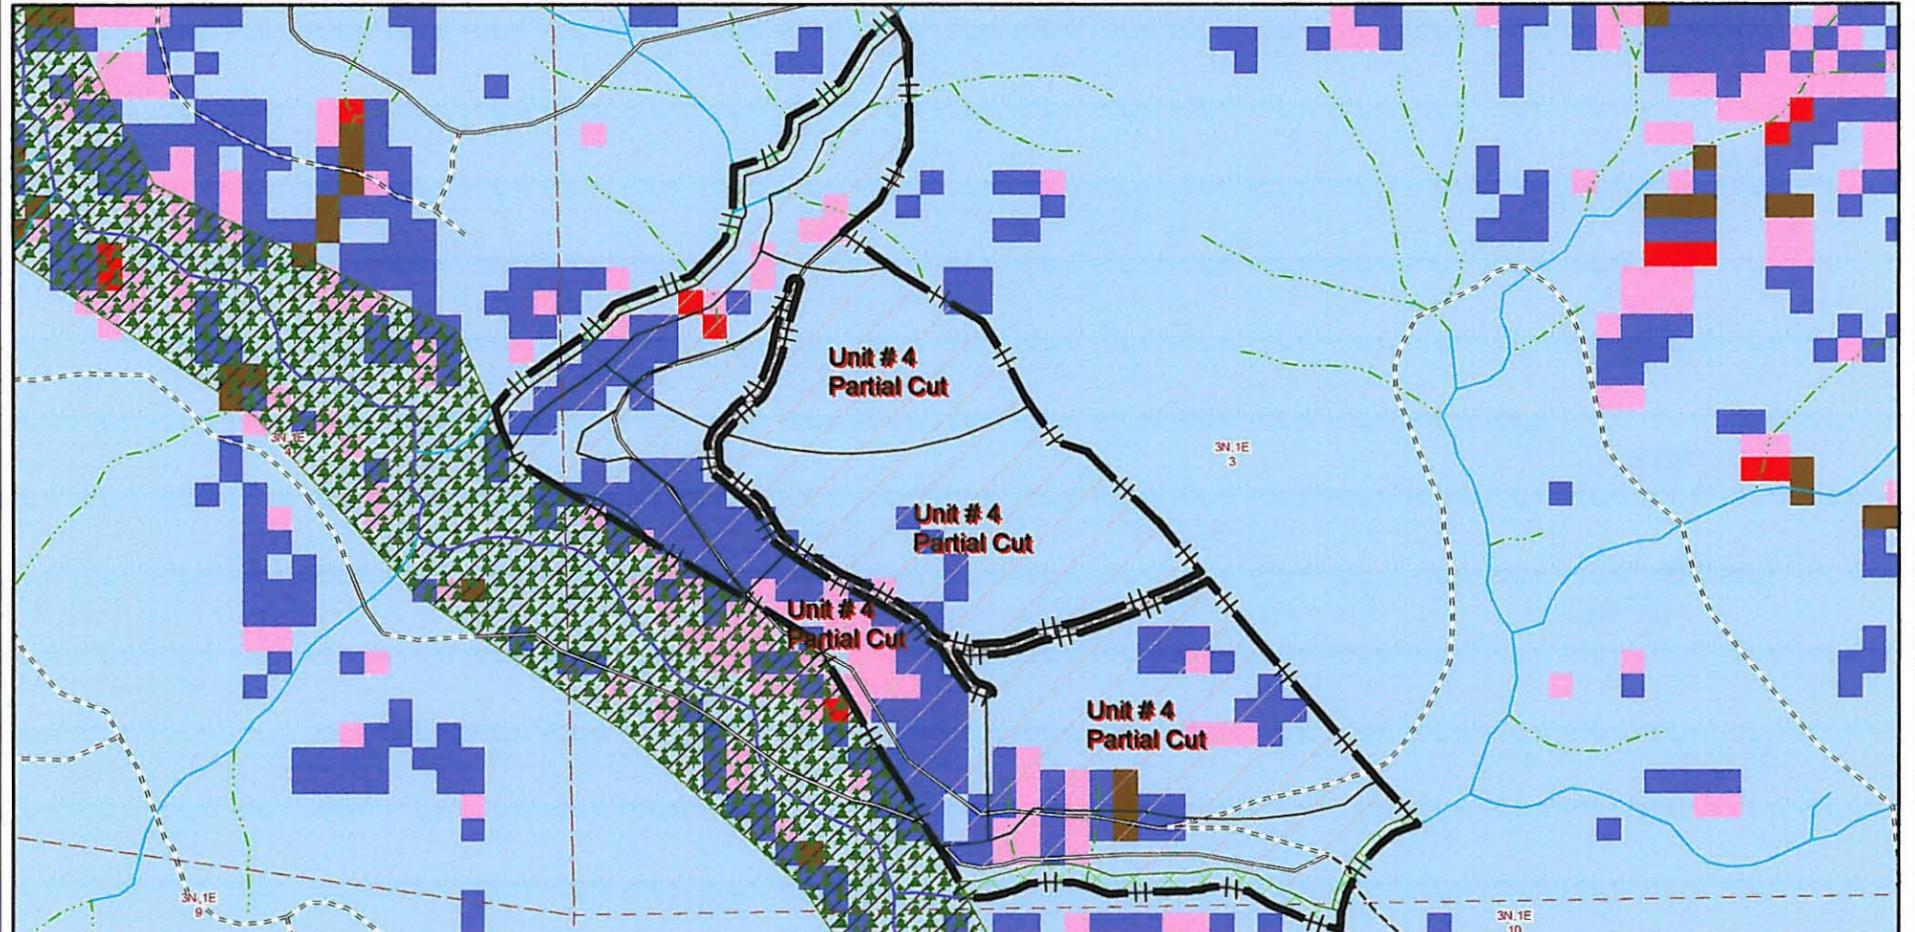
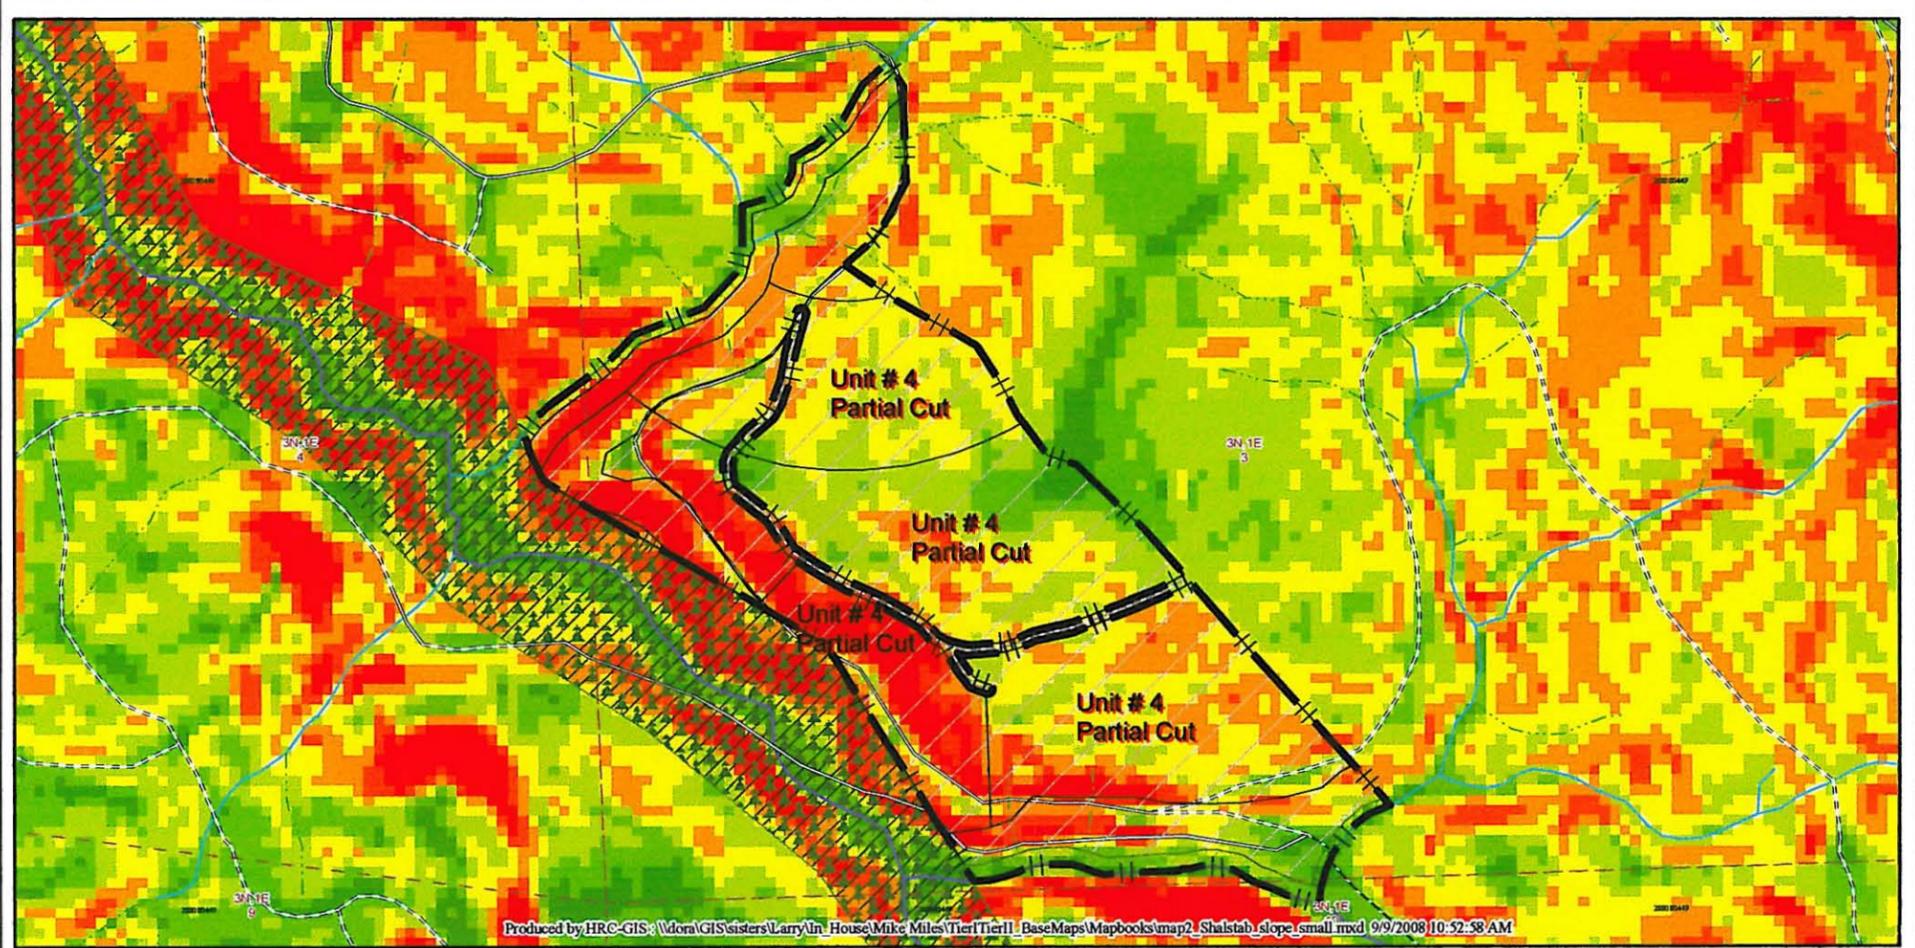
Figure 2 (Hillslope shade) reveals shadows indicative of consistent and even weathering of the slopes within the unit. The transitions from planar side slopes to ridgetop is smooth and subdued. Legacy skid roads are easily observed.

SHALSTAB modeling (Figure 2) highlights one area Value 1. The area is located within a Class III watercourse along the western edge of the unit. The watercourse channel is well entrenched (a product of erosion over time), includes steeply inclined side slopes and has a moderately inclined gradient. Old Growth stumps are located throughout the area and atop the channel sidewalls. The standing timber is straight and moderately dense. Harvest within atop these areas will be minimal since one of the pixels is located within the outerband for the downslope Class II and the other is within a single tree selection area (See Class III RMZ above). Value 2 shalstab is modeled central to the unit and upslope of the main haul road. A portion of this area is within a geology no harvest zone for landslide 4-4. The remaining areas of Value 2 include a mature 2nd growth stand of redwood and fir trees with typically small diameters. Intact skid road cross the nearly planar slope and may be the reason for the Shalstab modeling (Cutslopes). Additional Value 2 shalstab modeling is located flanking a Class III watercourse located at the western edge of east0west harvest unit boundary. This area is very steeply inclined and well vegetated. The steepness of the slope is a product of well indurated sandstone bedrock. With respect to potential failure, we considered it minimal since soils are very shallow and the current stand of timber is dense. Based on this review, the proposed harvest appears reasonable. Where the most critical (associated with watercourses), the stand will be partially harvested.

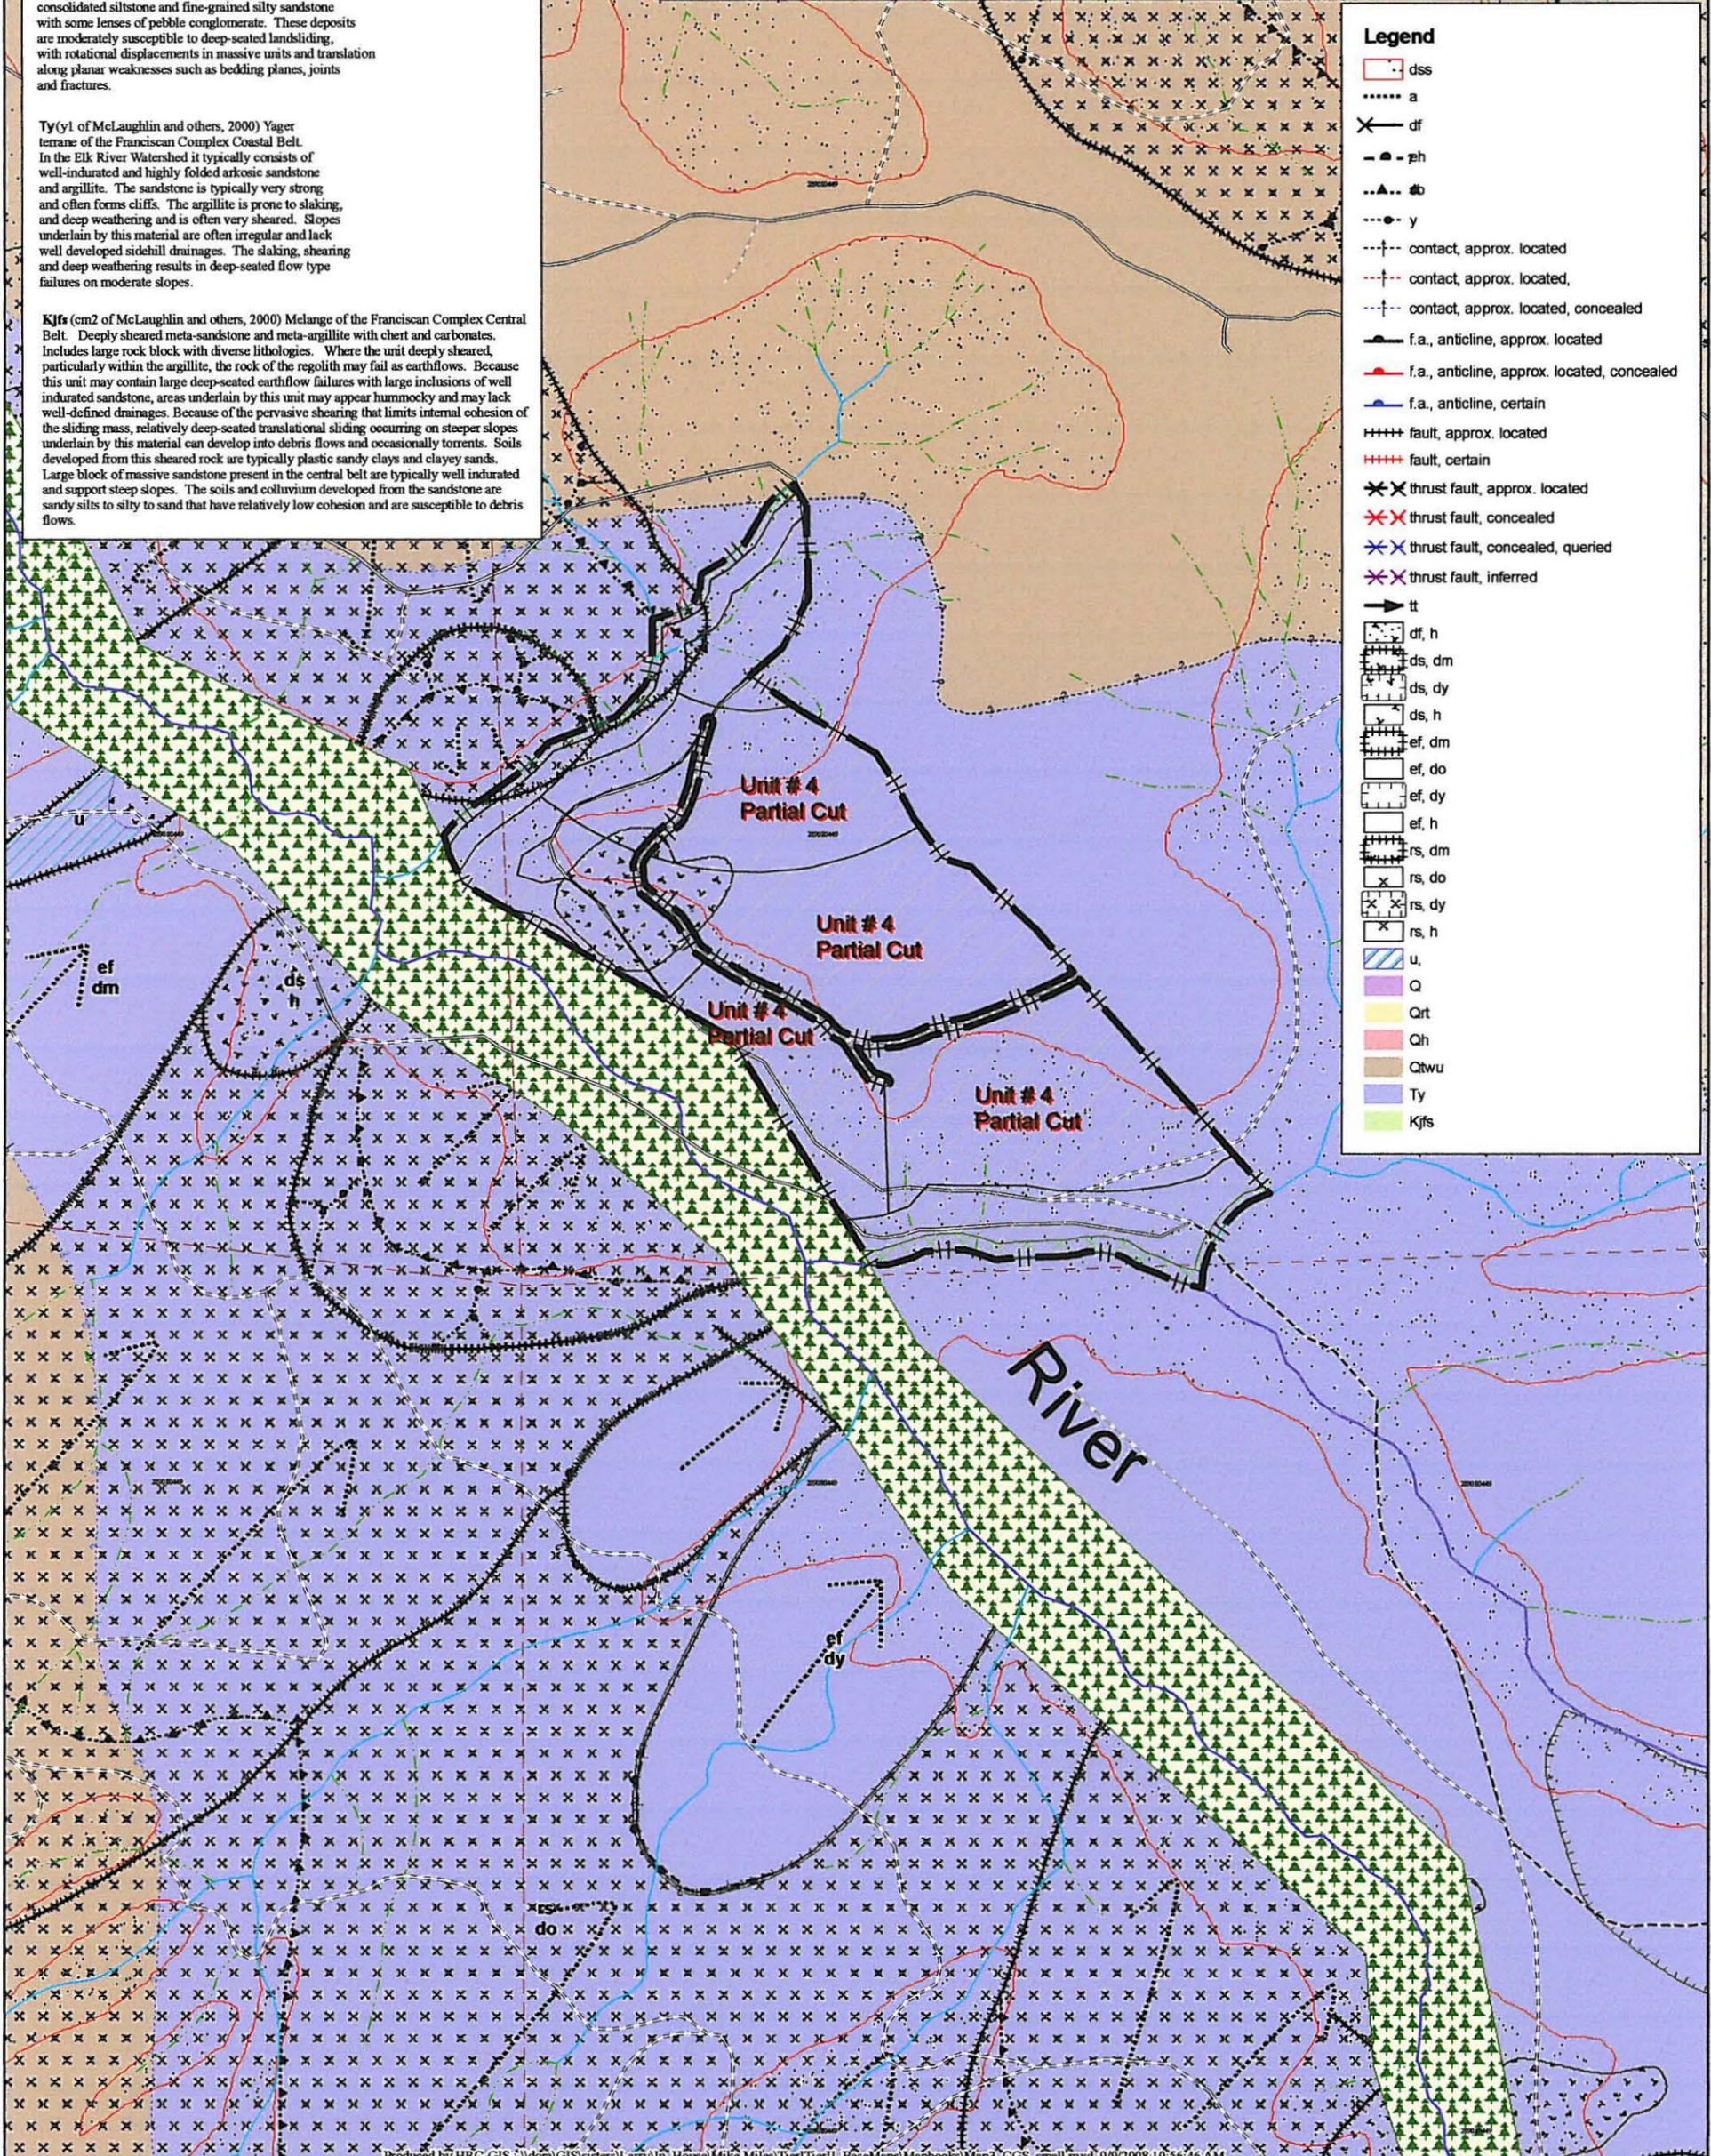
Figure 3 shows the unit to be underlain by the Yager Terrane. These sediments are composed of silts, sands, clays, and infrequent gravels that are well consolidated, potentially low grade metamorphosed. Nearly all of the moderate to steeply inclined slopes within the unit are mapped as debris slide slopes / source areas. One area located in the west is mapped as a debris flow.

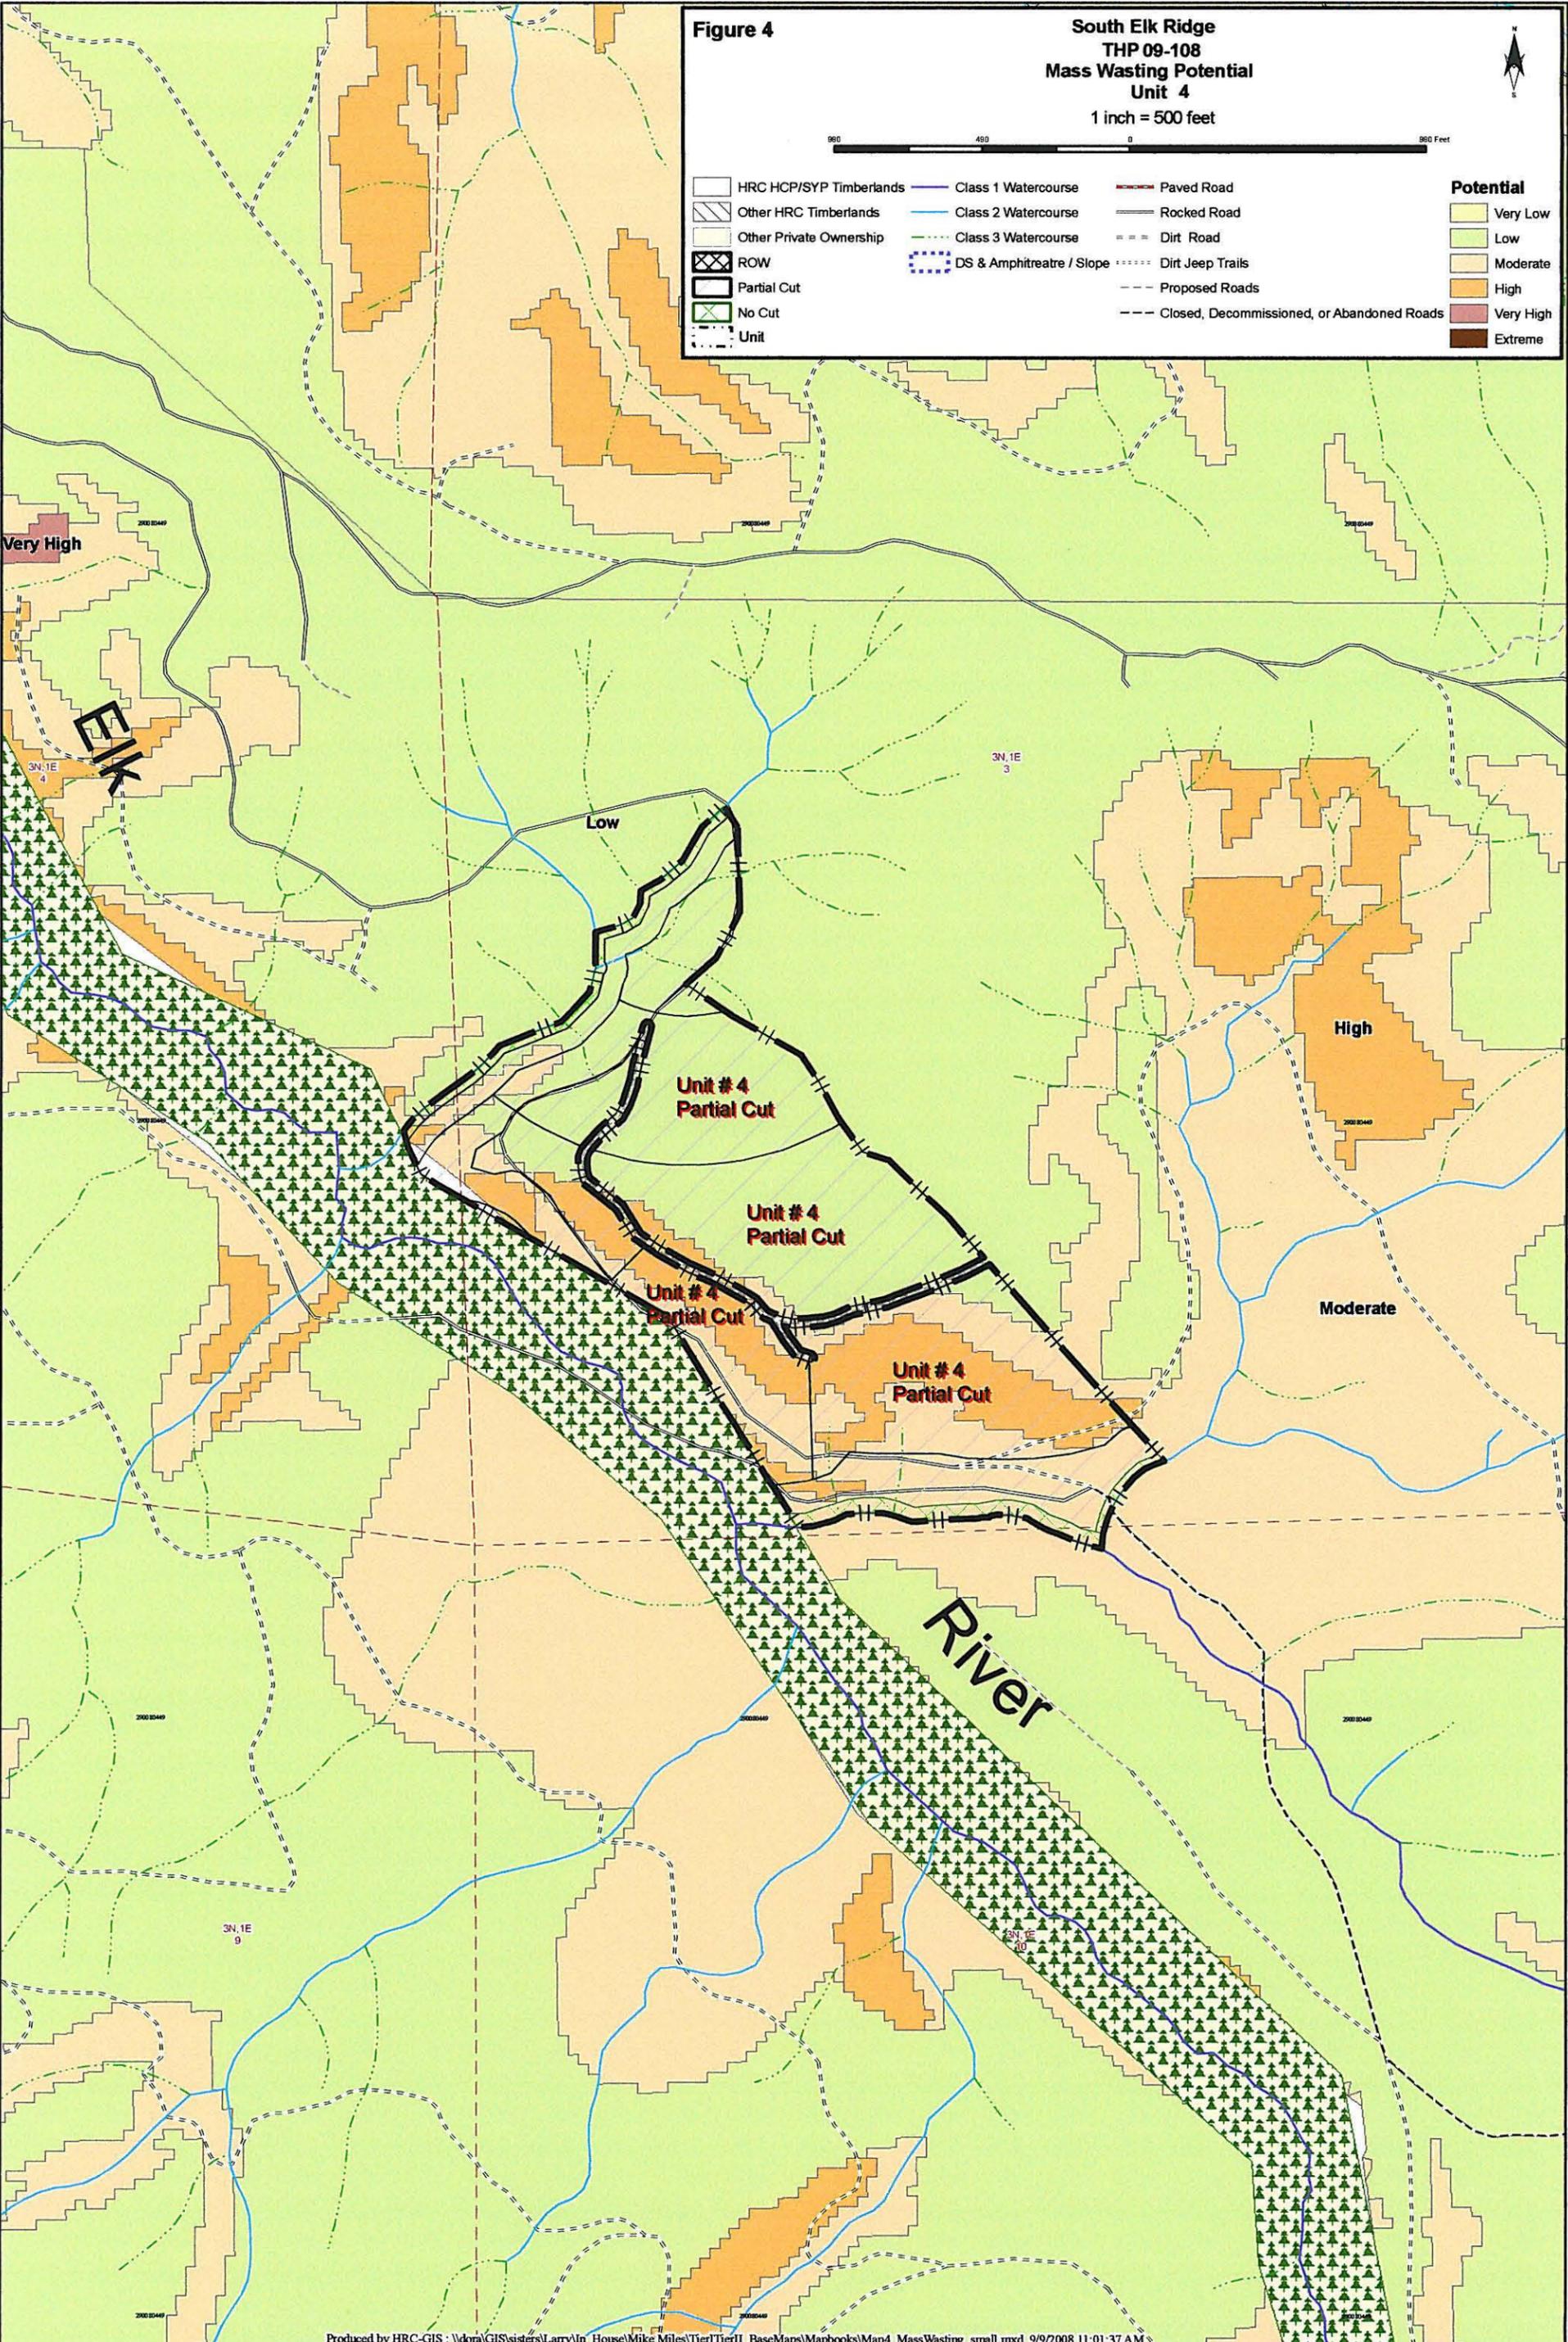
Figure 4

Mass Wasting Potential (MWP) modeling for the unit varies from low to high. The slope inclination is the factor that has resulted in the modeling of high mass wasting potential.

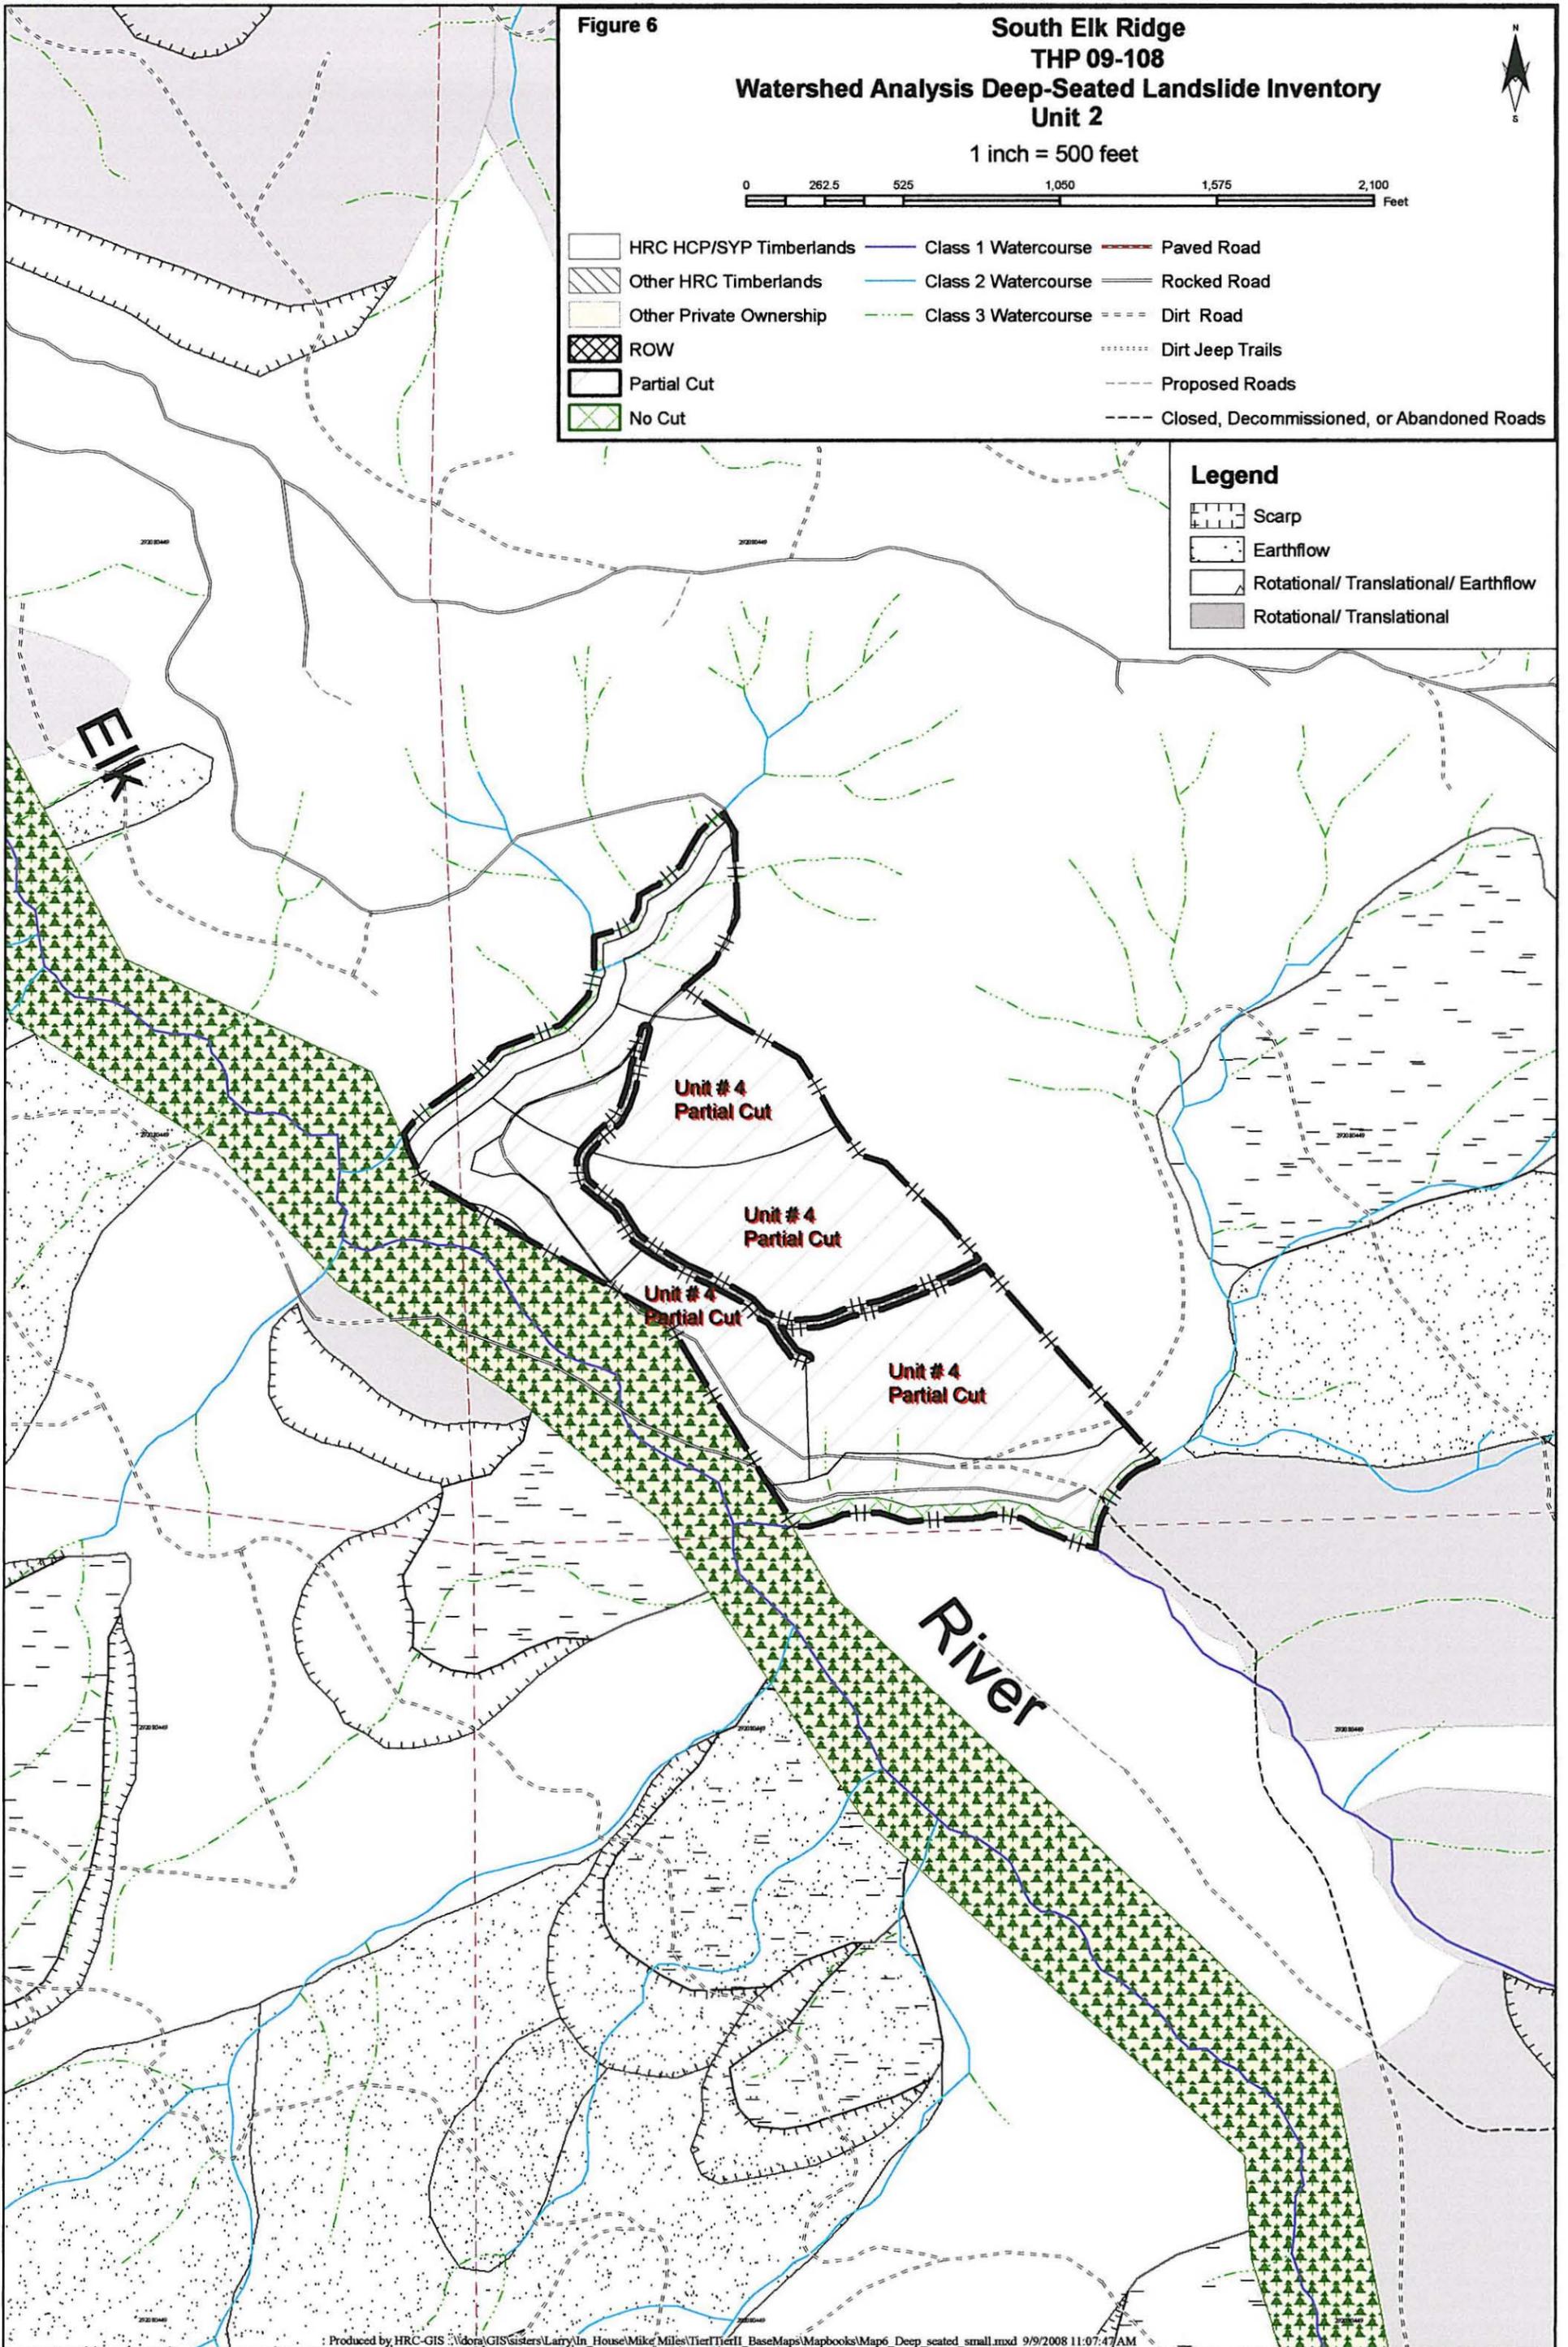
Figure 6 maps no areas of mass wasting within the unit.
